GEOLOGI FOR SAMFUNNET

GEOLOGY FOR SOCIETY

Report no.: 2013.014		ISSN: 0800–3416	Grading: Open
Title: Investigations on unstable rock slopes in Møre og Romsdal – status and plans after field surveys in 2012			
Authors: T. Oppikofer, A. Saintot, S. Otterå, R.L. Hermanns, E. Anda, H. Dahle, T. Eiken		Client: Norwegian Water Resources and Energy Directorate (NVE)	
County: Møre og Romsdal		Commune:	
Map-sheet name (M=1:250.000) Ålesund, Kristiansund, Røros, Ulsteinvik		Map-sheet no. and -name (M=1:50.000)	
Deposit name and grid-reference:		Number of pages: 323	Price (NOK): 1285,-
Fieldwork carried out: 2006–2012		Date of report: 13.11.2013	Map enclosures: 0
Fieldwork carried out: 2006–2012		Date of report: 13.11.2013	Project no.: 309900
Fieldwork carried out: 2006–2012		Date of report: 13.11.2013	Quality control: <i>Halvor Brundhoff</i>
<p>Summary:</p> <p>This report presents investigations, analyses and displacement measurements made between 2006 and 2012 on 131 unstable or potential unstable rock slopes in Møre og Romsdal County (Western Norway). An extract of this report is available in Norwegian (NGU rapport 2013.053).</p> <p>These investigations are part of the national plan for

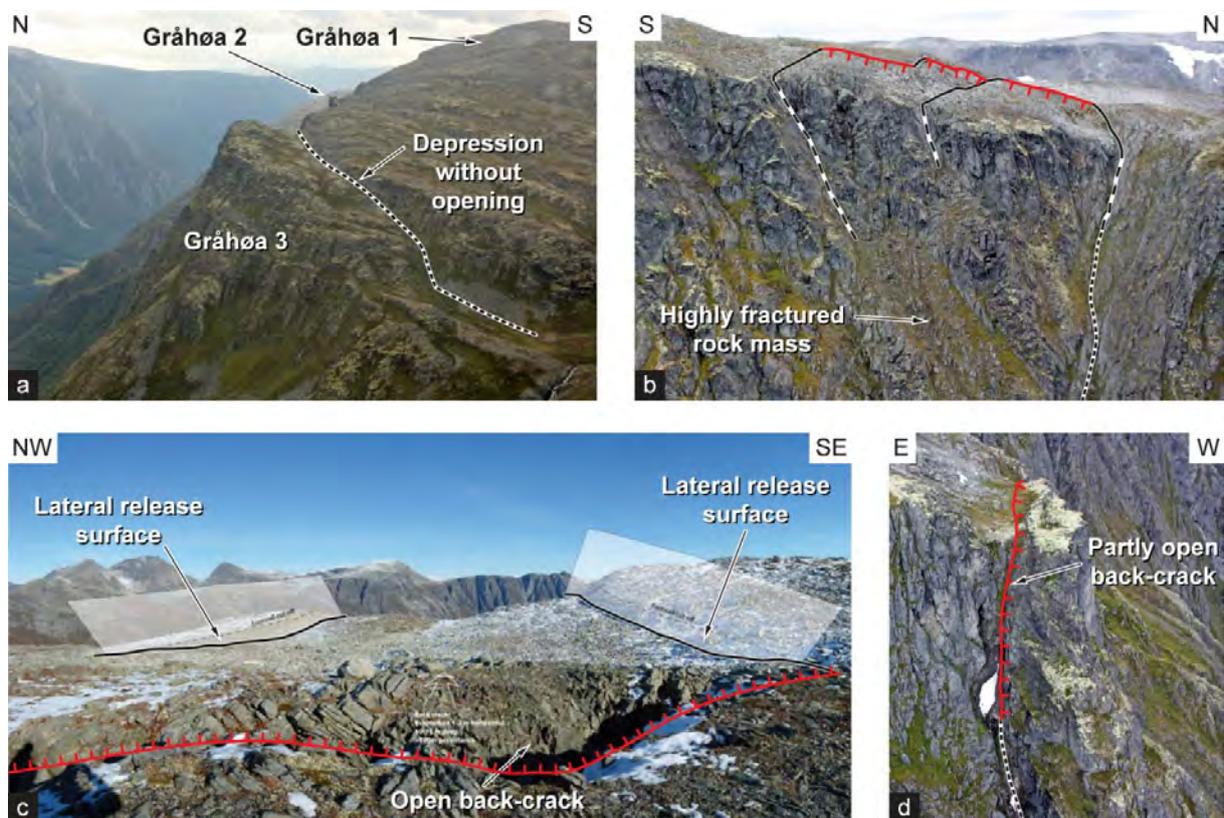
Figure 18: Photographs of the Gråhøa instabilities: a) the depression without visible opening in the back of Gråhøa 3 is probably created by an old fault; b) Gråhøa 1 is delimited by two lateral release surfaces resp. sliding surfaces forming a wedge. The rock mass at the base of the instability is highly fractured; c) view of the 2–3 m wide back-crack at Gråhøa 1 and the lateral release surfaces showing a clear offset (photo: H. Bunkholt, NGU); d) Gråhøa 2 is a small column detached by a partly open back-crack.

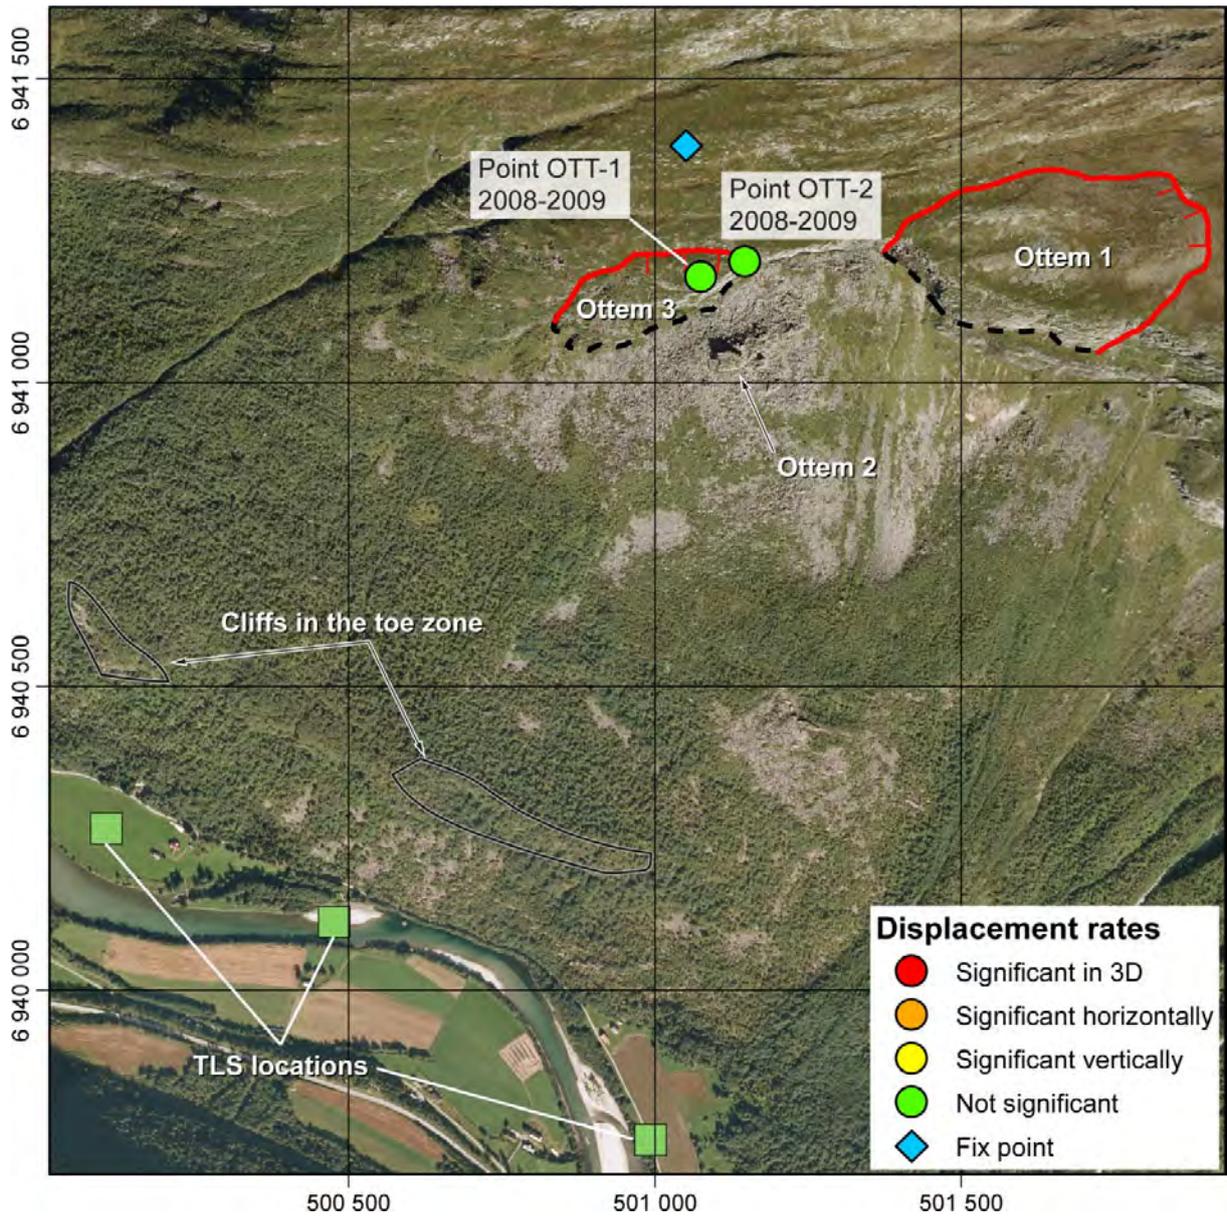
Figure 32: Map of the unstable rock slopes at Ottem with the location of dGNSS points for periodic displacement measurements. No significant displacements were detected over the 2008–2009 measurement period. The cliffs in the toe zone above Ottemsøyen were scanned by TLS in 2010 for structural analysis and possible detection of rockfall activity.

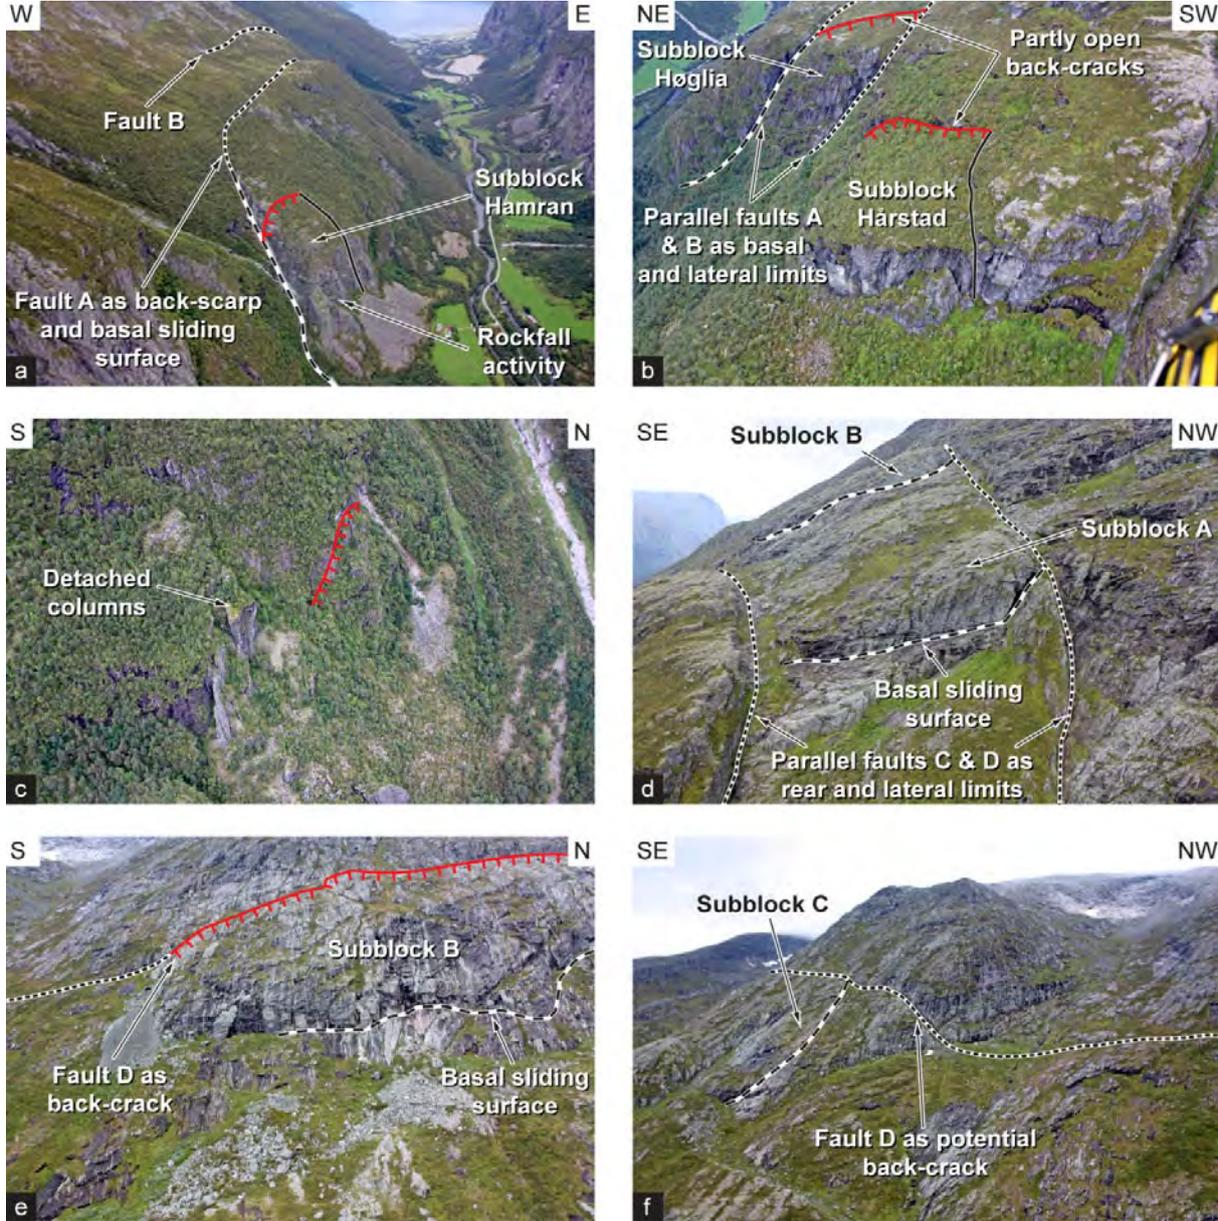
Figure 36: Photographs of the Storbotnen unstable rock slope: a) viewing north, the main unstable rock slope with an old fault as back-scarp and basal sliding surface. The subblock Hamran is prone to rockfalls; b) viewing SE, parallel faults delimiting the main unstable rock slope and two subblocks namely, Høglia and Hårstad; c) detached columns and small local instabilities at the foot of the slope at Hårstad; d) subblocks A and B located above Hårstad subblock; e) frontal view of subblock B with a well-defined basal sliding surface and a fault as back-crack; f) the fault forming the potential back-crack of subblock C has no visible opening.

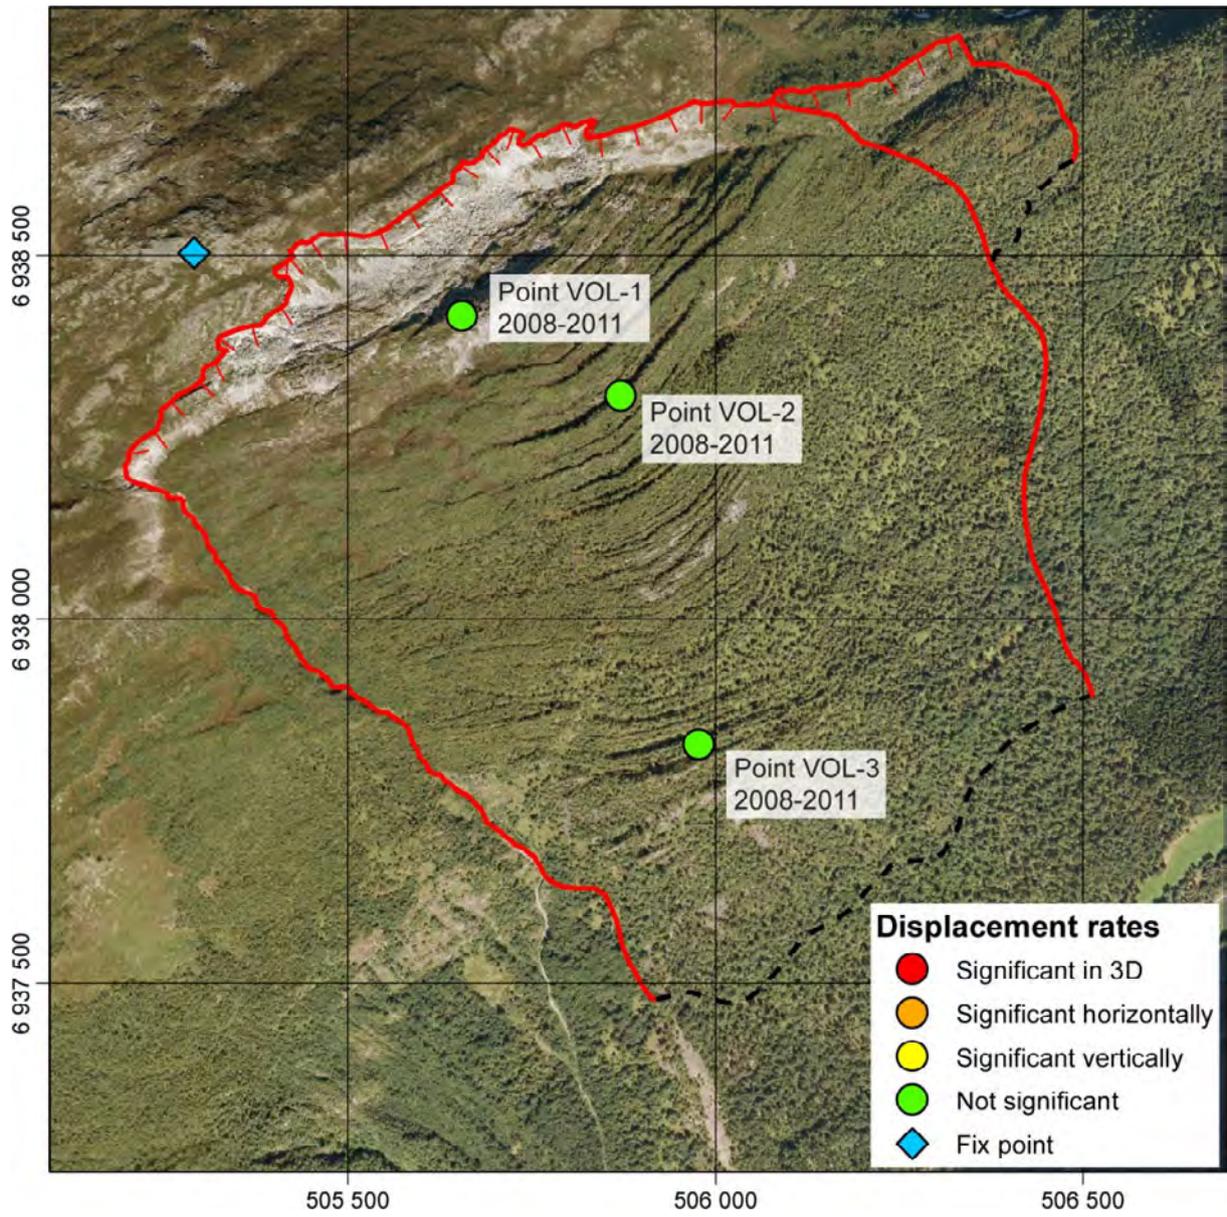
Figure 38: Map of the Vollan unstable rock slope with the location of dGNSS points for periodic displacement measurements. No significant displacements were detected over the 2006–2011 measurement period.

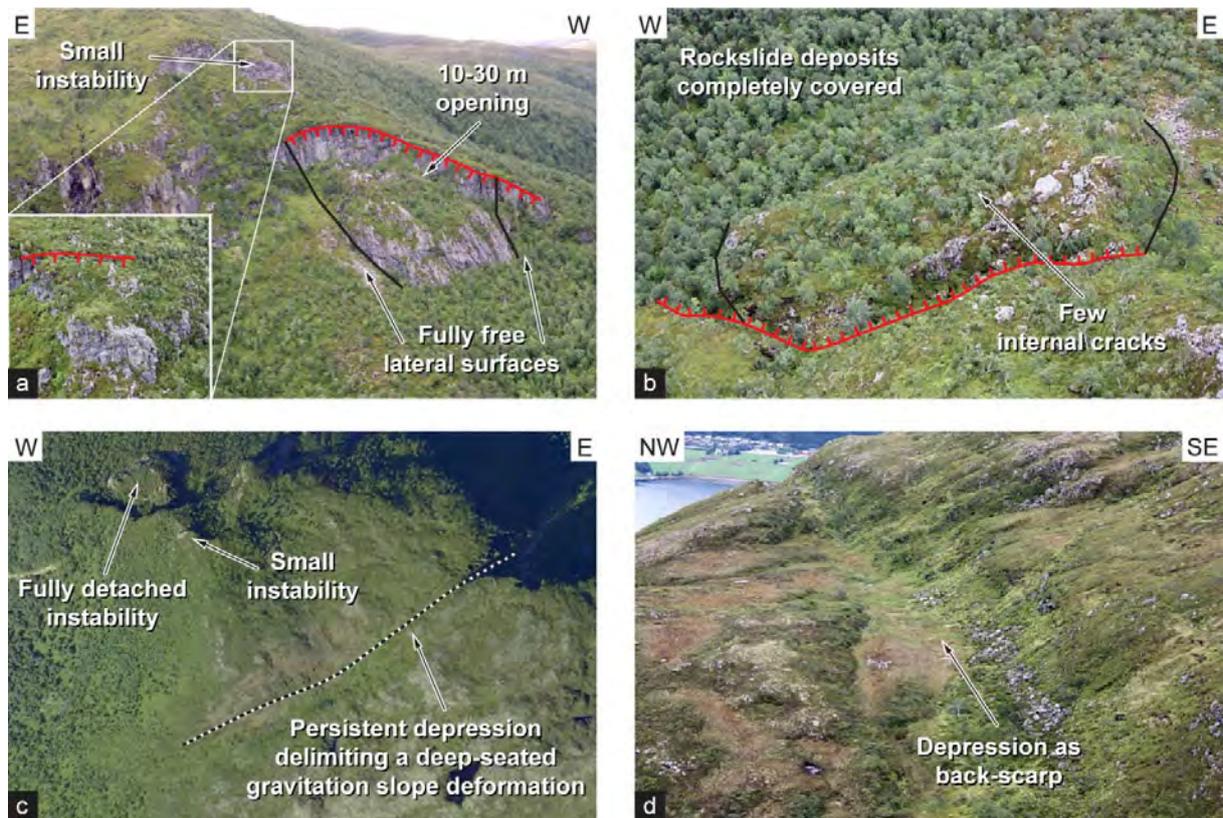
Figure 40: Photographs of the Røssholfjellet instability: a) and b) the instability Alteret is delimited by a wide open graben structure in the back and has free lateral surfaces; c) orthophoto showing a persistent depression delimiting a deep-seated gravitational slope deformation with the fully detached instability Alteret at its front; d) depression as back-scarp of the deep-seated gravitational slope deformation.

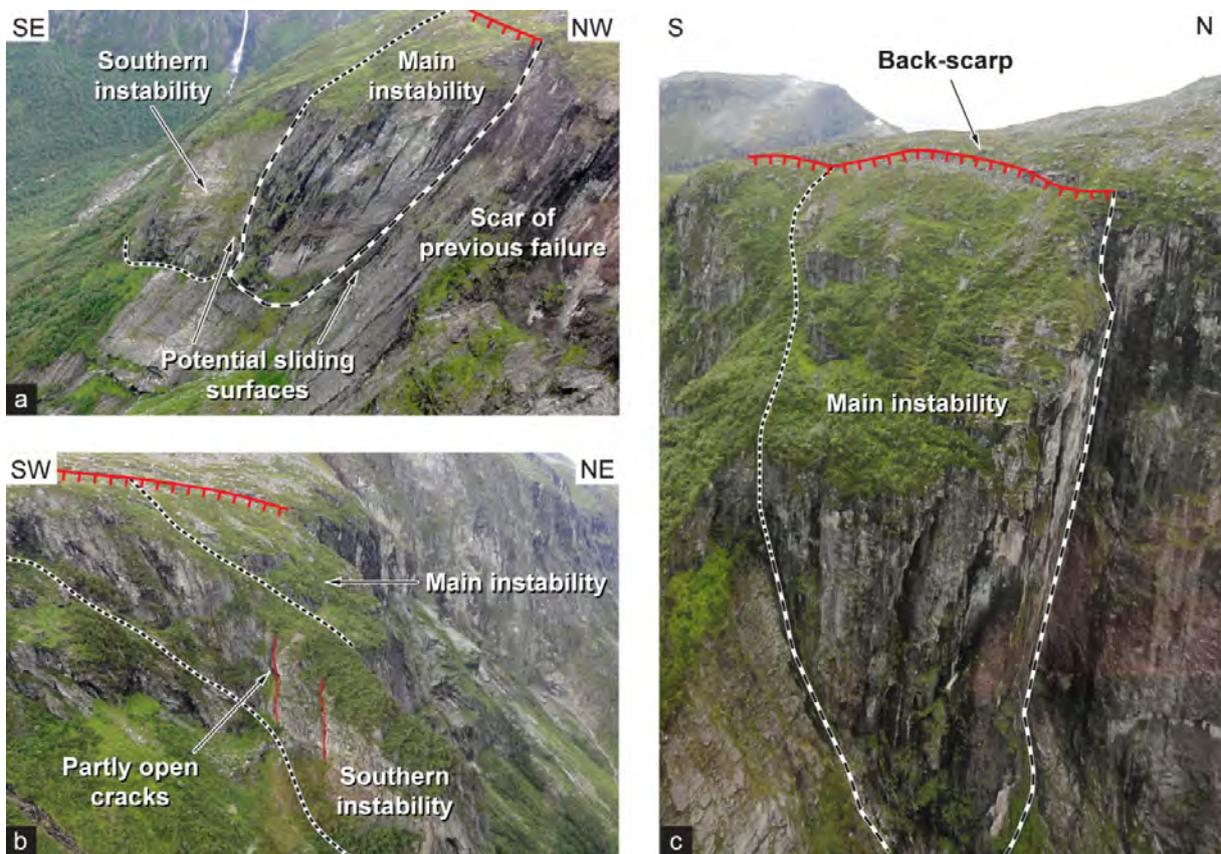
Figure 56: Photographs of Martinskora unstable rock slope: a) large valley-dipping surfaces form sliding surfaces for past rock slides and the present instabilities; b) the southern instability with fractures inside the block parallel to the main back-crack and with a moderately valley-dipping basal sliding surface; c) wedge failure on steeply NE- and E-dipping sliding surfaces.

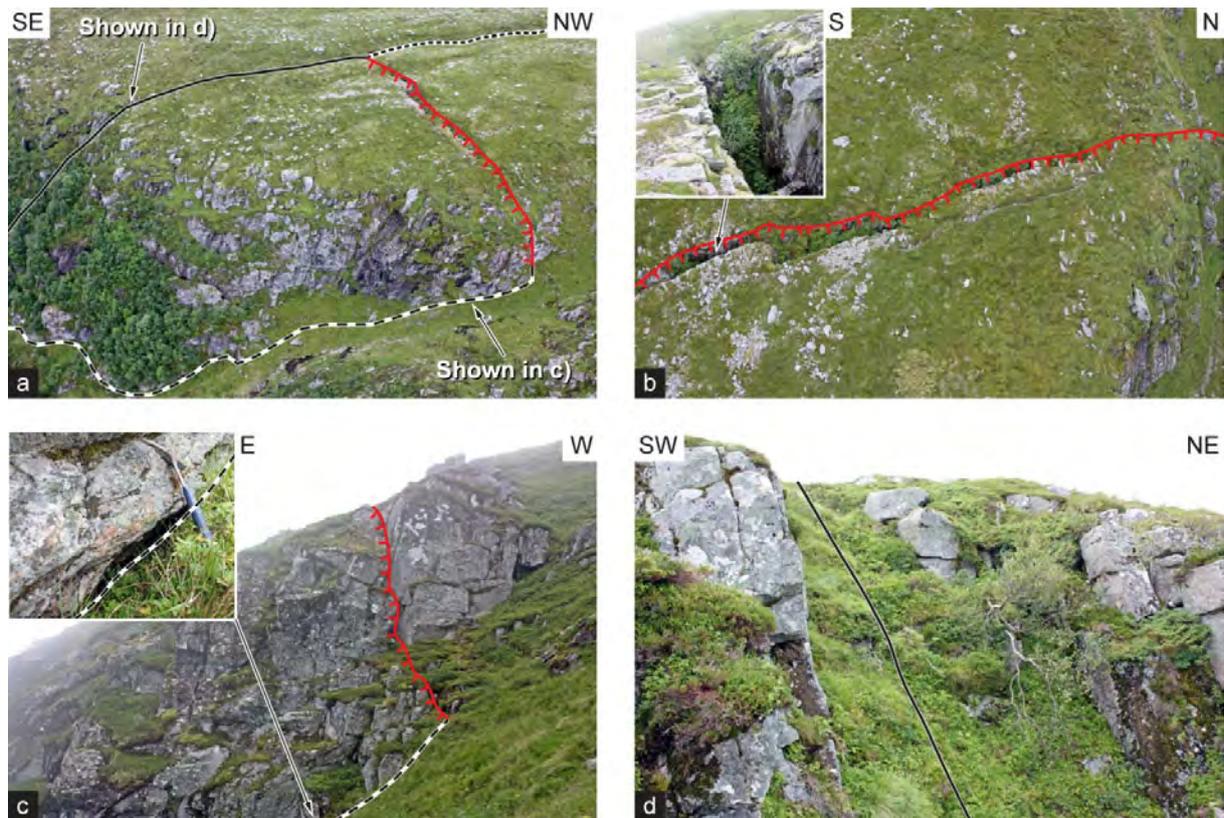
Figure 112: Photographs of the Grøthornet instability: a) overview of the instability; b) the back-crack is mainly formed by subvertical N-S-trending discontinuities and shows several dm to m opening; c) northern face of the instability with the continuous back-crack and the possible basal sliding surface (inset: apparent opening along the foliation-parallel basal sliding surface); d) lateral release surfaces marked by a surface depression.

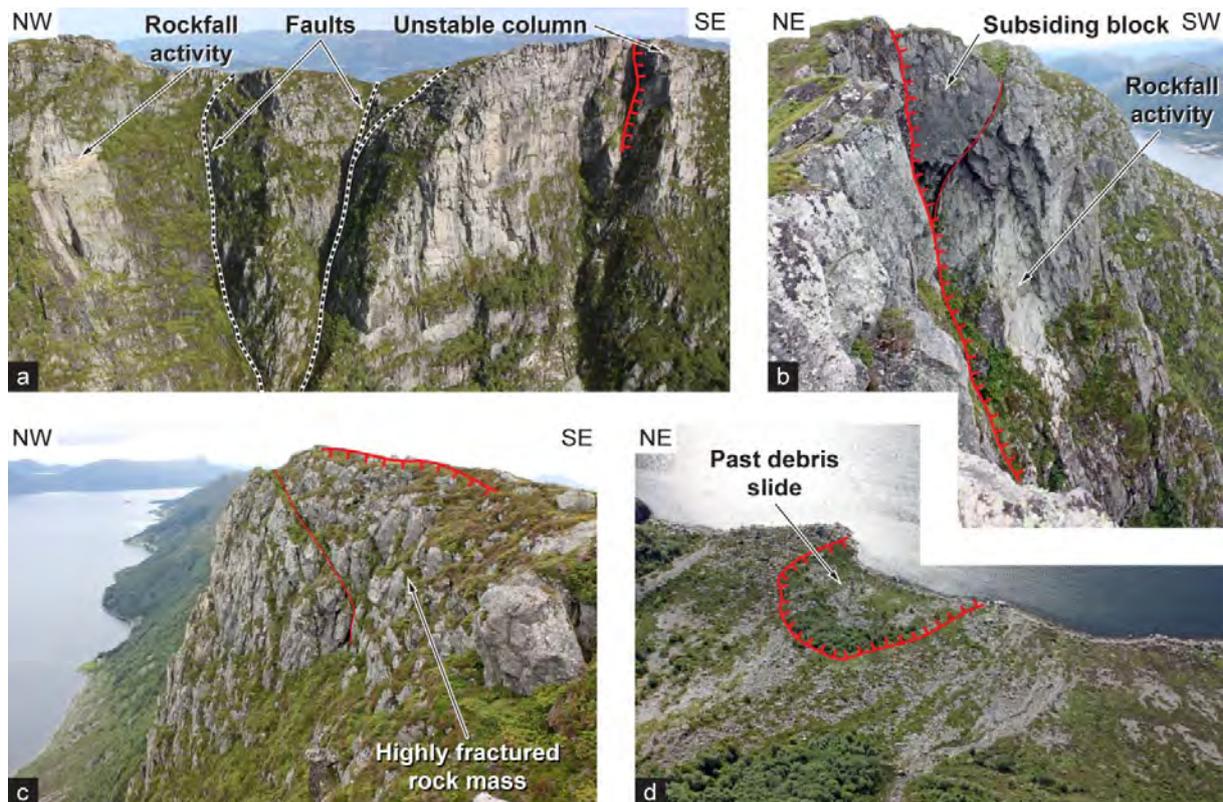
Figure 114: Photographs of the Laupsnipa instability: a) steeply S-dipping joints act as back-crack and as potential sliding surfaces. Large rockfall scars and potential rockfall blocks are observed at the front cliff; b) large talus slope at the foot of Laupsnipa with a past debris slide along the shoreline.

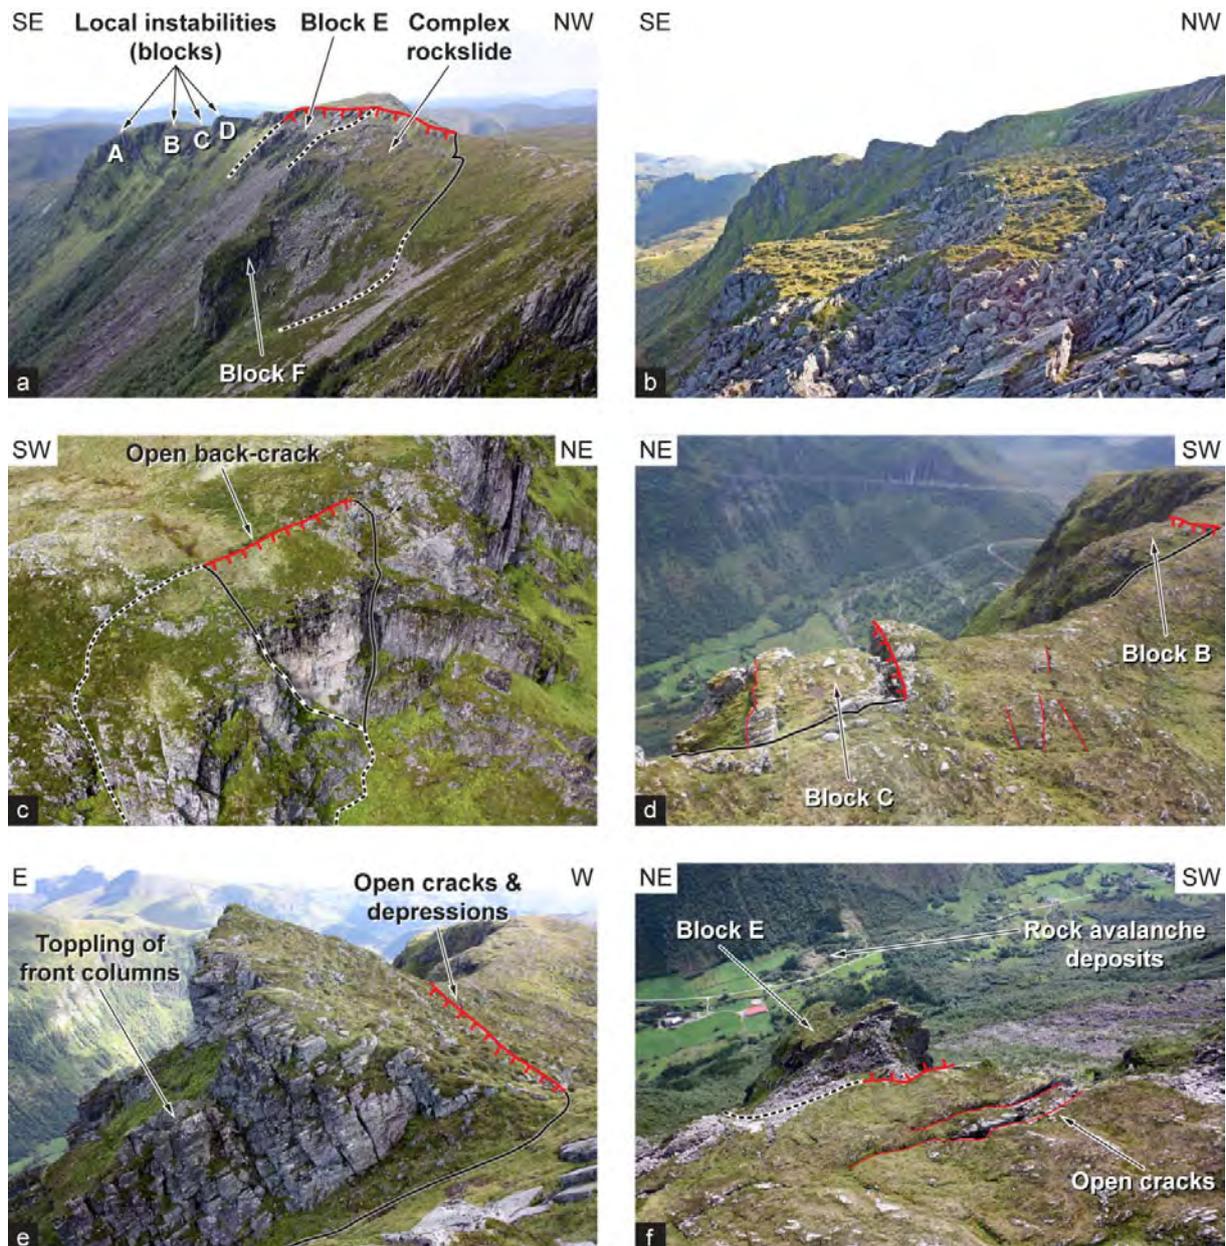
Figure 121: Photographs of the Storehornet instability: a) overview of the complex rockslide and of five localised instabilities; b) a series of scarps divided the complex rockslide into several compartments; c) block A is delimited by an open back-crack, but the lateral limits are uncertain; d) blocks B and C are delimited by open back-cracks and well-defined lateral release surfaces. Open cracks parallel to the back-crack of block C are visible; e) block D shows toppling movement of columns at its front and is delimited to the back by open cracks and surface depressions; f) block E is fully detached from the complex rockslide body. Rock avalanche deposits have crossed Saurdalen Valley and run-up on the opposite valley flank.

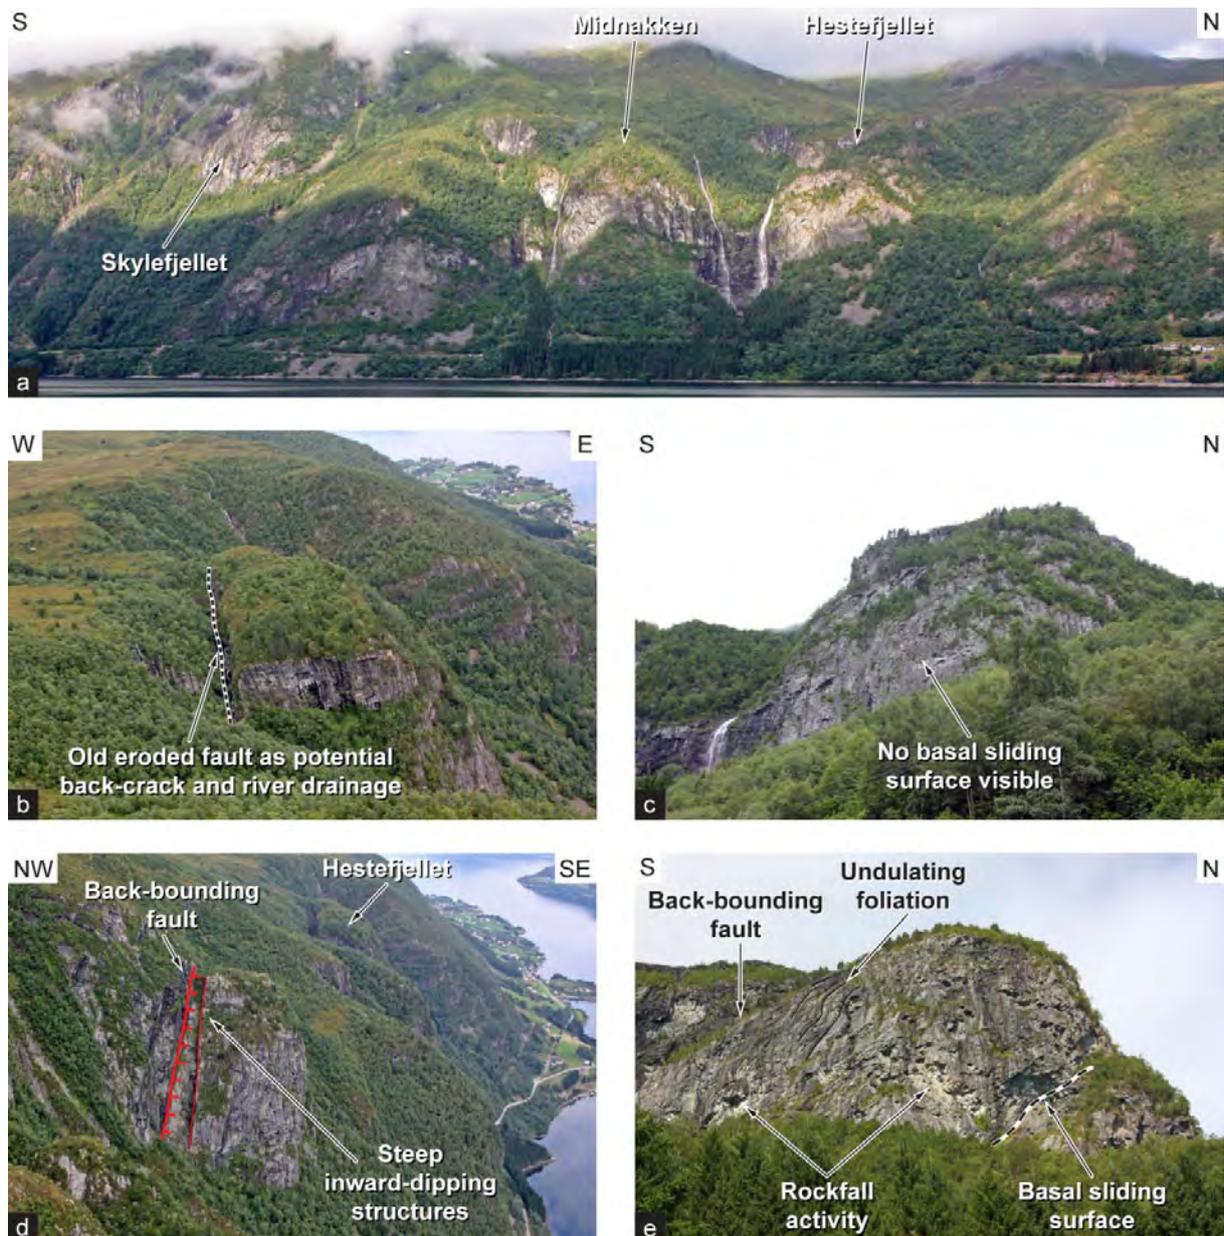
Figure 126: Photographs of the potential instability at Hestefjellet, the Skylefjellet instability and the Midnakken spur: a) overview photograph; b) Hestefjellet is back-bounded by an old eroded fault that guides the river drainage; c) no basal sliding surface is visible at the frontal cliff of Hestefjellet; d) Skylefjellet is back-bounded by the same old fault as Hestefjellet; e) a basal sliding surface parallel to the foliation is visible at Skylefjellet, along with relatively recent rockfall activity.

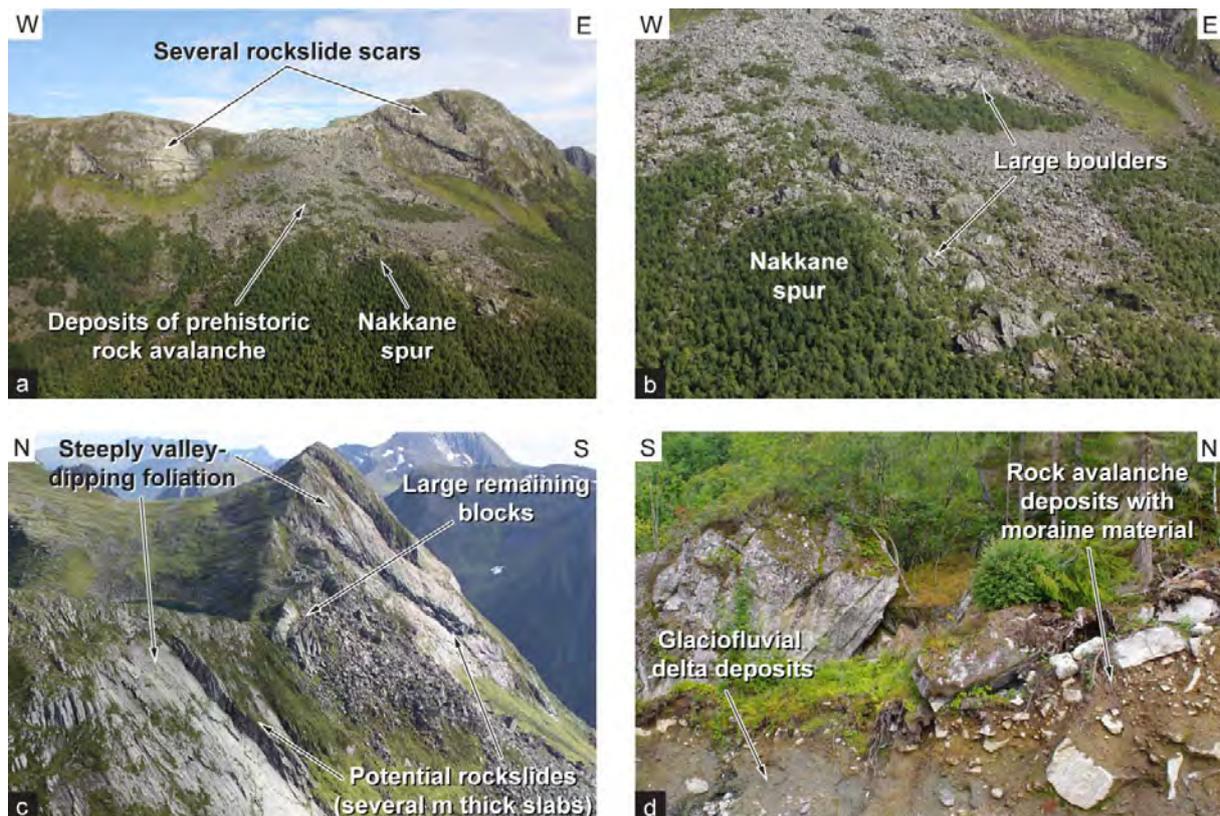
Figure 140: Photographs of the Skorgeurda unstable rock slope: a) frontal view of the rock avalanche deposits and scars; b) large boulders deposited on the slope at Nakkane spur; c) remaining blocks and slabs may slide on the steeply valley-dipping foliation that formed already the basal sliding surfaces of the prehistoric rock avalanche; d) rock avalanche deposits with incorporated moraine material and large boulders overlaying glaciofluvial deposits.

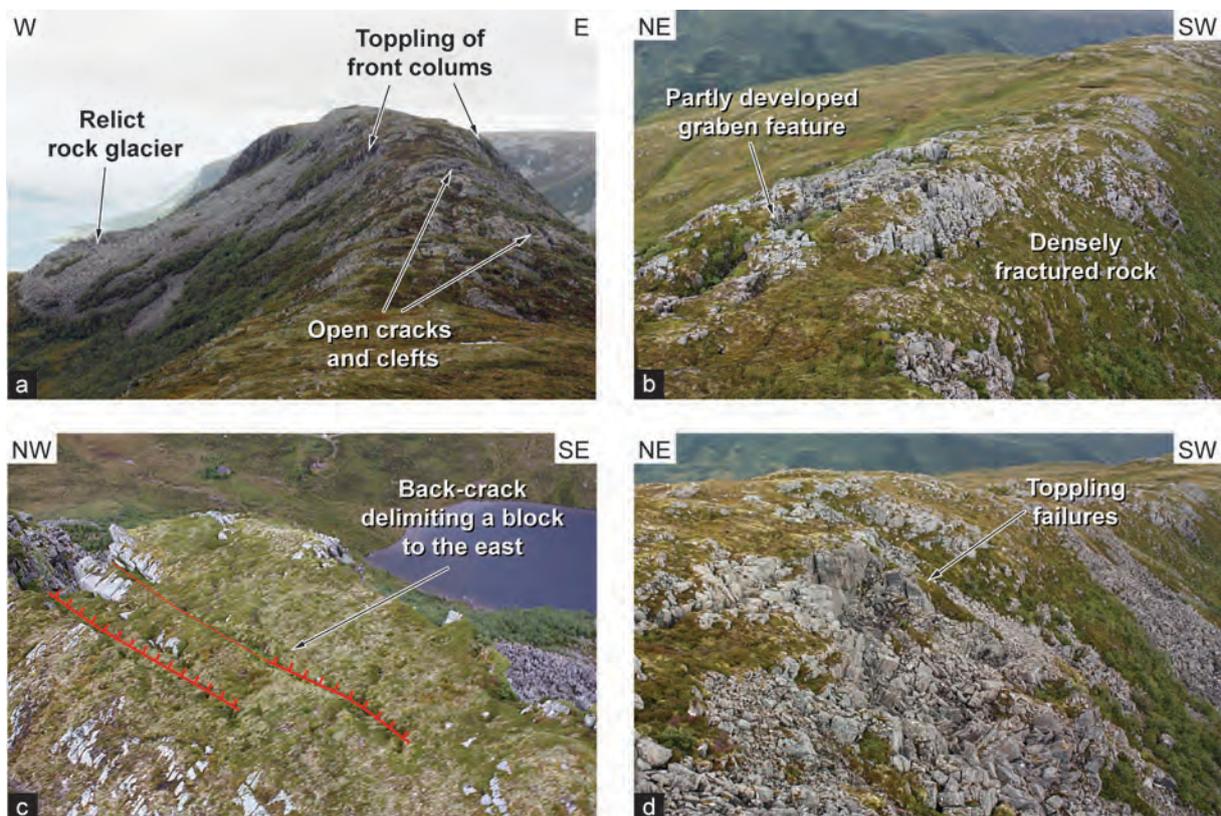
Figure 146: Photographs of the Otrefjellet rock slope: a) the mountain ridge is highly fractured and disintegrates towards the east and west by toppling; b) open cracks and grabens affect the densely fractured rock mass; c) back-cracks of a localised instability on the eastern flank; d) toppled blocks on the western flank.

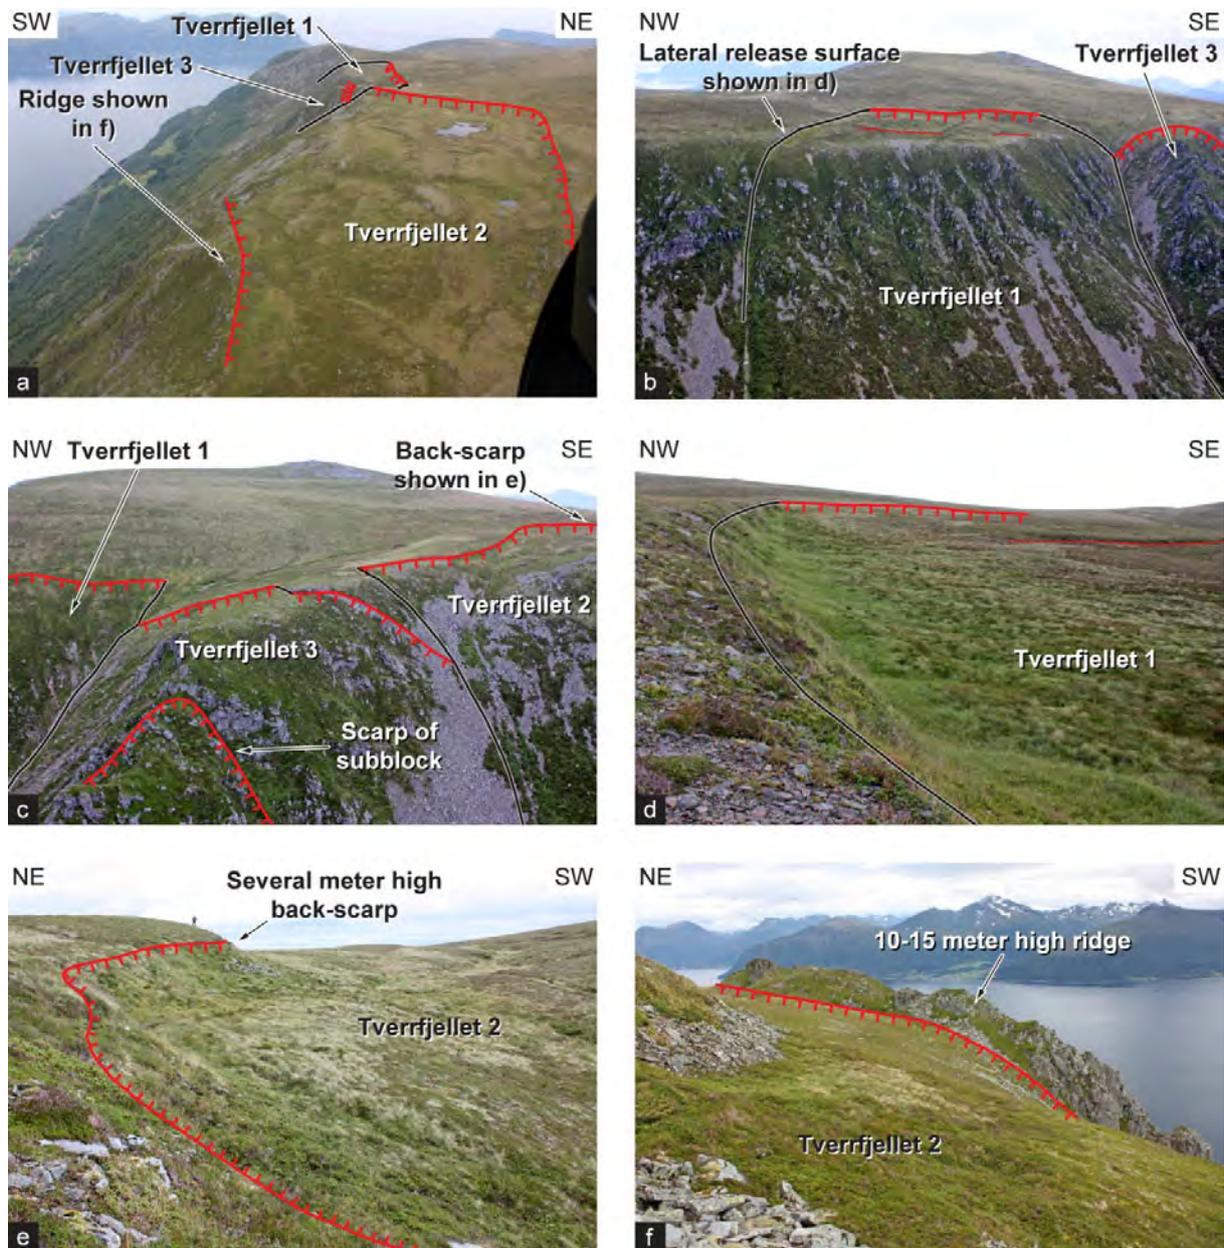
Figure 153: Photographs of the three Tverrfjellet unstable rock slopes: a) overview photograph displaying the ridge and lakes on Tverrfjellet 2; b) frontal view of Tverrfjellet 1 with few open cracks on the plateau; c) Tverrfjellet 3 is delimited by a 1–2 m open back-crack, a subblock is separated from the main instability by a 5 m wide graben; d) lateral release surface of Tverrfjellet 1 with a decreasing throw towards the back-scarp; e) back-scarp of Tverrfjellet 2; f) 10–15 m high ridge located in the eastern part of Tverrfjellet 2 indicates differential movement of two compartments of the unstable rock slope.

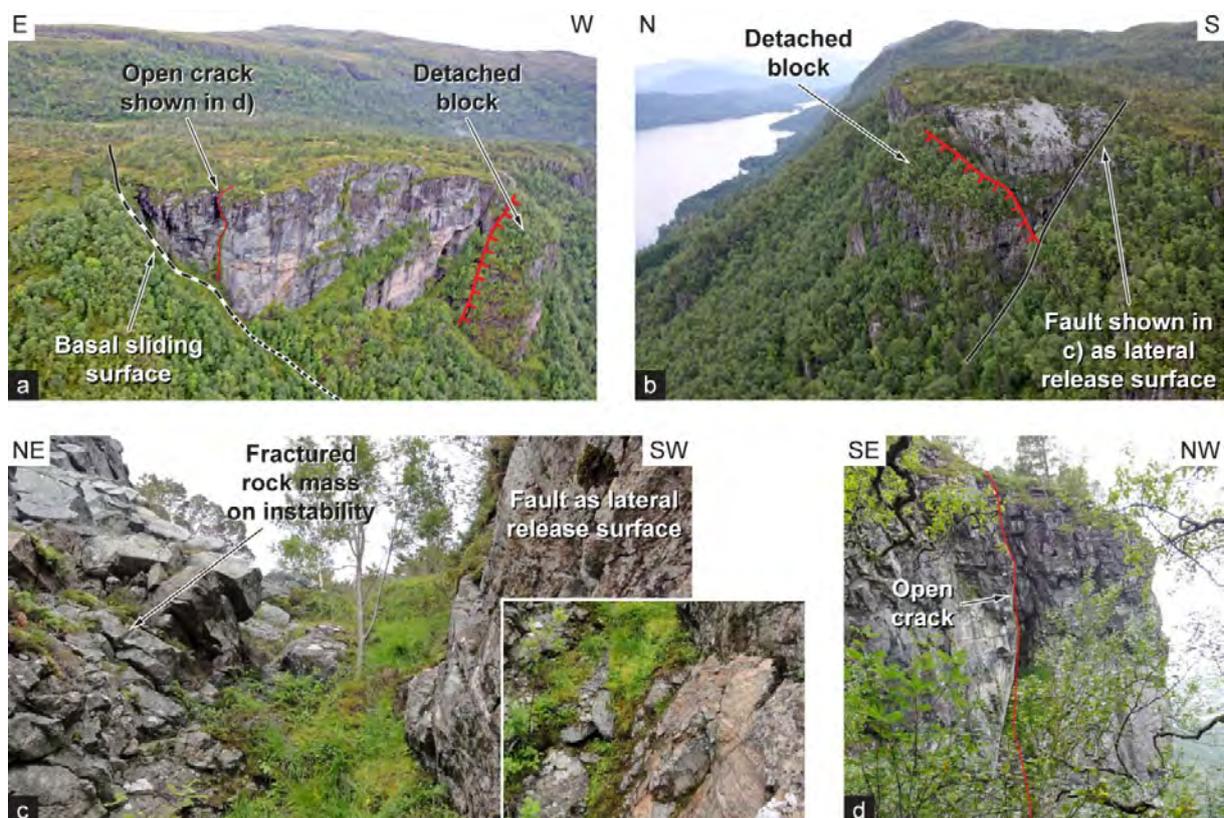
Figure 155: Photographs of the Rambjøra instability. a) frontal view of the instability with the basal sliding surface as eastern limit and detached blocks at the front; b) a fault forms the lateral release surface in the SE; c) detail of the SE-bounding fault (inset: mineralisation of the fault zone); d) open subvertical crack delimiting a column along the front cliff.

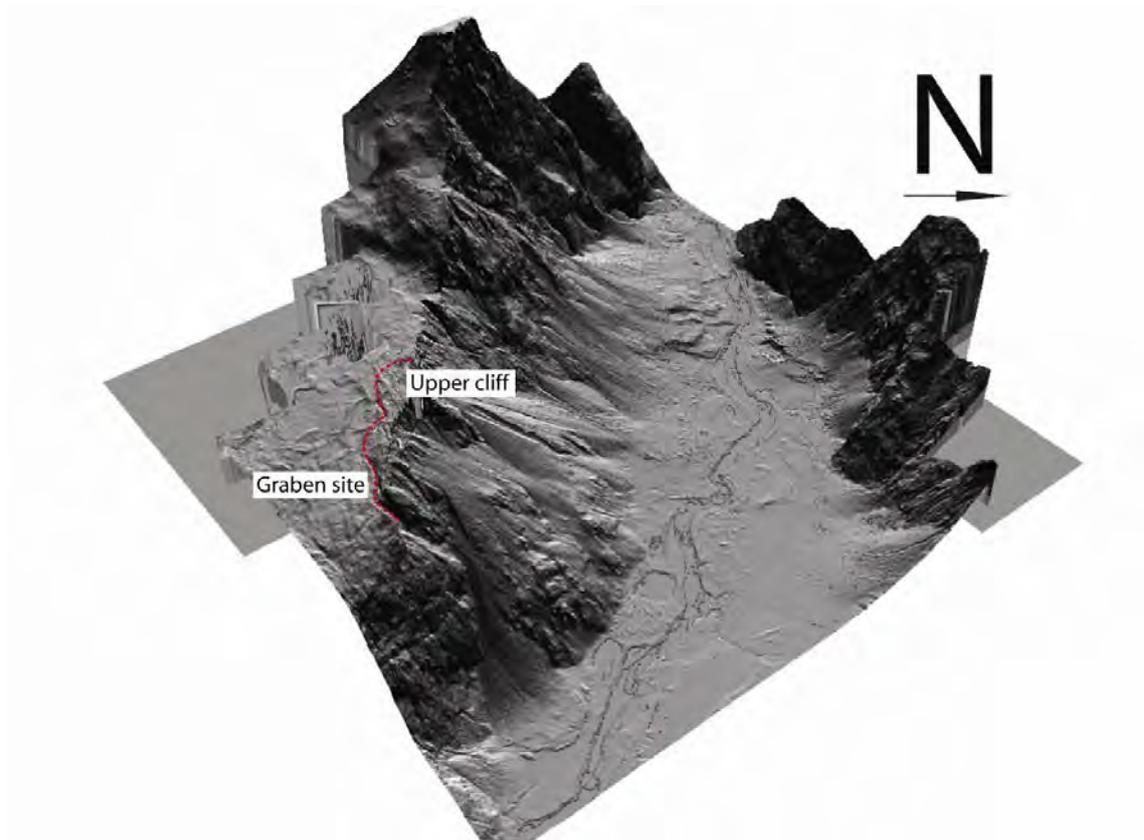
Figure 16: 3D view of Børa site, with the opened fracture in red.
