**GEOLOGICAL
SURVEY OF
NORWAY**

Report no.: 2020.038		ISSN: 0800-3416 (print) ISSN: 2387-3515 (online)		Grading: Open	
Title: GPR survey at Arildsløkka, Trondheim for the detection of historical reinforcement structures along the Nidelva riverbank					
Authors: Georgios Tassis, Inger-Lise Solberg, Marco Brønner, Bjørn-Eskil Larsen			Client: NVE		
County: Trøndelag			Commune: Trondheim		
Map-sheet name (M=1:250.000) Sør-Trøndelag			Map-sheet no. and -name (M=1:50.000) 1621-IV Trondheim		
Deposit name and grid-reference: Trondheim city center			Number of pages: 28 Map enclosures:		Price (NOK): 110,-
Fieldwork carried out: 21-22/11/2019 & 25-26-28-29/5/2020		Date of report: 13/11/2020		Project no.: 388001	
				Person responsible: <i>Jostein Mårdalen</i>	
Summary: The Norwegian Water Resources and Energy Directorate (NVE) is investigating measures to prevent landslides at Arildsløkka, Trondheim city center. Historical evidence shows that the area was secured by timber boxes in the year 1730 however, it is unknown whether these structures are still intact or if they have been reduced to single rows of pillars which are visible today. According to technical reports, the river flow has d

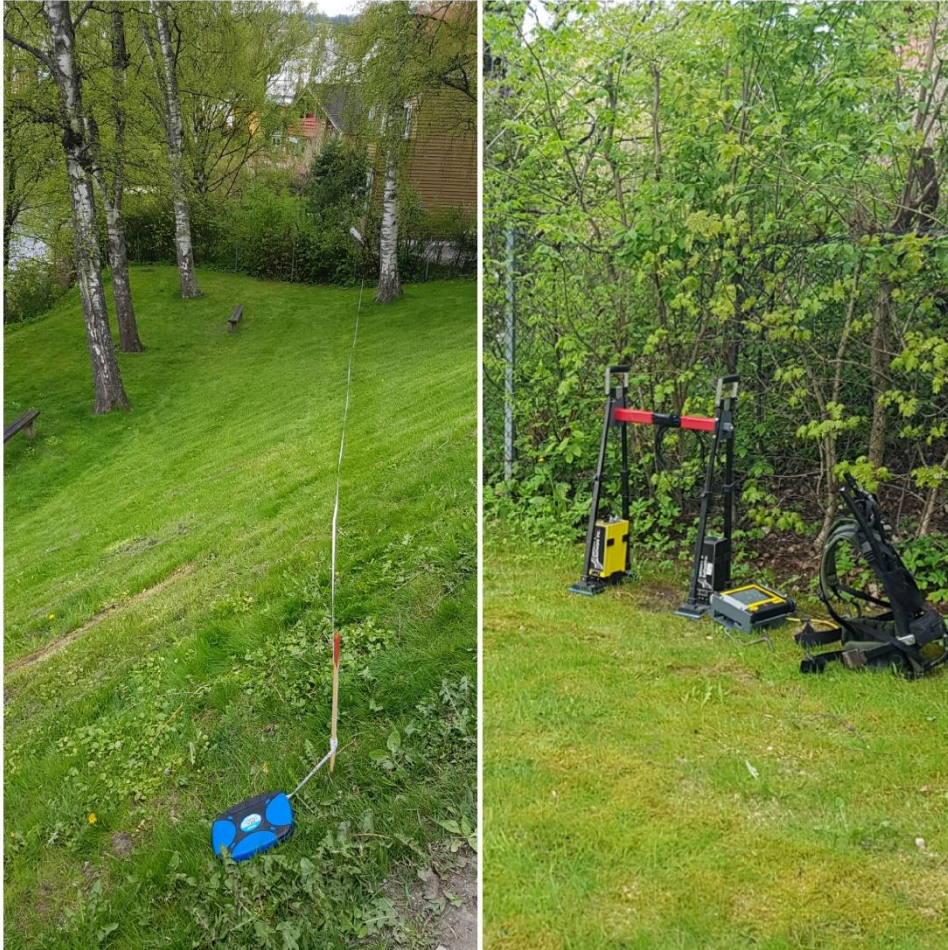
Figure 3.3: Photos from the second GPR survey at Arildsløkka in May 2020.

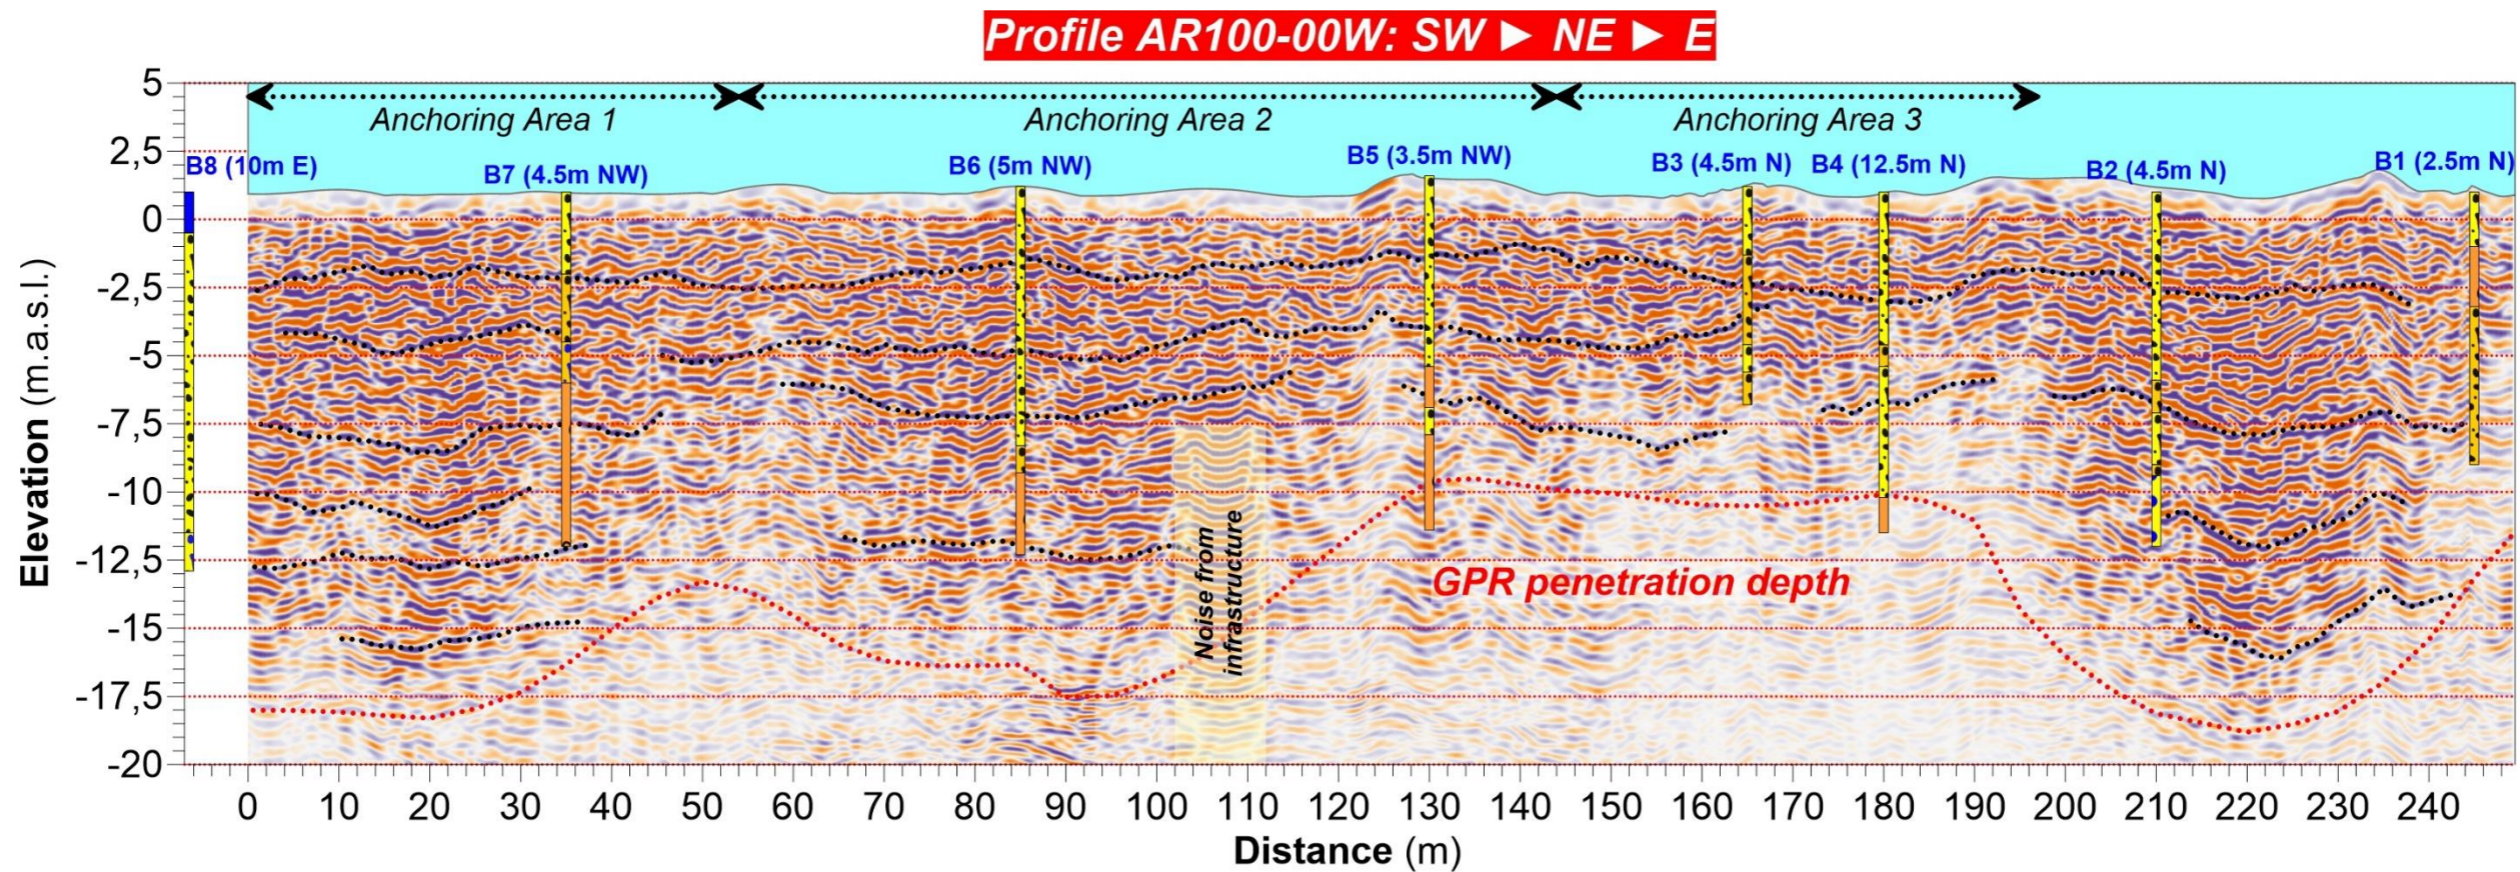
Figure 5.1: Processed radargram for profiles AR100-00W & AR100-00E with interpretations (red dotted line: GPR penetration depth, black dotted lines: prominent reflectors). Boreholes B1-B8 are from TK (1898), B462 is from TK (1986) and B1418-2 is from TK (2008). Borehole reports are available from NADAG (2020). Anchoring areas in AR100-00W are referring to the inferred construction, shown in figures 1.1b and 3.1.

In this section, the processing results for profiles AR100-00W and AR100-00E are presented. **Figure 5.1** displays the resulting radargrams for both profiles along with borehole data close to the profiles and anchoring areas as delineated in the map from 1772 shown in **figure 3.1**. It also shows interpretations concerning prominent reflectors in the ground and overall penetration depth and shaded areas of increased ambient noise. The borehole data incorporated in these radargrams have been fitted to the elevation of the profiles, even though all of them are drilled north of the survey lines. However, most of these boreholes are within five meters of the actual GPR profiles – with only a few exceptions – and therefore can be used as ground truth to help interpreting our results. Accurate distancing and direction of the position for each borehole is given in **figure 5.1**.

The borehole data indicate that the dominant sediments in the survey area are gravel/sand of various grain size and this is very well reflected in our results by the high penetration depth achieved locally. The occasional presence of silt/clay in the area does not hinder the signal from penetrating deep in the ground west of Nidareid bridge (profile AR100-00W – **top figure 5.1**), but it does so east of the bridge where the penetration depth is substantially decreased (profile AR100-00E – **bottom figure 5.1**). Our results validate that the study area offers different penetration depths locally, according to the composition of the ground and marks two distinct dielectric regimes west and east of the Nidareid bridge.

The gravel/sand layers which are dominant west of our study area together with the high number of stacks we were able to utilize by collecting our data in step mode, enable the electromagnetic signal to penetrate as deep as 20 meters locally, which well exceeds the assumed dimensions of the timber boxes. We may distinguish three areas of increased penetration, namely from 0 to 30, 70 to 110 and 200 to 240 meters distance. The reflectors revealed in profile AR100-00W are sub-horizontal in their majority which indicates naturally deposited sediments but also locally arcing downwards, portraying possible depressions in these layers. The most prominent of them represent changes in grain size in the ground and are shown in black dotted lines in **figure 5.1**. Penetration depth in this profile is almost continually high except for an area between 130 and 190 meters. According to the borehole data, there is no drastic geological change there, however, the GPR penetration depth shown in red dotted line in **figure 5.1** is drastically decreased (from 20 to 10 meters). Reflectors can still be seen in depth, but they are very weak compared to their neighboring ones and this can be linked to water saturation.

The eastern side of our study area surveyed by profile AR100-00E shows the opposite dielectric regime than the western one i.e. presents limited penetration depth (red dotted line) as easily seen in **figure 5.1**. Generally, it remains below 10 meters with this value only achieved locally at 0 to 10 and 60 to 70 meters distance. Typically, depth coverage is closer to 5 meters which is indicative of higher clay/silt content, also verified by the limited borehole data. Respectively, less prominent reflectors are marked in this profile with black dotted lines.

Despite the very good data quality and sufficient penetration depth for the predominant parts of the profiles, the data shows no direct indication for the existence of any wooden construction even though GPR data of such resolution should have responded to such infrastructure. However, assuming the ancient reinforcement were equal or similar to what is presented in figure 1.1a and b, one must assume that the timber boxes are not in existence any longer but the second or even third row of pillars is what is exposed today along the riverbank.
