**NGU REPORT**  
**2021.035**

Hazard and risk assessment of the  
Stiksmoen unstable rock slope in  
Aurlandfjord (Flåm, Vestland)

<b>Summary:</b> <p>Stiksmoen is located on a west-facing slope at approximately 120 m a.s.l. in the southern end of Aurlandfjord (Flåm municipality, Vestland county). The unstable rock slope is bounded by a well-developed backscarp, wide open in the north and open but less developed in the southern sector. The lower limit is mapped close to the foot of the frontal cliff of the unstable rock mass. The upper and central part of the instability is characterized by the presence of several open cracks, 10 to 15 meters deep. High rockfall activity is observed in the frontal cliff, with the detached blocks forming a block field. Structural and geophysical surveys allowed for the reconstruction of the sliding surface of Stiksmoen and the computation of its volume (ca. 0.4 million m<sup>3</sup>). Extensometers, dGNSS, ground-based and satellite-based radar measurements show similar displacement rates in the upper-central part and on the lower-frontal part of the unstable rock mass. The obtained displacement rates range from 0.9-2.5 cm/y towards the west, with

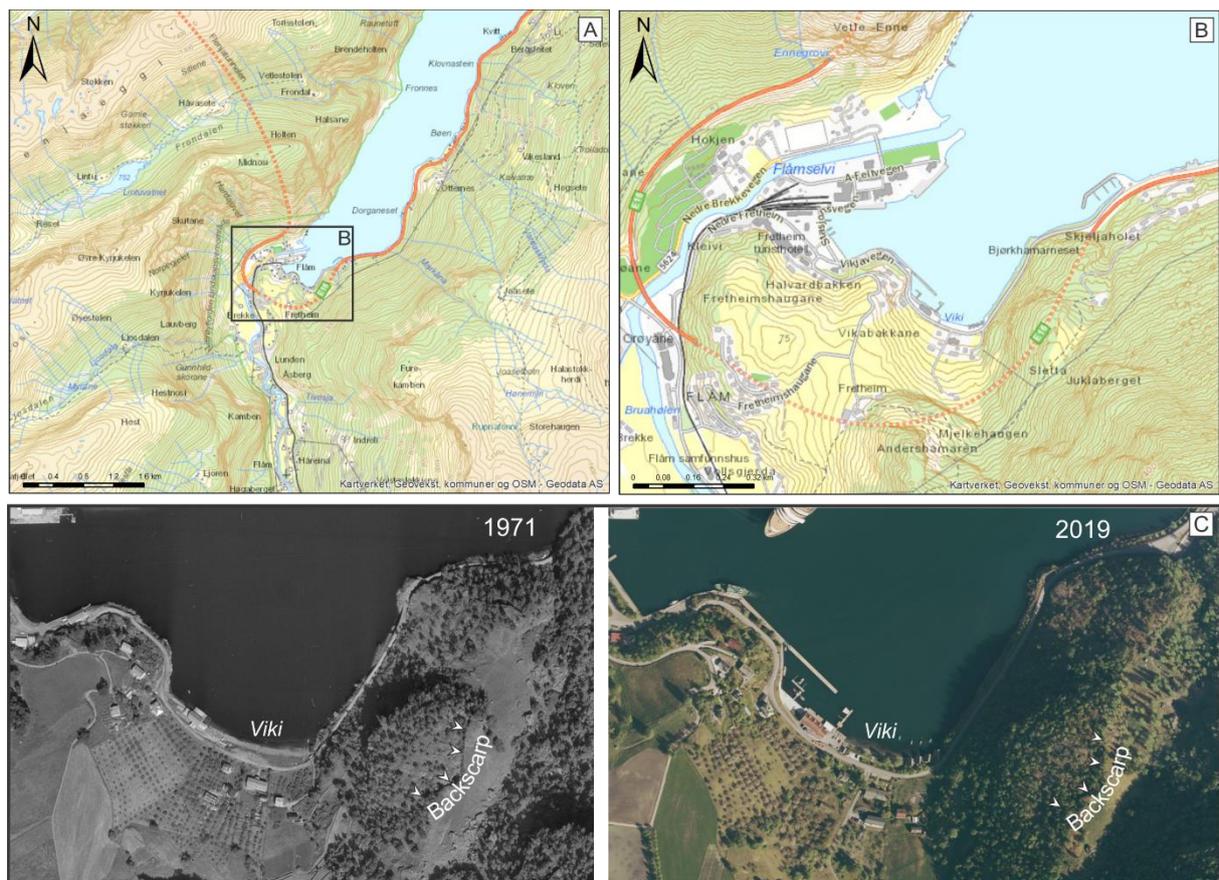
Figure 2. A) View to the southern end of the Aurlandfjord. B) Detailed view of Flåm and the location of the unstable rock slope. C) Aerial photos showing the unstable rock slope in 1971 and 2019.

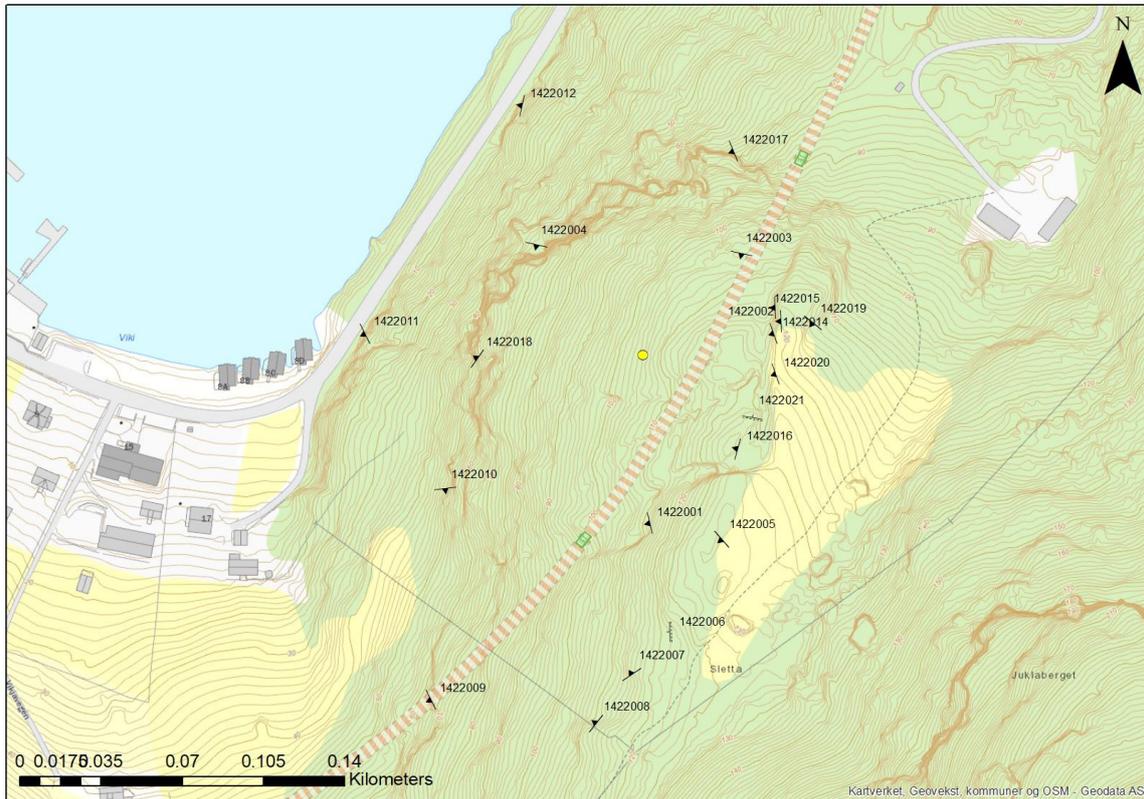
Figure 4. Location of sites where structural measurements were performed.

The phyllites in Stiksmoen are affected by different types of discontinuities (different sets of foliation and fractures). During field work, the orientation of these structures was measured at 20 sites using a compass, and each structure's dip and dip direction was measured (Figure 4). The spatial arrangement of discontinuities conditions the stability of the rock mass and the kinematics of its deformation. In this work, the orientation data was used to perform kinematic analyses of slope stability using the software Dips, version 7.0 (Rocscience.com).

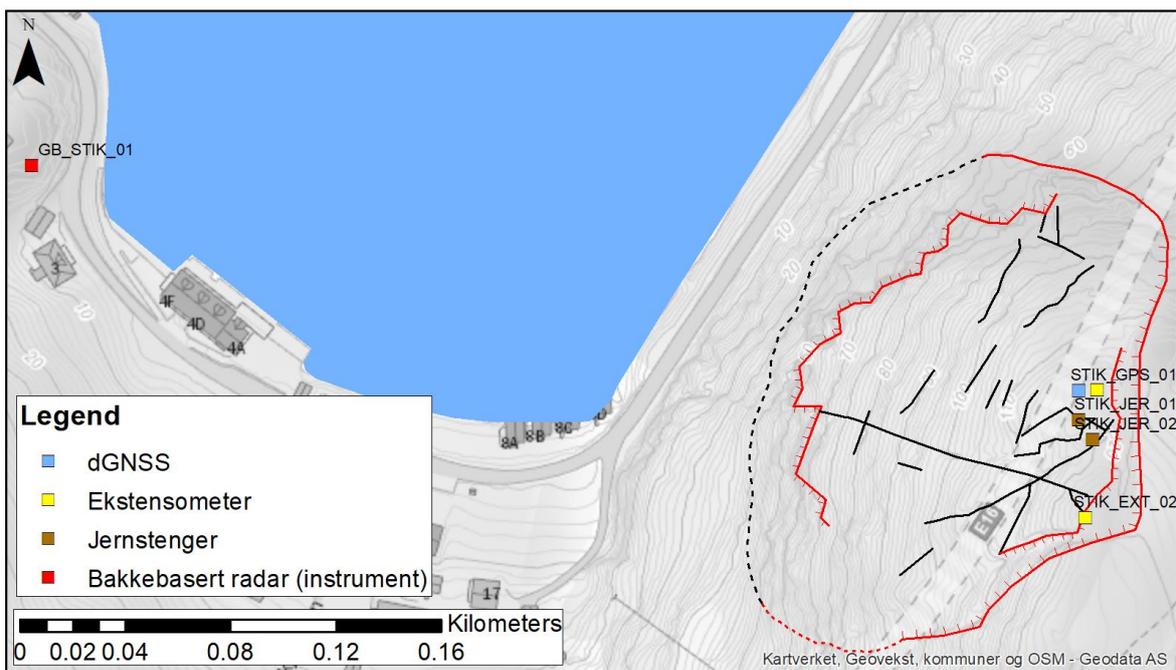
Figure 5. Map showing the limits of the unstable rock mass and the location of the dGNSS, extensometers and GB-InSAR stations.

The displacement rate of Stiksmoen has been determined using *in situ* and remote measurement techniques (Figure 5).

Differential Global Navigation Satellite Systems (dGNSS): In Stiksmoen, one rover point was installed (Figure 5). The point became part of the network with 32 stations that have been installed at Stampa between Ramnanosi and Otternes. This dGNSS network has reference points both in the valley bottom and in the plateau area. The measurement of the dGNSS point on Stiksmoen took place at least once a year since 2016. During the measurement, a dGNSS antenna was mounted on the bolts fixed to the outcrops for each acquisition campaign. Static phase measurements were performed with an interval of ca. one year between acquisitions. The measurements were then post-processed using the reference points set in the upper and lower part of Stampa. The displacement rate was considered significant when it meets the following two conditions:

Two extensometers were installed in 2016 in the backscarp (see location in Figure 5). The displacements measured along the years show a constant trend. The northern one shows a displacement rate of 1.5 cm/y and the southern one 0.9 cm/y (Figure 16).

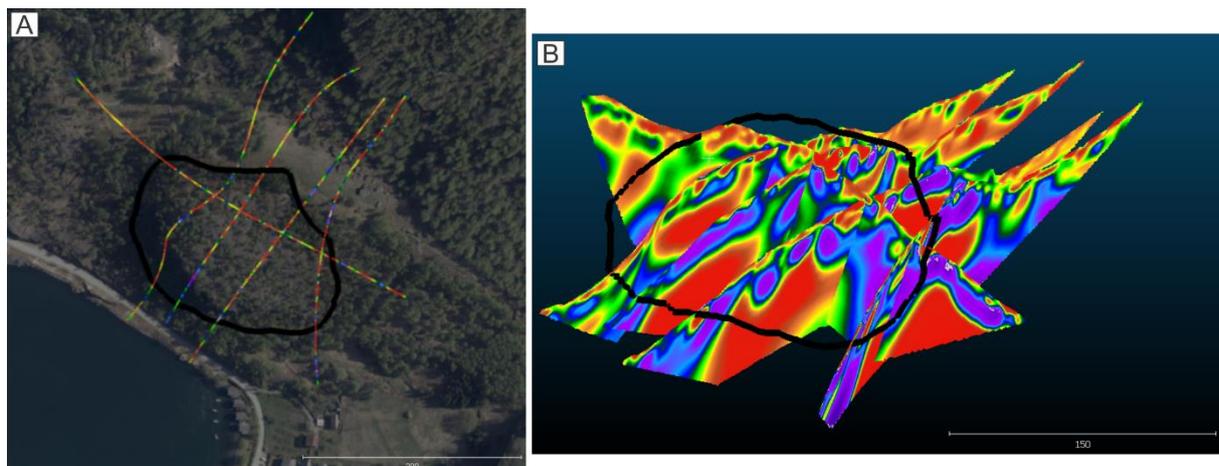
*Figure 6. Location of the ERT profiles and the limit of the unstable rock slope B) 3D View of the ERT profiles and the limit of the unstable rock slope (black line).*

In April 2021, a geophysical survey was carried out in Stiksmoen. The survey consisted of 5 Electrical Resistivity Tomography profiles (ERT; Figure 6) and 2 Ground Penetrating Radar (GPR) lines. The ERT method was chosen because it allows for mapping the contrasts in bedrock that result from different degrees of rock fracturing, water content, mineralization, etc. The ERT profiles were done using a Multiple Gradient array and 5 meters of electrode spacing. Four ERT profiles are SE-NW oriented, which means that they cross the unstable rock slope in the sense of the vector of displacement. One ERT profile was oriented NE-SW and crosses the unstable rock slope perpendicular to the other profiles in its upper-central part. A detailed description of the survey and processing of data can be seen in Tassis and Larsen (2021).

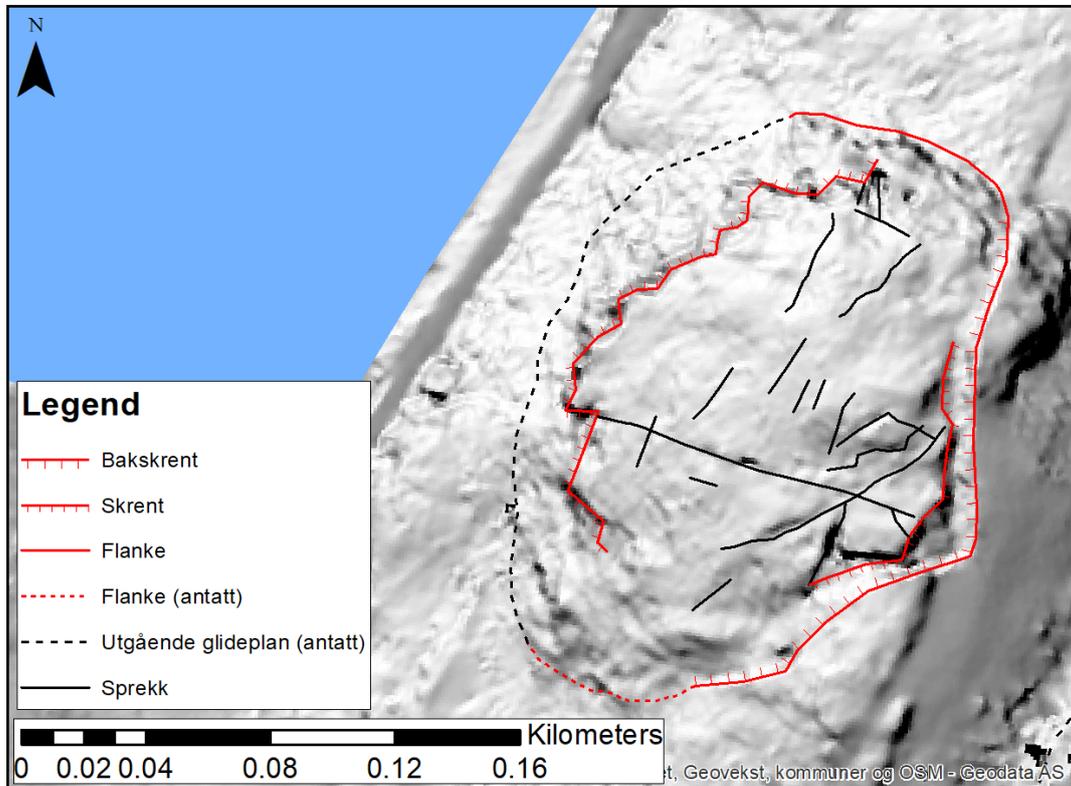
Figure 7. Hillshade map with mean lineaments observed on Stiksmoen.

by a cliff where small collapses in the form of rock falls occur. The toe of the unstable rock mass is covered by a block field that extends down to Vikjavegen (Figure 7; Figure 8). The sliding surface is not clearly visible on the slope, and it is considered to cut the slope close to where graphite material was observed (Figure 9).

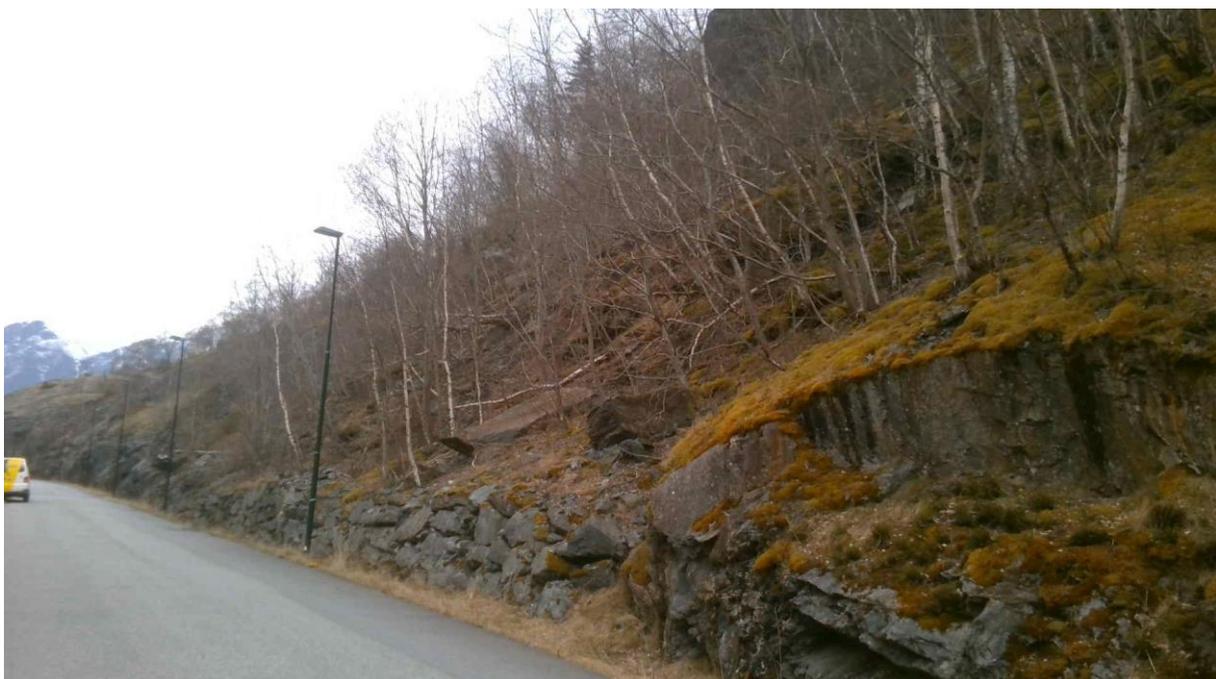
Figure 8. View to the north along Vikjavegen. Retention wall and accumulation of blocks detached from the frontal part of the instability.

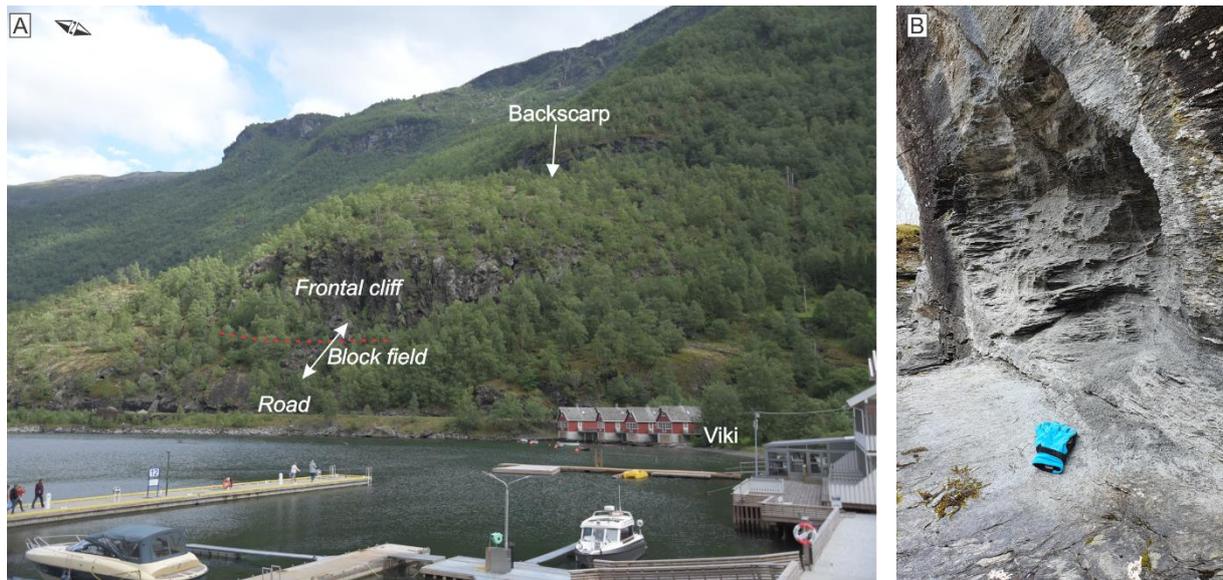
Figure 9. View of Stiksmoen from Flåm. The dashed red line marks the approximately location of the toe of the instability. B) Graphite rich lenses in the southern limit of the instability, close to the location of the toe.

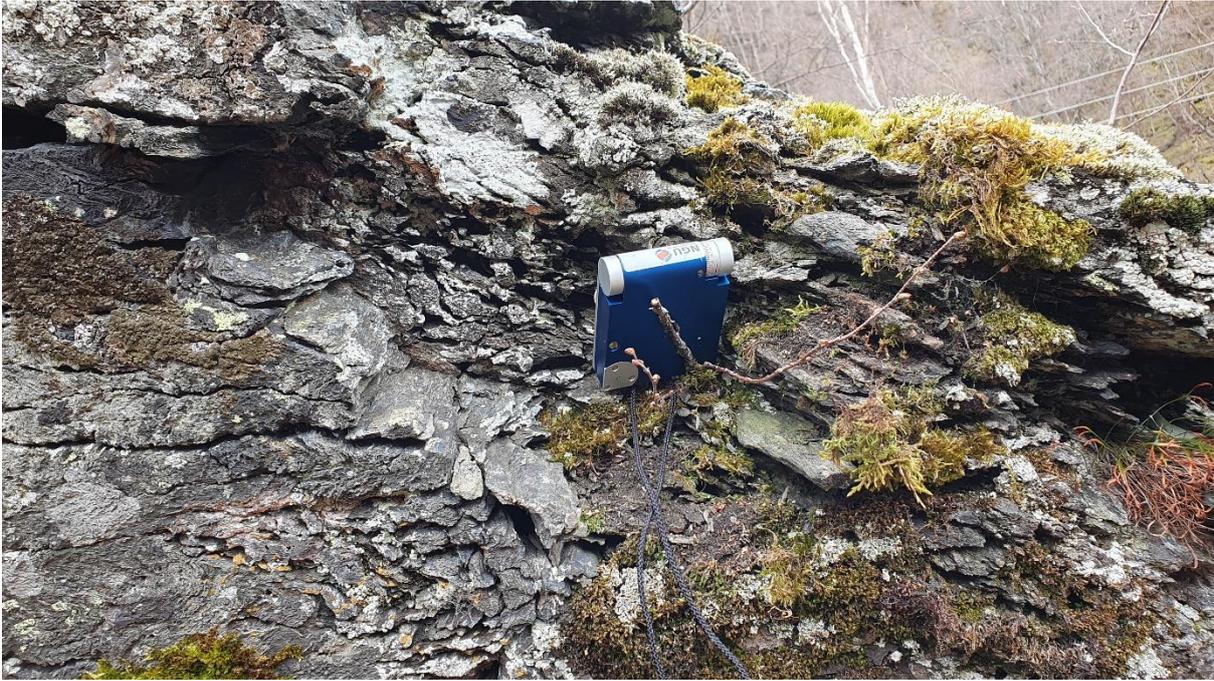
*Figure 10. Small scale folds affecting the phyllites in the southern part of the instability. (Picture: Martina Böhme).*

The foliation of the phyllites is highly variable but has a general trend dipping towards the west. Foliation is strongly folded, and due to developed crenulation cleavage, it is often difficult to measure foliation planes (Figure 10).

Grimstad (1987) proposed sliding along foliation planes dipping ca. 30° towards the fjord. In our work we propose an irregular sliding surface developed along the foliation, dipping towards the fjord, and with steps formed by the breaking up of minor-scale folds (Figure 10).

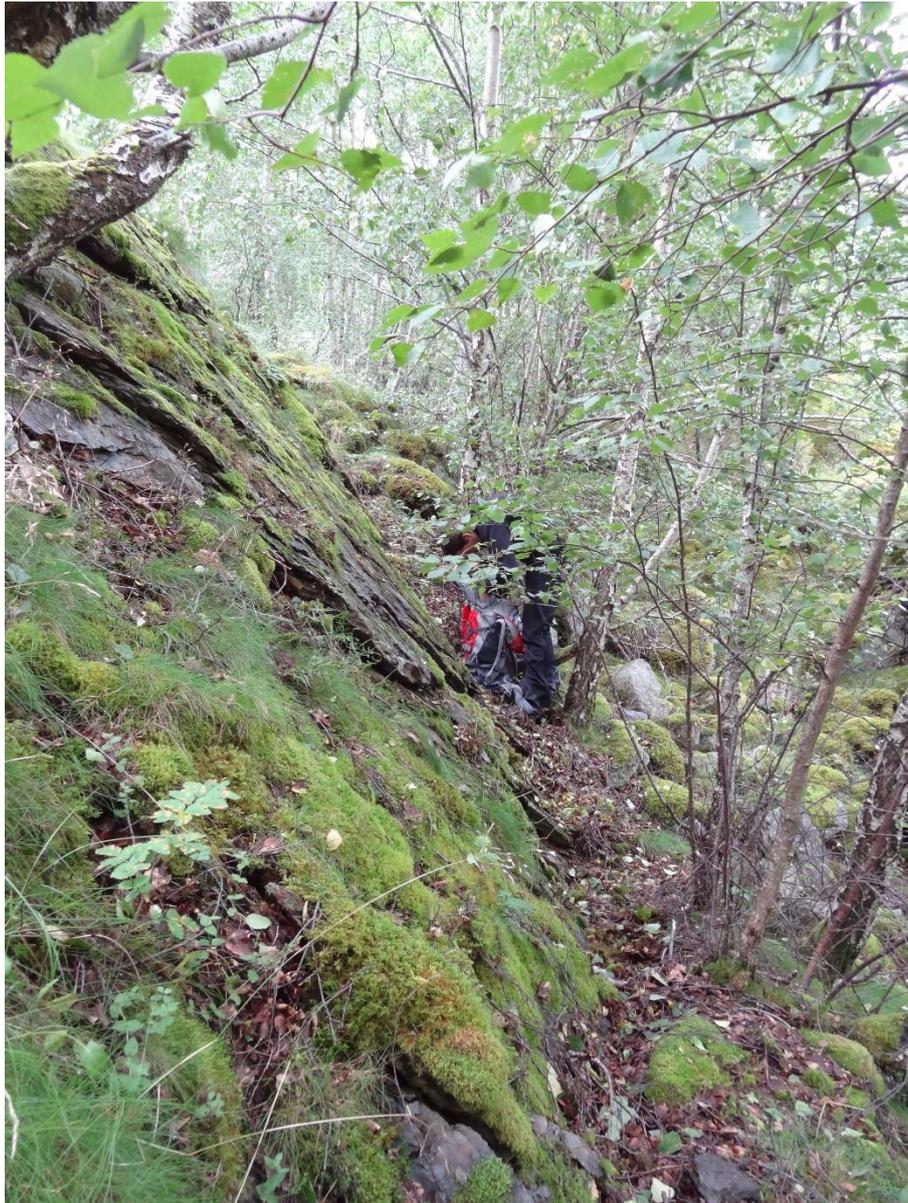
*Figure 11. View towards the southeast. Backscarp developed along the foliation.*

The fracture set that is best developed is dipping steeply into the slope with an average orientation of 114/57. Another set, less developed, has a very similar trend but is vertical (average orientation 308/90; Figure 12 and Figure 13). The backscarp is quite complex and follows different structures over its length. In the northern part, it is clearly developed along steeply dipping foliation planes (Figure 11; average orientation 260/58) while following multiple fracture planes further south.

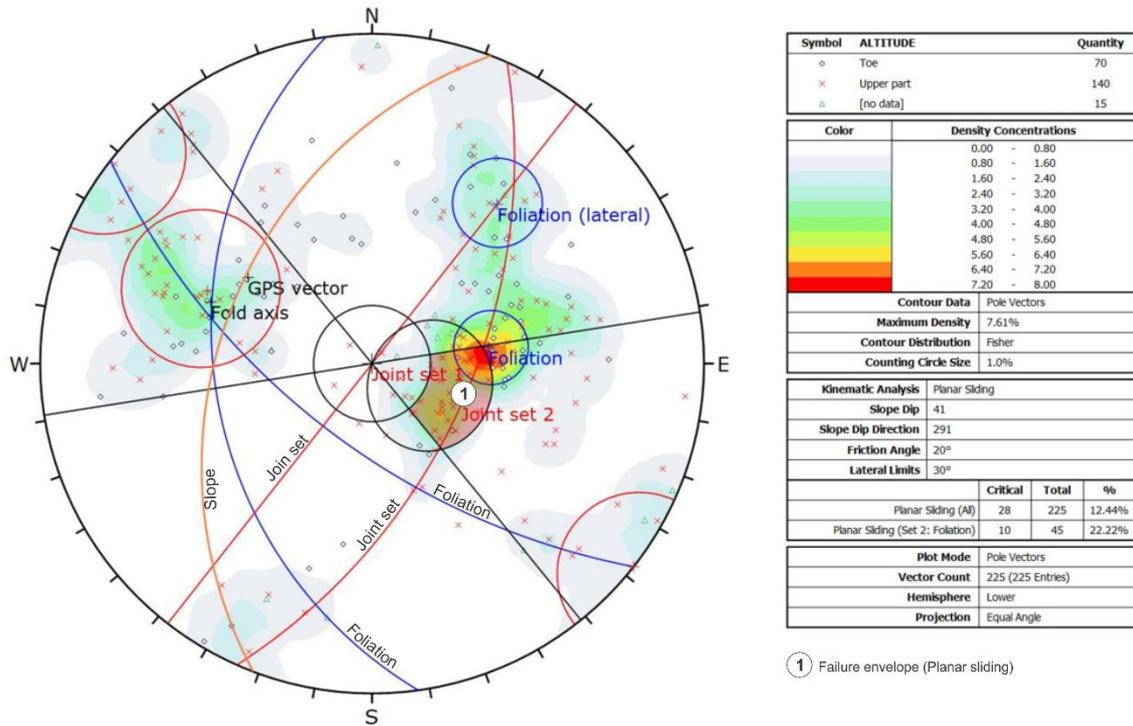
Figure 12. Kinematic analysis. Planar failure.

A kinematic analysis indicates planar sliding as well as wedge failure as probable failure mechanisms (Figure 12 and Figure 13). For both sliding mechanisms, foliation would form the sliding plane(s). For planar sliding, the general trend of foliation is most important. Whereas for wedge failure, sliding would additionally also take place on different foliation orientations, mainly as a lateral constraint. Planar sliding is consistent with the homogeneous degree of deformation of the rock mass. The unstable rock slope does not present specific sectors with higher deformation, which is seen on instabilities where the angle of the sliding surface changes.

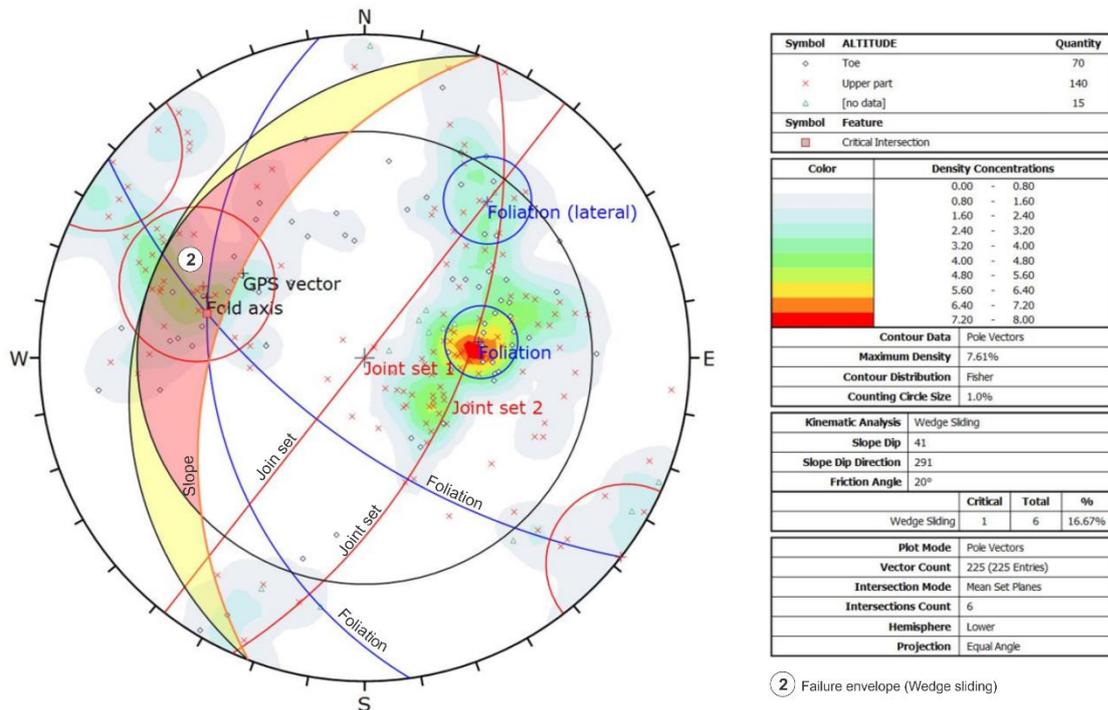
Figure 13. Kinematic analysis. Wedge failure.

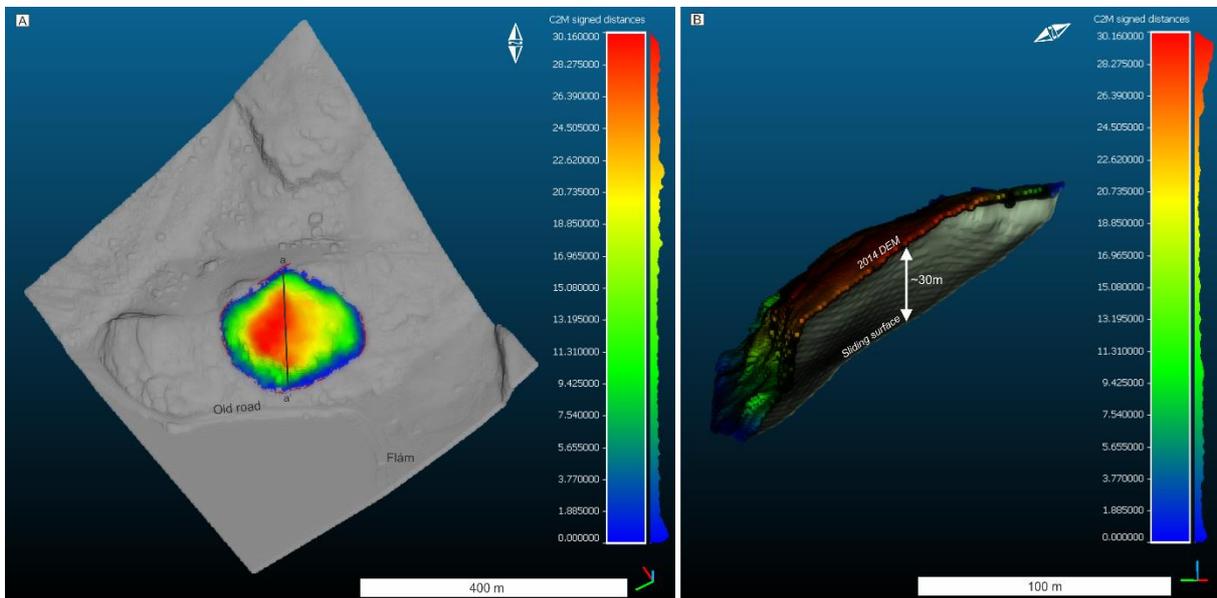
Figure 14. C2M (Cloud to Mesh) distances computed between the 2014 DEM and the reconstructed sliding surface show thicknesses of up to 30 meters. A) View of the 2014 DEM (grey colours), the thickness of the unstable rock slope (blue to red colours), and the location of slice shown in figure B. B) 3D profile showing the 2014 DEM with C2M distances, and the shape of the sliding surfaces.

The unstable rock slope extends over 0.02 km<sup>2</sup>. Its thickness is higher in the central-northern part, where it reaches ca. 30 meters (Figure 14). The reconstructed sliding surface is located approximately 70 above the Fretheim tunnel (Figure 15). The computed volume is 397 000 m<sup>3</sup>.

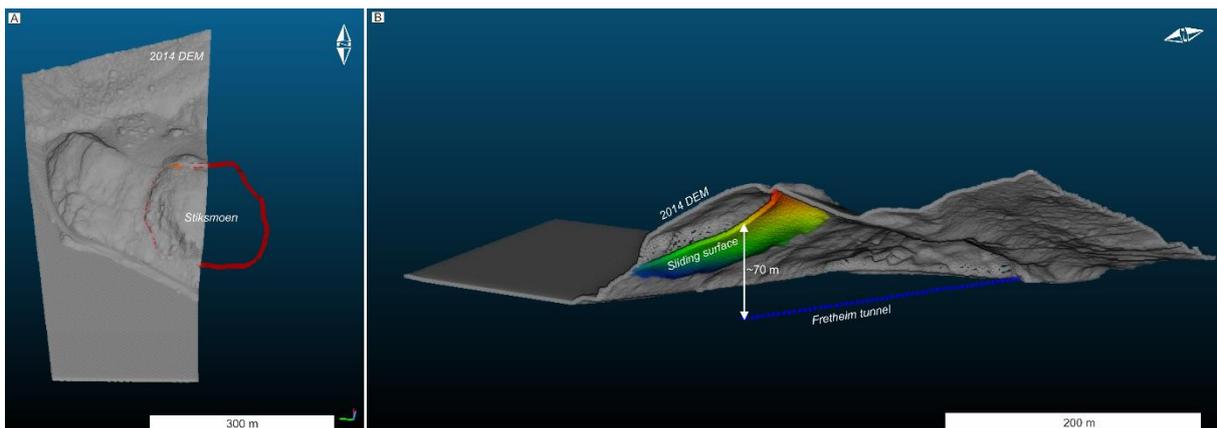
Figure 15. A) View of the 2014 topography and the limits of the unstable rock slope. The 2014 is cropped to the slice limits showed in figure B. B) Down-up 3D View of the 2014 topography (slice showed in A), the reconstructed sliding surface, and the path of Fretheim tunnel.

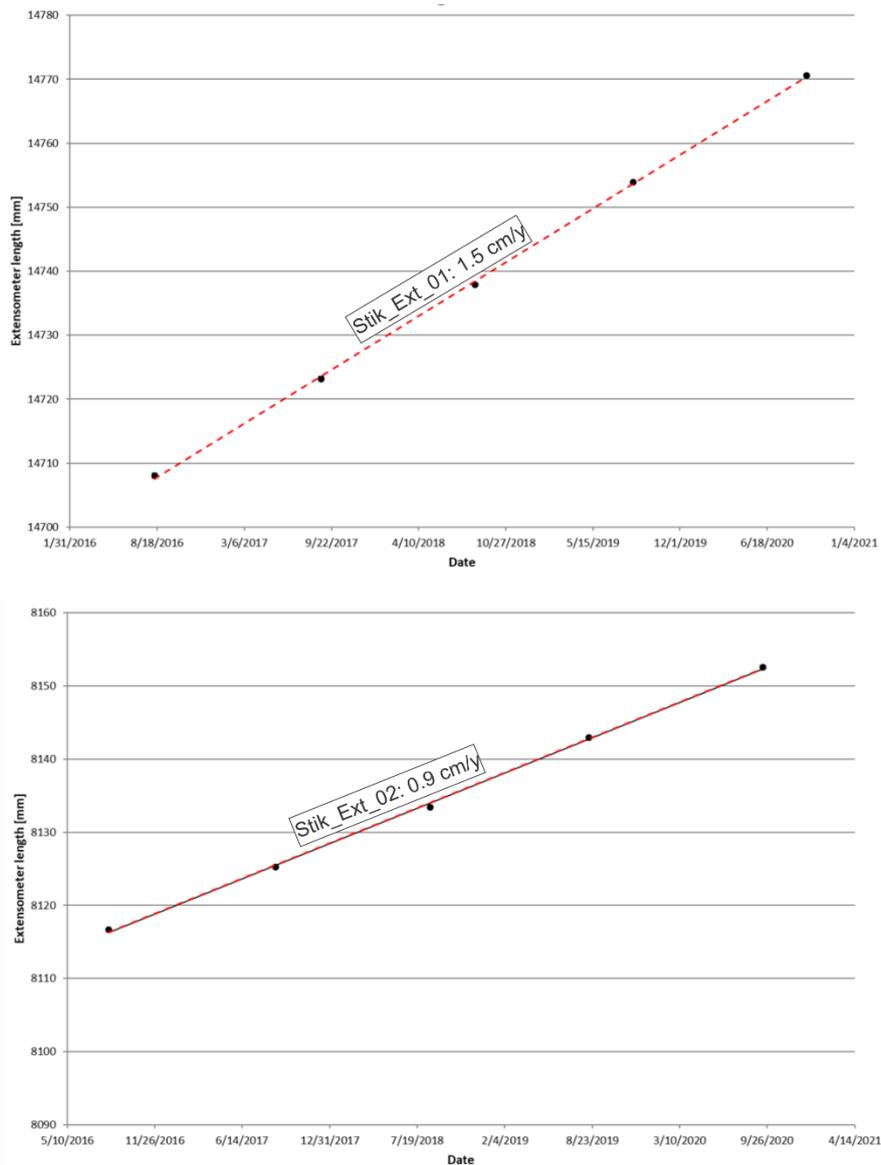
Figure 16. Displacement rates measured with extensometers. Orientation extensometer 1: 244/01. Orientation extensometer 2: 319/08.

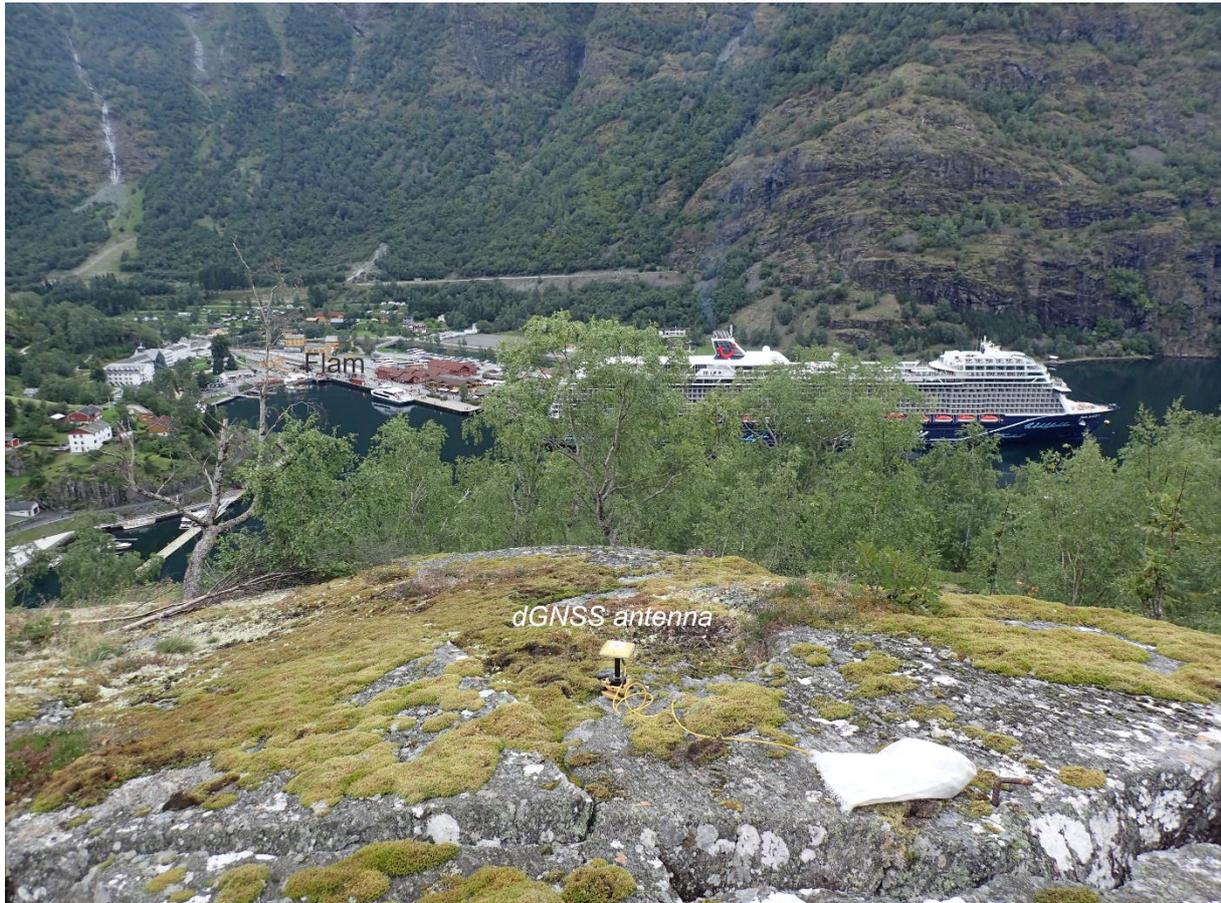
*Figure 17. Location of the dGNSS antenna in Stiksmoen.*

Since 2016, Stiksmoen has been annually measured using this method. The measuring point, installed on the unstable rock mass (Figure 17 and Figure 18), shows a statistically significant vertical and horizontal displacement. It is observed a constant trend in displacement between 2016-2020, both vertical and horizontal. The displacement rate measured is 24.6 mm/y with a vector oriented 305/40 (Figure 19).

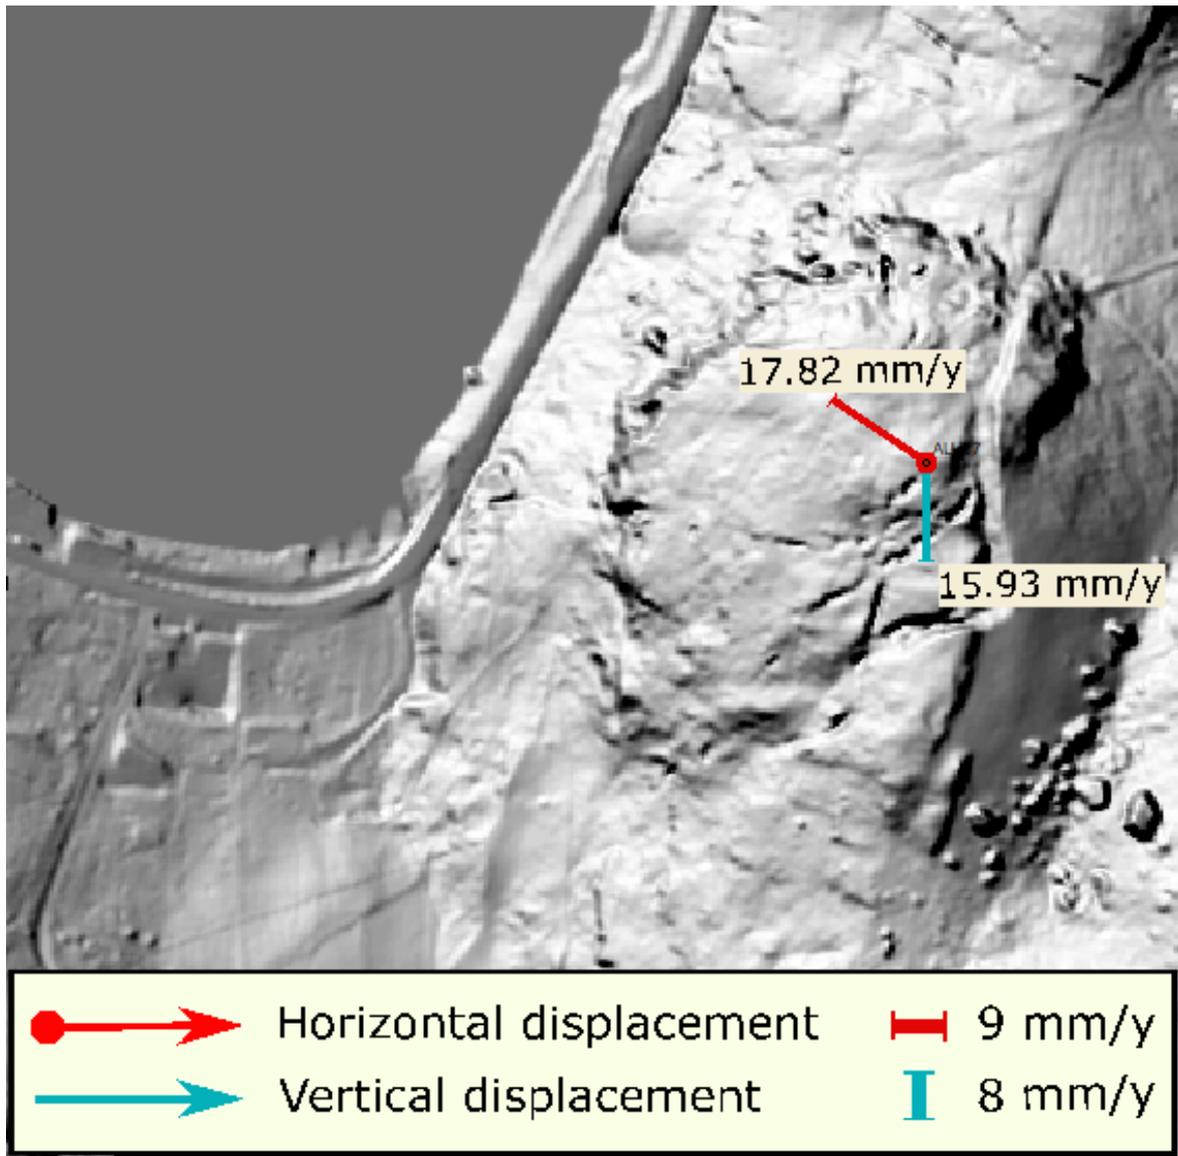
Figure 18. Hillshade with location of the dGNSS point and the corresponding vectors of displacement.

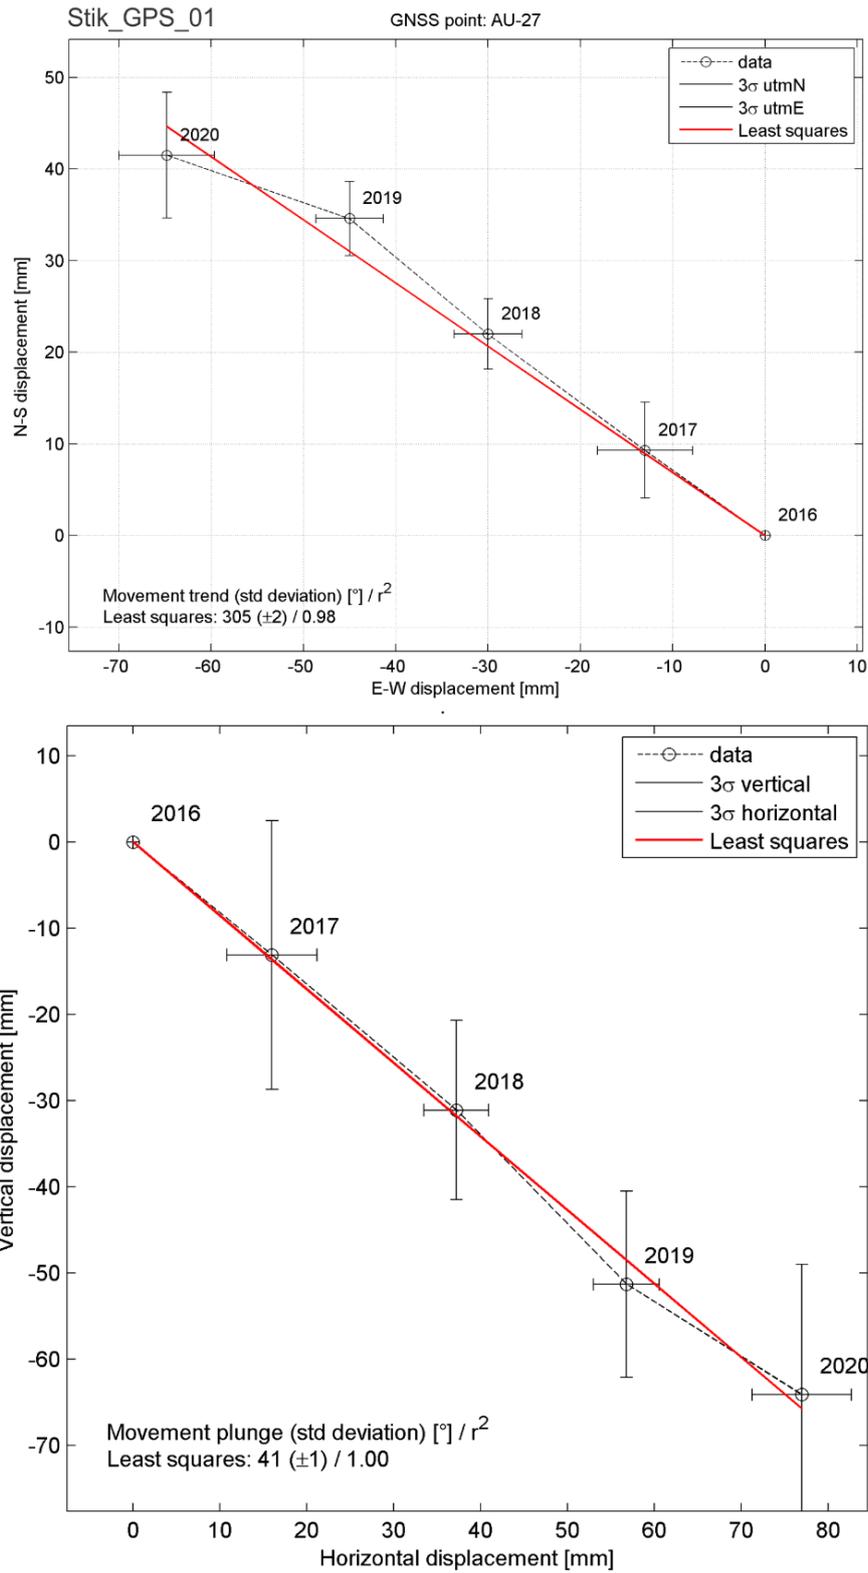
Figure 19. Displacement rate measured with dGNSS.

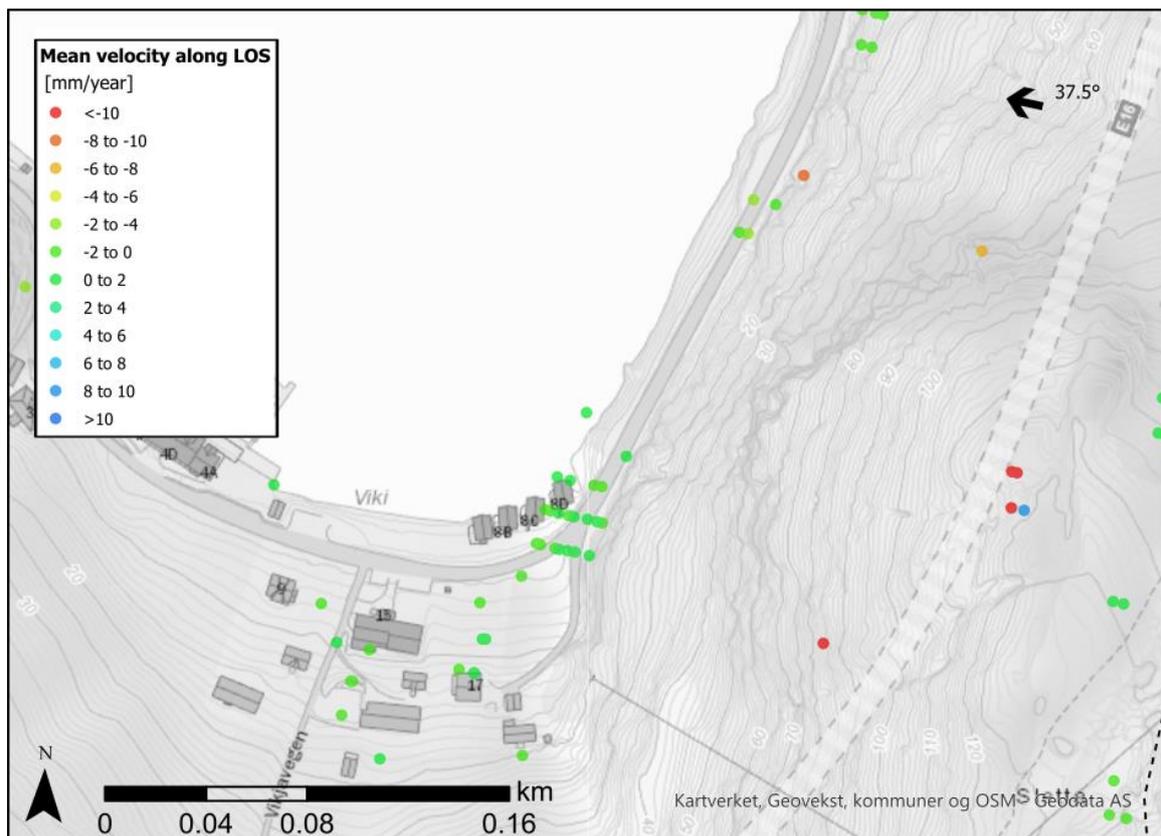
Figure 20 InSAR mean velocity [mm/year] along line-of-sight (LOS) in descending geometry (orientation of black arrow: LOS azimuth angle, label: LOS incidence angle).

Because of the vegetation coverage, and geometry of the area there is poorly coverage of InSAR data (Figure 20). However, some data exists from the Sentinel-1 descending radar (2016-2019)

for the upper-central part of the unstable rock mass, in the vicinity of the dGNSS point. The measurements show a displacement rate of 24.5 mm/y along the line-of-sight vector, oriented 281/37 (Figure 21). This is comparable to the displacement rate (24.6 mm/y) measured with dGNSS. The dGNSS displacement also indicates that the displacement direction is like the line-of-sight and InSAR displacement can thus be assumed to be of good quality.

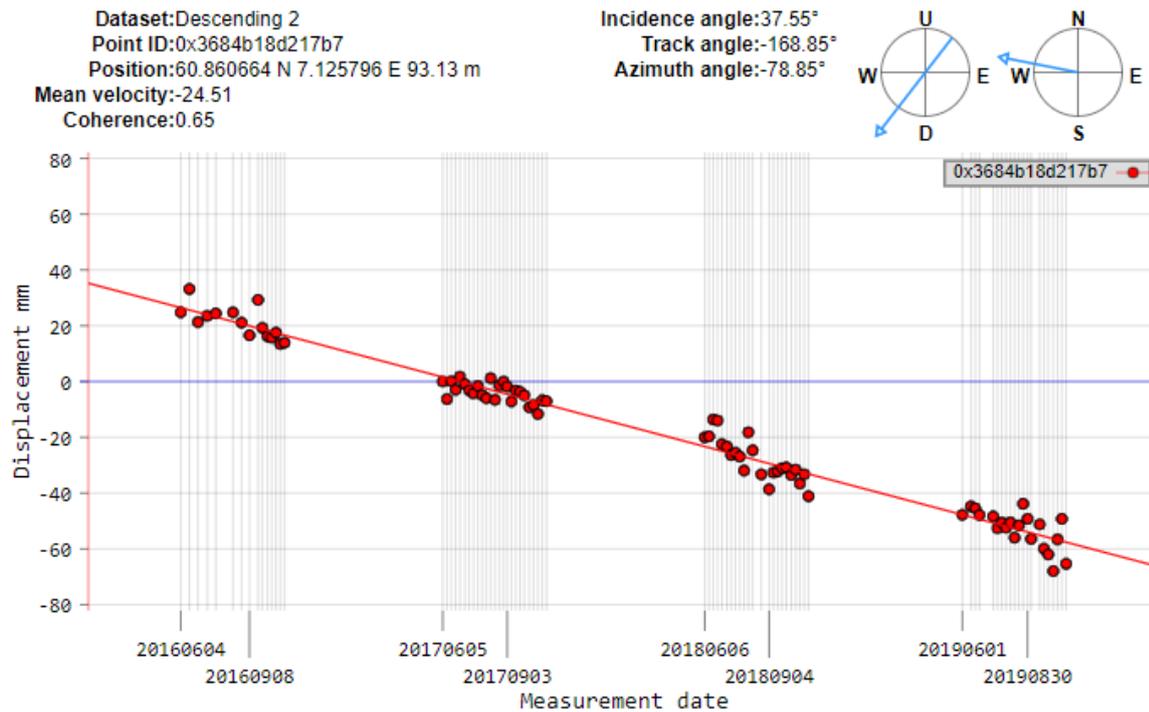
Figure 21 InSAR time series of points on the upper central part of Stiksmoen, showing a yearly displacement of 24.5 mm.

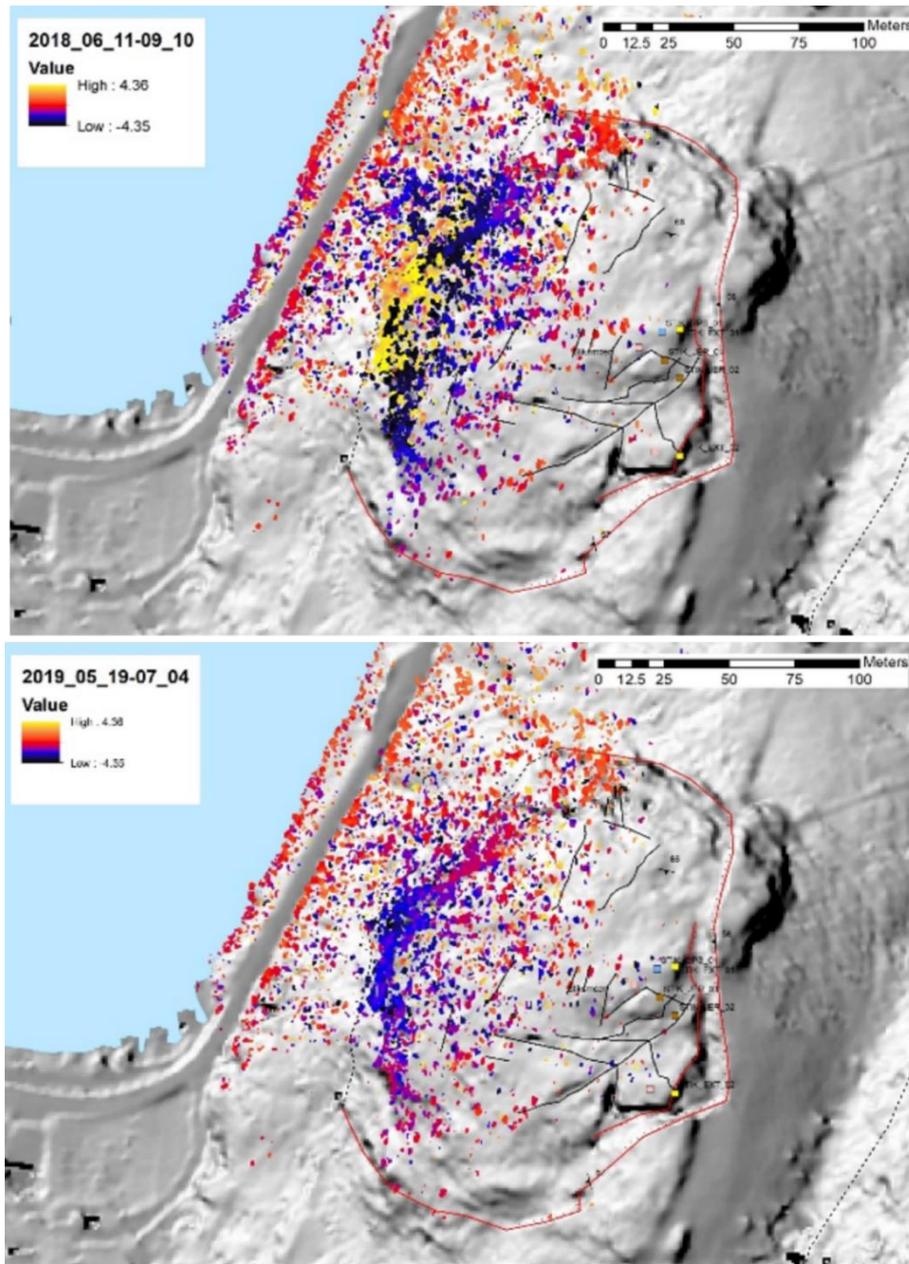
Figure 22. Hillshade maps and displacement rates measured with GB-InSAR. Upper part: results of the measurements in 2018. In yellow the area with phase wrapping (meaning displacement is higher than 4.4 mm). Lower figure: results of the measurements in 2019 (reference: NVE internal report).

NVE has carried out measurements with GB InSAR in 2018 and 2019. The unstable rock mass is quite vegetated in the upper and central part but not the frontal part, where the visibility of the radar was considered good enough to measure displacements. The measurements in 2018 are at 3-month intervals and in 2019 the measurements were 45 days apart. The displacement measured in both field campaigns is similar and in the order of 0.8-2.5 cm/y. The data suggest that a central part is moving faster than both flanks. The scattered datapoints on top of the forested block are not trustworthy (noise from the vegetation).

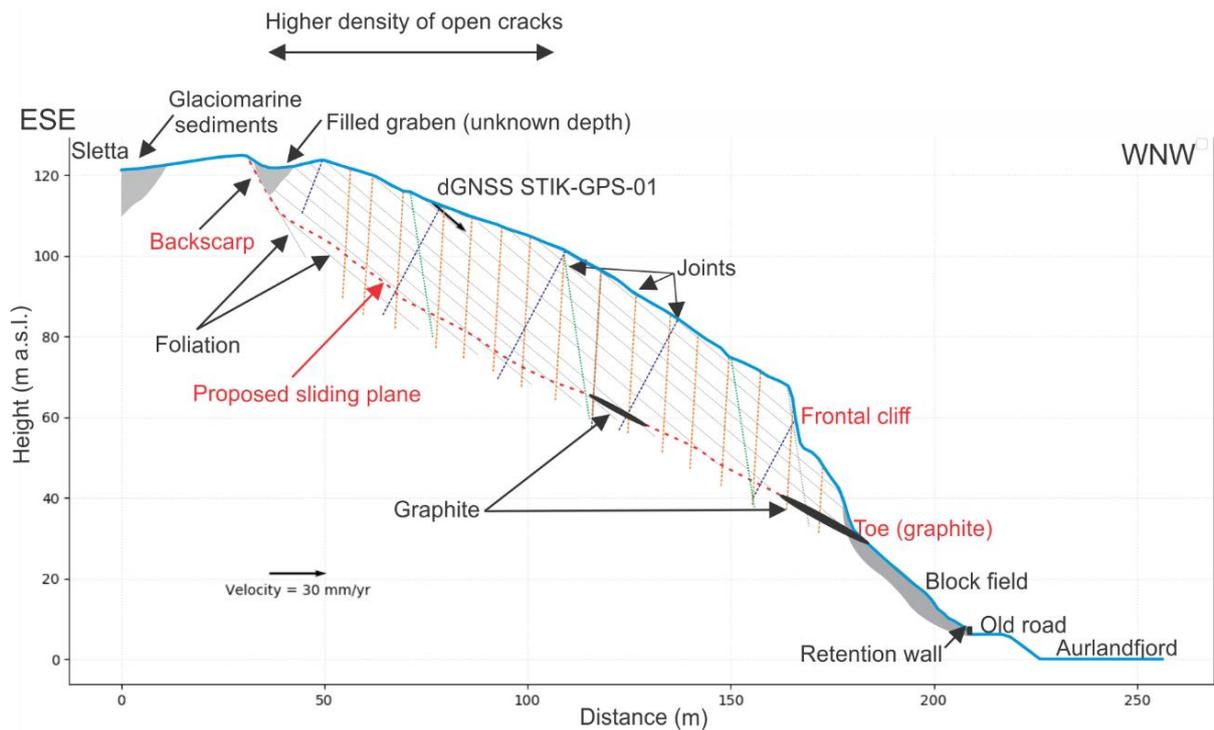
Figure 23. Conceptual geological model of Stiksmoen.

Displacement rates measured in the upper part of the unstable rock mass with dGNSS and satellite InSAR are very similar to those measured with the GB-InSAR in its frontal part. The dGNSS displacement vector is oriented ca. 305/40. The similar displacement rates in the upper and lower-frontal parts suggest a quite homogeneous displacement of the rock mass. The structural conditions and the dGNSS vector point out to a rupture taking place along a stair-step like surface cutting through the tight fold axis as well as through soft graphite rich lenses, as

observed in other parts of Stampa (Böhme et al., 2013; Blikra et al., 2013). The sliding surface cuts the slope between 30–40 m a.s.l., where a zone of graphite rich lenses is observed. In sum, the development of the unstable rock slope Stiksmoen is the result of a complex interaction between foliation with variable orientation and different joints sets, where graphite layers seem to play an important role in facilitating its development and favouring its displacement (Figure 23).

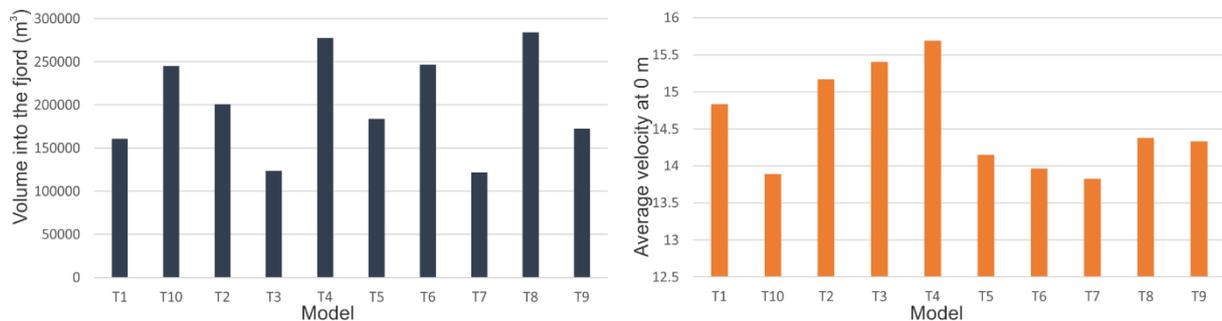
Figure 24. Histograms showing the distribution of volumes into the fjord and average velocity for the considered models.

The dynamic modelling of Stiksmoen showed that the collapse of ca. 0.4 million m<sup>3</sup> would imply a large volume of rocks reaching the fjord, in the vicinity of Flåm (Table 3 and Figure 24). The main propagation direction of the rock mass is WNW, but the southern part of the unstable rock mass would propagate on land towards Viki. The shortest run out (330 m) is observed in the T7 model and the longest one in the T4 model (413 m; Table 3). The modelled velocity of the rock mass when impacting the water ranges between 13.8 to 15.7 m/s.
