**NGU REPORT**  
**2021.035**

Hazard and risk assessment of the  
Stiksmoen unstable rock slope in  
Aurlandfjord (Flåm, Vestland)

<b>Summary:</b> <p>Stiksmoen is located on a west-facing slope at approximately 120 m a.s.l. in the southern end of Aurlandfjord (Flåm municipality, Vestland county). The unstable rock slope is bounded by a well-developed backscarp, wide open in the north and open but less developed in the southern sector. The lower limit is mapped close to the foot of the frontal cliff of the unstable rock mass. The upper and central part of the instability is characterized by the presence of several open cracks, 10 to 15 meters deep. High rockfall activity is observed in the frontal cliff, with the detached blocks forming a block field. Structural and geophysical surveys allowed for the reconstruction of the sliding surface of Stiksmoen and the computation of its volume (ca. 0.4 million m<sup>3</sup>). Extensometers, dGNSS, ground-based and satellite-based radar measurements show similar displacement rates in the upper-central part and on the lower-frontal part of the unstable rock mass. The obtained displacement rates range from 0.9-2.5 cm/y towards the west, with

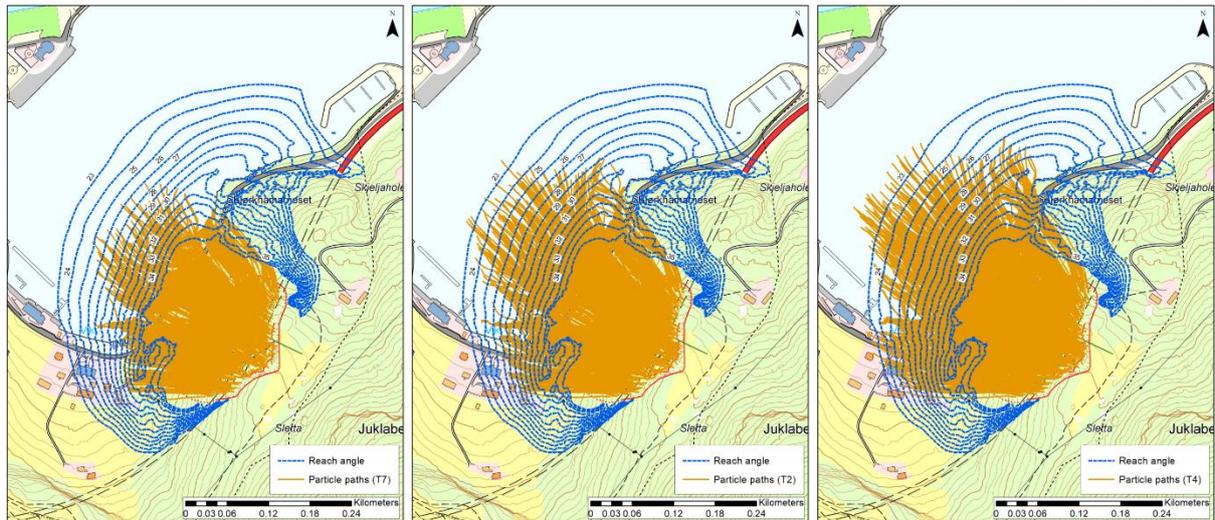
Figure 25. Propagation maps for the T7, T2 and T8 models. The path of the particles in the source area and the reach angles are shown.

In the model T4, the propagation indicates the rock mass reaching 26 m b.s.l. Models T4 and T8 show the largest volumes falling into the water, but the highest average velocity at the impact on the water is observed in model T4. Model T7 resulted in the smallest volume propagating into the water and lowest velocity at the impact with the water. Model T2 represents an intermediate scenario of these two extremes. In this scenario ca. 200 000 m<sup>3</sup> of rocks will enter the fjord at an average velocity of ca. 15 m/s (Table 3; Figure 25; Figure 26), spreading over 0.11 km<sup>2</sup>.

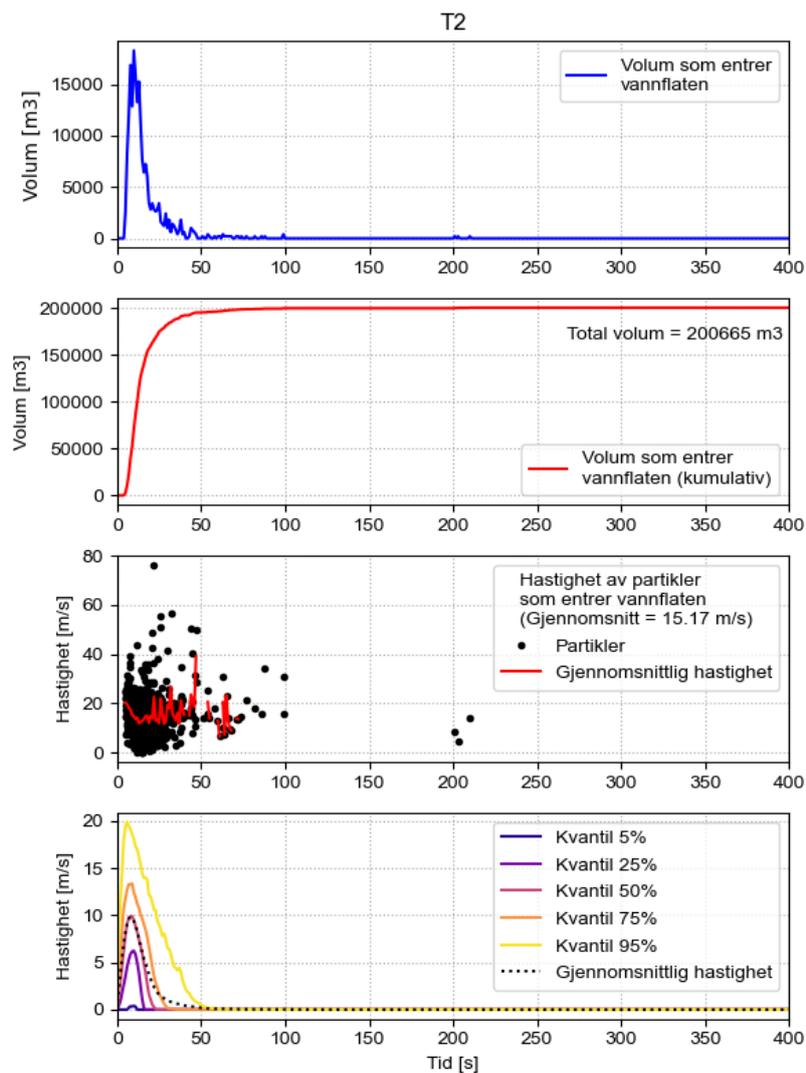
Figure 26. Scenario T2. Volume entering the fjord and velocities of particles when entering the fjord.

The intermediate scenario (T2) shows that shortly after the collapse of the rock mass most of the material has propagated into the fjord (Figure 26).

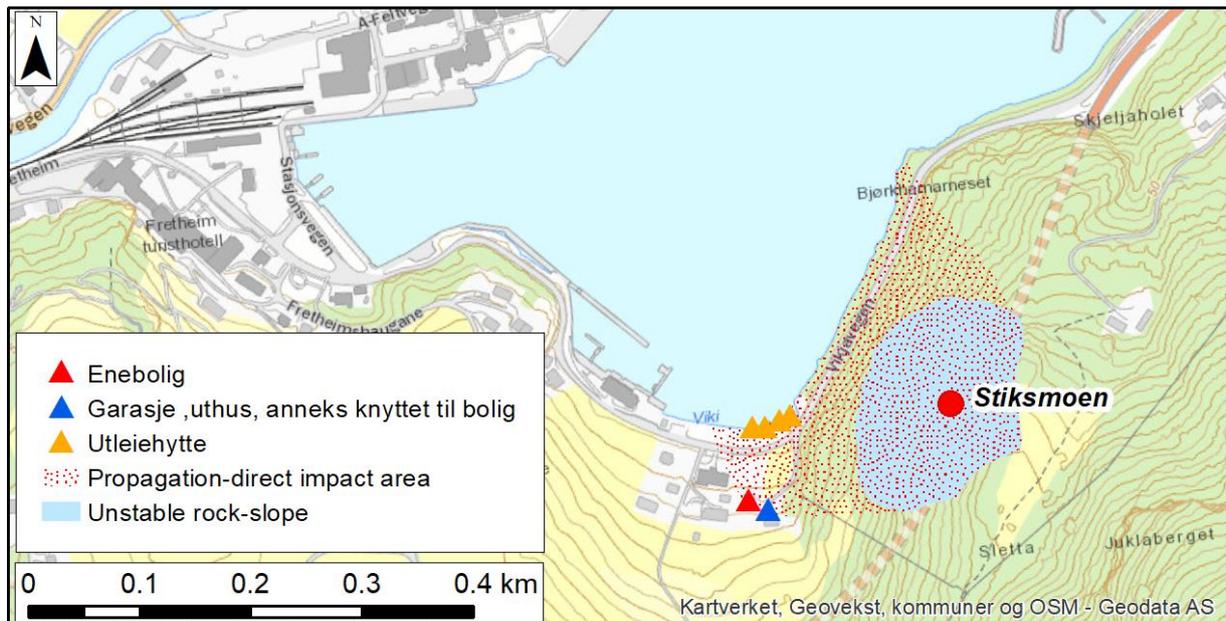
Figure 27. Consequences on the direct impact zone.

- 1) *Direct impact area:* there is 1 house with 2 residents in the run-out area. In addition, there are 4 cabins and 1 garage. For each cabin, the standard values are: 1 person minimum, 3 persons average and 6 persons maximum with an estimated exposure of 25%. For other types of buildings such as shed, garages, houses for animals, etc. no persons are considered. In total, this results in between 4 to 8 potential fatalities, in the direct impact zone, in case of a total collapse of Stiksmoen.

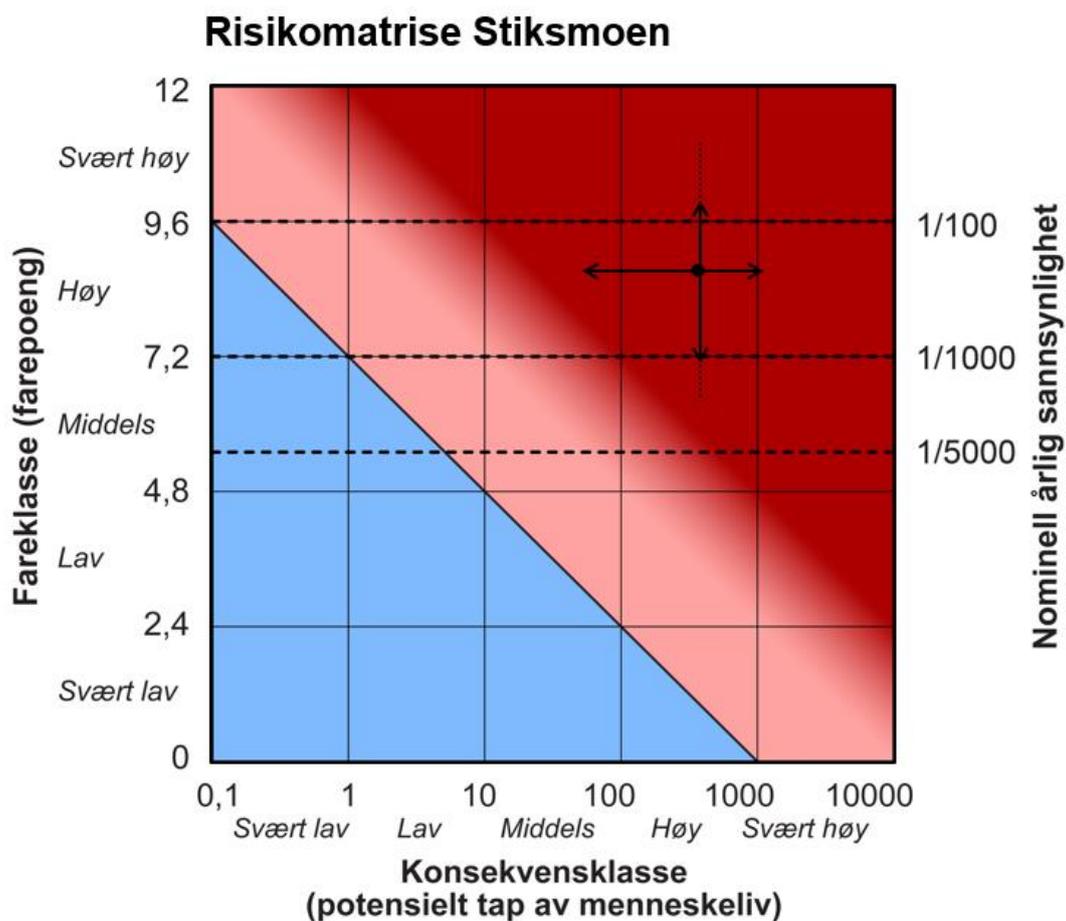
Figure 28. Risk matrix for Stiksmoen considering direct and indirect consequences.

The total risk is then 1.3 death/year, which corresponds to 374 deaths with the failure probability of  $3.48 \cdot 10^{-3}$ . This probability and consequence are then plotted inside the risk matrix. See Ap.Figure 3 for more details.

The result of the risk assessment is presented in Figure 28. According to our analysis Stiksmoen is classified as a high-risk site.
