GEOLOGI FOR SAMFUNNET

GEOLOGY FOR SOCIETY

Report no.: 2013.014		ISSN: 0800–3416	Grading: Open
Title: Investigations on unstable rock slopes in Møre og Romsdal – status and plans after field surveys in 2012			
Authors: T. Oppikofer, A. Saintot, S. Otterå, R.L. Hermanns, E. Anda, H. Dahle, T. Eiken		Client: Norwegian Water Resources and Energy Directorate (NVE)	
County: Møre og Romsdal		Commune:	
Map-sheet name (M=1:250.000) Ålesund, Kristiansund, Røros, Ulsteinvik		Map-sheet no. and -name (M=1:50.000)	
Deposit name and grid-reference:		Number of pages: 323	Price (NOK): 1285,-
Fieldwork carried out: 2006–2012		Date of report: 13.11.2013	Map enclosures: 0
Fieldwork carried out: 2006–2012		Date of report: 13.11.2013	Project no.: 309900
Fieldwork carried out: 2006–2012		Date of report: 13.11.2013	Quality control: <i>Halvor Brundhoff</i>
<p>Summary:</p> <p>This report presents investigations, analyses and displacement measurements made between 2006 and 2012 on 131 unstable or potential unstable rock slopes in Møre og Romsdal County (Western Norway). An extract of this report is available in Norwegian (NGU rapport 2013.053).</p> <p>These investigations are part of the national plan for

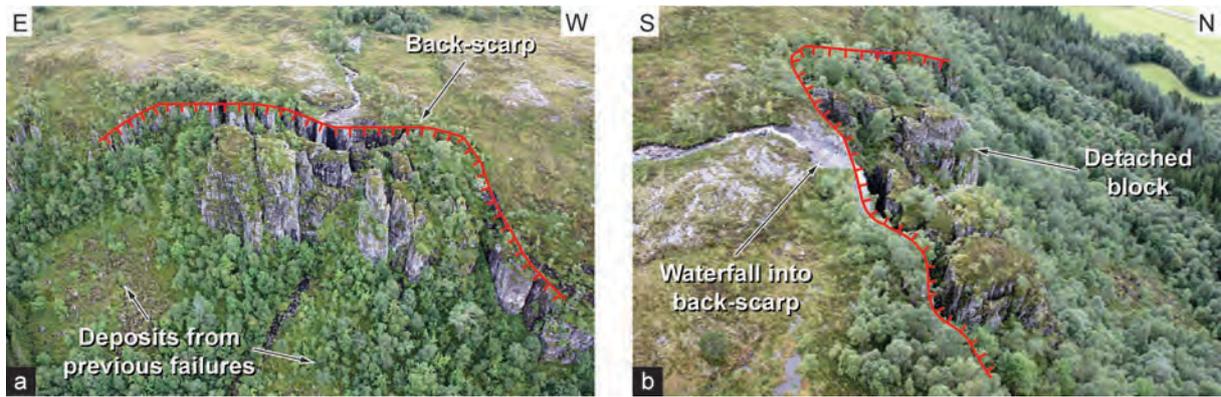
Geitaskaret (Figure 6) is situated on a north-facing slope 220 m above Skjerset. The site was surveyed during a helicopter reconnaissance flight in 2012. A 90 m wide and 30 m long instability is clearly detached from the back-scarp (Figure 7). Several cracks with a few meters opening divide the instability into distinct, small blocks with volumes smaller than 20 000 m³. A small waterfall runs into the back-crack and through the detached rock body. The water runs partly through the blocky deposits from previous failures. Previous failures from Geitaskaret have been of limited volumes (few thousand m³) and did likely not reach inhabited areas. Potential future failures are also expected not to reach inhabited areas (Dahle et al. 2011a).

Figure 7: Photographs of the Geitaskaret instability. The instability is divided by cracks into several blocks with of small volumes (<math><20\,000\text{ m}^3</math>).

Recommendation: A possible rock avalanche from the Geitaskaret instability will have no consequences. No further investigations or displacement measurements are necessary. The hazard and risk classification will be made after a simple run-out assessment. Further follow-up activities will be based on this classification.

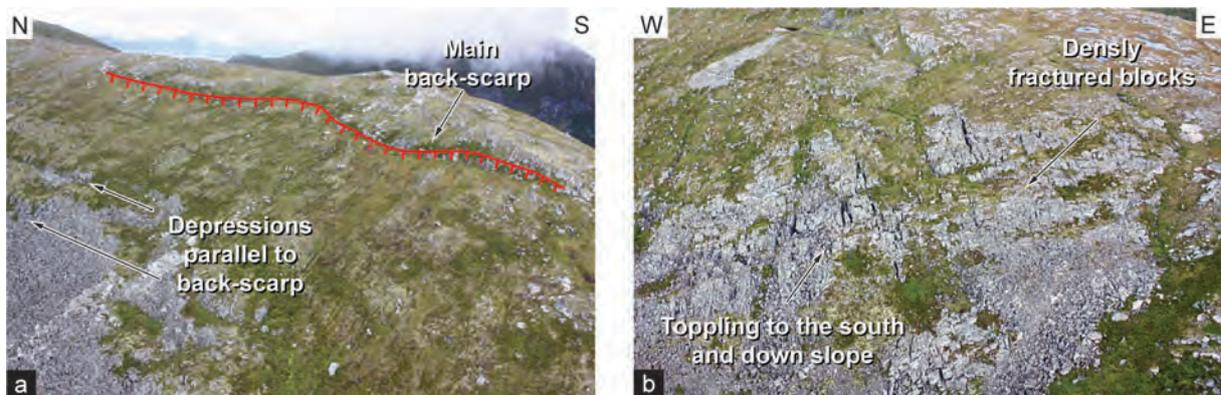
Trolldalsfjellet (Figure 6) is located on a west-facing slope 400 m above Litlvassdalen Valley. During a helicopter reconnaissance flight in 2012 the main back-scarp controlling the highest extent of the disturbed mass was observed together with several parallel cracks downslope that can be followed over a few tens of meters (Figure 8a). At 650 m a.s.l. the slope is continuously covered with blocks over a length of 600 m (Figure 8a). Depressions are present above and inside the blocky area. Especially in the northern part of the disintegrated area structures in the rock mass show a dense fracturing that enables toppling of small blocks downslope to the west or to the south (Figure 8b). This style of deformation let suppose that this unstable rock slope is formed locally by the in-situ disintegration of the rock mass into small blocks. Given this deformation style, a massive rock slope failure from Trolldalsfjellet seems unlikely, but cannot be ruled out. A rock slope failure from Trolldalsfjellet would only affect the uninhabited Litlvassdalen Valley (Dahle et al. 2011a).

Figure 8: Photographs of the Trolldalsfjellet unstable rock slope with large block fields originating likely from in-situ disintegration of the rock mass due to a dense fracture network which enables toppling of small blocks.

Recommendation: A possible rock avalanche from the Trolldalsfjellet instability will have no consequences. No further investigations or displacement measurements are necessary. The hazard and risk classification will be made after a simple run-out assessment. Further follow-up activities will be based on this classification.

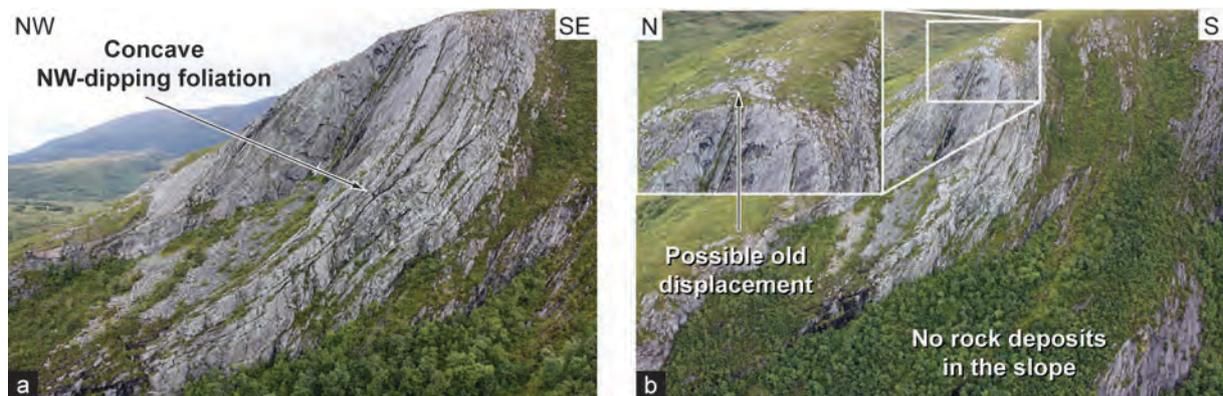
Ørnstolen (Figure 6) is situated on a west-facing slope 430 m above Sevika. A helicopter reconnaissance flight made in 2012 revealed a steeply NW-dipping foliation in the upper part that flattens out in the lower part (Figure 9a). The exposed foliation surfaces are likely the scar of a former rockslide, but no large rock avalanche deposits can be seen at the foot of the slope (Figure 9b). The same foliation surfaces could also be the basal sliding surface of the remaining unstable rock slope at Ørnstolen. However, there are no signs of deformation, except a small escarpment, where the foliation surface crosses the present topography on the top of the instability (inset in Figure 9b). Furthermore, there are rockfall deposits accumulating at the foot of the cliff of the Ørnstolen instability. A catastrophic failure of the Ørnstolen instability would likely reach some of the buildings in Sevika.

Figure 9: Photographs of the Ørnstolen instability with the foliation as basal sliding surface of a former rockslide and of the present instability. A small escarpment is observed on top of the instability in the continuation of the foliation surface (inset in b).

Recommendation: A possible rock avalanche from the Ørnstolen instability will have consequences. Geological field mapping is necessary to evaluate the structural and geological conditions, to quantify past displacements and assess the structures involved in the previous rockslide. The hazard and risk classification will be made after this field mapping. Further follow-up activities will be decided based on this classification.

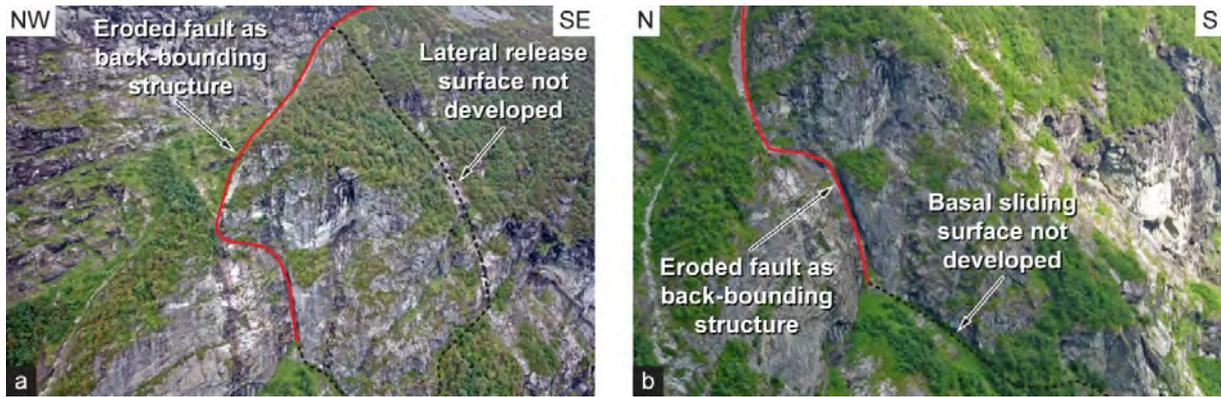
Bårsveinhamran is located on a southwest-facing slope at 590 m above the farm Gikling in Sunndalen Valley (Figure 10). A helicopter reconnaissance flight was made in 2011. An old fault forms a deep depression back of the rock spur, but there are no signs of deformation along this fault in the recent past (Figure 11). The fault would serve as back-bounding structure for this potential unstable rock slope, but no basal sliding surface and no the lateral release surface are developed although pre-existing planar structures favourable for sliding exist at Bårsveinhamran (Figure 11).

Figure 11: Photographs of the potential unstable rock slope at Bårsveinhamran. No signs of past deformation can be seen.

Recommendation: Bårsveinhamran is classified as a potential unstable rock slope. At present the remaining rock slope does not show any signs of past or present displacements or deformation of a large volume. No further investigations or displacement measurements are necessary and the hazard and risk classification will not be made. However, this site may lead to rockfalls and develop over time into an unstable rock slope, due to structural and geological conditions. The site should be revisited after years to decades to detect any changes and be followed-up on InSAR data.

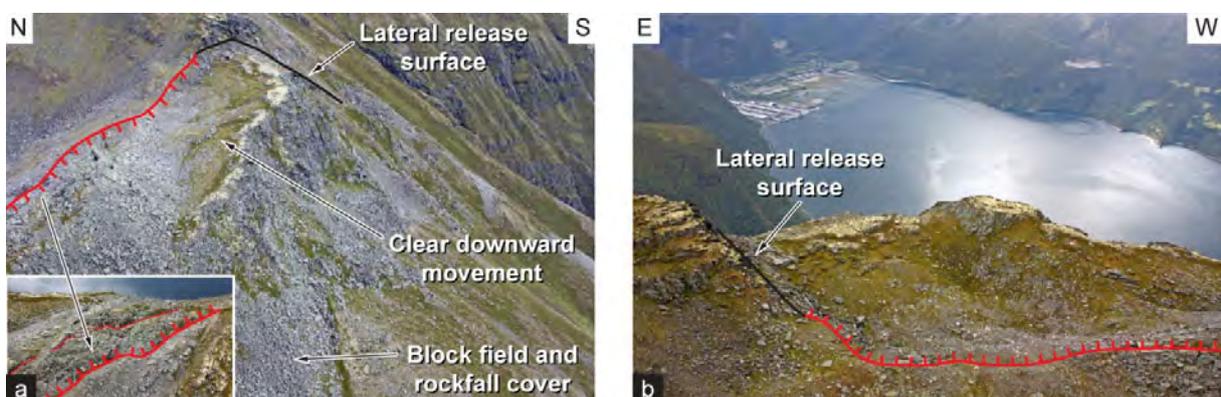
Fulånebbba is located on a southwest-facing slope at 1220 m above Oppdølstranda in Sunndalsfjord (Figure 10). The site was investigated by helicopter reconnaissance in 2011. Fulånebbba shows significant signs of past displacements with several meters of downward movement of a vegetated plateau relatively to the surrounding crest (Figure 12). To the east a obvious lateral release surface is visible. Other lateral and basal structures are not observable, partly due to an extensive cover with rockfall deposits. A massive failure of this unstable rock slope would likely reach Sunndalsfjord and subsequently create a displacement wave.

Figure 12: Photographs of the Fulånebbba unstable rock slope: a) lateral view showing the clear downward movement of the vegetated plateau and cracks parallel to the back-scarp along the crest (inset); b) downward view with the east-bounding lateral release surface. Sunndalsøra is in the back-ground.

Recommendation: A possible rock avalanche from the Fulånebbba instability will have consequences. Geological field mapping is necessary to evaluate the structural and geological conditions and to quantify past displacements. The hazard and risk classification will be made after this field mapping. Further follow-up activities will be decided based on this classification.

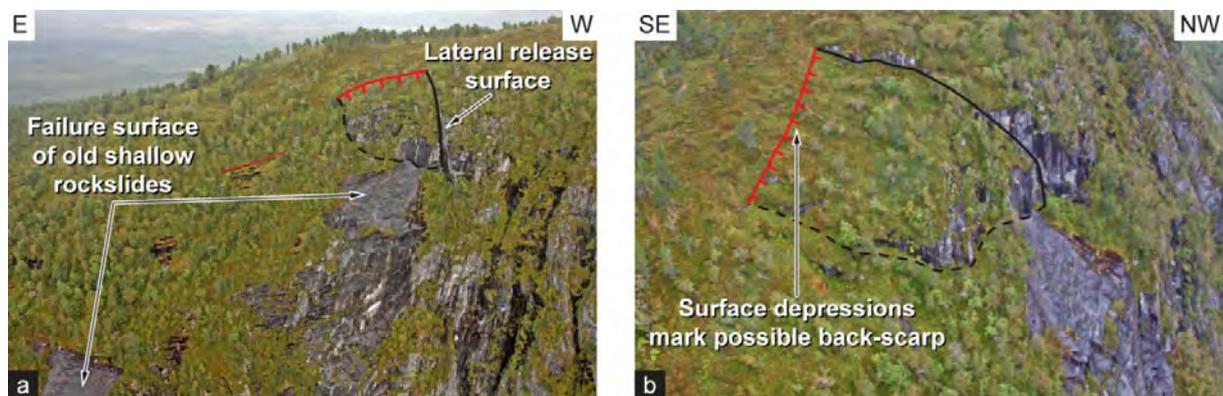
Gammelseterhaugen is located on a north-facing slope at 490 m above Ålvundfjord, close to Ålvund (Figure 10). A helicopter reconnaissance flight was made in 2011. There are several valley-dipping failure surfaces of previous shallow rockslides (Figure 13a). One of them may form the basal sliding surface of a small unstable rock slope (Figure 13b). Surface depressions in the back of the instability are possible morphologic expressions of a developing back-scarp. In turn, the western lateral release surface is clearly well developed. The volume of the Gammelseterhaugen instability is approximately of 25 000 m³ and thus too small to generate a significant displacement wave in Ålvundfjord and a total failure of the instability will therefore probably only affect the road Rv70.

Figure 13: Photographs of the Gammelseterhaugen unstable rock slope showing the scars of past small rockslides and the present unstable rock slope. Small cracks are also observed in other parts of the slope.

Recommendation: A possible rock avalanche from the Gammelseterhaugen instability will have no consequences. No further investigations or displacement measurements are necessary. The hazard and risk classification will be made after a simple run-out assessment. Further follow-up activities will be based on this classification.

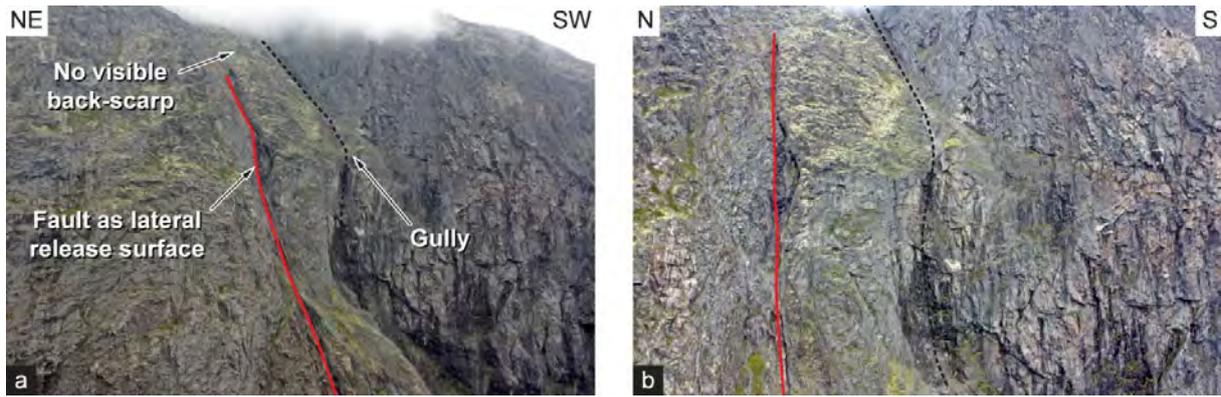
Gammelurkollen (Figure 10) is located on a west-facing slope approximately 870 m above Sandvatnet in Litldalen Valley. A helicopter reconnaissance flight was made in 2011. The site is situated in a linear depression and is delimited northward by an old fault that is partly eroded (Figure 14). It is likely that this entire depression is a wide ductile shear zone that is a typical tectonic structure in Western Norway. Other necessary structures to delimit an unstable rock slope, i.e. back-scarp, basal sliding surface or lateral release surface to the south, are missing or not visible. There is a large talus slope at the foot of the Gammelurkollen slope, which is formed by rockfalls originating from the rock wall, but also partly by transport along the gully from further uphill.

Figure 14: Photographs of the Gammelurkollen slope with the fault as north-bounding lateral release surface. Other necessary structures to delimit an unstable rock slope are however missing.

Recommendation: There are no signs that the Gammelurkollen rock slope might fail in a massive rock slope failure. No further investigations or displacement measurements are necessary and the hazard and risk classification will not be made. However, rockfalls are possible and their run-out area is given by the rockfall susceptibility map or more detailed hazard maps, where available.

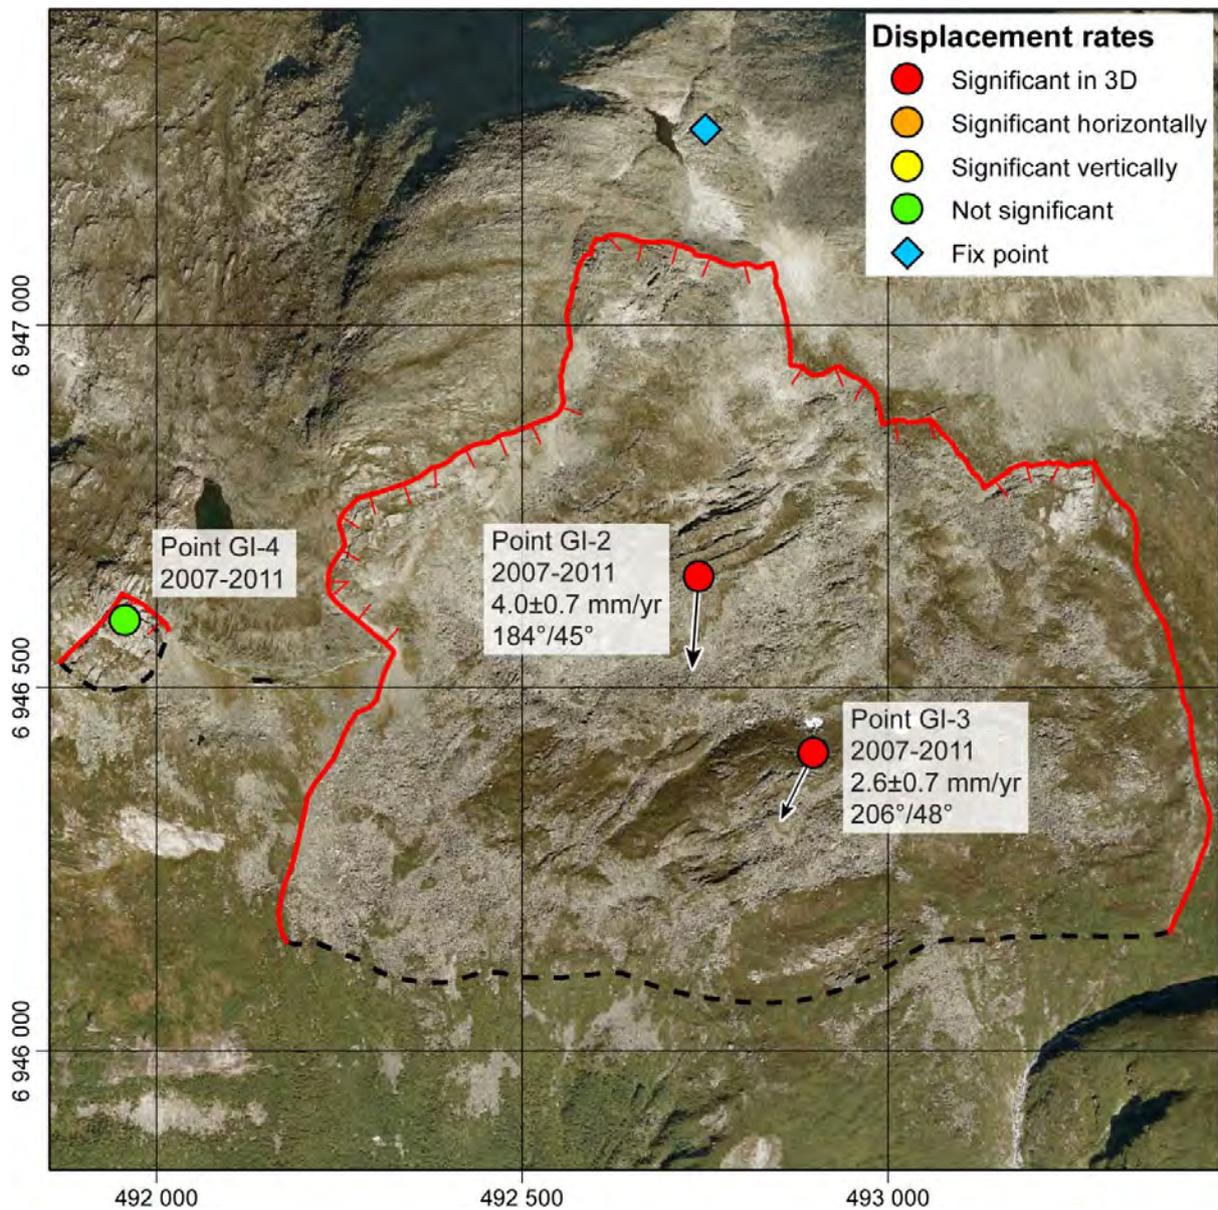
Herein, we present the results from dGNSS measurements in the years 2007, 2008, 2009 and 2011 (4 years interval). The fixed point is located above the back-scarp of Gikling 1, two measurement points (GI-2 and GI-3) are on Gikling 1 and one measurement point (GI-4) is on Gikling 2 (Figure 15). In the measurement period between 2007 and 2011, both points on Gikling 1 show significant horizontal and vertical displacements, however with an incoherent vertical trend for GI-3. The yearly three-dimensional displacement rates are 4.0 mm/year towards the South for GI-2 and 2.6 mm/year towards the SSW for GI-3. The measurement point GI-4 on Gikling 2 does not show significant horizontal or vertical displacements.

The measured displacement rates for Gikling 1 are relatively low compared to other large unstable rock slopes in Norway. The unstable rock slope Gikling 1 is likely in a creep state sliding downwards to the valley. Fresh debris slides in the scree deposits at the front of Gikling 1 are possibly caused by the advancing rock mass and thus a further sign of activity. A massive failure from Gikling 1 would form a rock avalanche that would cross Sunndalen Valley, destroy several buildings and likely dam the Driva River with the probability of a subsequent dam breach and outburst flood (Dahle et al. 2011a).

Figure 15: Map of the unstable rock slopes Gikling 1 and Gikling 2 with the location of dGNSS points for periodic displacement measurements and average displacement vectors for the 2007–2011 measurement period.

Recommendation: Significant displacements are measured at Gikling 1, while no significant displacements are measured up to now at Gikling 2. Periodic displacement measurements using dGNSS should be continued with 1–3 years interval. The hazard and risk classification needs to be made and further follow-up activities will be decided based on this classification.

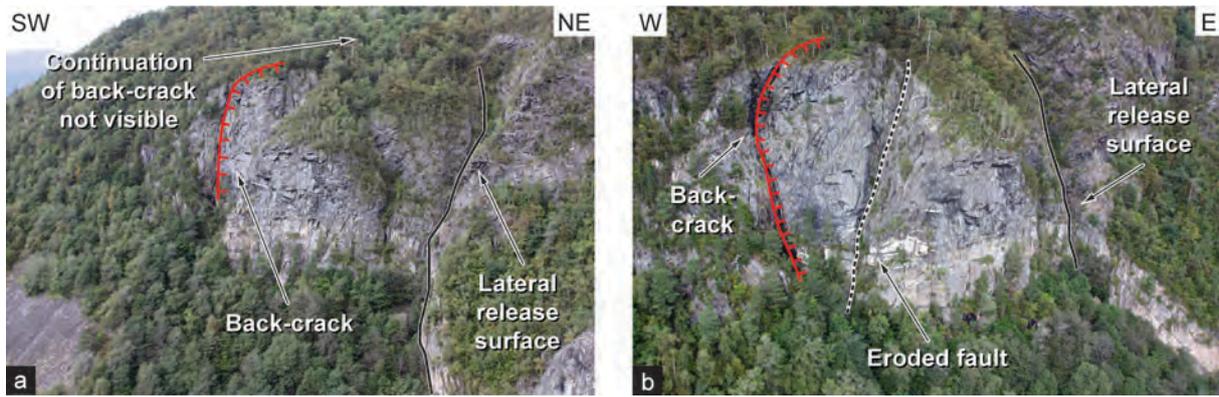
Gjersvollsetra is situated on a southeast-facing slope 300 m above Gjersvollen on the northern side of Sunndalsfjord (Figure 10). A helicopter reconnaissance flight in 2011 permitted the identification of two eroded ancient faults, acting as possible lateral release surface to the east and as limit between compartments of the instability, respectively (Figure 16). A partly open back-crack is observable at the western limit of the instability but its continuation is masked by the vegetation on the slope (Figure 16). The past displacements of the Gjersvollsetra instability were likely only small and there are no obvious signs of present activity. The Gjersvollsetra instability is of a relatively small volume ($\sim 150\,000\text{ m}^3$) and a failure will likely not reach inhabited areas.

Figure 16: Photographs of the Gjersvollsetra instability showing the partly open back-crack in the western part and eroded faults as lateral release surfaces to the East and as delimitation between two compartments of the unstable rock slope.

Recommendation: A possible rock avalanche from the Gjersvollsetra instability will have no consequences. No further investigations or displacement measurements are necessary. The hazard and risk classification will be made after a simple run-out assessment. Further follow-up activities will be based on this classification.

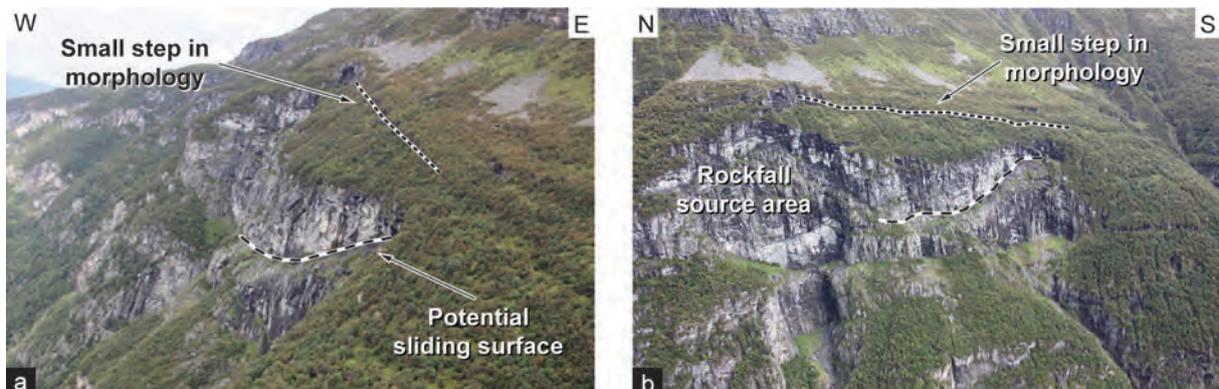
Grøvelnebb is located on a west-facing slope 620 m above Sunndalsfjord between Sunndalsøra and Oppdøl (Figure 10). A lineament, making out a small step in the morphology and favorably orientated to form the back-crack of a potential unstable rock slope, was closely observed during a helicopter reconnaissance flight in 2011 (Figure 17). No signs of openings or past displacements were observed along the lineament. Laterally the potential instability is delimited by deeply eroded gullies. Moderately valley-dipping surfaces are observed at the base of the Grøvelnebb rock slope (Figure 17), which might provide a potential sliding surface. Rockfalls are very frequent from the cliffs above the county road Fv70 at Oppdølstranda, including the Grøvelnebb rock slope.

Figure 17: Photographs of the Grøvelnebb potential unstable rock slope with the moderately valley-dipping potential sliding surface and the lineament forming a small step that might develop as the back-crack of a potential unstable rock slope.

Recommendation: Grøvelnebb is classified as a potential unstable rock slope. At present the remaining rock slope does not show any signs of past or present displacements or deformation of a large volume (except for rockfall activity). No further investigations or displacement measurements are necessary and the hazard and risk classification will not be made. However, this site may lead to rockfalls and develop over time into an unstable rock slope, due to structural and geological conditions. The site should be revisited after years to decades to detect any changes and be followed-up on InSAR data.

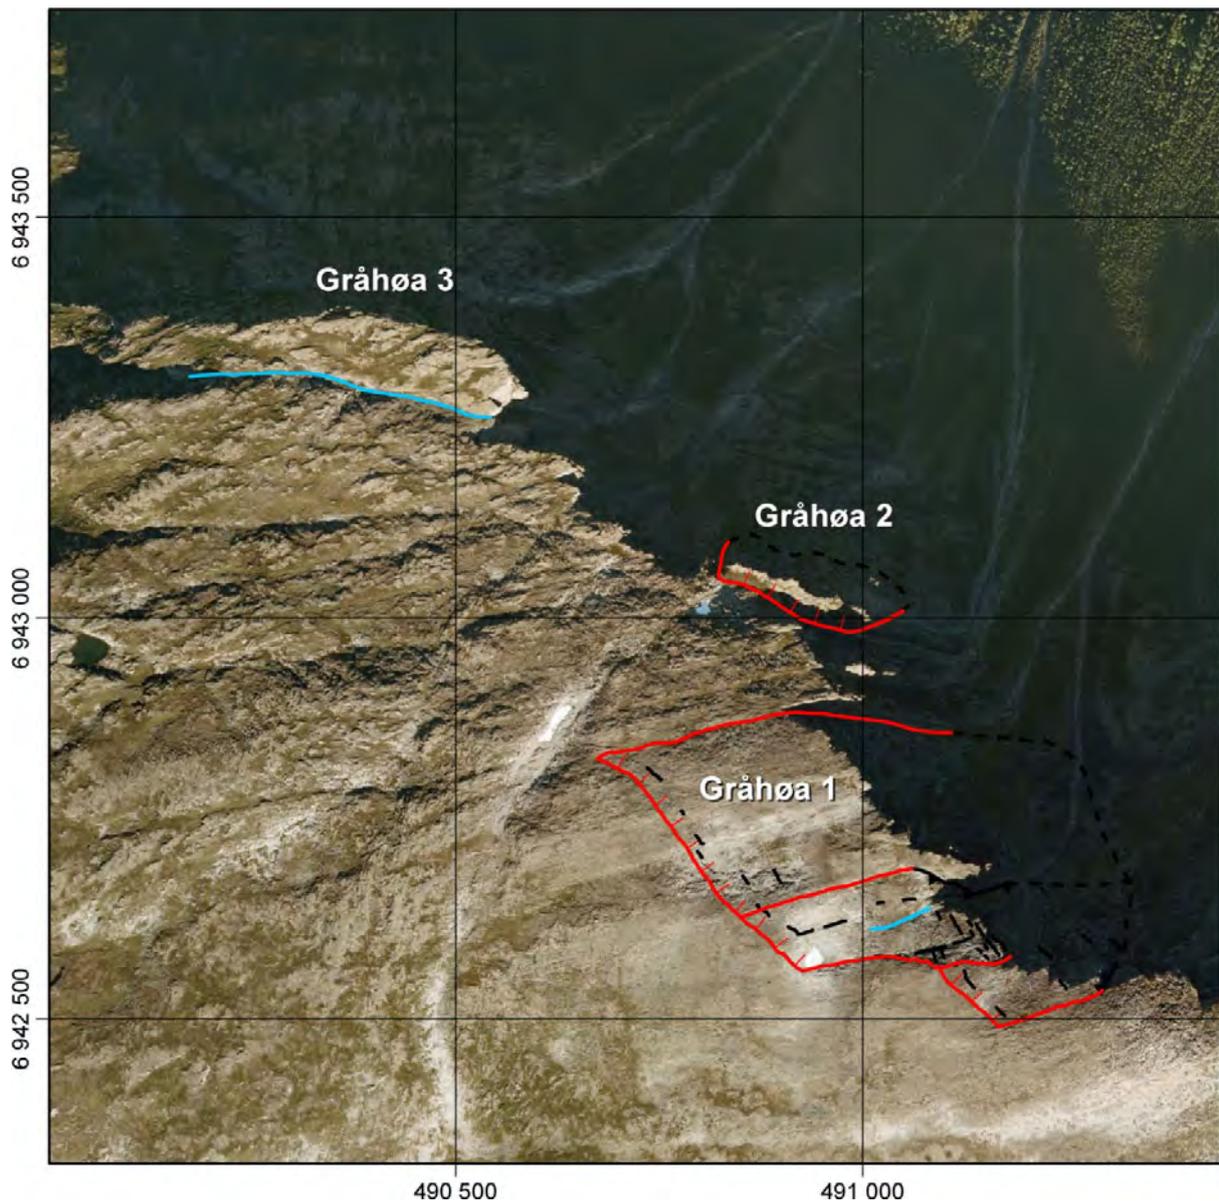
Gråhøa 1 is a complex unstable rock slope with several possible extents (Figure 19). The foliation-parallel lineaments form the lateral limits of the Gråhøa 1 instability and display a clear offset (Figure 18c). Their dip directions change from SSE-dipping in the north to NNW-dipping in the south leading to a wedge sliding mechanism (Figure 18b). The rock mass at the base of the instability is highly fractured that may indicate internal deformation of the instability. A 2–3 m wide and 10–15 m deep back-crack was opened by past displacements in ENE direction (Figure 18c). The total volume of the Gråhøa 1 instability is large enough to develop a rock avalanche that may reach the bottom of Sunndalen Valley, impact several buildings and maybe dam the river Driva with the probability of a subsequent dam breach and outburst flood (Dahle et al. 2011a).

Figure 19: Map of the Gråhøa instabilities.

Recommendation: Possible rock avalanches from the Gråhøa 1 and Gråhøa 2 instabilities will have consequences. Geological field mapping is necessary to evaluate the structural and geological conditions, define the extents of different compartments, estimate volumes and to quantify past displacements. The hazard and risk classification will be made after this field mapping. Further follow-up activities will be decided based on this classification.

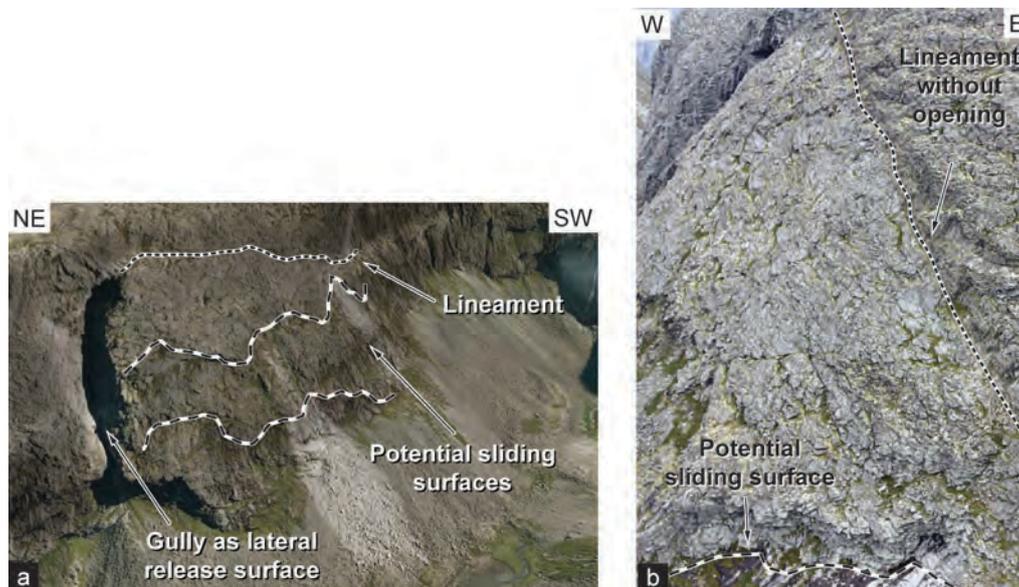
Hovennebba is situated on the west-facing slope 420 m above a small lake in Hareimdalen Valley, a small side-valley to Sunndalen Valley (Figure 10). A 500 m long lineament was observed in aerial photographs and interpreted as a potential back-crack (Figure 20a). A helicopter reconnaissance flight in 2011 allowed however to show that this lineament lacks openings or other signs of past displacements (Figure 20b). A deeply eroded gully delimits the Hovennebba rock slope to the north. Small rockslides have occurred along moderately valley-dipping sliding surfaces and similar small rockslides are likely to develop again. A large catastrophic collapse of the entire rock slope can however be ruled out according to the present structural development of the site. Moreover, a rock slope failure from Hovennebba would only affect the uninhabited Hareimdalen valley and have thus no major consequences.

Figure 20: Photographs of the Hovennebba rock slope: a) 3D view from Norge i 3D showing past small rockslides; b) the back-bounding lineament is not open.

Recommendation: There are no signs that the Hovennebba rock slope might fail in a massive rock slope failure. No further investigations or displacement measurements are necessary and the hazard and risk classification will not be made. However, rockfalls are possible and their run-out area is given by the rockfall susceptibility map or more detailed hazard maps, where available.

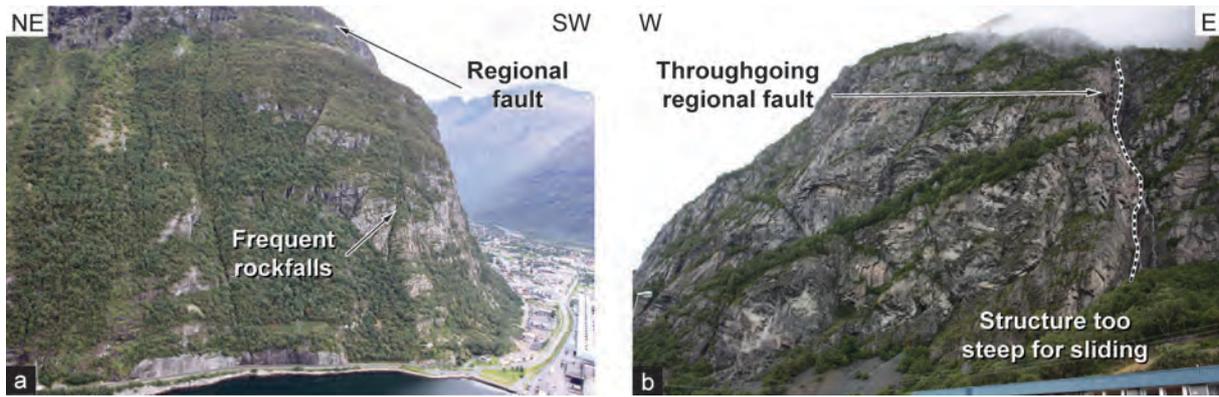
Hovsnebb 1 is located on a SW-facing slope 570 m above Sunndalsøra (Figure 10). The mountain side has been surveyed from helicopter in 2011. An old cataclasite-filled fault makes an approximately 900 m long and 80 m high escarpment at 570 m a.s.l. (Figure 21a). This fault crops out in the SE and forms a gully due to preferential erosion (Figure 21b). This fault would form a back-scarp of a large rock slope, but is too steep to daylight the topography and thus to allow sliding. There are no signs of recent movement along this fault.

Figure 21: Photographs of the Hovsnebbra 1 rock slope: a regional fault is a potential back-scarp for a large volume, but necessary structures to delimit an instability are missing.

Striated glacial surfaces are still present in the central and south-eastern part of the Hovsnebbra 1 rock slope and testify to the lack of recent gravitational failure along the slope. The slope Hovsnebbra 1 above Sundalsøra lacks necessary structures to delimit a massive unstable rock slope.

Recommendation: There are no signs that the Hovsnebbra 1 rock slope might fail in a massive rock slope failure. No further investigations or displacement measurements are necessary and the hazard and risk classification will not be made. However, rockfalls are possible and their run-out area is given by the rockfall susceptibility map or more detailed hazard maps, where available.

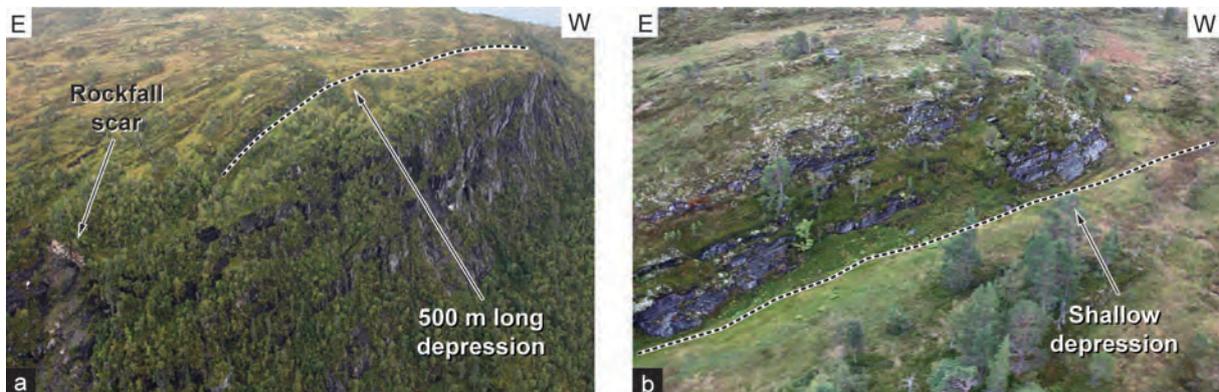
Høghamran (Figure 10) is located on a NE-facing slope 510 m above Stangvikfjord. A 500 m long shallow depression was observed during a helicopter survey in 2011 (Figure 22). This depression follows a contact between different bedrock units (fine bands of augengneiss, micaschist and metaarkose within the granitic to dioritic gneiss) (Tveten et al. 1998) and is thus not caused by gravitational deformation. Small rockfall scars are visible to the east of the Høghamran slope (Figure 22a), but there are no evidences for a large rock slope deformation.

Figure 22: Photographs of the Høghamran rock slope with a 500 m long depression caused by lithological differences and not by gravitation deformation.

Recommendation: There are no signs that the Høghamran rock slope might fail in a massive rock slope failure. No further investigations or displacement measurements are necessary and the hazard and risk classification will not be made. However, rockfalls are possible and their run-out area is given by the rockfall susceptibility map or more detailed hazard maps, where available.

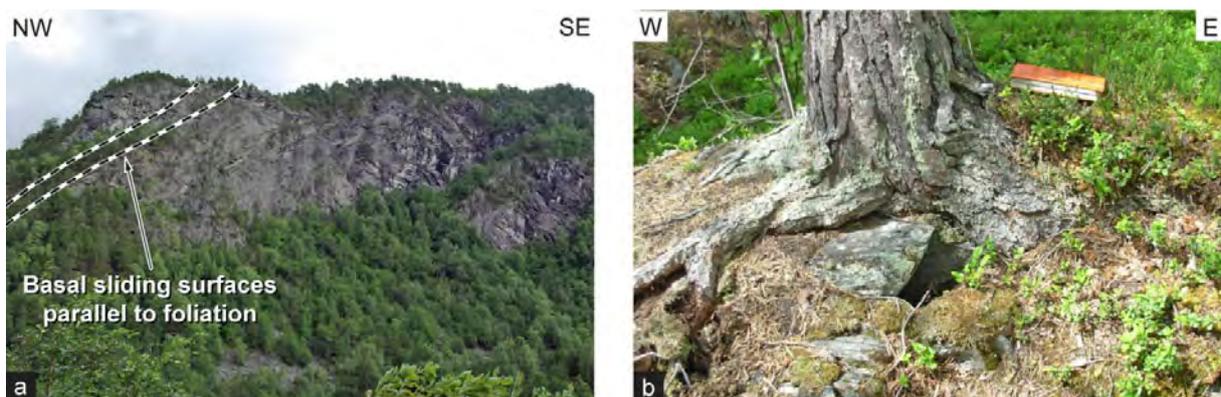
The Ivasnasen instability is periodically measured since 2010 using TLS and tape extensometers (Figure 24). Both tape extensometer points were measured again in 2011, but no significant displacements are detected. Repetitive TLS data acquired in 2011 and 2012 did also not reveal any significant displacements or rockfall activity. However, there has been recent opening or widening of a crack on the instability, which is evidenced by disturbed and twisted roots of a tree (Figure 23b).

Figure 23: Photographs of the Ivasnasen instability: a) basal sliding surfaces of the present instability are parallel to foliation and are in the continuation of the sliding surface of the past rockslide; b) disturbed tree growth due to (recent) opening or widening of a local crack on the instability.

Recommendation: No significant displacements are measured up to now at Ivasnasen. Periodic displacement measurements using tape extensometer and TLS should be continued with 3–5 years interval and to compare to past displacement rates obtained from cosmogenic nuclide dating. The hazard and risk classification needs to be made and further follow-up activities will be decided based on this classification.

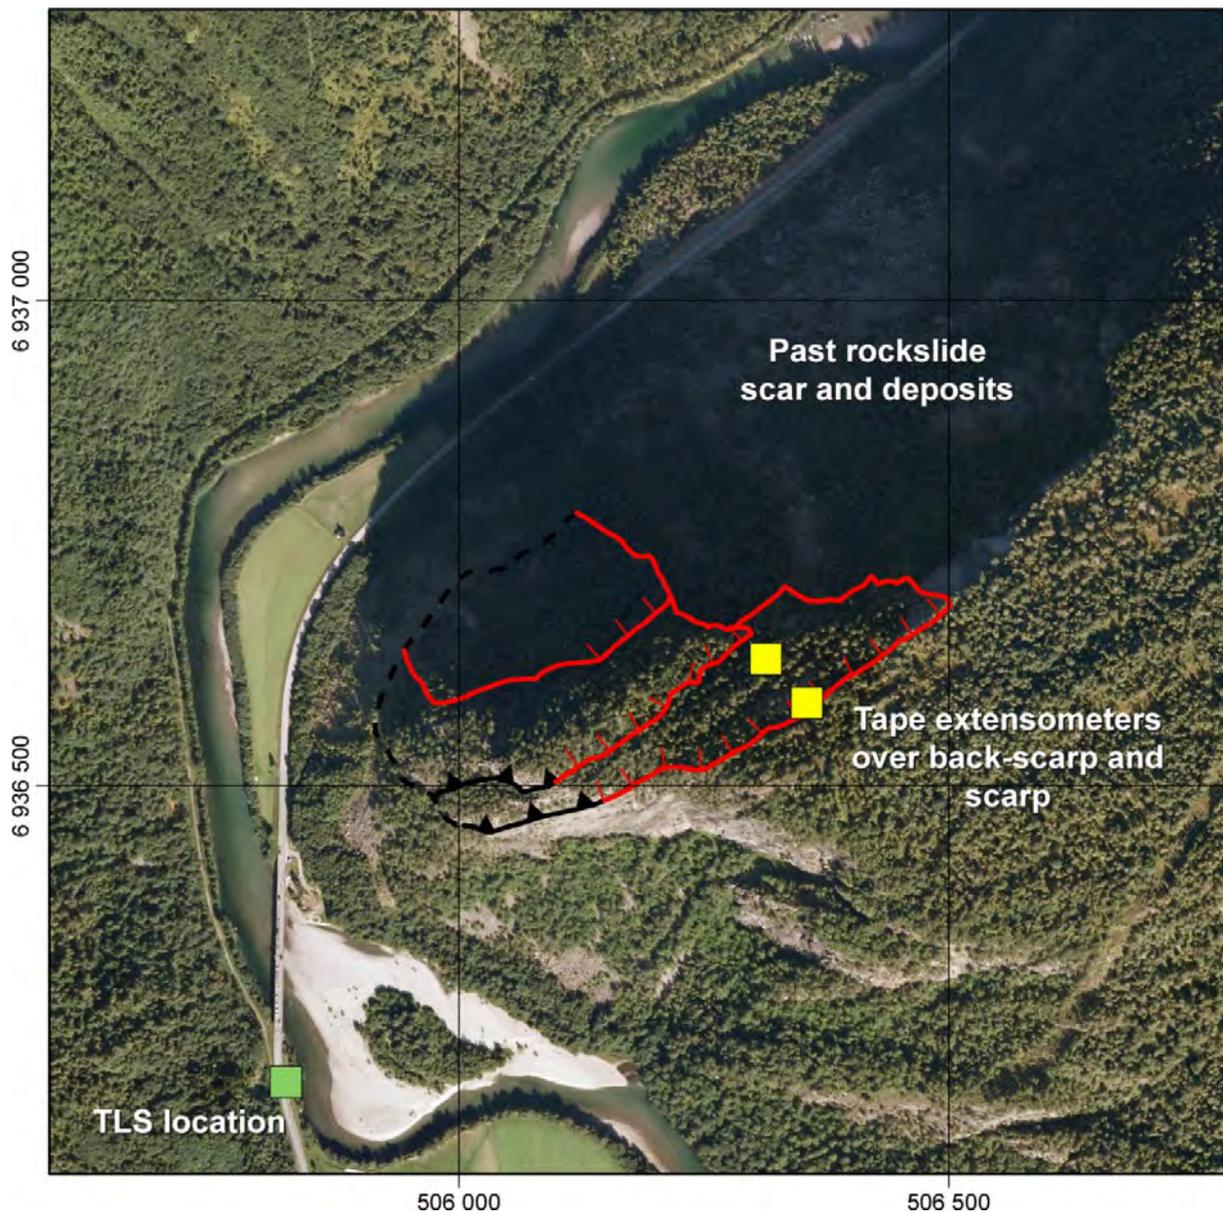
The volume of the Ivasnasen instability was assessed in detail and equals approximately 2.1 million m³ for the entire instability (Dreiås 2012). A rock avalanche from Ivasnasen will likely dam the river Driva with the consequence of upstream flooding and also downstream flooding in the event of a dam breach (Dahle et al. 2011a).

Figure 24: Map of the Ivasnasen instability showing three different compartments, as well as the location of measurement instrumentation (tape extensometer & TLS).

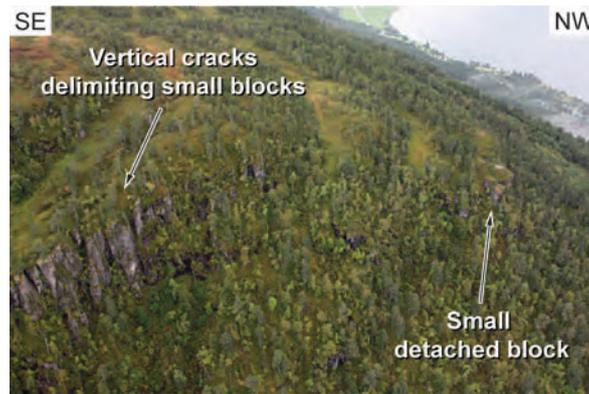
Kammen is located on a north-facing slope 410 m above Stangvikfjord, on the same slope section as the site Høghamran (Figure 10). Kammen was observed in a helicopter survey in 2011 (Figure 25). Several sets of vertical cracks delimit small columns along the front of the cliff. These detached blocks have only small volumes (few tens to hundreds of cubic meters) and their failure as rockfalls would not cause a displacement wave in Stangvikfjord.

Figure 25: Photograph of the Kammen rock slope. Only small blocks are delimited by vertical cracks.

Recommendation: There are no signs that the Kammen rock slope might fail in a massive rock slope failure. No further investigations or displacement measurements are necessary and the hazard and risk classification will not be made. However, rockfalls are possible and their run-out area is given by the rockfall susceptibility map or more detailed hazard maps, where available.

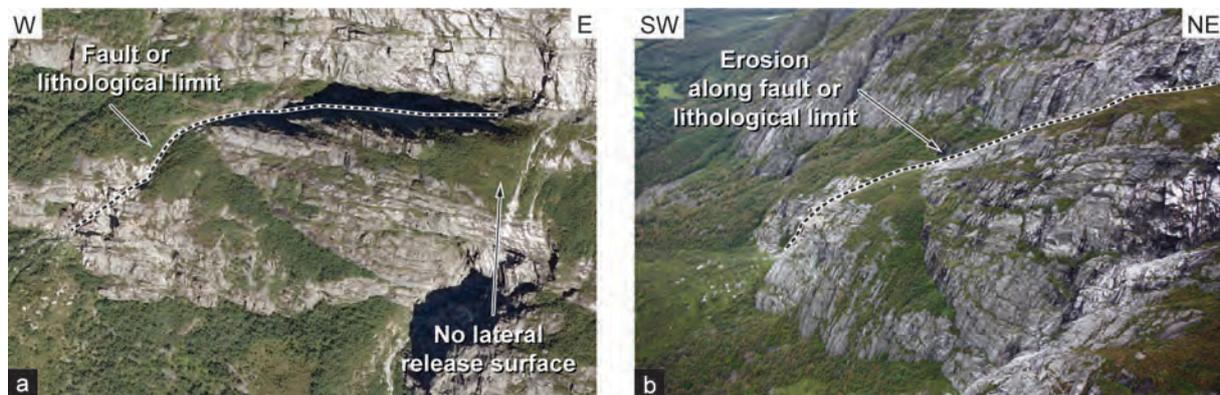
Klingfjellet 2 (Figure 10) is situated on the south-facing slope 500 m above Sunndalen Valley close to Romfo. The site was identified from aerial photos and surveyed from helicopter in 2011 (Figure 26). A large valley-parallel linear depression was interpreted as a potential back-crack from aerial photos. A helicopter survey in 2011 allowed however to ascertain that the depression is not caused by gravitational movements, but more likely by erosion of an old fault. Furthermore, lateral and basal structures are missing to delimit a potential instability (Figure 26).

Figure 26: Photographs of the Klingfjellet 2 rock slope: the lineament is formed by erosion of an old fault and is not a back-crack of an instability.

Recommendation: There are no signs that the Klingfjellet 2 rock slope might fail in a massive rock slope failure. No further investigations or displacement measurements are necessary and the hazard and risk classification will not be made. However, rockfalls are possible and their run-out area is given by the rockfall susceptibility map or more detailed hazard maps, where available.

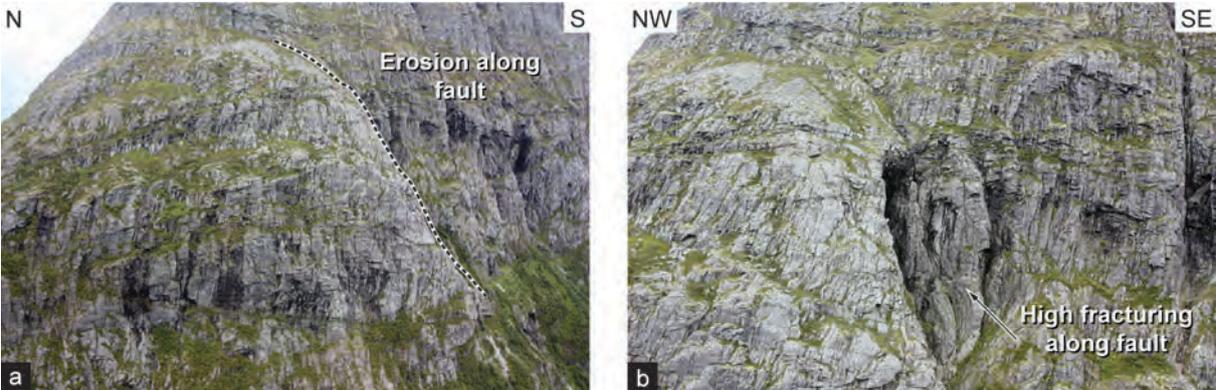
Litlkalkinn 3 is located on a west-facing slope above Litldalen Valley close to Sunndalsøra (Figure 10). The steep rock slope was surveyed during a helicopter reconnaissance flight in 2011 (Figure 27). A steep fault with high fracturing and preferential erosion was observed, but there are no signs of past displacements or present activity along it. Other structures necessary to delimit an instability are lacking and Litlkalkinn3 is therefore not an unstable rock slope.

Figure 27: Photographs of the Litlkalkinn 3 rock slope: the lineament is an old eroded fault and not related to an unstable rock slope.

Recommendation: There are no signs that the Litlkalkinn 3 rock slope might fail in a massive rock slope failure. No further investigations or displacement measurements are necessary and the hazard and risk classification will not be made. However, rockfalls are possible and their run-out area is given by the rockfall susceptibility map or more detailed hazard maps, where available.

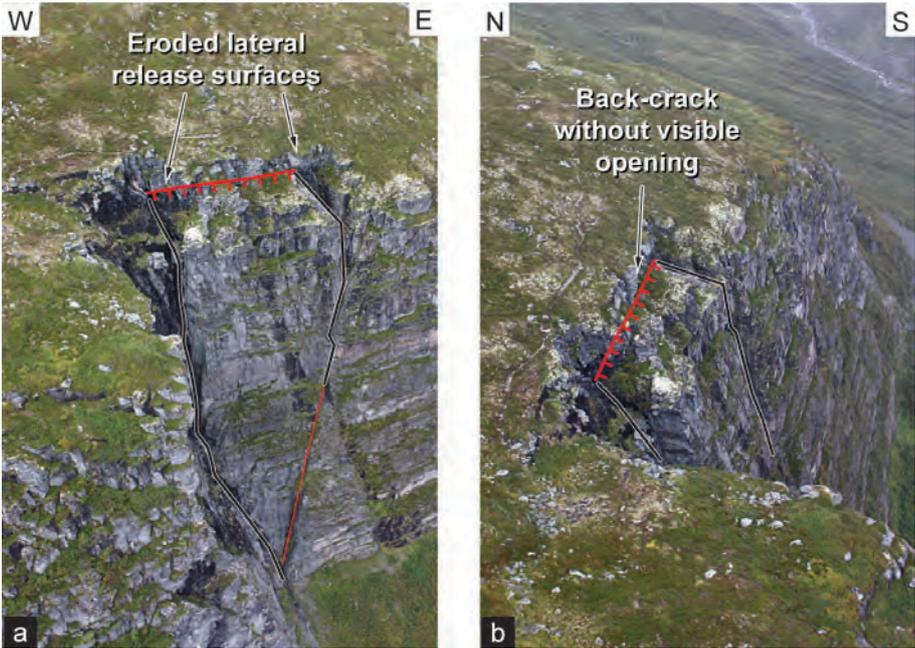
Merrakammen is located on a south-facing slope 525 m above Innerdalsvatna Lake in Innerdalen Valley (Figure 10). A helicopter survey was made in 2011 at Merrakammen. Eroded lateral release surfaces delimit a small volume on two sides (Figure 28). No back-crack might have developed at the site since no visible opening is observed along the linear structure that joins the lateral release surfaces. Only based on helicopter survey it is not possible to ascertain whether past displacement occurred at Merrakammen or not. A catastrophic failure of this instability might reach the cabins at Oppdølsetra, but will likely not cause a major displacement wave in the lake.

Figure 28: Photographs of the Merrakammen instability with its free lateral release surfaces and an apparent back-crack.

Recommendation: A possible rock avalanche from the Merrakammen instability will have consequences. Geological field mapping is necessary to evaluate the structural and geological conditions and to quantify past displacements. The hazard and risk classification will be made after this field mapping. Further follow-up activities will be decided based on this classification.

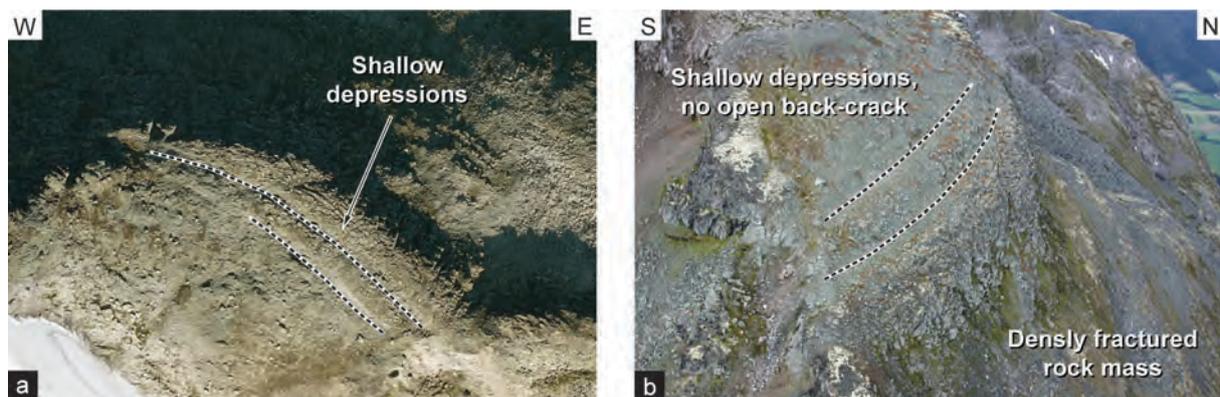
Mohaugen 1 (Figure 10) is situated on a northeast-facing slope 1130 m above Viromdalen Valley. Two 200 and 100 meter long depressions were observed from helicopter in 2011 (Figure 29). These depressions display no openings or other signs of past gravitational deformation and other structures are lacking to delimit an unstable rock slope. The rock mass is heavily fractured and small blocks are detached along the front cliff and from the southern side of the Mohaugen 1 rock slope (Figure 29b). These small blocks lead to rockfalls.

Figure 29: Photographs of the Mohaugen 1 rock slope: shallow depressions are likely not caused by gravitational movements of the rock slope; rockfalls from the densely fractured rock mass will occur.

Recommendation: There are no signs that the Mohaugen 1 rock slope might fail in a massive rock slope failure. No further investigations or displacement measurements are necessary and the hazard and risk classification will not be made. However, rockfalls are possible and their run-out area is given by the rockfall susceptibility map or more detailed hazard maps, where available.

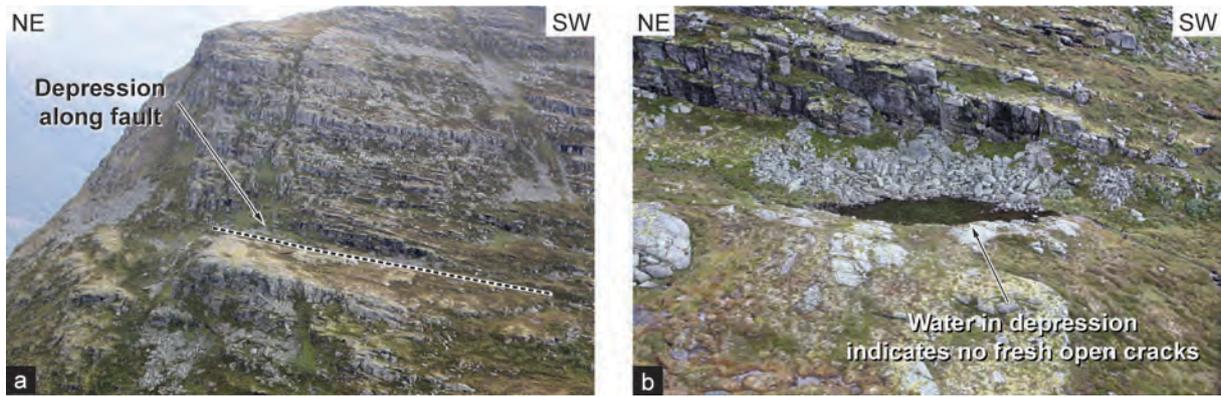
Mohaugen 2 (Figure 10) is located on a northwest-facing slope above the valley between Oppdøl and Ålvundseid. The site was observed from helicopter in 2011. A depression in a relatively flat terrain seems to delimit a small volume toward the cliff (Figure 30). This depression follows probably an old fault and water ponds inside the depression indicate that there are no recent openings indicating a back-crack formation (Figure 30b). Other structures to delimit an unstable rock slope are missing.

Figure 30: Photographs of the Mohaugen 2 rock slope: an old fault forms a depression that is locally filled with water, indicating no recent openings.

Recommendation: There are no signs that the Mohaugen 2 rock slope might fail in a massive rock slope failure. No further investigations or displacement measurements are necessary and the hazard and risk classification will not be made. However, rockfalls are possible and their run-out area is given by the rockfall susceptibility map or more detailed hazard maps, where available.
