GEOLOGI FOR SAMFUNNET

GEOLOGY FOR SOCIETY

Report no.: 2013.014		ISSN: 0800–3416	Grading: Open
Title: Investigations on unstable rock slopes in Møre og Romsdal – status and plans after field surveys in 2012			
Authors: T. Oppikofer, A. Saintot, S. Otterå, R.L. Hermanns, E. Anda, H. Dahle, T. Eiken		Client: Norwegian Water Resources and Energy Directorate (NVE)	
County: Møre og Romsdal		Commune:	
Map-sheet name (M=1:250.000) Ålesund, Kristiansund, Røros, Ulsteinvik		Map-sheet no. and -name (M=1:50.000)	
Deposit name and grid-reference:		Number of pages: 323	Price (NOK): 1285,-
Fieldwork carried out: 2006–2012		Date of report: 13.11.2013	Map enclosures: 0
Fieldwork carried out: 2006–2012		Date of report: 13.11.2013	Project no.: 309900
Fieldwork carried out: 2006–2012		Date of report: 13.11.2013	Quality control: <i>Halvor Brundhoff</i>
<p>Summary:</p> <p>This report presents investigations, analyses and displacement measurements made between 2006 and 2012 on 131 unstable or potential unstable rock slopes in Møre og Romsdal County (Western Norway). An extract of this report is available in Norwegian (NGU rapport 2013.053).</p> <p>These investigations are part of the national plan for

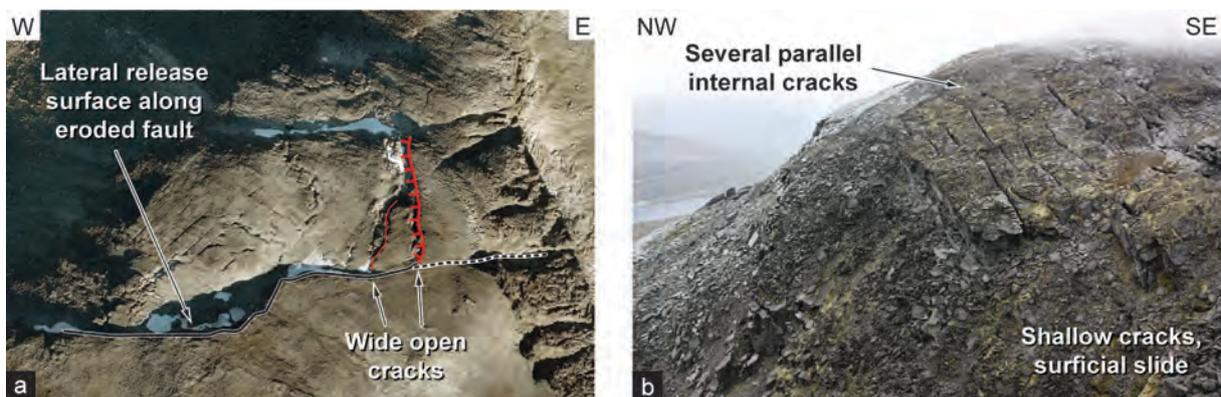
Otttdalskammen (Figure 10) is located on a NW-facing slope 410 m above the valley bottom in the inner end of Innerdalen Valley. The slope was surveyed from helicopter in 2011. The unstable rock slope has a clear south-bounding lateral release surface along an eroded fault and is delimited to the east by two open back-cracks (Figure 31a). The detached rock body shows a displacement of several tens of meters and has several internal slope-parallel cracks (Figure 31b). The foliation is moderately valley-dipping and may form the basal sliding surface of Otttdalskammen rockslide. Small compartments delimited by internal cracks have failed in the past (Figure 31b). Eventual failures at Otttdalskammen will only affect uninhabited areas and have no major consequences (Dahle et al. 2011a).

Figure 31: Photographs of the Otttdalskammen unstable rock slope: a) aerial photograph of the rock slope showing major structures and internal cracks; b) internal cracks delimit compartments that may fail individually towards the NW.

Recommendation: A possible rock avalanche from the Otttdalskammen rockslide will have no consequences. No further investigations or displacement measurements are necessary. The hazard and risk classification will be made after a simple run-out assessment. Further follow-up activities will be based on this classification.

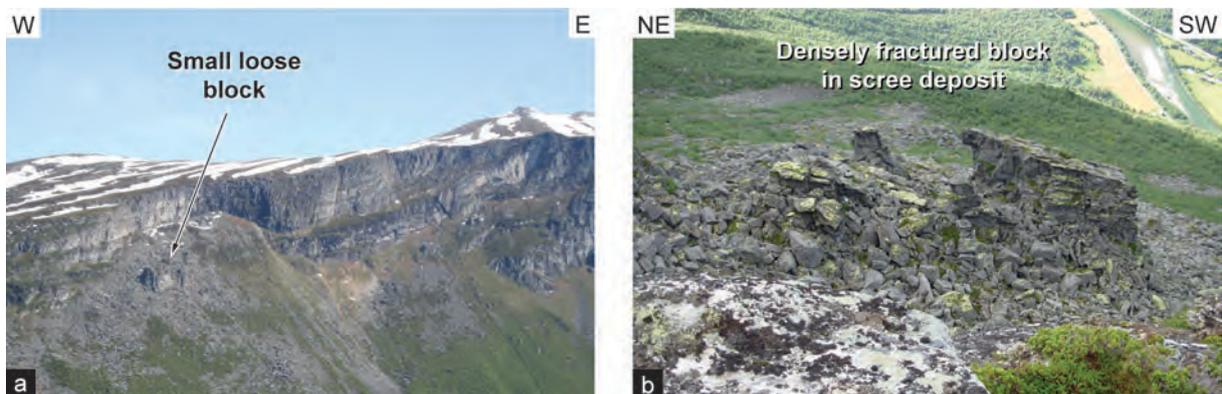
Ottem 2 is a talus slope formed by rockfalls and small rock avalanches from the steep cliffs at Ottem (Figure 32). A detached, highly fractured block lies on this talus slope (Figure 33). This block has a relatively small volume and the high fracturing lets suppose that it will disintegrate in smaller blocks. Ottem 2 is too small to form a large rock avalanche that would affect the settlements in Sunndalen Valley. This talus slope stretches down to the cliffs above Ottem 3 at 240 m a.s.l., but is grass- and forest-covered in the lower part. There are signs of movements of single blocks on this talus (Figure 33c) and the cliffs above Ottem 3 are prone to rockfalls (Figure 33d). However, there are no indications for a large unstable rock slope affecting the entire mountain side as it has been previously supposed (Henderson and Saintot 2007, Dahle et al. 2011a). The cliffs above Ottem 3 were scanned by TLS in 2010 for structural characterization of the cliffs and possible detection of rockfall activity. No repetitive scans are made yet. The foliation is subhorizontal, while other discontinuity sets are steep to subvertical with variable dip directions (N, NE, S, SW and NW). This structural setting enables rockfalls from the steep cliffs, but no planar or wedge sliding mechanism for a large unstable rock slope.

Figure 33: Photographs of the Ottem 2 instability: a) the fully detached block lies on a blocky talus slope; b) the block is highly fractured and will likely disintegrate into small blocks.

There are no signs that the Ottem 1 and Ottem 2 rock slopes might fail in massive rock slope failures. No further investigations or displacement measurements are necessary and the hazard and risk classification will not be made. However, rockfalls are possible and their run-out area is given by the rockfall susceptibility map or more detailed hazard maps, where available.

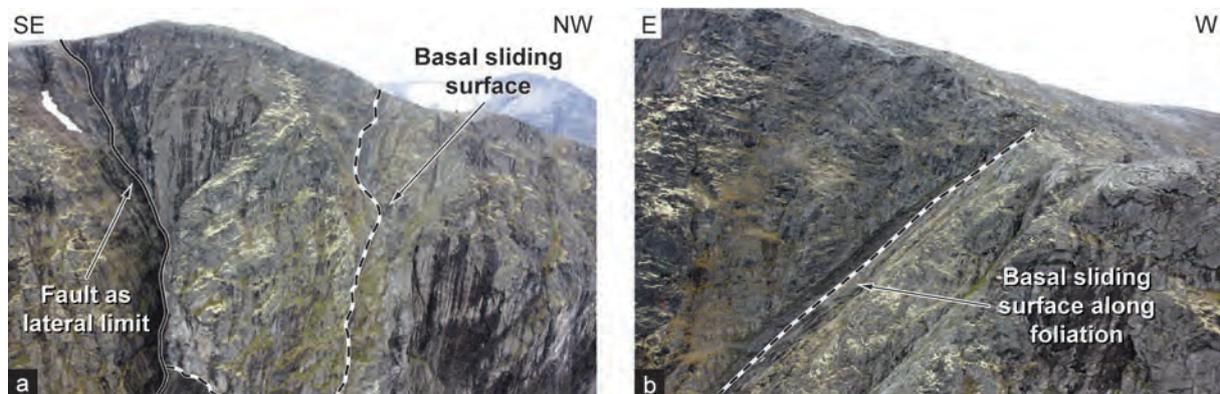
Serkjenebba (Figure 10) is located on a northeast-facing slope 1065 m above Dalavatnet Lake in Grødalen Valley. The unstable rock slope was observed by helicopter in 2011 and is delimited by an old fault to the SE and basal sliding surface to the north (Figure 34a). Foliation attitude changes along the mountainside and a basal sliding surface could have developed along the foliation where it is moderately SE-dipping in the northern part of the instability (Figure 34b). A lineament on the plateau marks the potential back-crack of the Serkjenebba instability, but there are no visible openings and only a small vertical apparent offset is seen. There are signs of high rockfall and debris flow activity at the unstable rock slope and its surroundings. A catastrophic failure of the Serkjenebba instability will reach Grødalen Valley and likely dam the river Grøa.

Figure 34: Photographs of the Serkjenebba instability: a) the instability is delimited by a NE-dipping fault to the SE and by a basal sliding surface to the NW; b) the moderately S-dipping basal sliding surface at the NW-limit of the instability is parallel to foliation.

Recommendation: A possible rock avalanche from the Serkjenebba, characterise the basal sliding surface instability will have consequences. Geological field mapping is necessary to evaluate the structural and geological conditions and to quantify past displacements. The hazard and risk classification will be made after this field mapping. Further follow-up activities will be decided based on this classification.

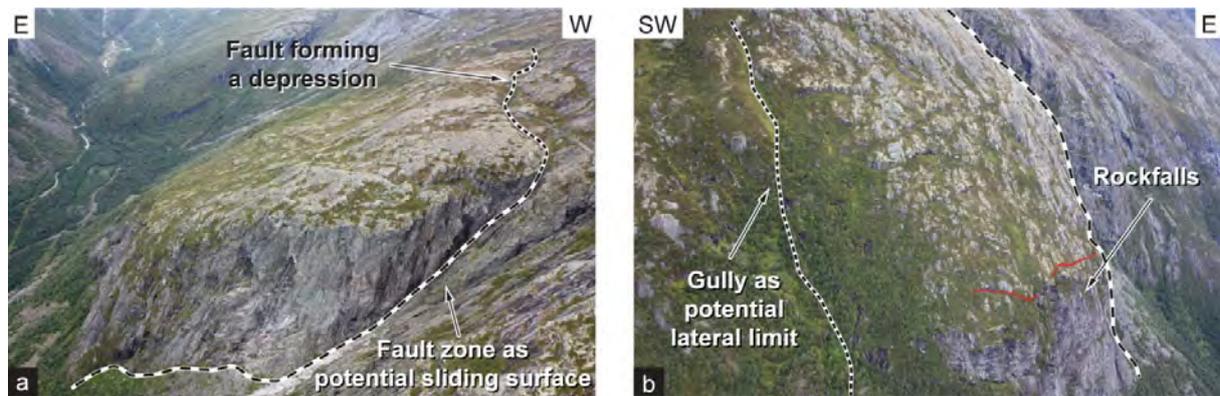
Steinbruhøa (Figure 10) is located on an east-facing slope 850 m above Litldalen Valley. A helicopter survey in 2011 has allowed the observation of an old fault zone forming the basal sliding surface of the potential unstable rock slope. This fault daylights on the plateau and forms small depressions probably due to preferential erosion (Figure 35a). A small gully marks a possible southern lateral limit of the instability, but this structure is very poorly developed (Figure 35b). Rockfall scars and possible small, shallow rockslides are observed along the frontal cliff (Figure 35b). There are no signs of recent activity (opening of back-cracks, offsettings etc.) of the potential unstable rock slope at Steinbruhøa.

Figure 35: Photographs of the potential unstable rock slope at Steinbruhøa: a) a fault zone delimits the potential instability at its base and back; b) the lateral limit to the south is poorly marked by a small gully, cracks along the front cliff delimit small rockslides and rockfalls.

Recommendation: Steinbruhøa is classified as a potential unstable rock slope. At present the remaining rock slope does not show any signs of past or present displacements or deformation of a large volume. No further investigations or displacement measurements are necessary and the hazard and risk classification will not be made. However, this site may lead to rockfalls and develop over time into an unstable rock slope, due to structural and geological conditions. The site should be revisited after years to decades to detect any changes and be followed-up on InSAR data.

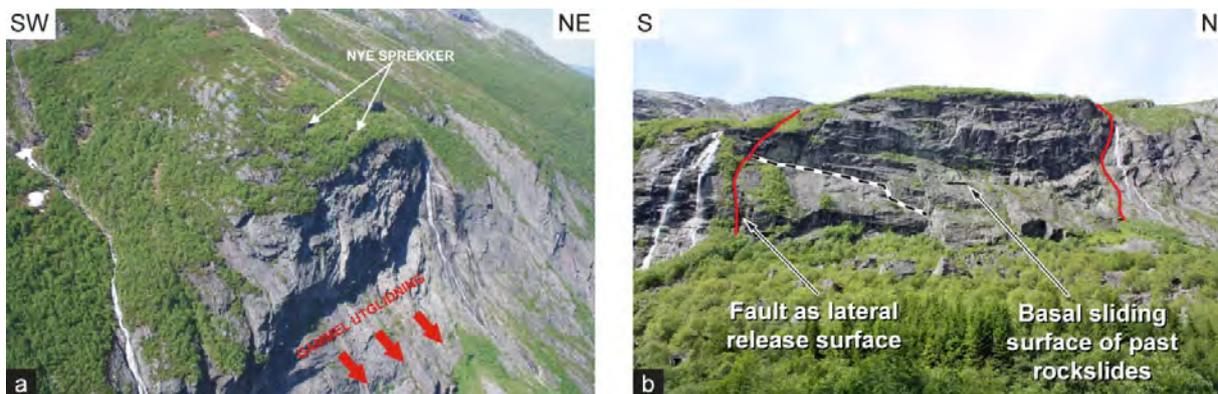
Storurhamran is located on the east-facing slope 400 m above Litldalen Valley (Figure 10). The site was investigated by helicopter in 2007 and described by Henderson & Saintot (2007) (Figure 37a). The steep cliffs at Storurhamran make this site nearly inaccessible to an eventual field work. The slope was therefore scanned by TLS in 2010 in order to assess the main structures of the cliff. The foliation is steeply dipping southwards, which is roughly perpendicular to the slope face. The cliff at Storurhamran is characterised by overhanging walls formed by SW- to W-dipping discontinuity sets and moderately E-dipping exfoliation surfaces. The latter appear to have formed the basal sliding surface of ancient rockslides and might also form the basal sliding surface of the present unstable rock slope (Figure 37b). These ancient rockslides explain the huge boulders found at the foot of the Storurhamran instability. A catastrophic failure would hit the road in Litldalen Valley and probably dam the Litldalselva River, but will not directly impact inhabited areas.

Figure 37: Photographs of the Storurhamran instability: a) aerial photograph (from Henderson & Saintot 2007); b) frontal view of the instability showing the past sliding surfaces and the huge boulders at the foot of the slope.

Recommendation: A possible rock avalanche from the Storurhamran instability will have no consequences. No further investigations or displacement measurements are necessary. The hazard and risk classification will be made after a simple run-out assessment. Further follow-up activities will be based on this classification.

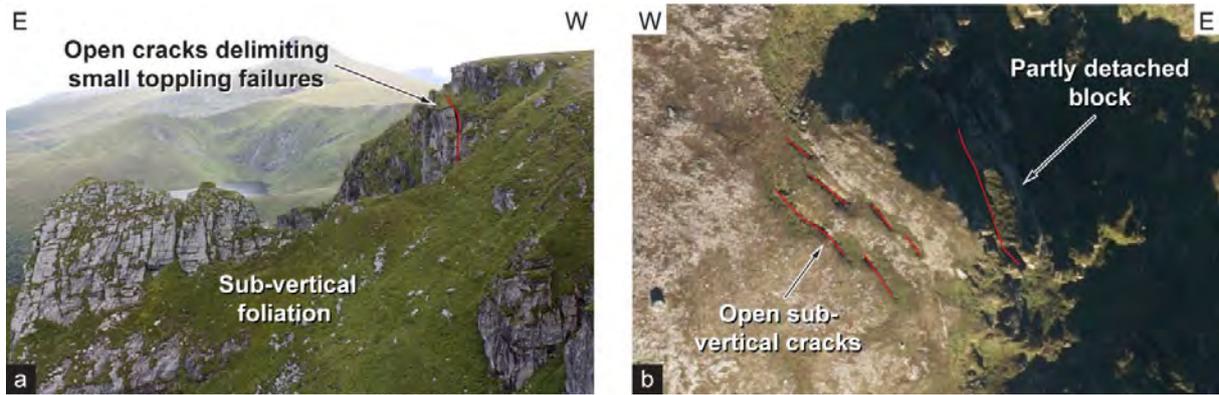
Stemshesten (Figure 39) is situated on a northeast-facing slope 510 m above Austheim. The site has been earlier described by Dahle et al. (2011). A helicopter reconnaissance flight in 2012 revealed several 2–4 meters long open vertical cracks on the mountain top without visible connectivity of the crack system (Figure 41b). An intact block with a volume of 20 000 to 30 000 m³ is observed at the front of Stemshesten (Figure 41). A spur with little internal deformation is separated from the mountain side by a saddle (Figure 41a), but there are no structures delimiting a large unstable rock slope. The subvertical valley-dipping foliation enables toppling failures. Large boulders are deposited at the foot of the slope and a fresh rock slope failure of a smaller volume shows that there is some activity at Stemshesten. The possible rock slope failures at Stemshesten have relatively small volumes and they would not form a rock avalanche with an excessive run-out distance, i.e. longer than that of rockfalls.

Figure 41: Photographs of the Stemshesten: a) the intact spur in the East is separated from the mountainside by a saddle, but there are no indications of past displacements; b) toppling failures are possible along the subvertical foliation delimiting small blocks.

Recommendation: There are no signs that the Stemshesten rock slope might fail in a massive rock slope failure. No further investigations or displacement measurements are necessary and the hazard and risk classification will not be made. Rockfalls and small rock avalanches are however possible and their run-out area is given by the rockfall susceptibility map or more detailed hazard maps, where available.

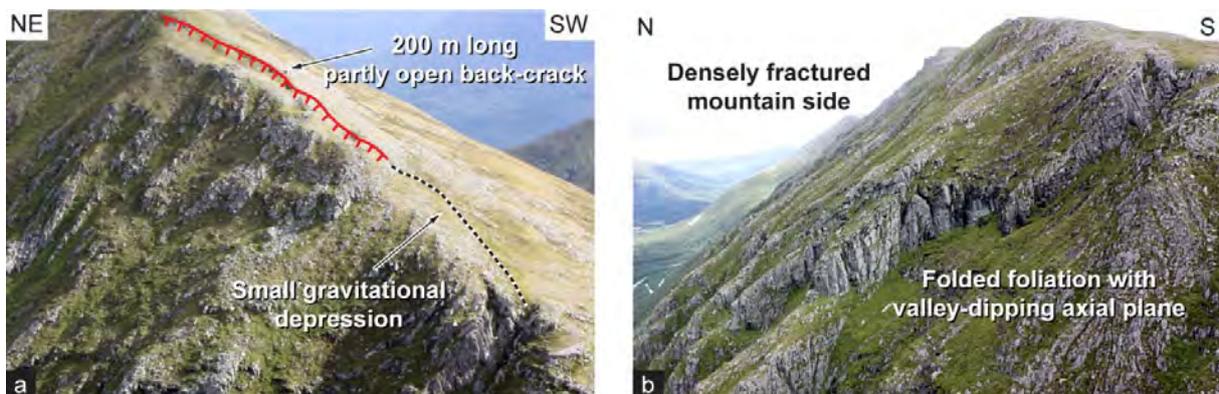
Talstedhesten (Figure 39) is located on a northwest-facing slope 600 m above Langvatnet Lake. A helicopter reconnaissance flight made in 2012 showed an unstable rock slope that is delimited by a 350 m long discontinuous back-crack (Figure 42a). It is partly open and partly a shallow depression. The unstable rock slope is free on both lateral sides, but no basal sliding surface is visible. The apparent downthrow indicates small past displacements. Foliation is mainly steeply NE-dipping (dipping perpendicular to the mountain side), but is folded and the axial plane seems to be valley-dipping (Figure 42b). The absence of large scree deposits below the densely fractured mountainside indicates little activity. A massive rock slope failure from Talstadhesten would form a rock avalanche and create a displacement wave in Langvatnet Lake.

Figure 42: Photographs of the Talstadhesten unstable rock slope: a) the back-scarp is partly open and partly a shallow depression; b) the rock mass is highly fractured and folded along a valley-dipping axial plane.

Recommendation: A possible rock avalanche from the Talstadhesten instability will have consequences. Geological field mapping is necessary to evaluate the structural and geological conditions and to quantify past displacements. The hazard and risk classification will be made after this field mapping. Further follow-up activities will be decided based on this classification.

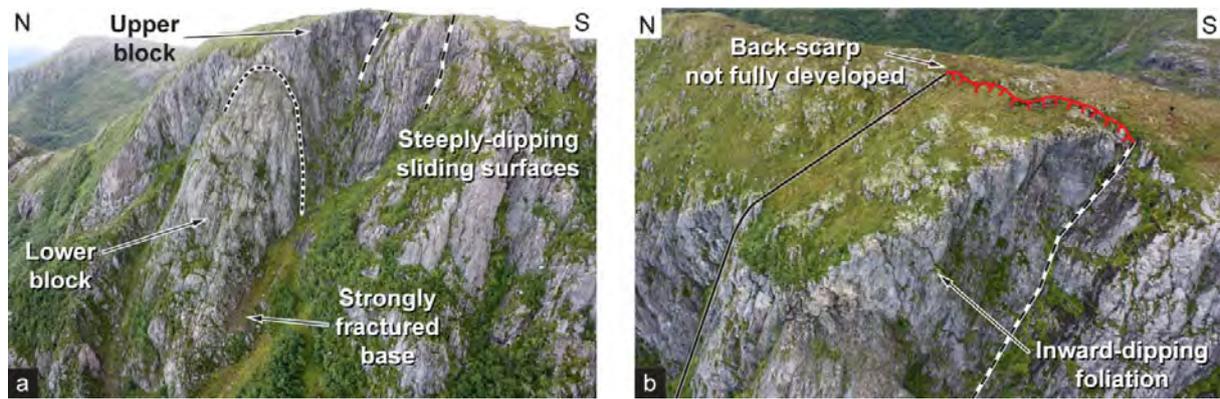
Bendsethornet is located on a northwest-facing slope 540 m above Grunnefjord (Figure 43) between Ræstad and Bendset. The site has earlier been described under the name Kløvhaugen by Dahle et al. (2011) and overflowed by helicopter in 2012. The back-crack is not fully developed (Figure 44b). A set of persistent steep N-dipping fractures forms possible sliding surfaces in the upper part of the slope (Figure 44a). Foliation is moderately S-dipping (Figure 44b). Observations from helicopter suggest that the instability is possibly separated into two compartments: a relatively intact upper block is resting on a lower block with a strongly fractured or even crushed base (Figure 44a). The total volume is estimated to approximately 2 million m³. A small part of the instability was blasted in the 1930s and iron bolts were installed across the back-crack in 1937. The bolt distances were measured in 2009 and no opening of the crack was recorded (Dahle et al. 2011a). A rock avalanche from Bendsethornet would impact some buildings and might create a displacement wave in Grunnefjord.

Figure 44: Photographs of the Bendsethornet instability: a) the instability is divided into an intact upper block and a strongly fractured lower block; b) detail of the upper block showing a partly open back-scarp and one of the possible sliding surfaces.

Recommendation: A possible rock avalanche from the Bendsethornet instability will have consequences. Geological field mapping is necessary to evaluate the structural and geological conditions and to quantify past displacements. The hazard and risk classification will be made after this field mapping. Further follow-up activities will be decided based on this classification.

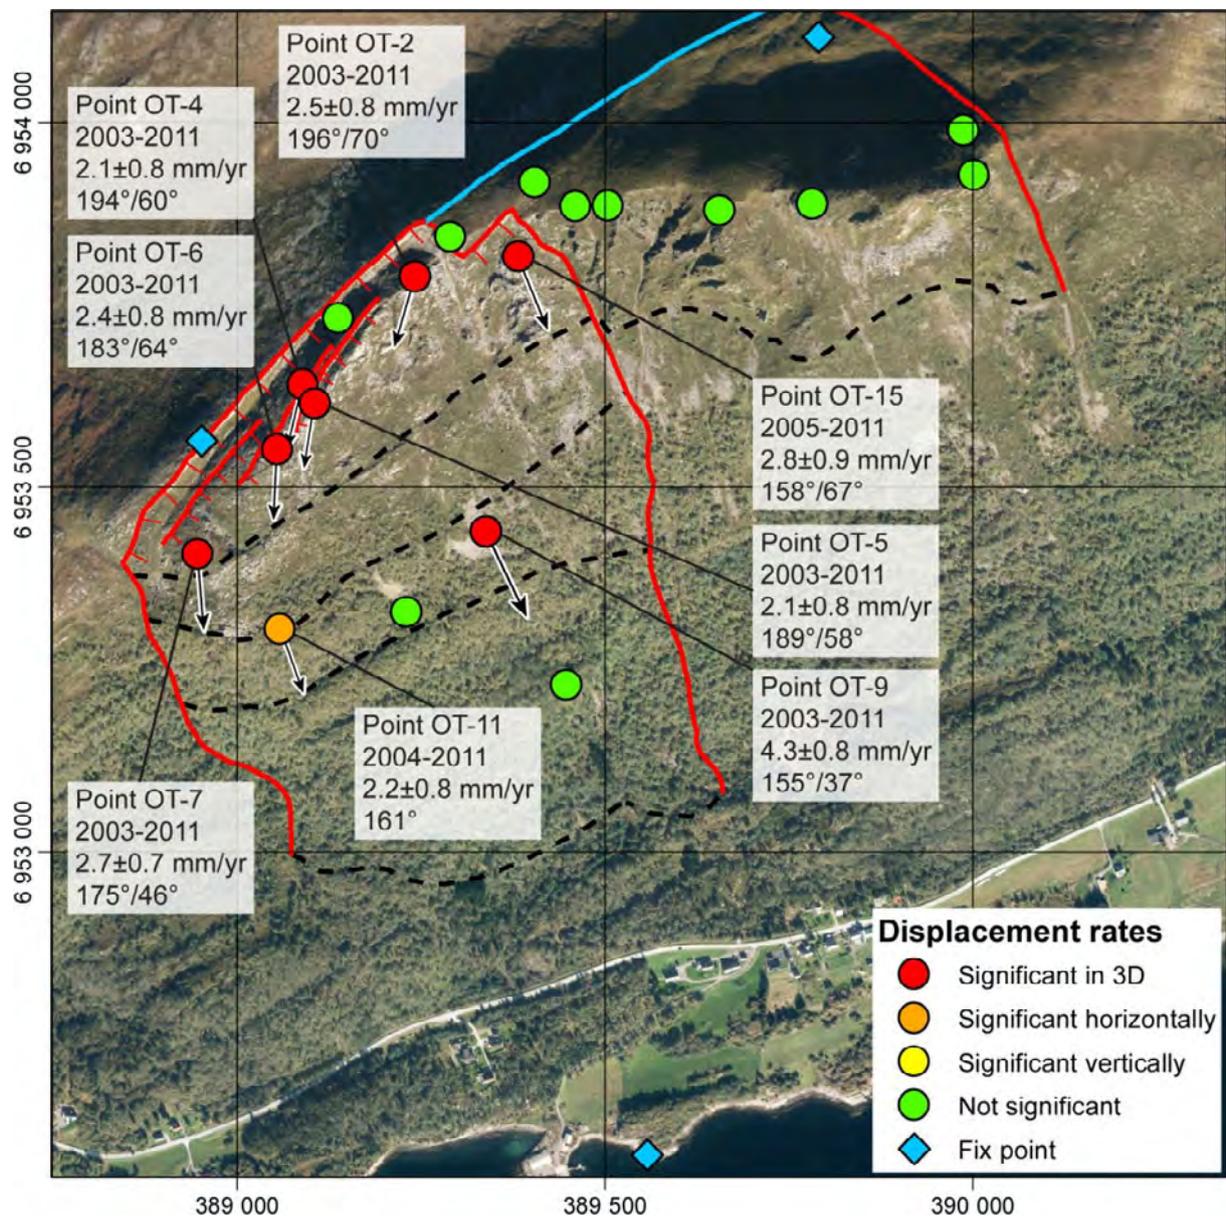
A total of 12 measurement points were set out between 2003 and 2004 on the south-western part of the Oppstadhornet unstable rock slope, which has undergone large displacements in the past and is actively moving (Figure 45). The points were yearly measured between 2003 and 2008, and again in 2011. The points in the uppermost part of the slope (OT-2, OT-4 to OT-7 and OT-15) have significant displacements in 3D with displacement rates ranging from 2.1 to 2.8 mm/year. The displacement vectors are downslope SSE to SSW directed and moderately to steeply (46° to 70°) plunging. In the middle part of the unstable rock slope (at points OT-9 and OT-11) displacement vectors have a shallower plunge angle of 37° . The high displacement rates at OT-9 of 4.3 mm/year are incoherent with the other measurements and a field verification of the setting of this point needs to be undertaken. The points in the lower part of the slope do not have significant displacements over the 2003–2011 measurement period.

Seven additional measurement points were installed in 2005 on the north-eastern part of the slope based on results of geophysical investigations that indicate a possible sliding surface under this slope section. However, no significant displacements are recorded between 2005 and 2011 (Figure 45).

Figure 45: Map of the Oppstadhornet unstable rock slope with the location of dGNSS points for periodic displacement measurements and average displacement vectors for the 2003–2011 measurement period.

Recommendation: Significant displacements are measured at Oppstadhornet. Periodic displacement measurements using dGNSS should be continued with 1–3 years interval. The setting of dGNSS measurement point OT-9 needs to be verified in the field. The hazard and risk classification needs to be made and further follow-up activities will be decided based on this classification.

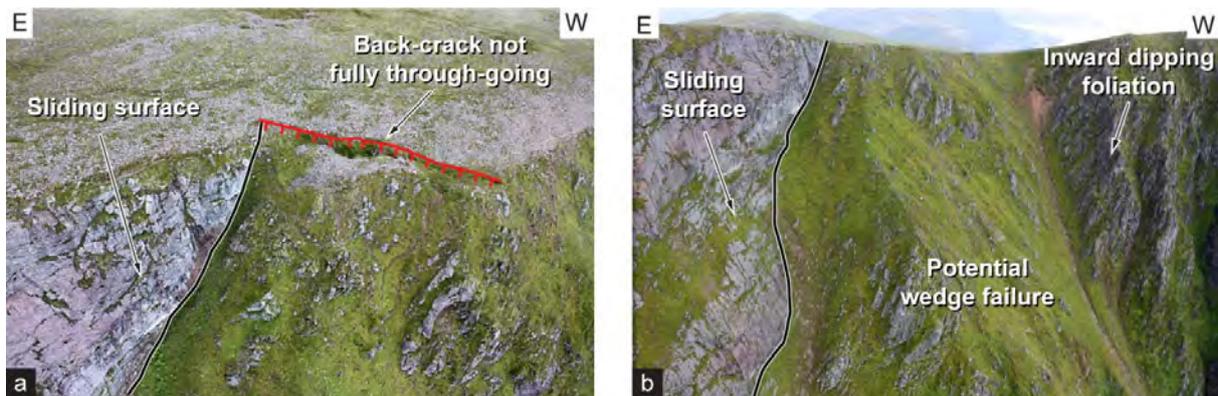
Ræstadhornet is situated on a north-facing slope at 650 m above Ræstadvika Bay (Figure 43). The site has been earlier described by Dahle et al. (2011). A helicopter reconnaissance flight in 2012 revealed evident signs of past deformation with a 70 m long, partly open back-crack (Figure 46a). The unstable rock slope is delimited to the SE by a steeply N-dipping surface. This red-coloured surface is relatively planar and might form the basal sliding surface of the Ræstadhornet instability (Figure 46). Inward-dipping foliation surfaces at the western limit of the unstable rock slope might form with the basal sliding surface a wedge failure mechanism (Figure 46b). However, the exact extent of the instability could not be determined based on aerial photographs and helicopter reconnaissance, which impedes to estimate the volume. Large rock slope failures have occurred in the past from Ræstadhornet creating a large talus slope. The debris could be remobilised by a new failure from Ræstadhornet, but this would likely slow down the rock avalanche due to the low angle of the talus slope.

Figure 46: Photographs of the Ræstadhornet instability: a) the back-crack is partly open; b) a potential wedge failure is delimited by the planar, red-coloured sliding surface in the SE and inward-dipping foliation surfaces in the W.

Recommendation: A possible rock avalanche from the Ræstadhornet instability will have consequences. Geological field mapping is necessary to evaluate the structural and geological conditions and to quantify past displacements. The hazard and risk classification will be made after this field mapping. Further follow-up activities will be decided based on this classification.

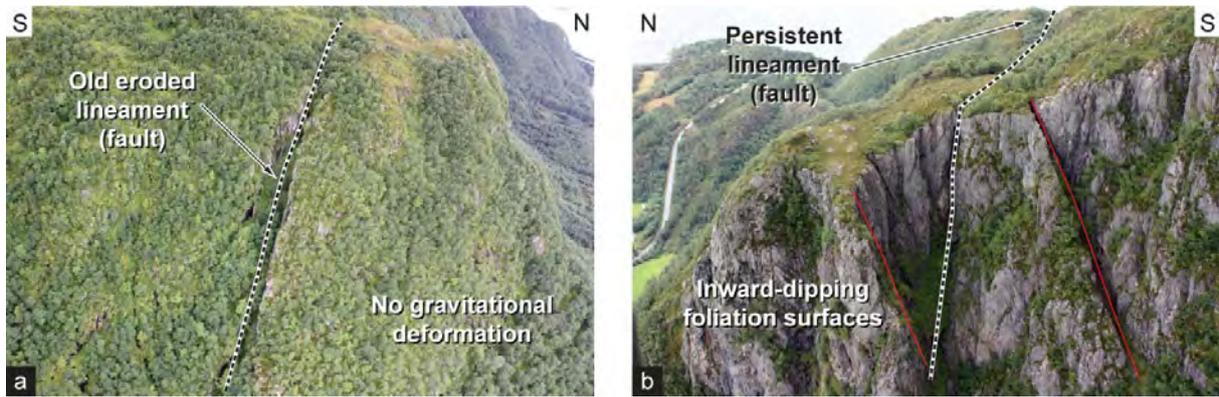
Sundsørøra is located on a north-facing slope 330 m above Grunnefjord (Figure 43). An old heavily eroded subvertical fault was observed during a helicopter reconnaissance flight in 2012 (Figure 47a). This fault is mostly filled and vegetated and there are no signs of past gravitational displacements. Other major structures are inward-dipping foliation surfaces and do not favor sliding (Figure 47b). There are no structures delimiting a large unstable rock slope. However, rockfall activity is observed at the western end of the investigated rock slope.

Figure 47: Photographs of the Sundsbørøra rock slope: a) an old eroded fault delimits the spur to the South; b) main structures are inward-dipping foliation surfaces and impede sliding.

Recommendation: There are no signs that the Sundsørøra rock slope might fail in a massive rock slope failure. No further investigations or displacement measurements are necessary and the hazard and risk classification will not be made. However, rockfalls are possible and their run-out area is given by the rockfall susceptibility map or more detailed hazard maps, where available.

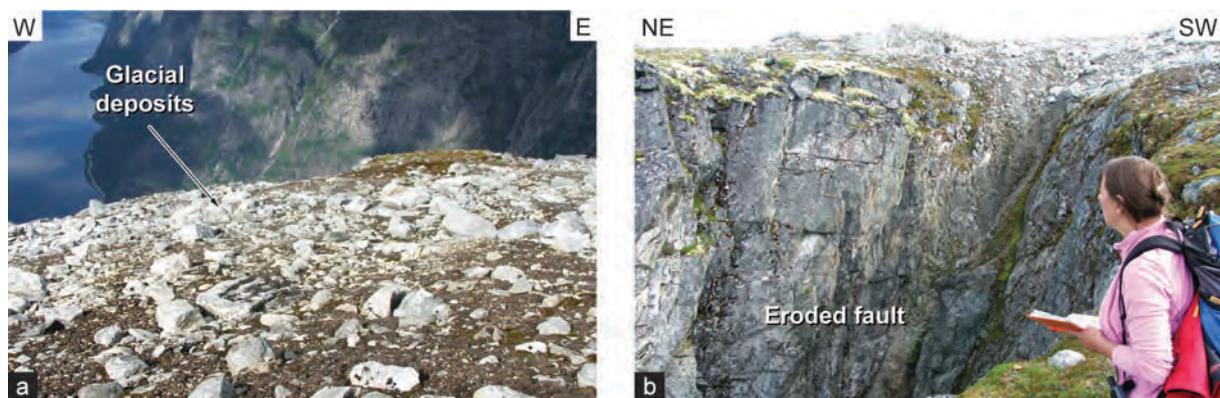
Børa is situated on a north-facing slope 1160 m above Eikesdalen Valley (Figure 48). The site was visited in field in 2010. Glacial deposits with sub-rounded blocks mixed with soil cover the top surface at Børa (Figure 49). Soil-creep could lead to shallow landslides. Erosion along a NW-SE-trending fault seems to form the western limit of a potential instability (Figure 49), but there are no open cracks or other structures delimiting an unstable rock slope at Børa. W-E-trending depressions near the edge are likely not related to any gravitational deformation, but are possibly carved out during the last glaciation by drainage near the lateral margin of the glacier in Eikesdalen Valley.

Figure 49: Photographs of the Børa rock slope in Eikesdalen Valley: a) glacial deposits cover the slope; b) an eroded fault could form a lateral release surface, but there are no visible openings and other structures are missing to delimit an unstable rock slope.

Recommendation: There are no signs that Børa rock slope might fail in a massive rock slope failure. No further investigations or displacement measurements are necessary and the hazard and risk classification will not be made. Rockfalls and debris slides are however possible and their run-out area is given by the rockfall susceptibility map or more detailed hazard maps, where available.

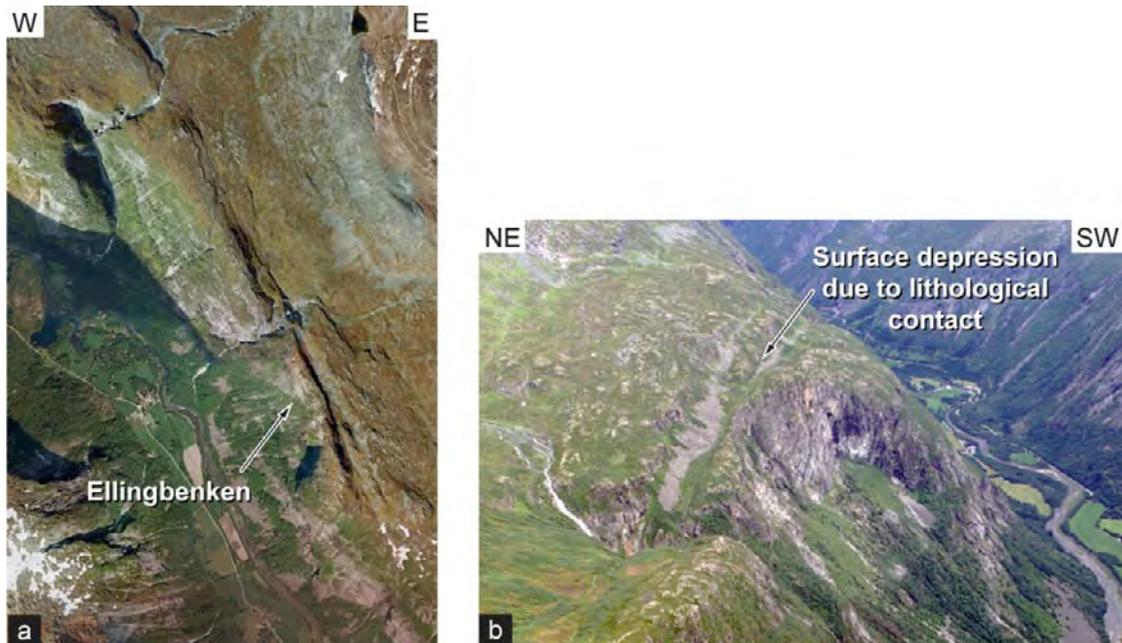
Ellingbenken is located on a southwest-facing slope 700 m above Setra in Eikesdalen Valley (Figure 48). A helicopter reconnaissance flight in 2010 revealed a conspicuous 2 km-long and 50–100 m wide depression (Figure 50). This depression marks the lithological contact between two gneiss units (Tveten et al. 1998) and is thus not related to gravitational movements of the Ellingbenken rock slope. No major visible cracks were detected. Water ponds inside the depression are also indicating absence of fractured and deformed bedrock. Rockfall deposits are however evident inside the depression and at the cliff side (Figure 50b).

Figure 50: Photographs of the Ellingbenken rock slope: a) aerial photograph showing a long lineament and depression marking the contact between two gneiss units; b) the lithological contact does not delimit a large unstable rock slope toward the valley.

Recommendation: There are no signs that Ellingbenken rock slope might fail in a massive rock slope failure. No further investigations or displacement measurements are necessary and the hazard and risk classification will not be made. However, rockfalls are possible and their run-out area is given by the rockfall susceptibility map or more detailed hazard maps, where available.

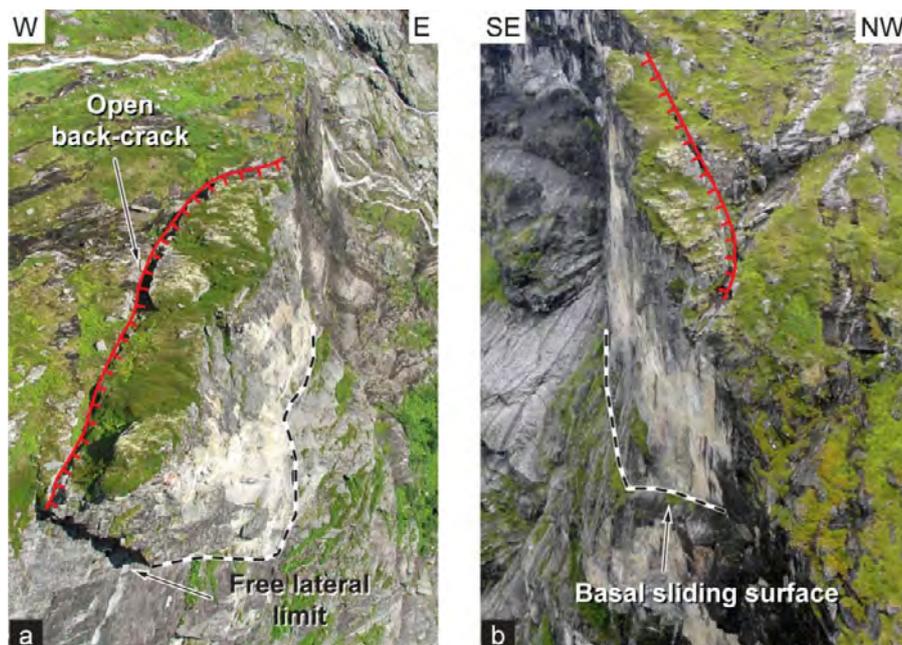
Evelsfonnhøa is situated on an east-facing slope 980 m above Eikedalsvatnet Lake (Figure 48). A helicopter reconnaissance flight in 2010 showed a large column delimited by an open back-crack (Figure 51). The column has a free lateral limit to the southwest, but there is no visible open lateral release surface in the north. A possible sliding surface is visible at the base of the column (Figure 51b). The structures present at Evelsfonnhøa enable sliding and toppling of the instability.

Figure 51: Photographs of a columnar failure of ca. 110000 m³ developed on Evelsfonnhøa rock slope.

Recommendation: Periodic displacement measurements are started at the Evelsfonnhøa instability, but the time-series is not sufficiently long to determine displacement rates. Periodic displacement measurements using TLS should be continued with 1–3 years interval. Additionally, geological field mapping is necessary to evaluate the structural and geological conditions and to quantify past displacements. The hazard and risk classification needs to be made and further follow-up activities will be decided based on this classification.

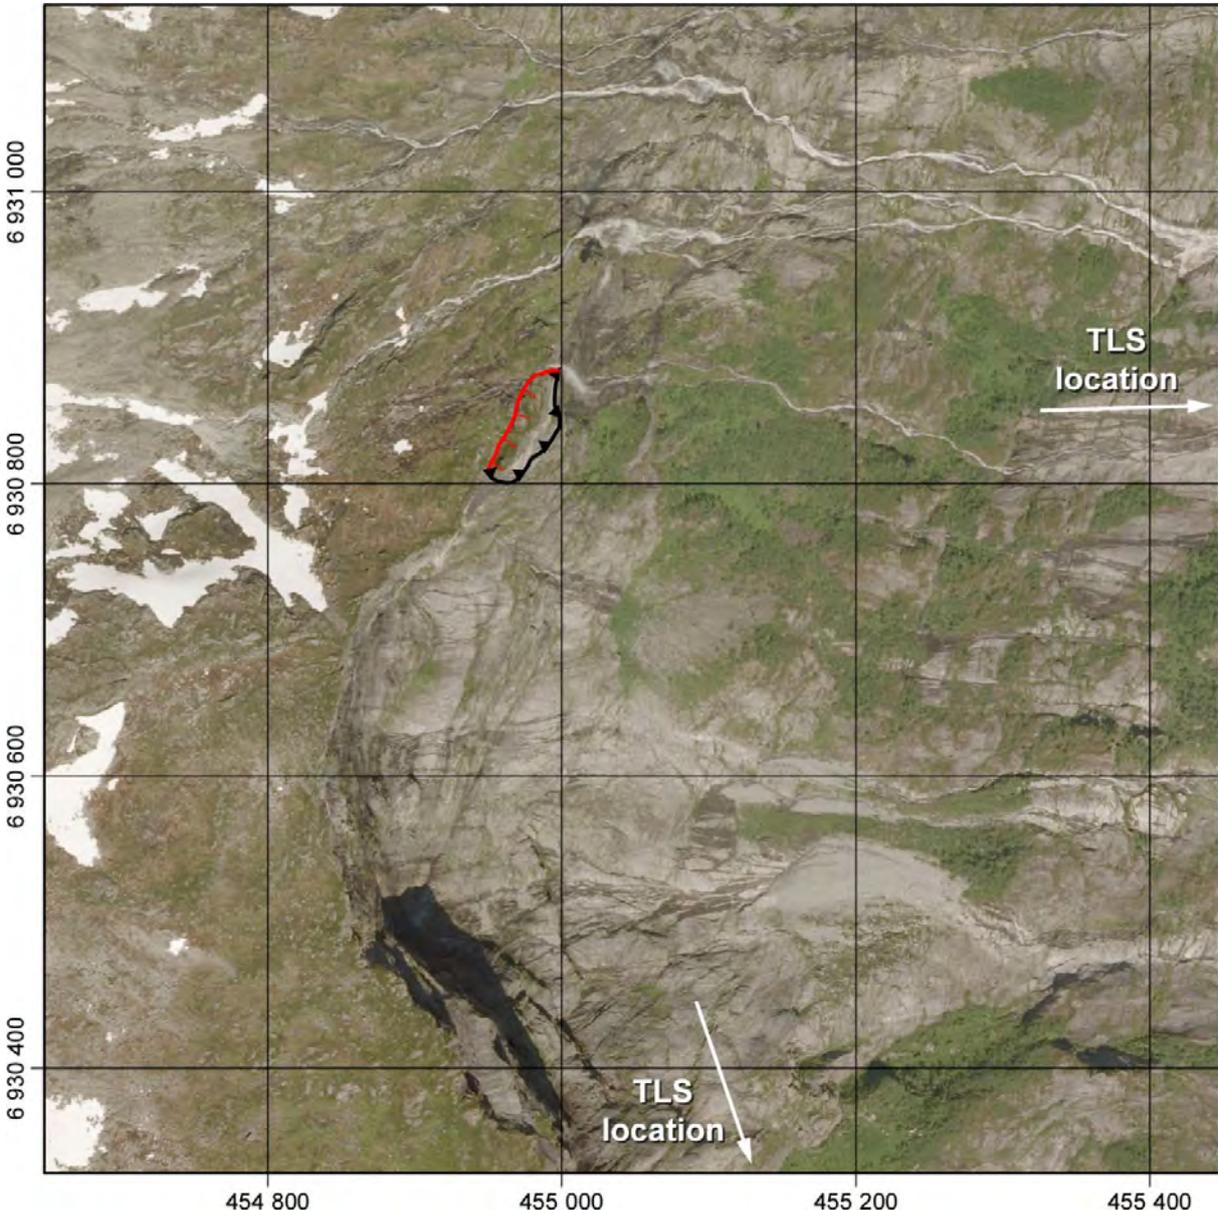
The Evelsfonnhøa instability is inaccessible to field work. Therefore it was scanned by TLS from two locations around Eikedalsvatnet Lake providing a reference dataset for periodic displacement measurements (Figure 52). TLS data allowed estimating the orientation of the basal sliding surface to moderately NE-dipping ($046^{\circ}/48^{\circ}$) and the back-crack is subvertical dipping to the SE ($132^{\circ}/86^{\circ}$), i.e. straight to the valley side. The volume of the Evelsfonnhøa instability was assessed to 110000 m^3 based on TLS data. A failure from Evelsfonnhøa is likely to reach Eikedalsvatnet Lake and cause a displacement wave (Dahle et al. 2011a).

Figure 52: Map of the Evelsfonnhøa instability showing directions to the locations of measurement instrumentation (TLS).

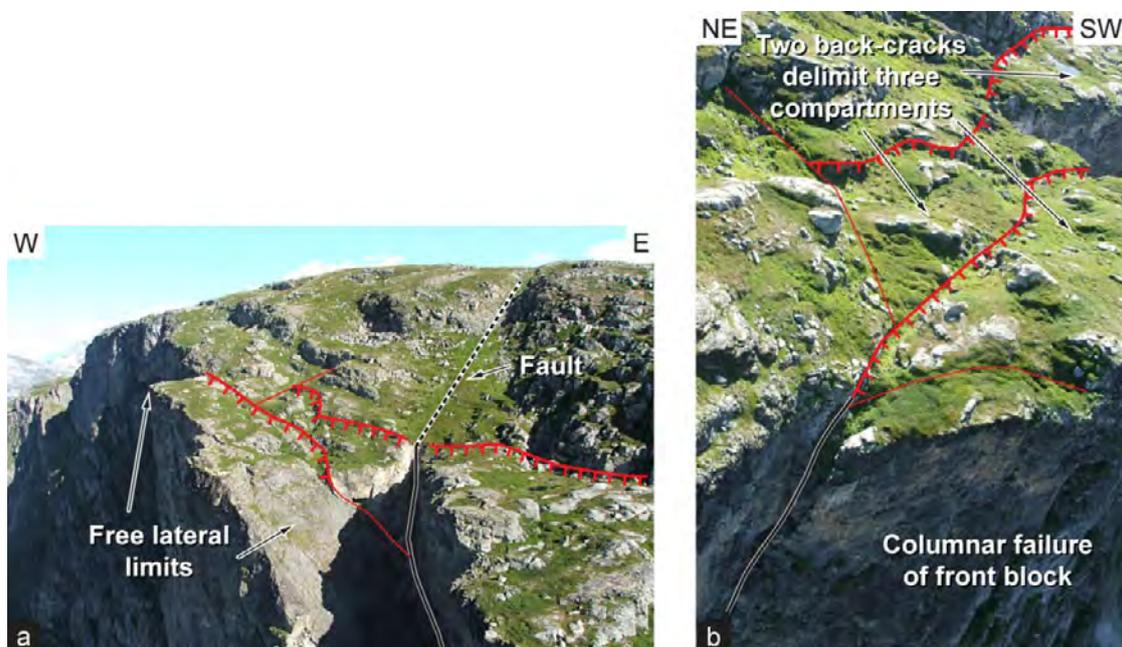
Kjøttåfjellet is located on a southwest-facing slope 900 m above Litlevatnet Lake in Eikesdalen Valley (Figure 48). A helicopter reconnaissance flight in 2010 showed an instability with an open back-crack and free lateral limits (Figure 53). A second, partly open back-crack further inward in the mountainside delimits two additional compartments that are separated by a brecciated ancient fault (Figure 53a). In 2011 bolts for tape extensometer measurements were installed at three locations over the back-crack and an internal crack (Figure 54), in order to detect possible widening of the cracks. The Kjøttåfjellet instability was scanned by TLS from two locations in the valley for structural characterization and providing a reference dataset for periodic displacement measurements (Figure 54).

Figure 53: Photographs of the Kjøttåfjellet instability showing the free lateral side limits of the frontal block (left) and the three unstable blocks (right).

Recommendation: Periodic displacement measurements are started at the Kjøttåfjellet instability, but the time-series is not sufficiently long to determine displacement rates. Periodic displacement measurements using TLS should be continued with 1–3 years interval. Additionally, geological field mapping is necessary to evaluate the structural and geological conditions and to quantify past displacements. The hazard and risk classification needs to be made and further follow-up activities will be decided based on this classification.

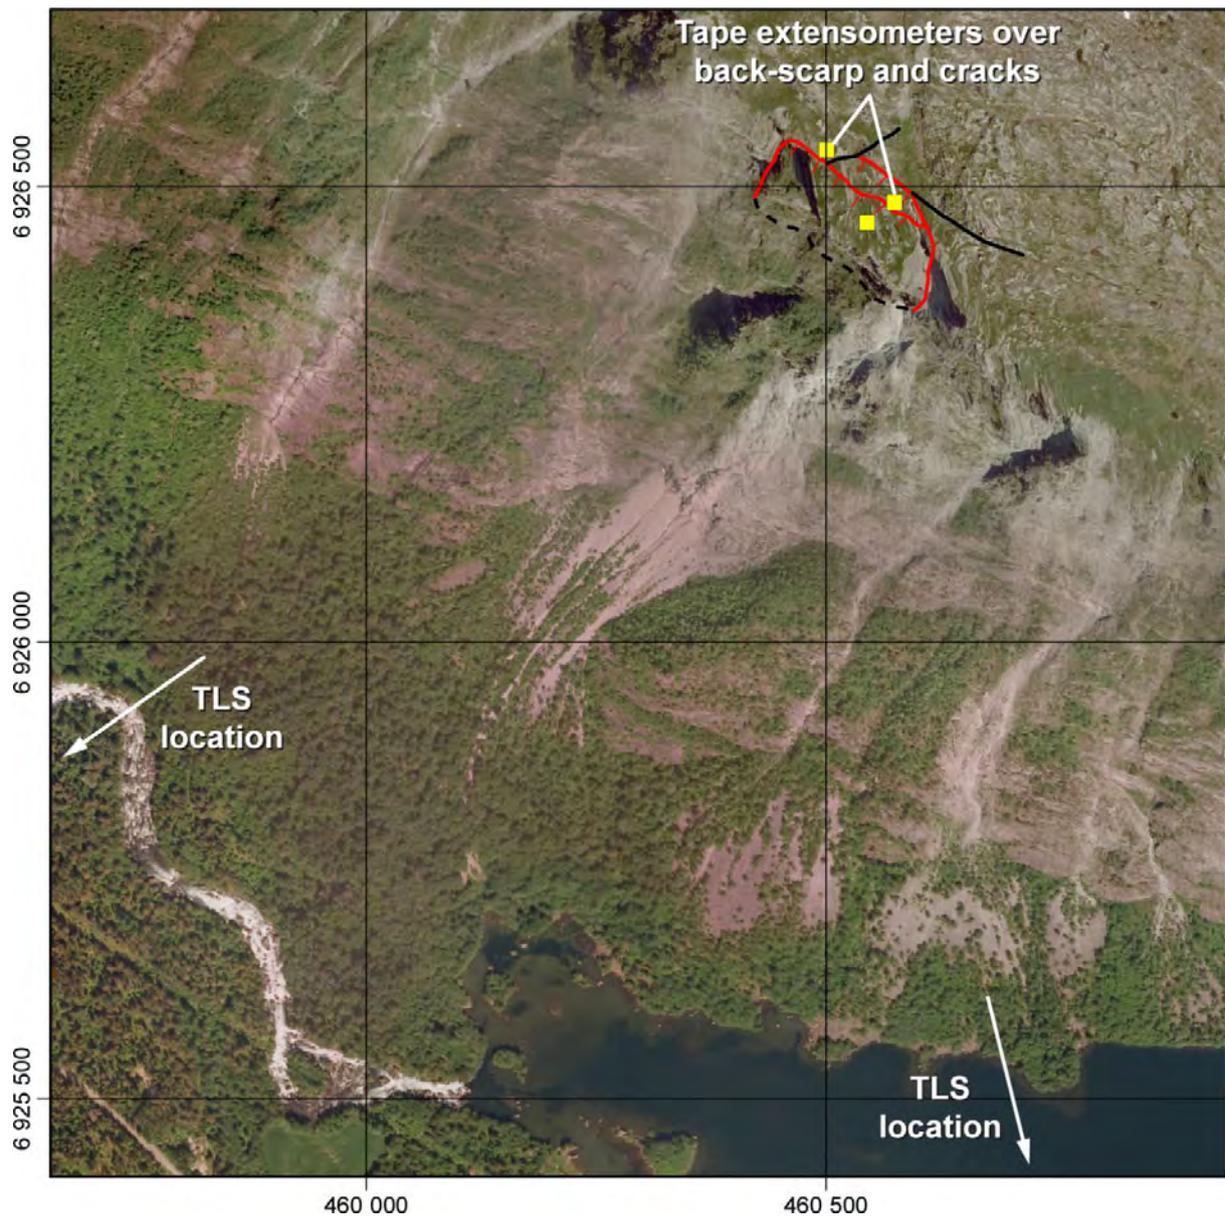
Rock avalanche deposits are found in the Eikesdalen Valley below the Kjøttåfjellet instability (Figure 54). This rock avalanche dammed the valley to form Litlevatnet Lake. The source area of the rock avalanche is not exactly known, but could be located in the surroundings of the present instability at Kjøttåfjellet. Cosmogenic nuclide dating of three rock avalanche deposit samples taken gives an age of 2900 ± 400 years BP.

Figure 54: Map of the Kjøtafjellet instability showing locations of measurement instrumentation (tape extensometer), respectively directions to the locations of measurement instrumentation (TLS).

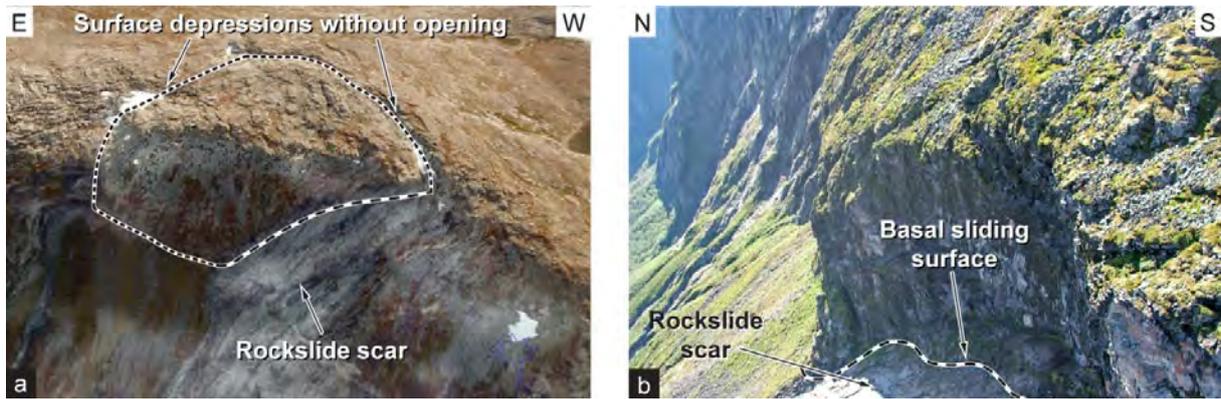
Litleaksla is located on a northeast-facing slope at ca. 1060 meters above Litlevatnet Lake in Eikesdalen Valley (Figure 48). The site was observed by helicopter in 2010 and no large instability is currently developed despite the presence of old sliding surfaces, which likely continue inside the remaining rock mass (Figure 55b). Surface depressions form the lateral and rear limit of a potential instability, but no signs of opening or past displacement were observed (Figure 55a). No major cracks are visible on the slope. The surface of the rock slope was probably dismantled by glacial erosion and rockfall activity is conspicuous from the site.

Figure 55: Photograph of the Litleaksla rock slope: a) 3D view from Norgei3D showing depressions as lateral and rear limit of a potential instability, but no signs of opening or past displacement were observed; b) the basal sliding surface of a past rockslide continues likely into the remaining rock mass.

Recommendation: There are no signs that Litleaksla rock slope might fail in a massive rock slope failure. However, a more detailed helicopter reconnaissance flight is planned, focussing on the observed surface depressions.

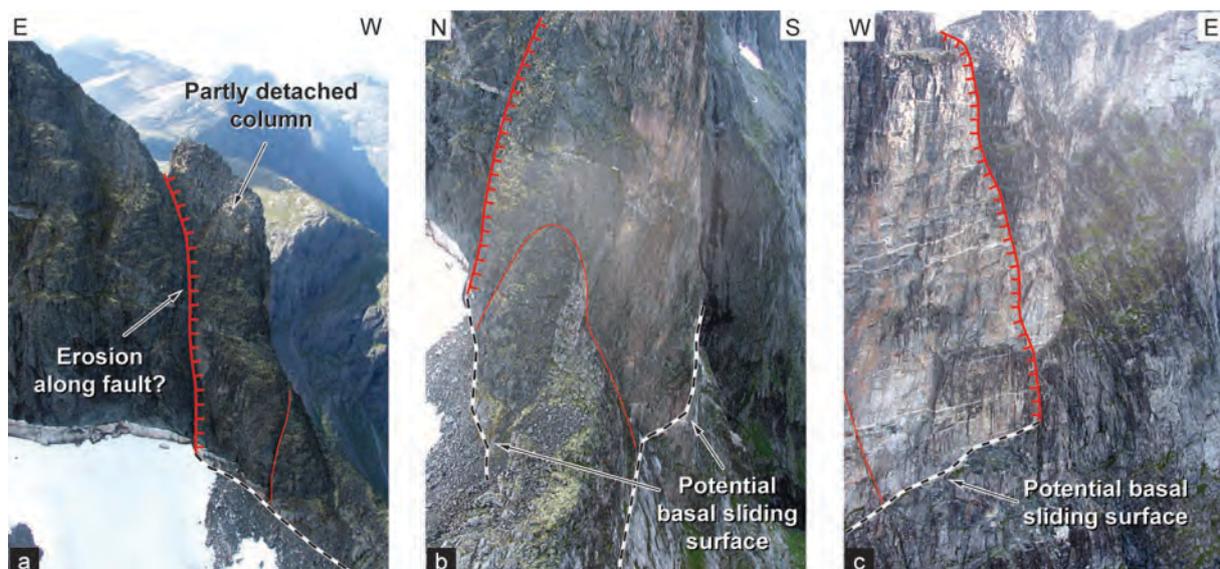
Vikesoksa is situated on a southwest-facing slope 1390 m above Vikeelva River, an eastern tributary of Eikesdalsvatnet Lake (Figure 48). Vikesoksa was observed during a helicopter reconnaissance flight in 2010. At the western tip of the ridge, a steep structure partly detaches a column (Figure 57). The nature of this structure is however unknown, but it is more likely formed by preferential erosion along a pre-existing fault rather than opening of a crack by any displacements of the column. A penetrating set of inherited steeply SW-dipping structures can be seen in the column and provides possible basal sliding surfaces. However, there is no visible activity along the structures delimiting the instability. Rockfall activity from the steep faces of the column is evident.

Figure 57: Photographs of Vikesoksa instability displaying the structures which delimit a column. However, no signs of past displacements are observable, apart from rockfall activity from the steep faces of the column.

Recommendation: A possible rock avalanche from the Vikesoksa instability will have consequences. Geological field mapping is necessary to evaluate the structural and geological conditions and to quantify past displacements. The hazard and risk classification will be made after this field mapping. Further follow-up activities will be decided based on this classification.

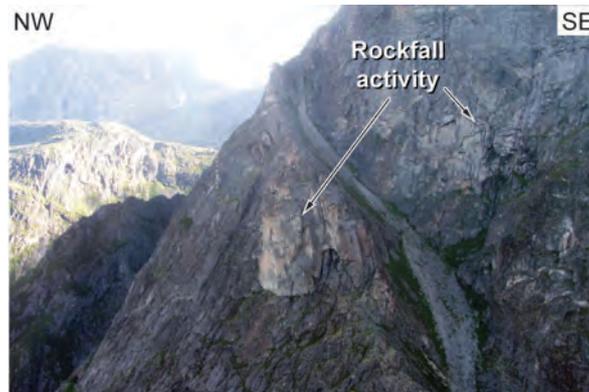
Vikesætra is located on a west-facing slope 950 m above Eikesdalsvatnet Lake (Figure 48). The rock slope was observed during a helicopter reconnaissance flight in 2010, but no signs of gravitational movements or open cracks delimiting an unstable rock slope were observed (Figure 58). Some weathering and rockfall activity exists from the rock face.

Figure 58: Photograph of Vikesætra rock slope showing rockfall activity from the steep cliff.

Recommendation: There are no signs that the Vikesætra rock slope might fail in a massive rock slope failure. No further investigations or displacement measurements are necessary and the hazard and risk classification will not be made. However, rockfalls are possible and their run-out area is given by the rockfall susceptibility map or more detailed hazard maps, where available.
