GEOLOGI FOR SAMFUNNET

GEOLOGY FOR SOCIETY

Report no.: 2013.014		ISSN: 0800–3416	Grading: Open
Title: Investigations on unstable rock slopes in Møre og Romsdal – status and plans after field surveys in 2012			
Authors: T. Oppikofer, A. Saintot, S. Otterå, R.L. Hermanns, E. Anda, H. Dahle, T. Eiken		Client: Norwegian Water Resources and Energy Directorate (NVE)	
County: Møre og Romsdal		Commune:	
Map-sheet name (M=1:250.000) Ålesund, Kristiansund, Røros, Ulsteinvik		Map-sheet no. and -name (M=1:50.000)	
Deposit name and grid-reference:		Number of pages: 323	Price (NOK): 1285,-
Fieldwork carried out: 2006–2012		Date of report: 13.11.2013	Map enclosures: 0
Fieldwork carried out: 2006–2012		Date of report: 13.11.2013	Project no.: 309900
Fieldwork carried out: 2006–2012		Date of report: 13.11.2013	Quality control: <i>Halvor Brundhoff</i>
<p>Summary:</p> <p>This report presents investigations, analyses and displacement measurements made between 2006 and 2012 on 131 unstable or potential unstable rock slopes in Møre og Romsdal County (Western Norway). An extract of this report is available in Norwegian (NGU rapport 2013.053).</p> <p>These investigations are part of the national plan for

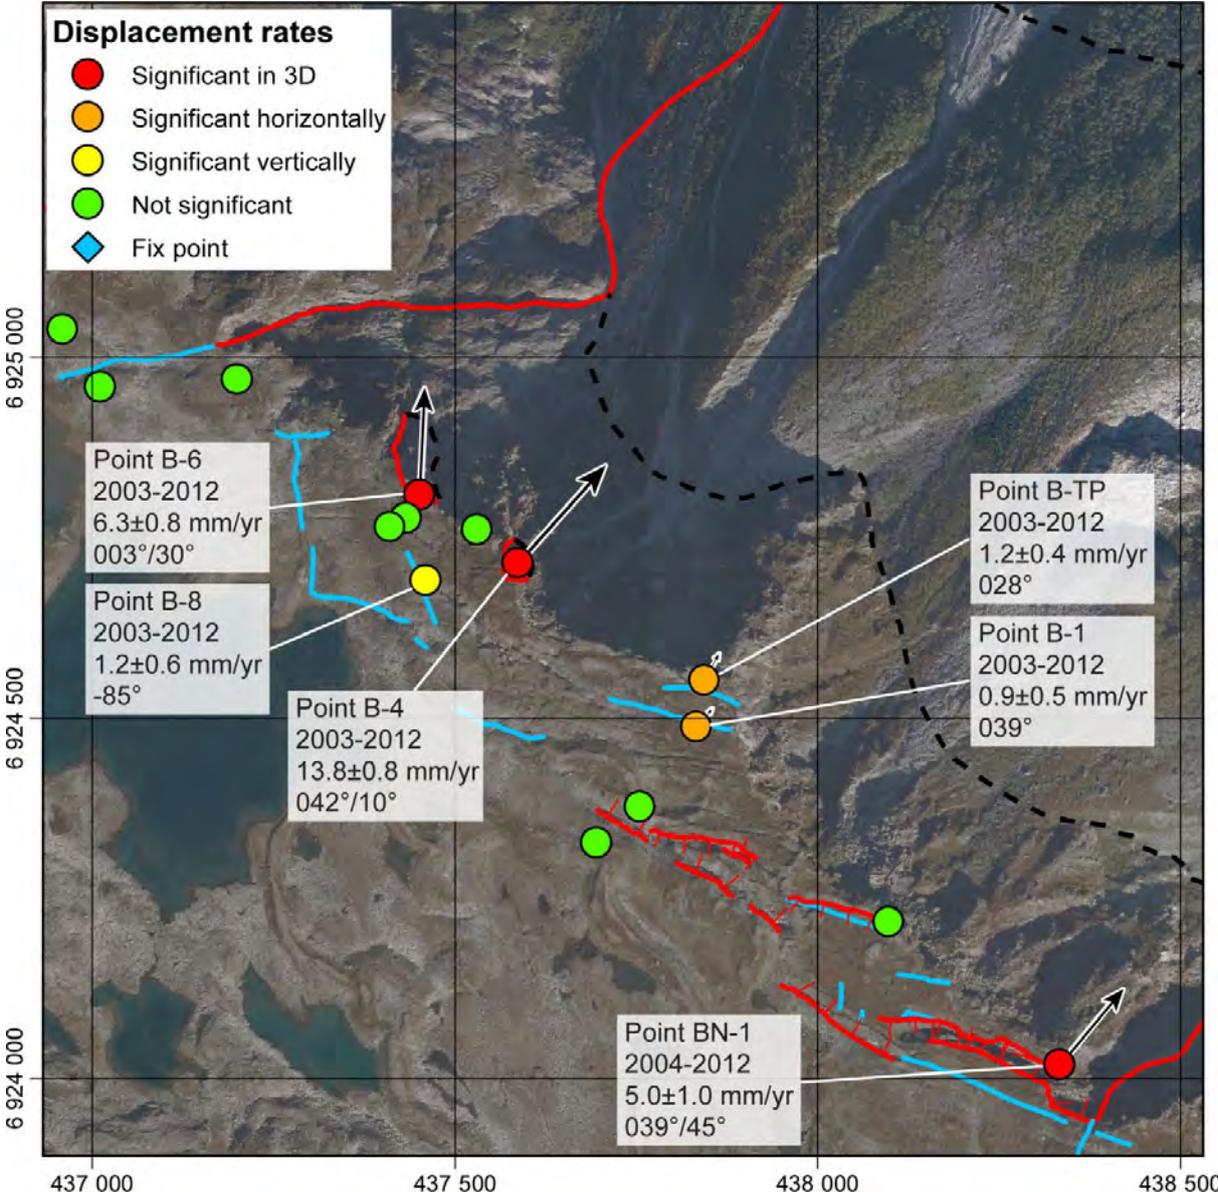
A total of 17 measurement points (15 in 2003, one in 2004 and one in 2009) were set out on the Børa unstable rock slope, as well as on localised, detached blocks along the front cliff of the unstable rock slope (Figure 60). All points were measured in 2004, 2006 and 2010, but only selected points were measured in 2008, 2009 and 2012. Points with significant displacements over the 9 years measurement period are mainly located along the frontal cliff on detached blocks (points B-4 and B-6) and compartments of the unstable rock slope, which might fail individually from the main instability (points B-1, B-TP and B-N1).

The displacement rates measured on the detached blocks are 13.8 and 6.3 mm/year for points B-4 and B-6, respectively (Figure 60). The displacement directions to the NE and to the N, respectively, are matching with the kinematics given by the orientation of major structures delimiting these blocks. The plunge of the displacement vectors are relatively gentle (10° and 30°, respectively). This indicates a toppling component of the movement, especially for the detached block at point B-4.

Point BN-1 at the SE-end of the unstable rock slope moves 5.0 mm/year in a downslope direction with a plunge angle of 45° (Figure 60). These high displacement rates compared to the surroundings suggest that the ridge surrounding point BN-1 is detached from the total unstable area. However, the lateral limit of this compartment is not visible in the field. The prominent graben structure observed behind this ridge might also be the expression of these increased displacement rates.

Figure 60: Map of the Børa unstable rock slope with the location of dGNSS points for periodic displacement measurements and average displacement vectors for the 2003–2012 measurement period.

Two points in the central part of the Børa unstable rock slope (B-1 and B-TP) have significant horizontal displacements with 0.9 to 1.2 mm/year in NNE-direction (Figure 60). However, no vertical trend was observed, which might also indicate toppling movements. The measurement point B-8 is located on the plateau more than 100 m inwards from the frontal cliff, where active movements are generally observed at Børa. It shows a significant vertical displacement in upward direction by 1.2 mm/year. Such a displacement is inconsistent with general gravitational deformation and has only limited significance since other surrounding points are not significantly moving (Figure 60). Point B-8 might thus be placed on a small, local block that is extruded due to differential movements between compartments of the unstable rock slope.

Recommendation: Significant displacements are measured at Børa. Periodic displacement measurements using dGNSS and TLS should be continued with 1–3 years interval. The hazard and risk classification needs to be made and further follow-up activities will be decided based on this classification.

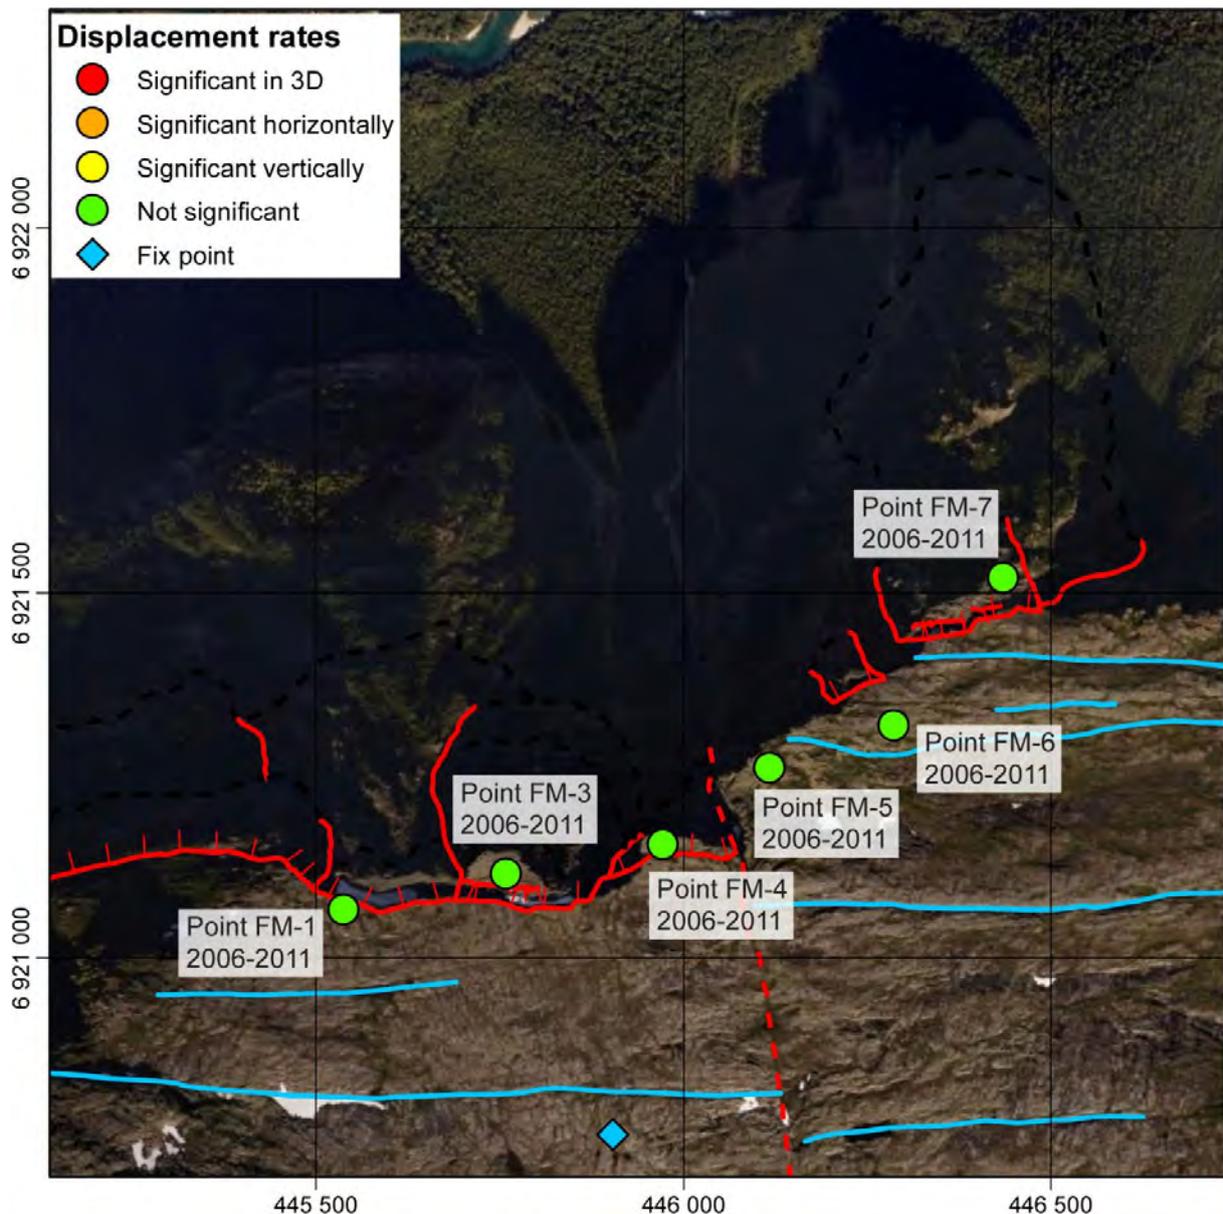
Flatmark is located on a north-facing slope 920 m above Skiri and Flatmark in Romsdalen Valley (Figure 59). This complex unstable rock slope is divided into several compartments (Figure 61) that could individually fail although they are structurally similar. Field mapping was made in 2006 and several studies describe this unstable rock slope (Henderson and Saintot 2007, Dahle et al. 2011a, Saintot et al. 2011b, Saintot et al. 2012). The unstable rock slope is periodically measured using dGNSS since 2006, TLS since 2007 and tape extensometer since 2011. Here, the latest results from dGNSS and TLS measurements and cosmogenic nuclide dating of rock avalanche deposits are presented. No repetitive tape extensometer measurements are made up to now.

Six dGNSS measurement points were installed at Flatmark in 2006 (Figure 61). The points FM-3, FM-4 and FM-7 are located on detached compartments that have obviously moved in the past. All points were measured again in 2007, 2008 and 2011, but no significant displacements were recorded over the 5 years measurement period.

Periodic displacement measurements by TLS focused on the western compartment of the Flatmark unstable rock slope, which is back-bound by a more than 20 m wide graben (located at dGNSS measurement point FM-3) (Figure 61). Repetitive TLS acquisitions were made in 2011, but no significant changes are detected over the 3 years measurement period. New TLS acquisitions from the valley bottom were made in 2012, but they cannot be compared to previous scans acquired from the top of the unstable rock slope due to the difference in the view angles.

Figure 61: Map of the Flatmark unstable rock slope with the location of dGNSS points for periodic displacement measurements. No significant displacements were detected over the 2006–2011 measurement period.

Recommendation: No significant displacements are measured up to now at Flatmark. Periodic displacement measurements using dGNSS should be continued with 3–5 years interval. The hazard and risk classification needs to be made and further follow-up activities will be decided based on this classification.

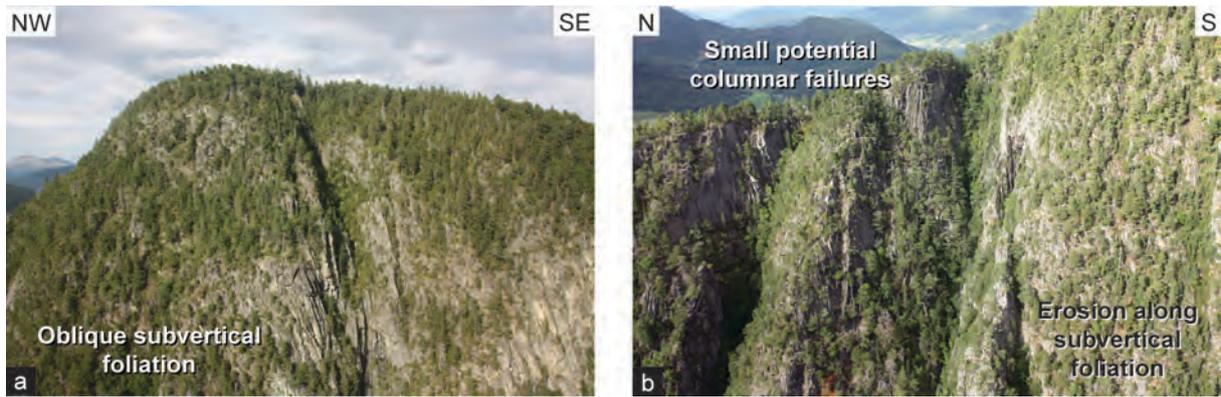
Frisvollfjellet (Figure 59) is situated on a southwest-facing slope above Romsdalsfjord south of Norvika. The site was surveyed from helicopter in 2011. Several gullies are eroded along the subvertical foliation (Figure 62). At Frisvollfjellet there is neither an open back-crack nor other structures necessary to delimit an unstable rock slope. Small columns delimited by the foliation and subvertical discontinuities might fail by toppling, but the volume (tens to hundreds of m³) is too small to cause a significant displacement wave in Romsdalsfjord.

Figure 62: Photographs of the Frisvollfjellet rock slope: a) the subvertical foliation is locally eroded forming deep gullies; b) small columns are delimited by the foliation and subvertical joints.

Recommendation: There are no signs that the Frisvollfjellet rock slope might fail in a massive rock slope failure. No further investigations or displacement measurements are necessary and the hazard and risk classification will not be made. However, rockfalls are possible and their run-out area is given by the rockfall susceptibility map or more detailed hazard maps, where available.

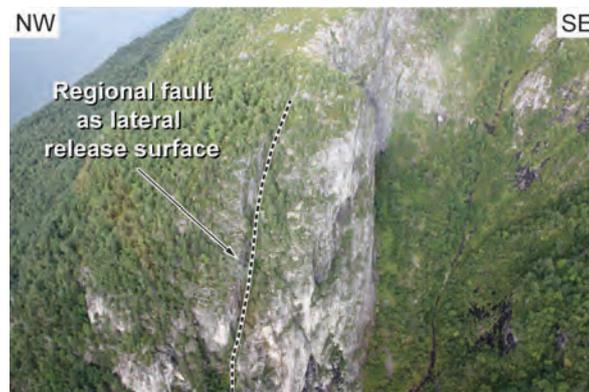
Kvarvesnippen (Figure 59) is located on a southwest-facing slope 390 m above Romsdalsfjord. A helicopter reconnaissance flight in 2012 revealed an eroded, persistent lineament (Figure 63), which might form the lateral release surface for an instability located south of it. There are no visible openings along this potential lateral release surface. The instability is free on all other sides, including upward at the back due to erosion. However, there are no major discontinuities visible that might form a basal sliding surface. A massive failure of the Kvarvesnippen instability would create a displacement wave in Romsdalsfjord.

Figure 63: Photographs of the Kvarvesnippen instability: an eroded regional fault forms a potential lateral release surface and the instability is free on all other sides.

Recommendation: A possible rock avalanche from the Kvarvesnippen instability will have consequences. Geological field mapping is necessary to evaluate the structural and geological conditions and to quantify past displacements. The hazard and risk classification will be made after this field mapping. Further follow-up activities will be decided based on this classification.

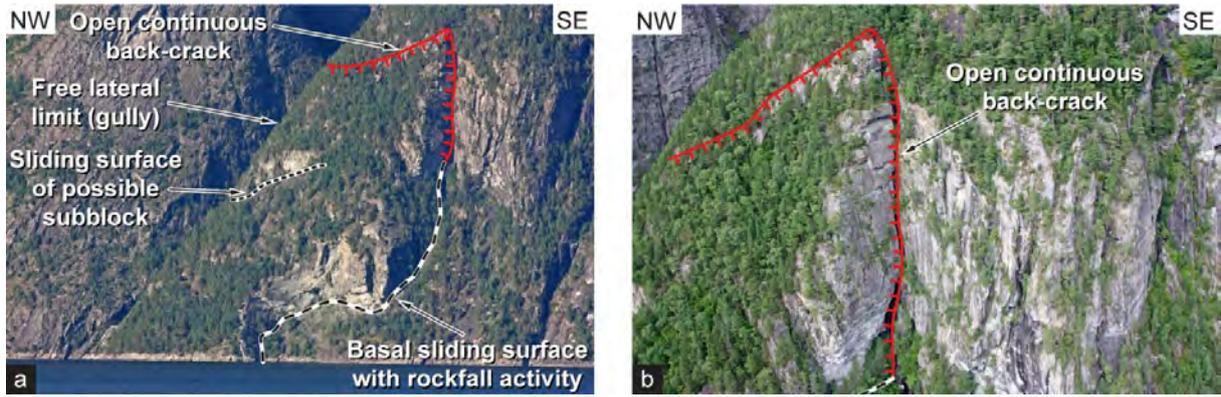
Kvitfjellgjølet (Figure 59) is located on a southwest-facing slope 310 m above Romsdalsfjord. A helicopter reconnaissance flight in 2011 revealed an open continuous back-crack delimiting an unstable rock slope (Figure 64, Figure 65). The instability has also a clear basal sliding surface, which was likely already involved in rock slope failures of the surrounding slopes. Fresh rockfall scars above the basal sliding surface might indicate internal deformation of the rock slope and is thus a sign of activity of the rockslide (Figure 64a). The northern boundary of the instability is formed by a deeply eroded gully and is thus free. A possible subblock is found in the upper part of the instability with a clear sliding surface at its base (Figure 64a).

Figure 64: Photographs of the Kvitfjellgjølet instability: a) the unstable rock slope is delimited by an open back-crack, a gully as free lateral limit and a well marked basal sliding surface; b) detail of the open continuous back-crack.

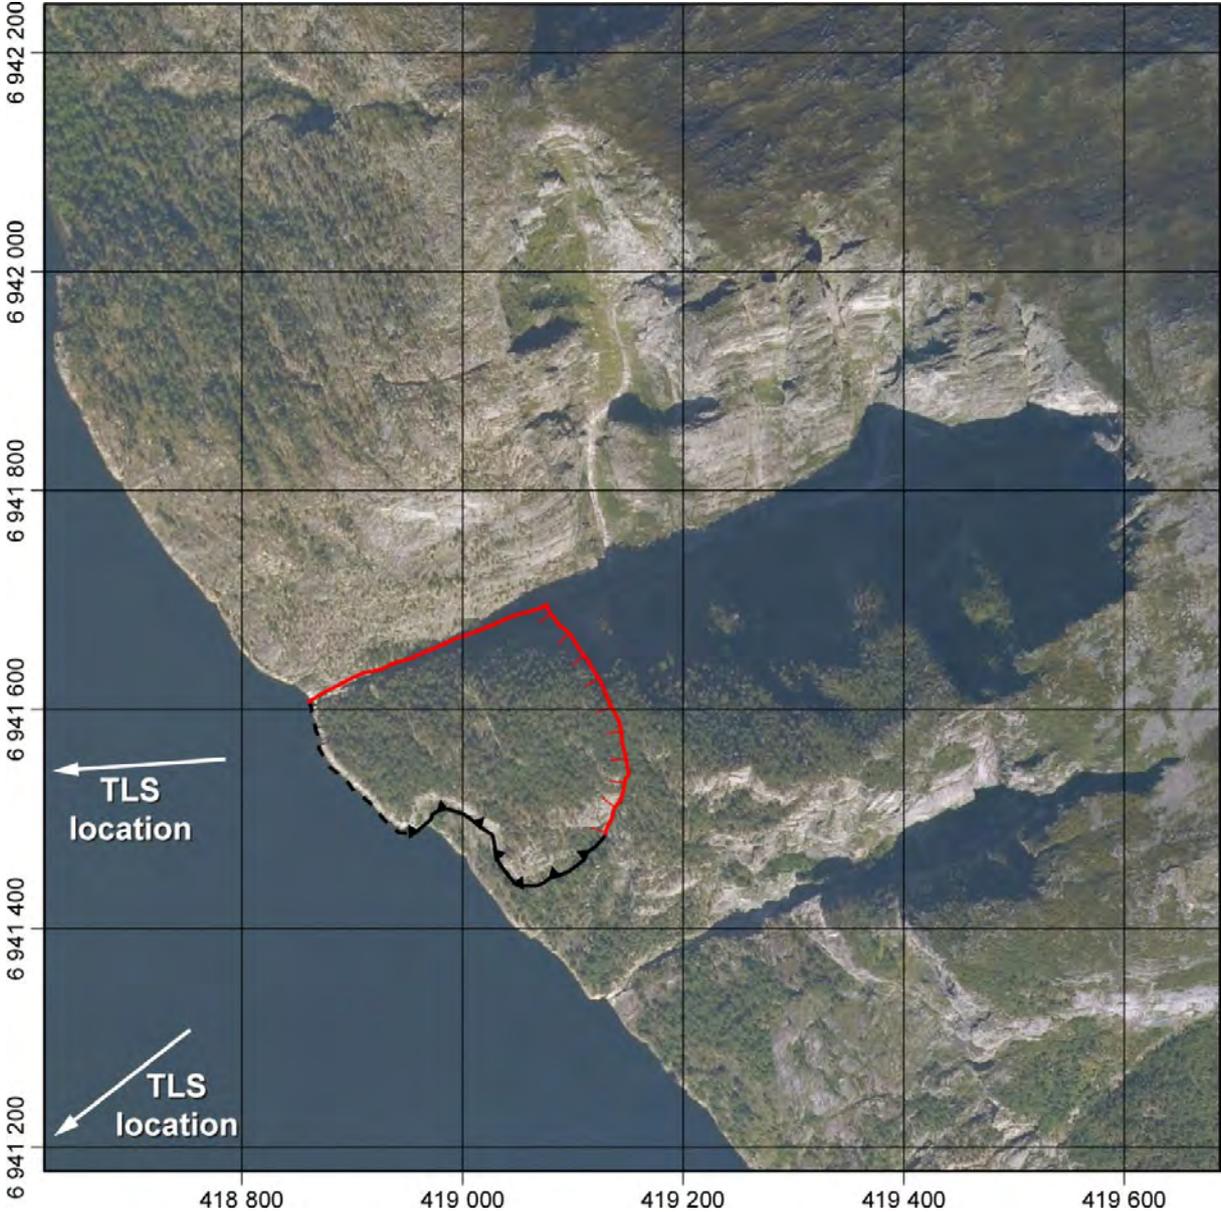
Figure 65: Map of the Kvitfjellgjølet instability showing directions to the locations of measurement instrumentation (TLS).

The Kvitfjellgjølet instability is inaccessible for field work. Therefore it was scanned by TLS in 2012 from two locations on the opposite side of Romsdalsfjord providing a reference dataset for periodic displacement measurements (Figure 65). Additionally, a test with ground-based InSAR measurements was performed in 2012 by Åknes/Tafjord Early-Warning Centre. This test showed that periodic displacement measurements with ground-based InSAR is feasible, but the results may not be optimal due to (1) poor signal strength inherent to the long distance and (2) atmospheric disturbances caused by the fjord (Kristensen 2012).

The TLS dataset and the observed structures allow estimating the volume of the Kvitfjellgjølet instability to 2.5 million m³. A massive failure from Kvitfjellgjølet will cause a displacement wave in Romsdalsfjord.

Recommendation: Periodic displacement measurements are started at the Kvitfjellgjølet instability, but the time-series is not sufficiently long to determine displacement rates. Periodic displacement measurements using TLS should be continued with 1–3 years interval. The hazard and risk classification needs to be made and further follow-up activities will be decided based on this classification.

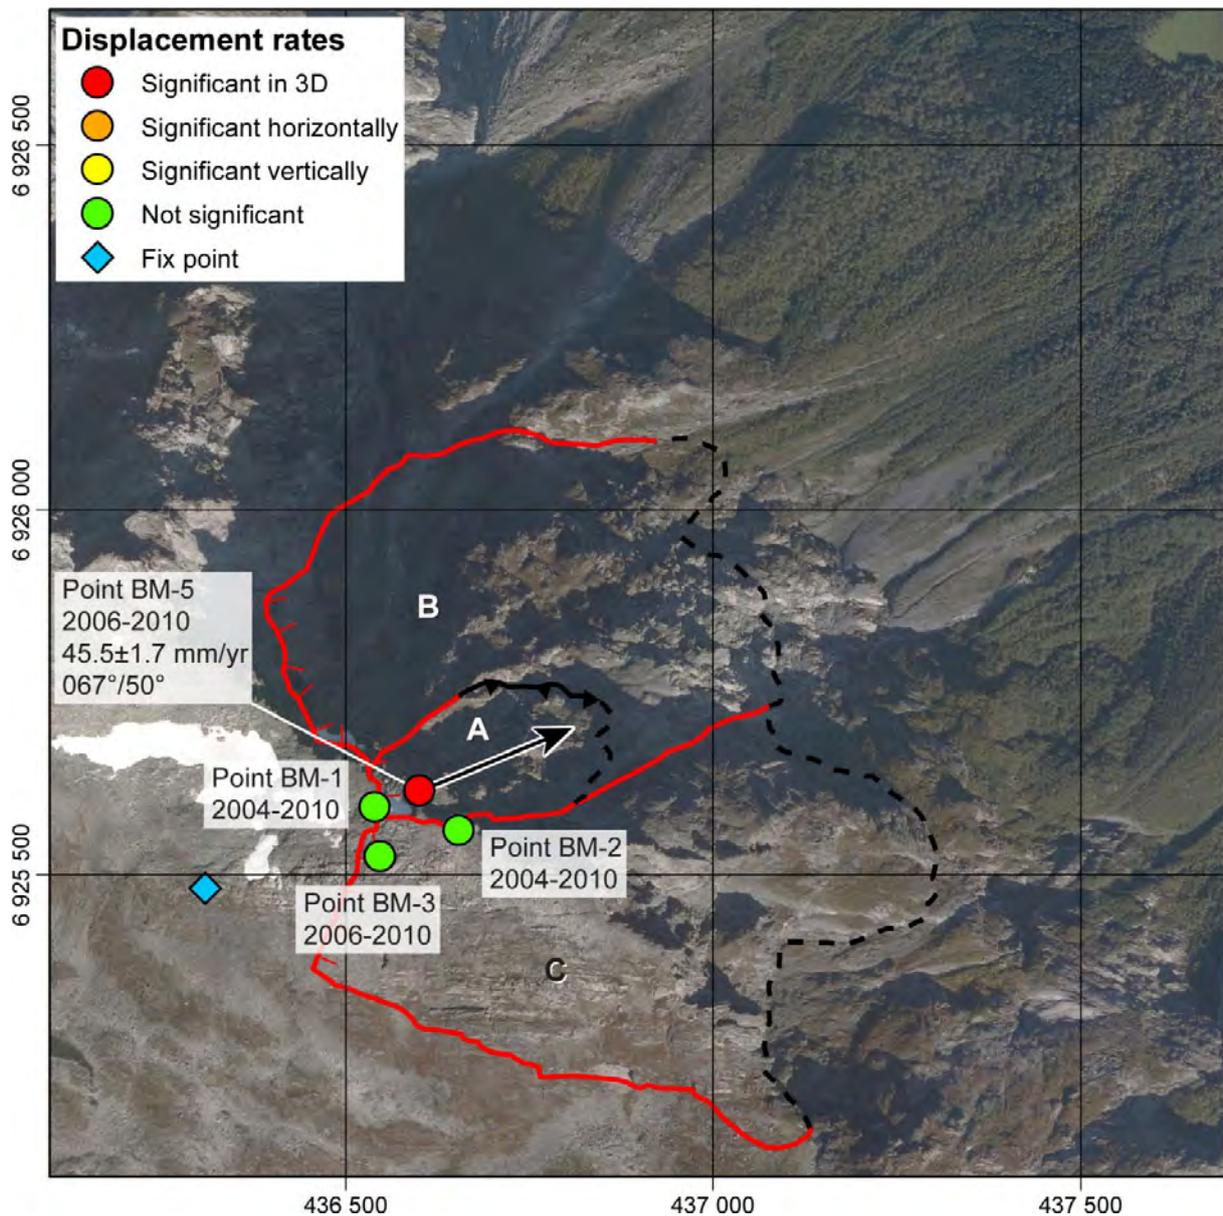
Two measurement points were installed on the Mannen unstable rock slope in 2004 and two more in 2006 (Figure 66). The measurement point BM-5 located on the top of the instability is actively moving with an average displacement rate of 45.5 mm/year towards the ENE with a plunge angle of 50° (Figure 66). The instability in this case certainly refers to scenario A or in a lesser extent to scenario B as defined by Dahle et al. (2011b) (Figure 66). These scenarios A and B involve volumes of 2–3.5 Mm³ and of 25–30 Mm³, respectively (Saintot et al. 2011a, Saintot et al. 2012). The other measurement points are located on top of the plateau and have no significant displacements over the measurement period (6 years for BM-1 and BM-2, 4 years for BM-3). These results signify that scenario C as defined by Dahle et al. (2011b) is not actively moving, even though open cracks indicate some displacements in the past (see also discussion in Dahle et al. 2008, Dahle et al. 2011c, Saintot et al. 2012).

Figure 66: Map of the Mannen unstable rock slope with the location of dGNSS points for periodic displacement measurements and average displacement vectors for the 2004–2010 measurement period. Letters A, B and C refer to scenarios as defined by Dahle et al. (2011b).

Recommendation: Mannen is under continuous monitoring and data are being sent to the Åknes/Tafjord Early-Warning Centre, which is also responsible for further follow-up activities. New scenarios should be defined for the Mannen unstable rock slope based on the latest monitoring results and investigations.

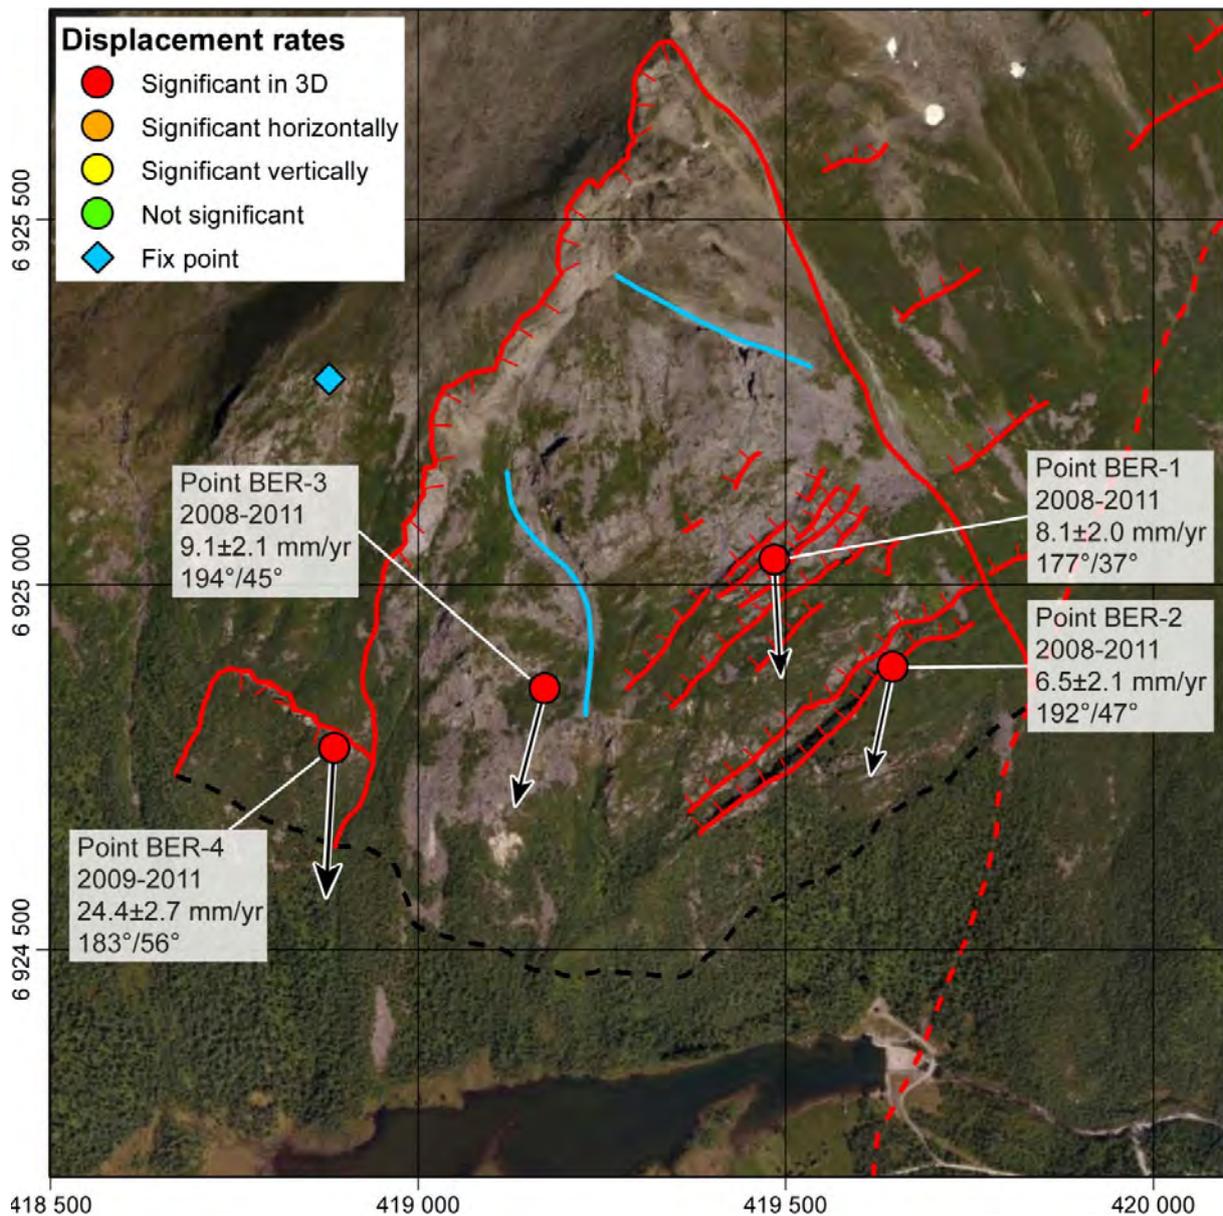
Four dGNSS measurement points were set out in 2008 and 2009 on the Middagstinden unstable rock slope (Figure 68). Repetitive measurements were made in 2009, 2010 and 2011 and all four points show significant horizontal and vertical displacements: the points BER-1, BER-2 and BER-3 are located on the main part of the unstable rock slope and move with 6.5 to 9.1 mm/year towards the S to SSW with a plunge angle ranging from 37° to 47° (Figure 68). Point BER-4 is located on the located instability west of the main unstable rock slope and moves with 24.4 mm/year towards the S with a plunge angle of 56°.

Figure 68: Map of the Middagstinden unstable rock slope with the location of dGNSS points for periodic displacement measurements and average displacement vectors for the 2008–2011 measurement period.

Recommendation: Significant displacements are measured at Middagstinden. Periodic displacement measurements using dGNSS and TLS should be continued with 1–3 years interval. Terrestrial cosmogenic nuclide dating of the sliding surface exposed at the back-scarp is planned in order to date the onset of displacement and assess paleo-displacement rates. The hazard and risk classification needs to be made and further follow-up activities will be decided based on this classification.

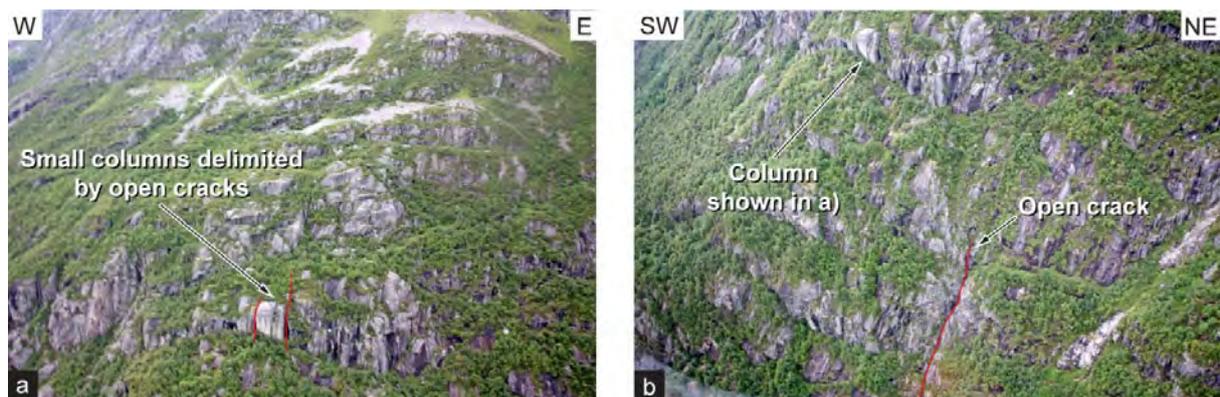
Mjølvafjellet is situated on a southwest-facing slope 640 m above Halså in the outer part of Romsdalen Valley (Figure 59). A helicopter reconnaissance flight was made in 2011 and showed vertical cracks that are partly open and delimit small columns that may lead to rockfalls (Figure 69). The slope is vegetated and there are no significant traces of recent rockfall activity. The observed structures do not delimit a large unstable rock slope.

Figure 69: Photographs of the Mjølvafjellet rock slope: open vertical cracks affect the vegetated rock slope and locally delimit small columns that might lead to rockfalls.

Recommendation: There are no signs that the Mjølvafjellet rock slope might fail in a massive rock slope failure. No further investigations or displacement measurements are necessary and the hazard and risk classification will not be made. However, rockfalls are possible and their run-out area is given by the rockfall susceptibility map or more detailed hazard maps, where available.

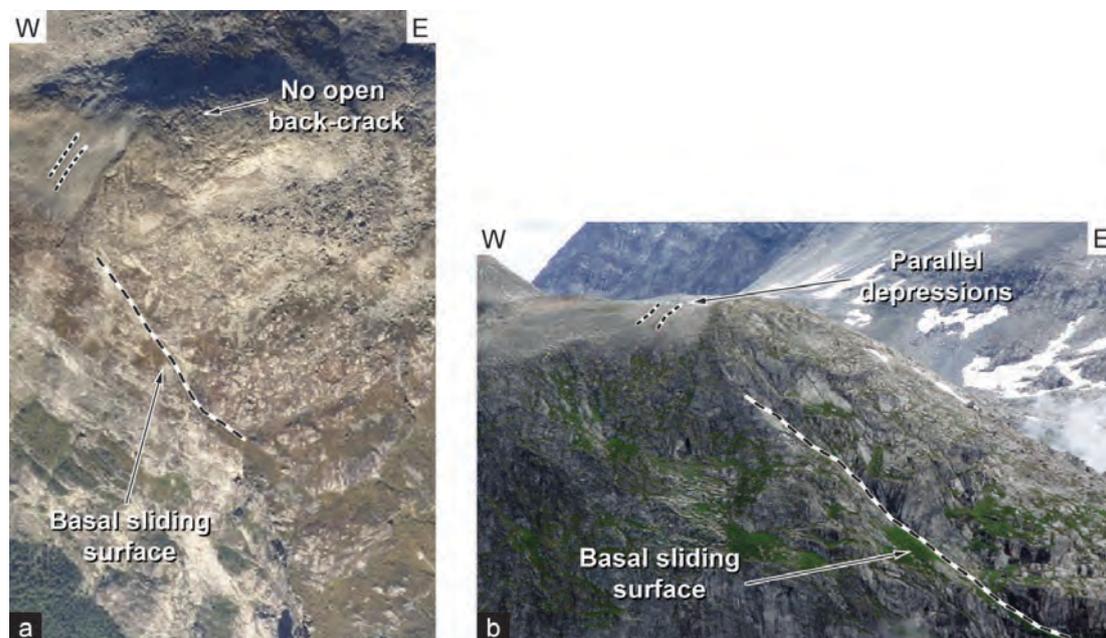
The bedrock displays steep NW- or SE-dipping foliation and associated meter-scale amplitude folds with axial planes gently dipping to the SE. An undulating SE-dipping basal sliding surface crops out on the southwestern edge of the site (Figure 70b). It follows a SE-dipping schistosity (likely a cleavage) that developed nearly parallel to the fold axial planes. Two SSW-NNE-trending surface depressions are observed to the northwest, on the top of the unstable rock slope (Figure 70). These discontinuous depressions are of unknown nature and no bedrock openings are actually visible (Figure 70b). No eastern lateral limit can be defined. In the lower SE-part of the rock slope the rock mass looks more heavily fractured than in the upper NW-part (Figure 70a), which could be related to internal deformation of the rock mass, but more likely to surface alteration processes. Finally, Olaskarstinden is classified as a potential unstable rock slope because no clear signs of past displacements are observable.

Downward the steep slope and at various locations in the surrounding of the site sliding surfaces of previous failures are well displayed. The SE-dipping schistosity acted as sliding surfaces, NW-SE steep fractures as lateral surfaces, and the steep NW-dipping or SE-dipping foliation detached the blocks at the back. The volumes involved in those previous events could have reached several 100 000 m³.

Figure 70: Photographs of the potential unstable rock slope at Olaskarstinden with a possible basal sliding surface and surface depressions: a) aerial photograph showing higher fracturing in the lower SE-part of the rock slope; b) the possible basal sliding surface formed along an undulating schistosity.

Recommendation: Olaskarstinden is classified as a potential unstable rock slope. At present the remaining rock slope does not show any signs of past or present displacements or deformation of a large volume (except for rockfall activity). No further investigations or displacement measurements are necessary and the hazard and risk classification will not be made. However, this site may lead to rockfalls and develop over time into an unstable rock slope, due to structural and geological conditions. The site should be revisited after years to decades to detect any changes and be followed-up on InSAR data.

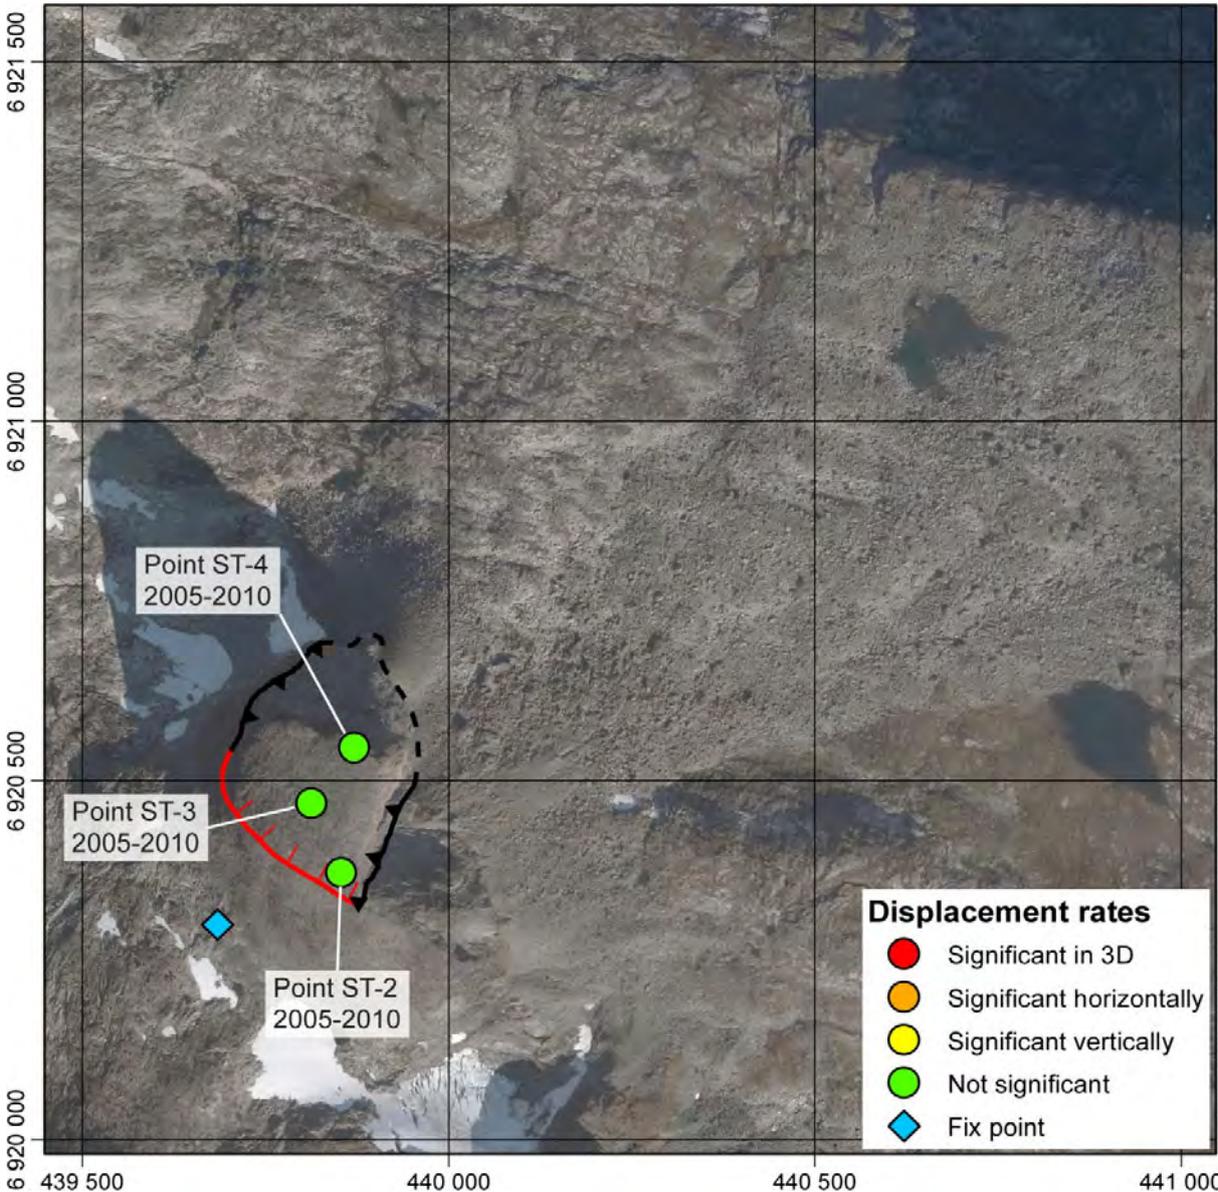
Three dGNSS measurement points were installed at Svarttinden in 2005 (Figure 71). All points were measured again in 2006, 2007 and 2010, but no significant displacements were recorded over the 5 years measurement period.

A previous rock slope failure occurred from the eastern part of the basal sliding surface. Its volume is estimated to 3–4 million m³ based on a reconstruction of the pre-failure topography. The rock avalanche reached the edge of the plateau, but not the valley floor (or only a small part of it). Rock avalanche deposits at Remmen likely originated from the steep cliffs of the southern flank of Romsdalen Valley (modified from Saintot et al. 2012). Cosmogenic nuclide dating of 3 rock avalanche deposit samples at Svarttinden provide an age between 7800 ± 700 and 10 500 ± 900 years.

Figure 71: Map of the Svarttinden instability with the location of dGNSS points for periodic displacement measurements. No significant displacements were detected over the 2005–2010 measurement period.

Recommendation: No significant displacements are measured up to now at Svarttinden. Periodic displacement measurements using dGNSS should be continued with 3–5 years interval. The hazard and risk classification needs to be made and further follow-up activities will be decided based on this classification.

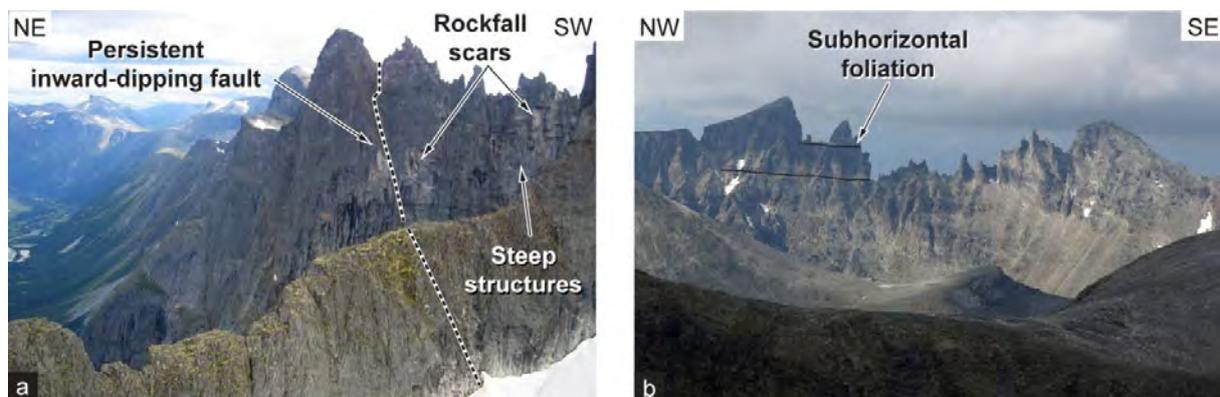
Trolltindan is located on a northeast- to east-facing slope 1510 m above Romsdalen Valley (Figure 59) and comprises the steep high cliffs of Trollveggen, which is a major tourist attraction in the valley. A helicopter reconnaissance flight was made in 2006 along the pinnacles forming the mountain crest of Trolltindan (Figure 72). Several rock slope failures occurred in the past, mainly in the form of rockfalls, but also as larger failures. In 1998 a volume of approximately 75 000 m³ collapsed and formed a small rock slope failure, which did not have an excessive run-out distance. The foliation is subhorizontal, while other discontinuity sets are very steeply dipping to subvertical (Figure 72). A persistent fault is inward-dipping and crosses the Trolltindan mountain (Figure 72a). This structural setting delimits relatively small volumes that may fail as rockfalls or small rock slope failures. On the other hand, there is a moderately valley-dipping structure at the foot of Trolltindan, which might form the basal sliding surface of an unstable rock slope. However, there are no morphologic evidences to define an unstable rock slope, but a closer look at the steep cliffs at Trolltindan is necessary.

Figure 72: Photographs of the Trolltindan rock slope: a) lateral view showing the inward-dipping fault and other steep structures; b) view from the back-side of Trolltindan showing the subhorizontal foliation.

Recommendation: Trolltindan is classified as a potential unstable rock slope. At present the remaining rock slope does not show any signs of past or present displacements or deformation of a large volume (except for rockfall activity). However, this site may lead to rockfalls and develop over time into an unstable rock slope, due to structural and geological conditions. Nonetheless, a more detailed helicopter reconnaissance flight is planned, focussing on the valley-dipping structure at the foot of Trolltindan and cracks within the cliff delimiting potential instabilities.

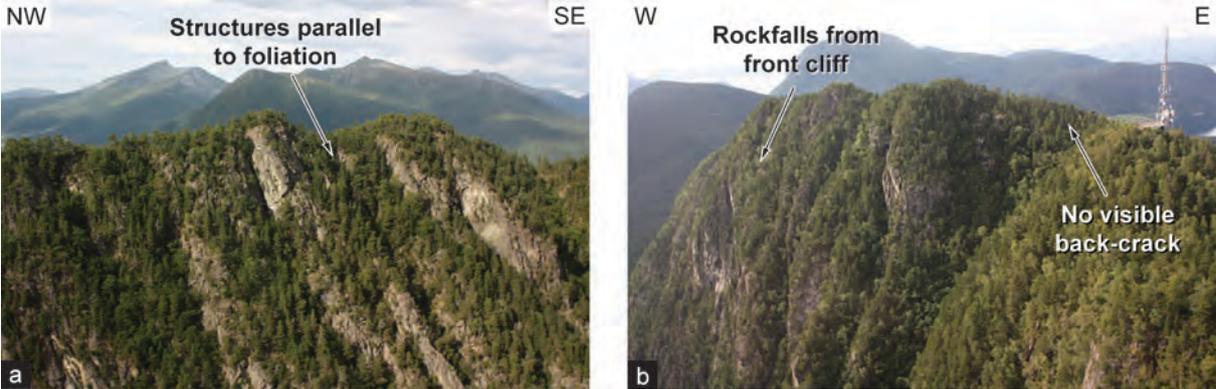
Veten (Figure 59) is located on a southwest-facing slope 410 meter above Romsdalsfjord, NW of Klungnes. A helicopter reconnaissance flight in 2011 revealed steeply S-dipping structures parallel to foliation (Figure 73a), which may favour sliding. On the other hand, no open cracks were observed and other necessary structures to delimit an unstable rock slope are missing. There are no signs of past displacements or current activity, except for rockfalls from the subvertical frontal cliff.

Figure 73: Photographs of the Vetten rock slope: a) the foliation is steeply S-dipping, but the observed structures do not delimit an unstable rock slope; b) there are no visible open cracks and no signs of activity except rockfalls from the steep frontal cliff.

Recommendation: There are no signs that the Vetten rock slope might fail in a massive rock slope failure. No further investigations or displacement measurements are necessary and the hazard and risk classification will not be made. However, rockfalls are possible and their run-out area is given by the rockfall susceptibility map or more detailed hazard maps, where available.

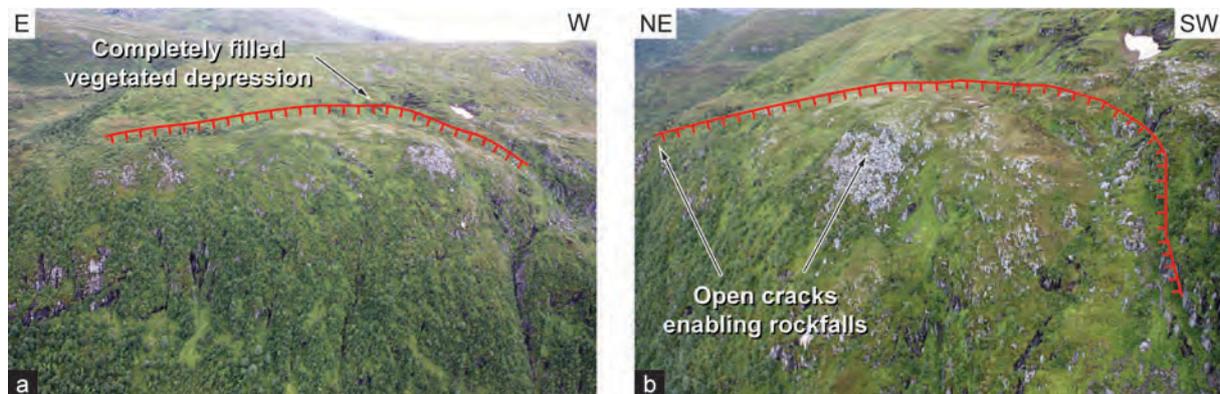
Seteraksla (Figure 74) is located on a northeast-facing slope 330 m above Rekdalsdalen Valley. A helicopter reconnaissance flight in 2012 showed an obvious back-scarp that has developed over 800 m in length and fully delimits the unstable rock slope (Figure 75). The back-scarp is marked as a surface depression in the ESE-part of the slope and by an up to 10 m high escarpment in its NW-part (Figure 75a). The lateral and basal limits of the unstable rock slope are poorly developed and not conspicuous on the terrain. There are no major cracks on the instability and no signs of recent displacement of the unstable rock slope as a whole. However, there are open cracks at several locations at the front of the instability (Figure 75b). They delimit small blocks that might induce rockfalls with volumes of tens to hundreds of m³. A massive failure from Seteraksla is unlikely and consequences would be small, since there are only very few buildings in Rekdalsdalen Valley (Dahle et al. 2011a).

Figure 75: Photographs of the Seteraksla unstable rock slope: a) an escarpment and depression form the back-scarp; b) open cracks delimit small blocks that lead to rockfalls.

Recommendation: A possible rock avalanche from the Seteraksla unstable rock slope will have no consequences. No further investigations or displacement measurements are necessary. The hazard and risk classification will be made after a simple run-out assessment. Further follow-up activities will be based on this classification.

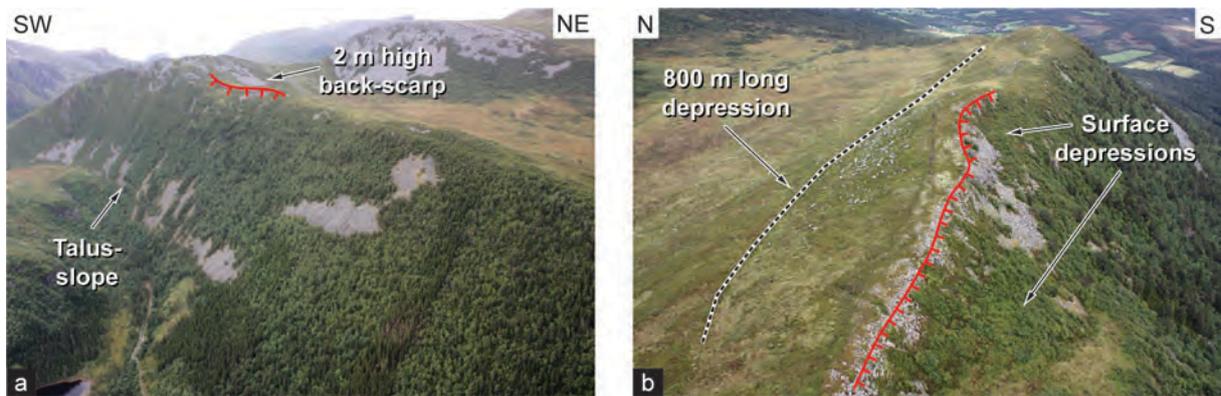
Snaufjellet (Figure 74) is located on a south-facing slope 345 m above Botnavatn Lake in Nakkedalen Valley. A helicopter reconnaissance flight was made in 2012 and revealed an 800 m long lineament north of, and parallel to, the ridge where the instability is located. It might be the result of past gravitational movements of the unstable rock slope (Figure 76). However, there are no signs of current activity, and necessary structures to delimit a large unstable rock slope are missing. Few, steep outcrops are visible along a two meter high back-scarp in the western part of the instability (Figure 76a). A large talus slope testifies of past rockfall activity. However, dense vegetation cover on the slope indicates only minor current rockfall activity. A massive failure from Snaufjellet could reach Botnavatn Lake and the road Fv147, but no buildings are located in the run-out area (Dahle et al. 2011a).

Figure 76: Photographs of the Snaufjellet unstable rock slope: a) cliffs along the ridge lead to rockfalls forming a large talus slope; b) a surface depression behind the mountain ridge indicates possible past displacements of a large unstable rock slope.

Recommendation: A possible rock avalanche from the Snaufjellet unstable rock slope will have no consequences. No further investigations or displacement measurements are necessary. The hazard and risk classification will be made after a simple run-out assessment. Further follow-up activities will be based on this classification.

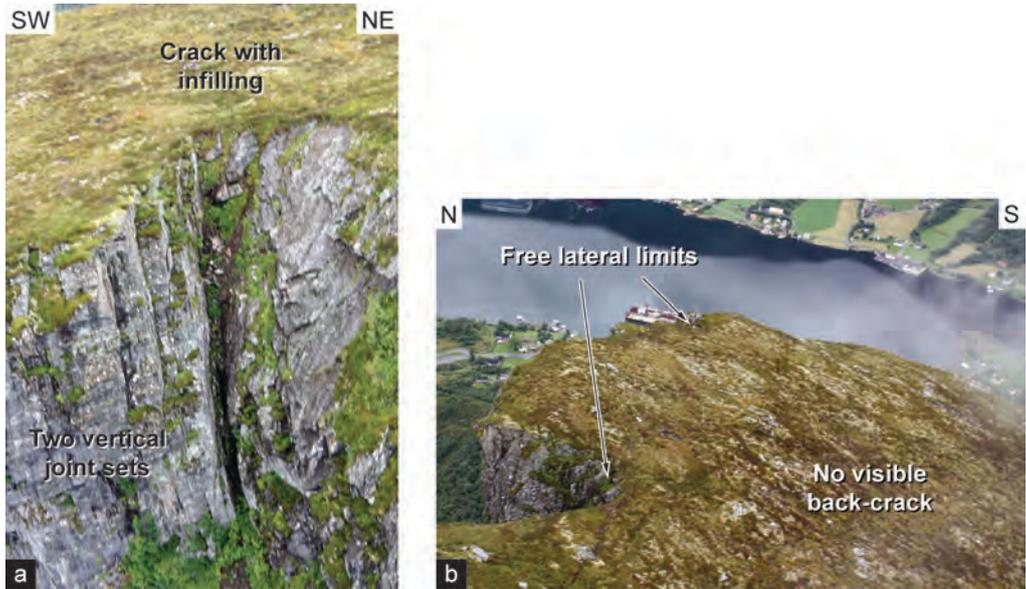
Strandastolen is located on a northeast-facing slope 510 m above the inner part of Tomrefjord close to the town of Tomra (Figure 74). A helicopter reconnaissance flight in 2012 showed a small instability that is laterally delimited by eroded and partly filled, vertical cracks (Figure 77). No through-going open back-crack was observed and there were only small to no past displacements (Figure 77b). However, a field survey by H. Dahle showed locally open cracks with up to 30 cm in width. The dimensions of the instability are roughly 60 m wide, 30 m long and 50 m high. This gives a maximum volume of approximately 90 000 m³. The massive failure of this instability would reach Tomrefjord and would create a minor displacement wave.

Figure 77: Photographs of the Strandastolen instability: a) the south-western lateral release surface is partly open and filled with loose debris; b) no recent displacement is visible.

Recommendation: A possible rock avalanche from the Strandastolen instability will have consequences, which will be assessed in the hazard and risk classification. Further follow-up activities will be decided based on this classification.

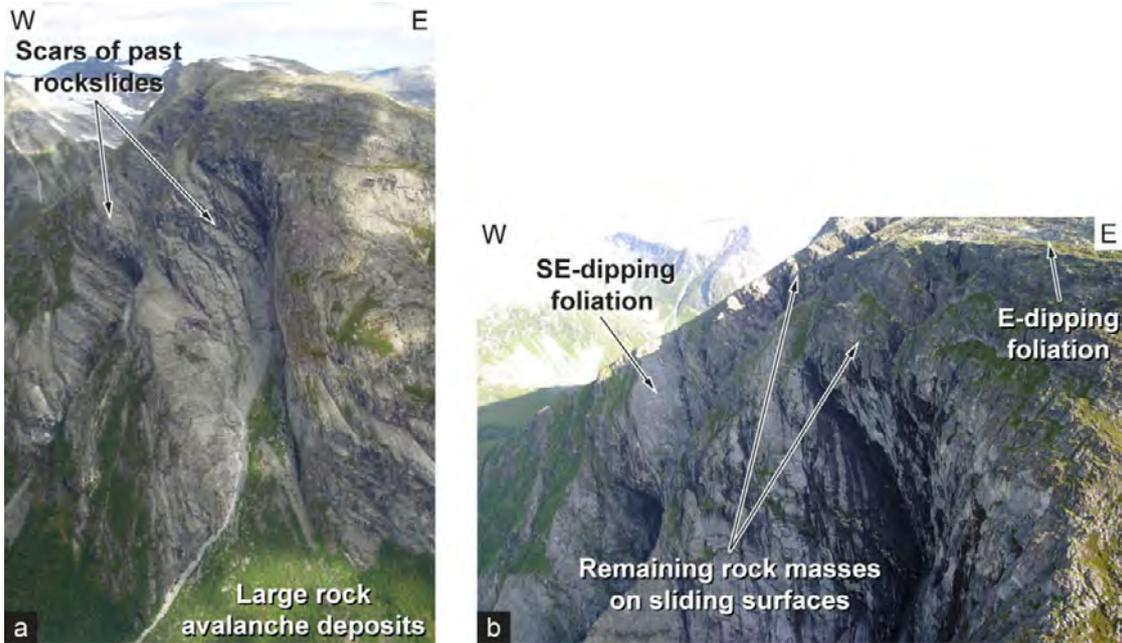
Figure 79: Photographs of the Alstadfjellet rock slope: numerous past failures occurred along SE-dipping foliation surfaces, but no large potential instability is delimited at present.

Recommendation: There are no signs that the Alstadfjellet rock slope might fail in a massive rock slope failure. However, a more detailed helicopter reconnaissance flight is planned, focussing on rock masses that remain on the sliding surfaces of past rockslides.

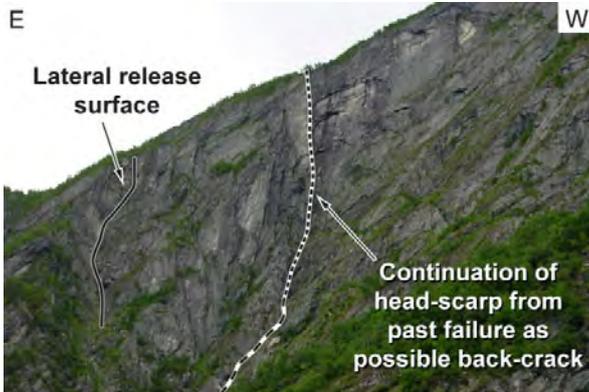
Alvikhornet 3 is located on a northeast-facing slope 600 m above Tafjord (Figure 78). Reconnaissance by boat and field mapping in 2006 showed a potential back-crack that follows the back-scarp of a past failure (Figure 80). Deposits of this past rock slope failure with a volume of 0.7 million m³ are found in the fjord (Longva et al. 2009). A potential instability with an estimated volume of 2 million m³ (Dahle et al. 2011a) is delimited by this potential back-crack, a poorly developed lateral release surface and a moderately ENE-dipping basal sliding surface probably formed by an exfoliation surface.

Figure 80: Photograph of the potential instability Alvikhornet 3 that is delimited by a possible back-crack, a poorly developed lateral release surface and a basal sliding surface probably formed by exfoliation.

Recommendation: Alvikhornet 3 is classified as a potential unstable rock slope. At present the remaining rock slope does not show any signs of past or present displacements or deformation of a large volume. No further investigations or displacement measurements are necessary and the hazard and risk classification will not be made. However, this site may lead to rockfalls and develop over time into an unstable rock slope, due to structural and geological conditions. The site should be revisited after years to decades to detect any changes and be followed-up on InSAR data.
