GEOLOGI FOR SAMFUNNET

GEOLOGY FOR SOCIETY

Report no.: 2013.014		ISSN: 0800–3416	Grading: Open
Title: Investigations on unstable rock slopes in Møre og Romsdal – status and plans after field surveys in 2012			
Authors: T. Oppikofer, A. Saintot, S. Otterå, R.L. Hermanns, E. Anda, H. Dahle, T. Eiken		Client: Norwegian Water Resources and Energy Directorate (NVE)	
County: Møre og Romsdal		Commune:	
Map-sheet name (M=1:250.000) Ålesund, Kristiansund, Røros, Ulsteinvik		Map-sheet no. and -name (M=1:50.000)	
Deposit name and grid-reference:		Number of pages: 323	Price (NOK): 1285,-
Fieldwork carried out: 2006–2012		Date of report: 13.11.2013	Map enclosures: 0
Fieldwork carried out: 2006–2012		Date of report: 13.11.2013	Project no.: 309900
Fieldwork carried out: 2006–2012		Date of report: 13.11.2013	Quality control: <i>Halvor Brundhoff</i>
<p>Summary:</p> <p>This report presents investigations, analyses and displacement measurements made between 2006 and 2012 on 131 unstable or potential unstable rock slopes in Møre og Romsdal County (Western Norway). An extract of this report is available in Norwegian (NGU rapport 2013.053).</p> <p>These investigations are part of the national plan for

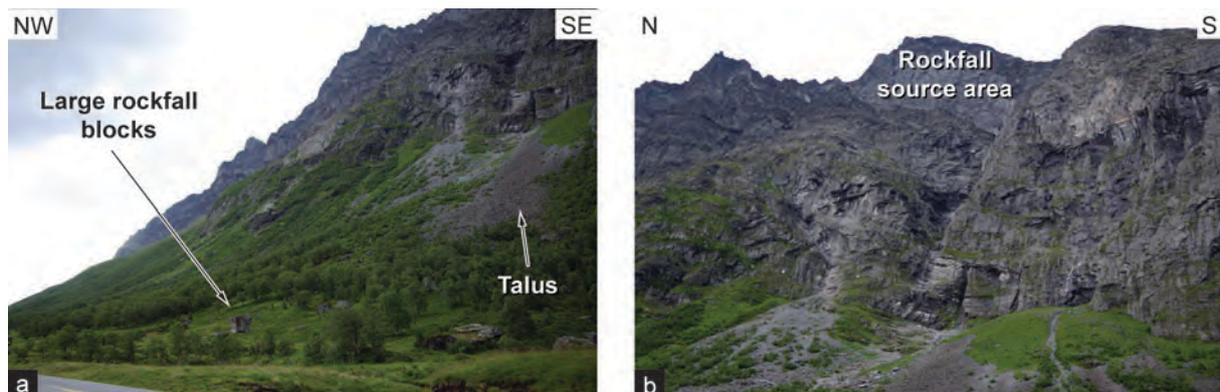
Hegrehamrane (Figure 78) is located on a west-facing cliff 690 m above Eidsdalen Valley. Reconnaissance by car and helicopter in 2007 showed steep cliffs that are prone to rockfalls (Figure 81). Past rockfalls have formed large talus slopes at the foot of the cliff, while large single blocks are observed on the valley floor (Figure 81a). There are no visible structures that would delimit a large unstable rock slope.

Figure 81: Photographs of the Hegrehamrane cliffs: a) talus slopes and large rockfall boulders on the valley floor indicate past rockfall activity; b) fresh rockfall scars are visible at several locations on the steep cliffs.

Recommendation: There are no signs that the Hegrehamrane rock slope might fail in a massive rock slope failure. No further investigations or displacement measurements are necessary and the hazard and risk classification will not be made. However, rockfalls are possible and their run-out area is given by the rockfall susceptibility map or more detailed hazard maps, where available.

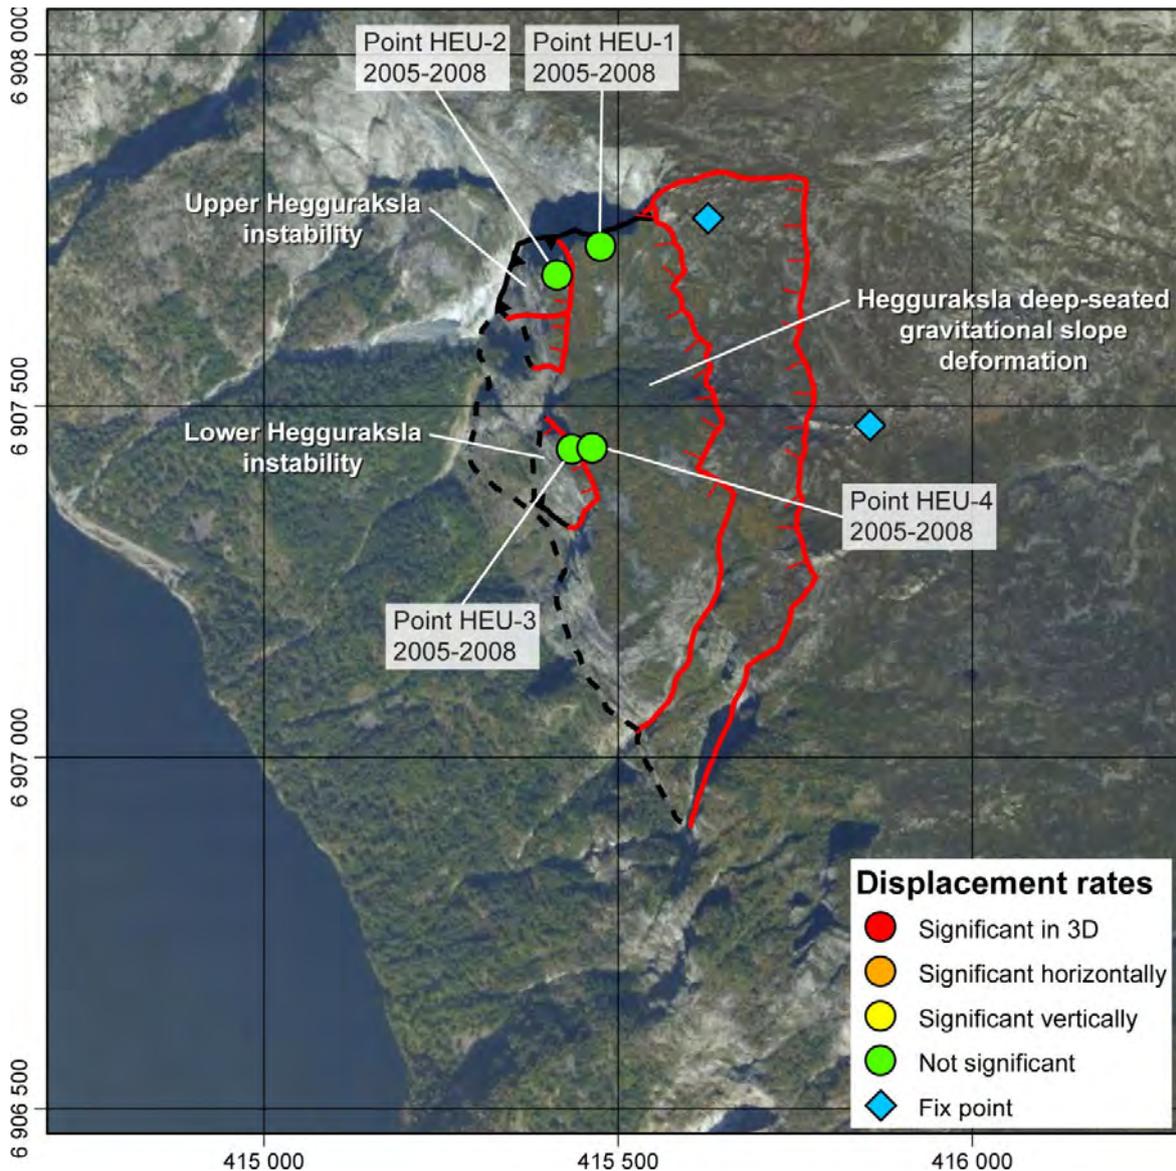
Figure 82: Map of the Hegguraksla unstable rock slope with the location of dGNSS points for periodic displacement measurements. No significant displacements were detected over the 2005–2008 measurement period.

The Hegguraksla rock slope is affected by a deep-seated gravitational slope deformation over a width of more than 600 m (Figure 82). A several meter high escarpments marks the back-scarp of this large unstable rock slope with an estimated volume of approximately 24 million m³ (Oppikofer 2009). Two instabilities are located along the frontal cliff of the Hegguraksla deep-seated gravitational slope deformation (Figure 82) with estimated volumes of 0.78–1.0 million m³ for the Upper Hegguraksla instability and 0.40 million m³ for the Lower Hegguraksla instability (Oppikofer 2009). Open back-cracks indicate past displacements of the instabilities and most continuous monitoring instrumentation focuses on these instabilities (Kristensen and Blikra 2010). Crackmeters installed in the back-crack of the Upper Hegguraksla instability indicate small displacements of less than 1 mm/year.

The Upper and Lower Hegguraksla instabilities were measured periodically using dGNSS between 2005 and 2008. Four dGNSS points were installed in August 2005 (Figure 82). One point is located on each of the localised instabilities (HEU-2 and HEU-3) and two other points are located on the deep-seated gravitational slope deformation (HEU-1 and HEU-4). All points were measured again in October 2005, August 2006, August 2007 and August 2008, but no significant displacements were recorded in the 3 years measurement period.

Recommendation: Hegguraksla is under continuous monitoring and data are being sent to the Åknes/Tafjord Early-Warning Centre, which is also responsible for further follow-up activities.

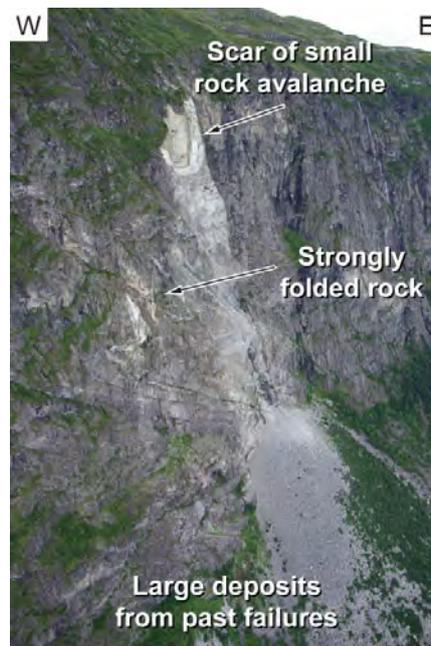
Jimdalen is located on a southwest-facing slope 710 m above the Jimdalen Valley, 1.8 km SE of Tafjord (Figure 78). A helicopter reconnaissance flight in 2007 showed a large talus slope formed by past rockfalls and a small rock avalanche (Figure 83). The fresh scar in the upper part of the cliff is from a small rock avalanche that occurred in 1992. The foliation orientation is very variable due to strong folding. There are no open cracks or other visible structures that might delimit a large unstable rock slope.

Figure 83: Photograph of the Jimdalen rock slope: the scar and deposits of past rockfalls and a small rock avalanche are visible, but no open cracks or structures delimiting a large unstable rock slope are visible.

Recommendation: There are no signs that the Jimdalen rock slope might fail in a massive rock slope failure. No further investigations or displacement measurements are necessary and the hazard and risk classification will not be made. However, rockfalls are possible and their run-out area is given by the rockfall susceptibility map or more detailed hazard maps, where available.

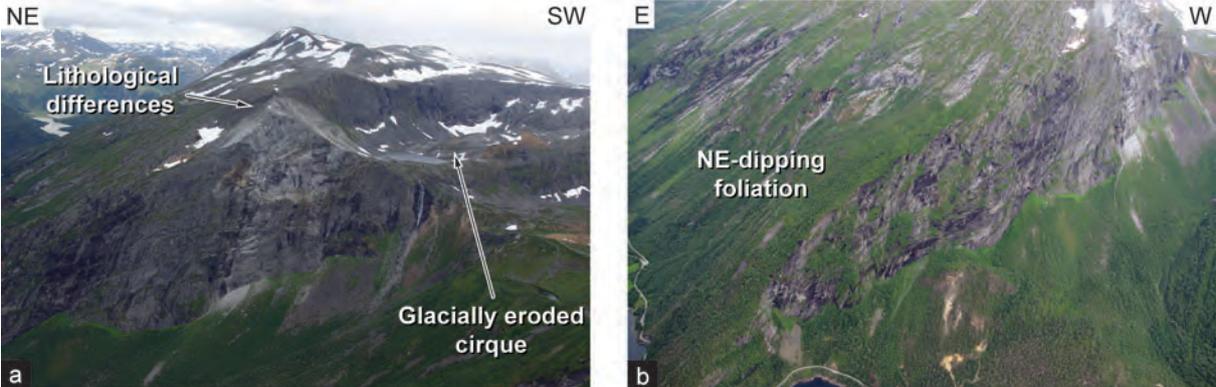
Kallen is located on a northeast-facing slope 1030 m above Onilsavatnet Lake, 1.8 km south of Tafjord (Figure 78). A large post-glacial rockslide with an estimated volume of 100 million m³ originated from Kallen and dammed Onilsavatnet Lake (Longva et al. 2009). The steeply N-dipping cliffs at Kallen were probably the southern lateral release surface of this past rockslide (Figure 84). Three samples of the rock avalanche deposits were dated to 11 200 ± 1500 years BP using cosmogenic nuclide dating. Colour differences in the bedrock at Kallen (Figure 84a) were interpreted as signs of an unstable rock slope, but a helicopter reconnaissance flight in 2007 did not reveal any open cracks or other signs of past displacements at the mountain top of Kallen and the ridge trending eastwards down to Onilsavatnet Lake (Figure 84b).

Figure 84: Photographs of the Kallen rock slope: a) the steeply N-dipping cliffs at Kallen were the lateral release surface of a large post-glacial rockslide, but no large unstable rock slope remains; b) there are no visible open cracks on the mountain ridge running eastward from Kallen down to Onilsavatnet Lake.

Recommendation: There are no signs that the Kallen rock slope might fail in a massive rock slope failure. No further investigations or displacement measurements are necessary and the hazard and risk classification will not be made. However, rockfalls are possible and their run-out area is given by the rockfall susceptibility map or more detailed hazard maps, where available.

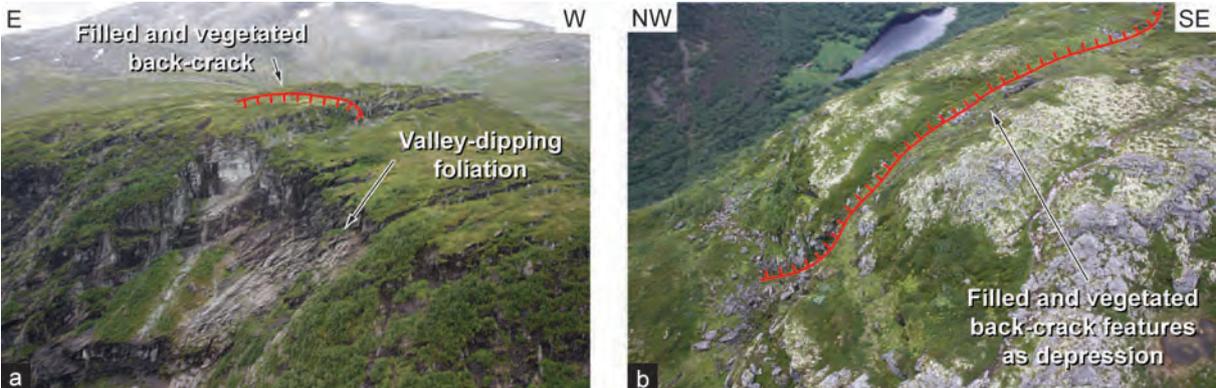
Kilstiheia (Figure 78) is located on a north-facing slope 600 m above Verpesdalen Valley. An unstable rock slope was identified during a helicopter reconnaissance flight in 2011. An instability is delimited by a well-developed back-crack that is filled and vegetated (Figure 85). The gneiss foliation is moderately dipping towards the valley and served as basal sliding surface in past rockslides, whose scars are well visible on the rock slope (Figure 85a). The foliation also likely forms the basal sliding surface of the present instability at Kilstiheia. Lateral release surfaces are however not well-developed although structures along which they can develop, i.e. parallel to the presumed sliding direction, exist (Figure 85a). A massive failure from Kilstiheia would affect a few houses in Verpesdalen Valley.

Figure 85: Photographs of the Kilstiheia instability: a) rockslides occurred along the valley-dipping foliation forming the basal sliding surface; b) the instability is delimited by a filled and vegetated back-crack.

Recommendation: A possible rock avalanche from the Kilstiheia instability will have consequences. Geological field mapping is necessary to evaluate the structural and geological conditions, to quantify past displacements and assess the structures involved in previous rockslides. The hazard and risk classification will be made after this field mapping. Further follow-up activities will be decided based on this classification.

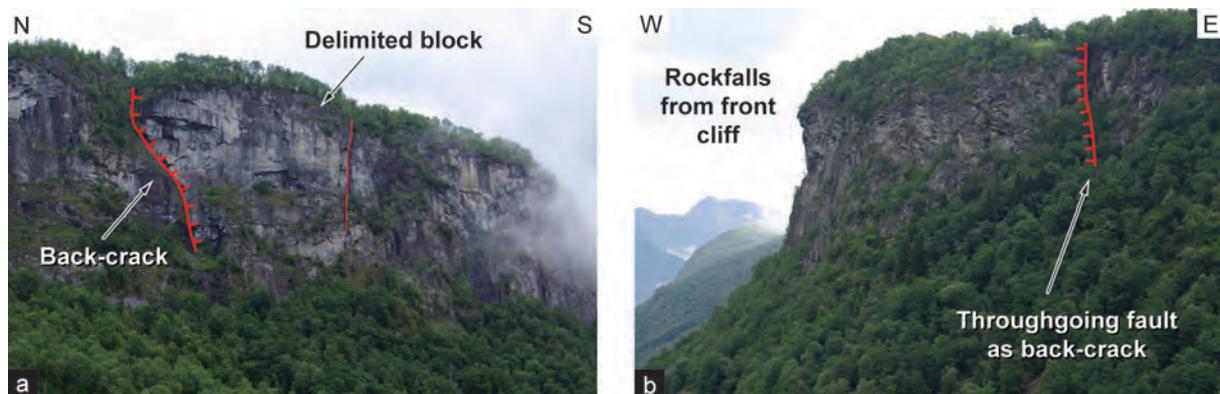
Kleivahammaren (Figure 78) is situated close to Kleiva on a west-facing slope 270 m above Eidsdalen Valley. Reconnaissance by car in 2007 revealed a sub-vertical fault that forms the back-crack of an unstable rock slope (Figure 86). No openings of the back-crack can be seen on the top of the hill as it is covered by forest, but the fault trace is nonetheless visible as a shallow surface depression. A small compartment along the front cliff is delimited by a sub-vertical crack (Figure 86a), but there are no signs of past displacements. A talus slope below cliff indicates high rockfall activity.

Figure 86: Photographs of the Kleivahammaren instability: a through-going structure that may act as the back-crack of a large instability is observed and should be further investigated.

Recommendation: A possible rock avalanche from the Kleivahammaren instability will have consequences. Geological field mapping is necessary to evaluate the structural and geological conditions and to quantify past displacements. The hazard and risk classification will be made after this field mapping. Further follow-up activities will be decided based on this classification.

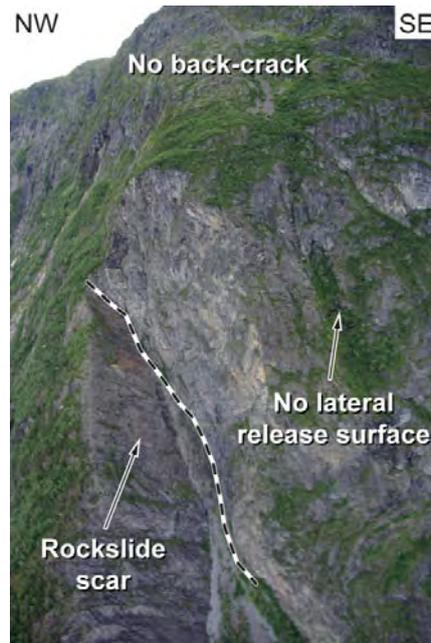
Kloven is located on a southwest-facing slope 770 m above Jimdalen Valley, 1 km SE of Tafjord (Figure 78). A helicopter reconnaissance flight in 2007 showed a past rockslide scar with a planar basal sliding surface and a subvertical lateral release surface (Figure 87). This basal sliding surface likely continues into the mountainside and might thus be activated in a future rockslide. However, there is currently no open back-crack or lateral release surface to delimit an unstable rock slope (Figure 87).

Figure 87: Photograph of the potential unstable rock slope at Kloven: the basal sliding surface of a past rockslide likely continues into the mountainside. The lack of back-crack and lateral release surface indicates that no past displacement occurred at this potential instability.

Recommendation: Kloven is classified as a potential unstable rock slope. At present the remaining rock slope does not show any signs of past or present displacements or deformation of a large volume. No further investigations or displacement measurements are necessary and the hazard and risk classification will not be made. However, this site may lead to rockfalls and develop over time into an unstable rock slope, due to structural and geological conditions. The site should be revisited after years to decades to detect any changes and be followed-up on InSAR data.

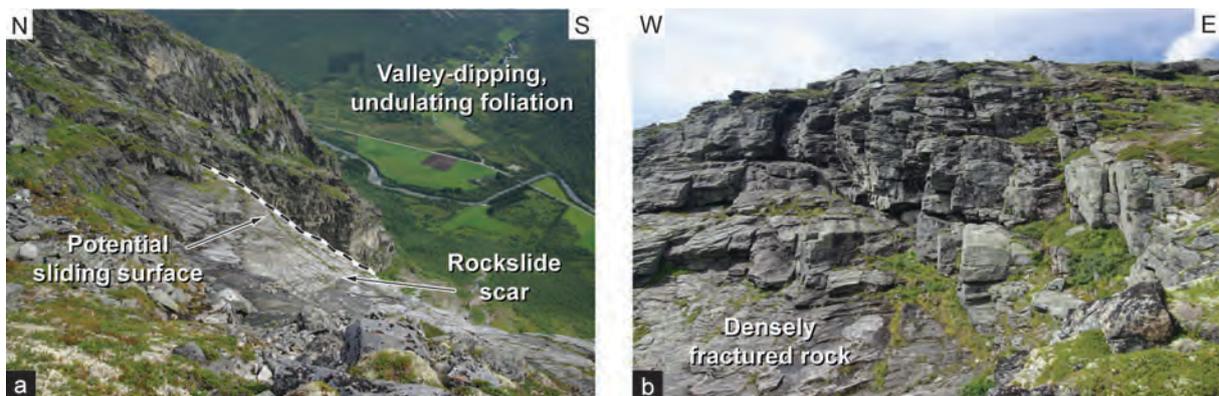
Figure 88: Photographs of the Krikeberget rock slope: rockslides occurred in the past along a gently valley-dipping foliation.

Krikeberget (Figure 78) is situated on a southeast-facing slope 750 m above Valldalen Valley. Field mapping in 2007 showed a gently valley-dipping foliation that formed the basal sliding surface of past rockslides (Figure 88). These failure were however of small volume and did not form a rock avalanche with excessive run-out distance. Furthermore, there is no open back-crack or other structures linked to a large gravitational deformation within the slope. The bedrock is densely fractured and may currently lead to rockfalls.

Recommendation: There are no signs that the Krikeberget rock slope might fail in a massive rock slope failure. No further investigations or displacement measurements are necessary and the hazard and risk classification will not be made. However, rockfalls are possible and their run-out area is given by the rockfall susceptibility map or more detailed hazard maps, where available.

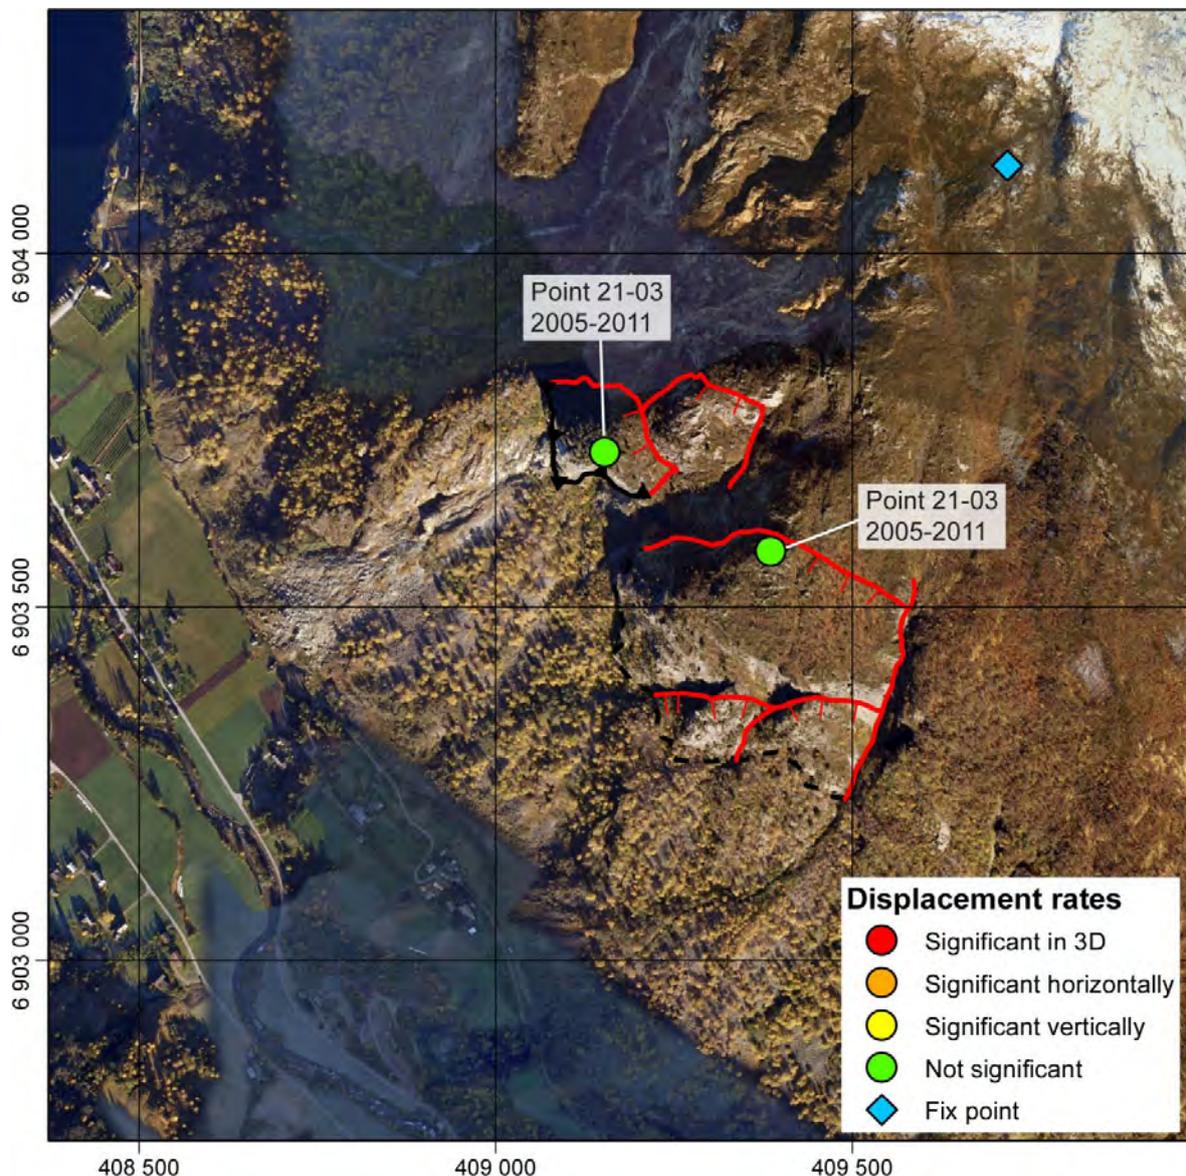
Two dGNSS points were installed in 2005 (Figure 89). Point 21-02 is located on Kvitfjellet 1 and point 21-03 on Kvitfjellet 2. Both points were measured again in 2006, 2007 and 2011, but no significant displacements were recorded over the 6 years measurement period.

Kvitfjellet 1 was scanned by TLS from several locations in the valley bottom and the talus slope formed by previous rockfalls (Figure 89). Repetitive scans made in 2009, 2010, 2011 and 2012 did not reveal significant displacements of the unstable rock slopes. However, more than ten rockfalls from the Kvitfjellet 1 instability are detected between 2006 and 2012.

Figure 89: Map of the Kvitfjellet 1 & 2 instabilities with the location of dGNSS points for periodic displacement measurements. No significant displacements were detected over the 2005–2011 measurement period.

Recommendations: No significant displacements are measured up to now at Kvitfjellet 1 & 2. Periodic displacement measurements using dGNSS and TLS should be continued with 3–5 years interval. The hazard and risk classification needs to be made and further follow-up activities will be decided based on this classification.

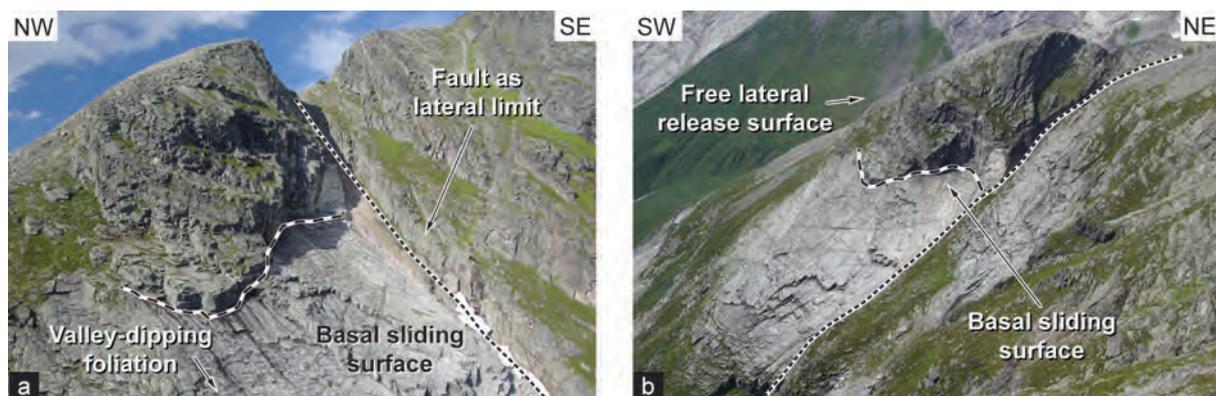
Remsfjellet (Figure 78) is located on a south-facing slope 1120 m above Rem village in Vall-dalen Valley. Helicopter reconnaissance and field mapping was carried out in 2007. The instability is on the western termination of a mountain ridge with a deeply eroded vertical N-S-trending brecciated fault as eastern lateral free limit (Figure 90). The instability stands on a moderately valley-dipping basal sliding surface denuded downward by past rockslides (Figure 90). However, there are no signs of past displacements of the remaining block along the sliding surface as well as no visible offset at the back of the potential instability. The volume of the potential unstable rock slope is probably less than 0.5 million m³.

Figure 90: Photographs of the potential instability at Remsfjellet: a remaining block is located on a planar basal sliding surface and delimited to the east by an eroded fault. There are however no signs of past displacements.

Recommendation: Remsfjellet is classified as a potential unstable rock slope. At present the remaining rock slope does not show any signs of past or present displacements or deformation of a large volume. No further investigations or displacement measurements are necessary and the hazard and risk classification will not be made. However, this site may lead to rockfalls and develop over time into an unstable rock slope, due to structural and geological conditions. The site should be revisited after years to decades to detect any changes and be followed-up on InSAR data.

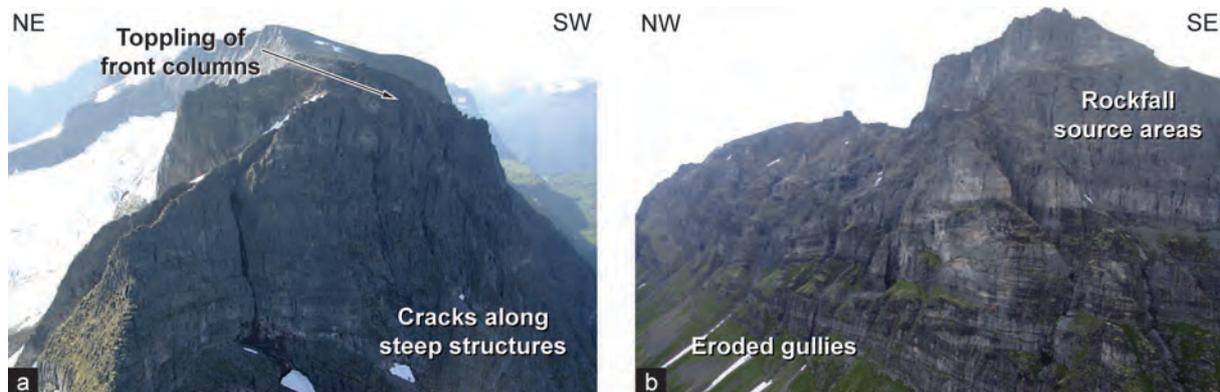
Skorene 1 & 2 (Figure 78) are located at 1185 m to 1360 m above Løvoll and Eide settlements and Eidsvatnet Lake in Eidsdalen Valley (Figure 91). Along the entire mountain side the foliation is flat-laying. Subvertical cross-cutting structures lead to rockfall activity and delimit front columns with a volume of tens of thousands of m³ that might topple. Further downslope gullies are eroded out. On the northern part of the mountain range, a N-S-trending

brecciated hematite-rich fault cuts the ridge in two parts (Figure 91a) and highly fractured rocks are at the crest of the ridges. Scree deposits cover the slope at the foot of the cliffs. Some big blocks are present in the scree deposits.

Figure 91: Photographs of the Skorene cliffs: the foliation is flat lying but a dense network of cross-cutting subvertical fractures leads to columnar failures and rockfall formation; the northern part of the site is a double ridge separated by a large fault zone.

Recommendations: There are no signs that the Skorene 1 & 2 rock slopes might fail in massive rock slope failures. No further investigations or displacement measurements are necessary and the hazard and risk classification will not be made. However, rockfalls are possible and their run-out area is given by the rockfall susceptibility map or more detailed hazard maps, where available.

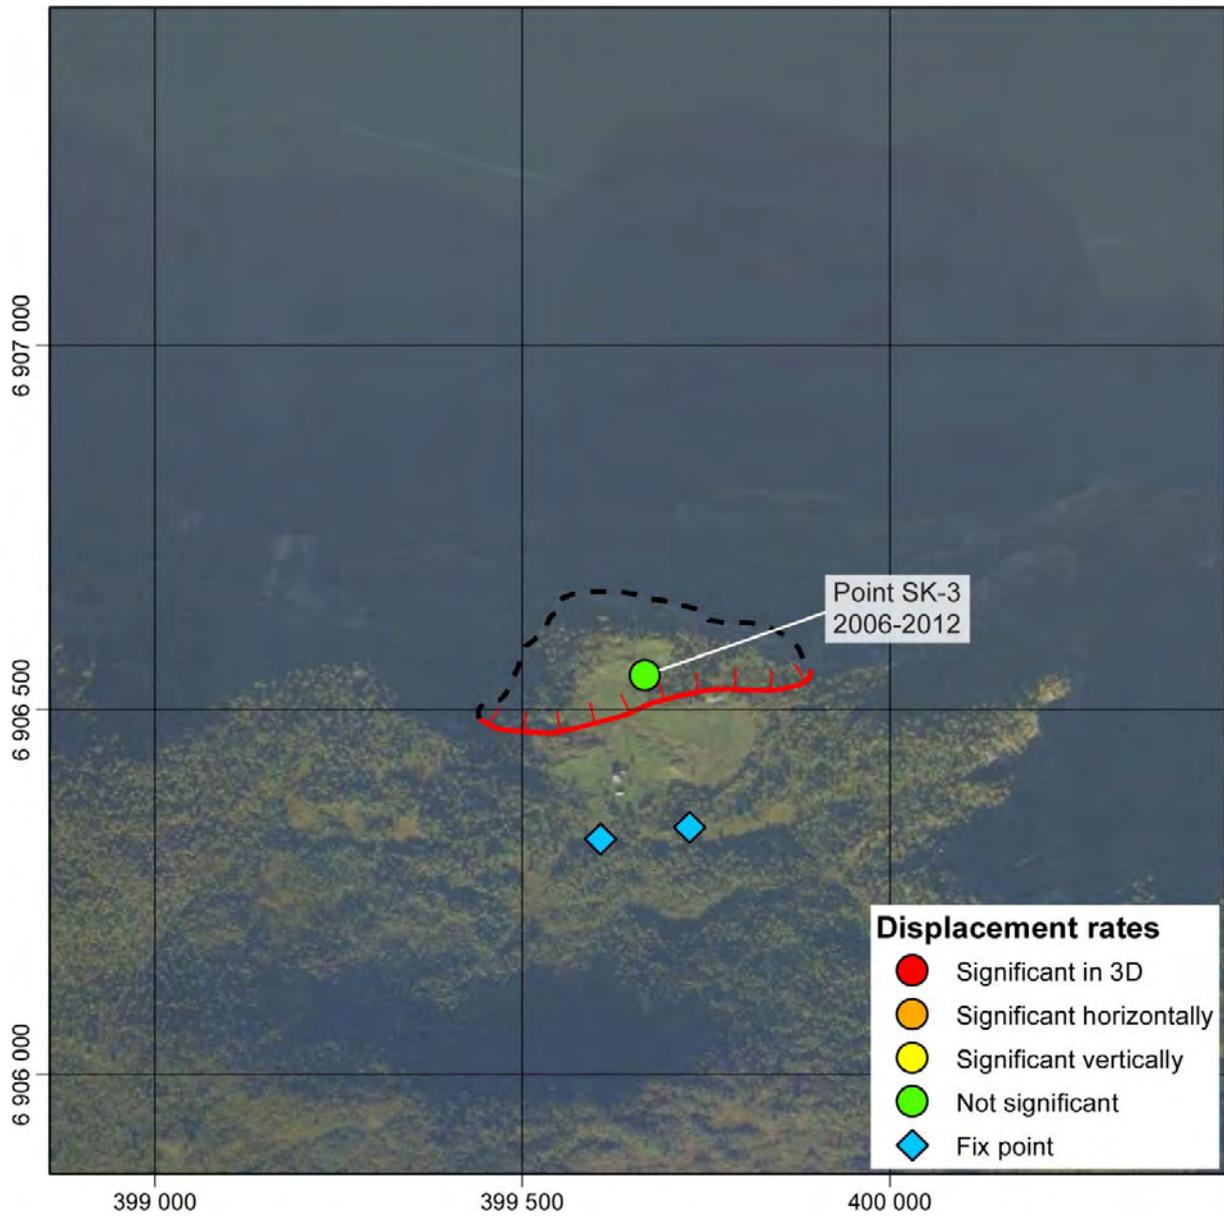
One dGNSS measurement points was installed on Skrednakken 1 in 2006 (Figure 92) and measured again in 2007 and 2012. No significant displacement was recorded over the 6 years measurement period. A potential collapse of this instability would impact Norddalsfjord and create a displacement wave (Dahle et al. 2011a).

Figure 92: Map of the potential instability at Skrednakken 1 with the location of dGNSS points for periodic displacement measurements. No significant displacements were detected over the 2006–2012 measurement period.

Recommendation: Skrednakken 1 is classified as a potential unstable rock slope. At present the remaining rock slope does not show any signs of past or present displacements or deformation of a large volume. Periodic displacement measurements with dGNSS did not reveal significant displacements. No further investigations or displacement measurements are necessary and the hazard and risk classification will not be made. However, this site may lead to rockfalls and develop over time into an unstable rock slope, due to structural and geological conditions. The site should be revisited after years to decades to detect any changes and be followed-up on InSAR data.

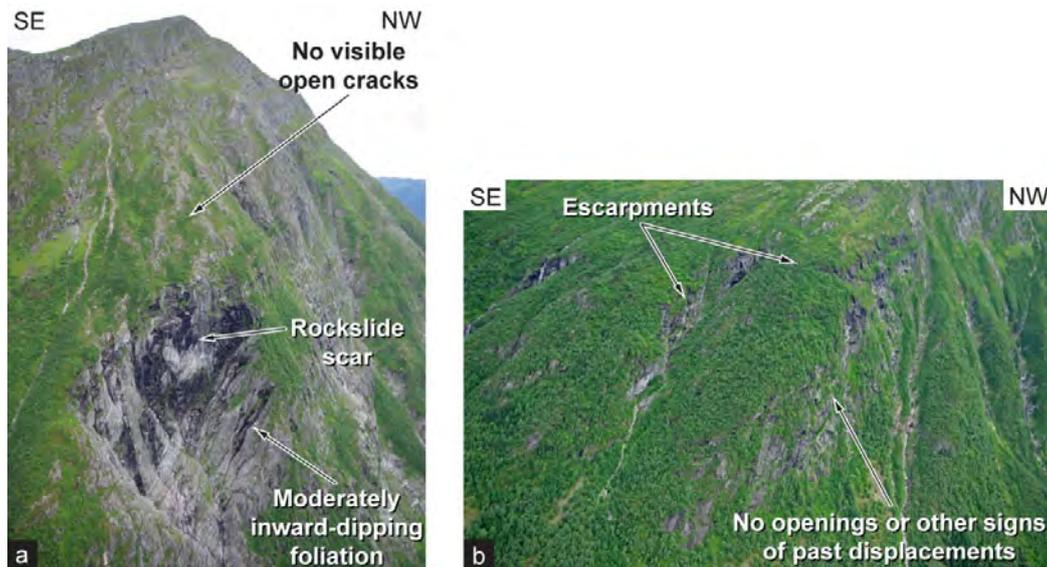
Storhornet 1 & 2 (Figure 93) are located on a northeast-facing cliff 1020 m respectively 500 m above Stordalen Valley. A helicopter reconnaissance flight made in 2007 did not show large unstable rock slopes at Storhornet 1 & 2. A past rockslide at Storhornet 1 used the moderately S-dipping foliation as basal sliding surface (Figure 94a). On the other hand, there are no open cracks above this scar and no large unstable rock slope is delimited at Storhornet 1. Two several meter high WNW-ESE and N-S-trending escarpments were identified on aerial photographs and supposed to delimit an instability at Storhornet 2 (Figure 94b). However, there are no visible openings or other signs of past displacements. No large unstable rock slope is delimited at Storhornet 2.

Figure 94: Photographs of the Storhornet 1 & 2 rock slopes (in a and b respectively): a) no open cracks are visible above the scar of a past rockslide at Storhornet 1; b) several meters high escarpments were supposed to delimit an instability at Storhornet 2, but no openings or other signs of past displacements are visible.

Recommendations: There are no signs that the Storhornet 1 & 2 rock slopes might develop toward massive rock slope failures. No further investigations or displacement measurements are necessary and the hazard and risk classification will not be made. However, rockfalls are possible and their run-out area is given by the rockfall susceptibility map or more detailed hazard maps, where available.

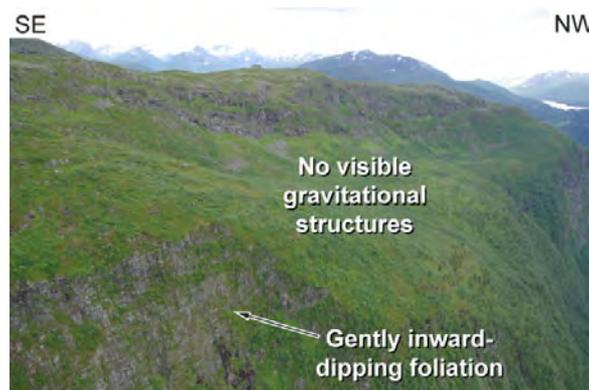
Tuva is located on a north-facing slope 750 m above Stordal (Figure 93). The site was identified as potential deep-seated gravitational slope deformation based on aerial photograph analysis in Henderson et al. (2006). A helicopter reconnaissance flight and field survey in 2007 did not reveal any large gravitational structures delimiting an unstable rock slope (Figure 95). The foliation is gently S-dipping and thus not favourably oriented for sliding. A subvertical NNE-SSW-trending discontinuity set might delimit laterally small blocks that could fail as rockfalls.

Figure 95: Photographs of the Tuva rock slope: no signs of large gravitational deformation are visible.

Recommendation: There are no signs that the Tuva rock slope might fail in a massive rock slope failure. No further investigations or displacement measurements are necessary and the hazard and risk classification will not be made. However, rockfalls are possible and their run-out area is given by the rockfall susceptibility map or more detailed hazard maps, where available.

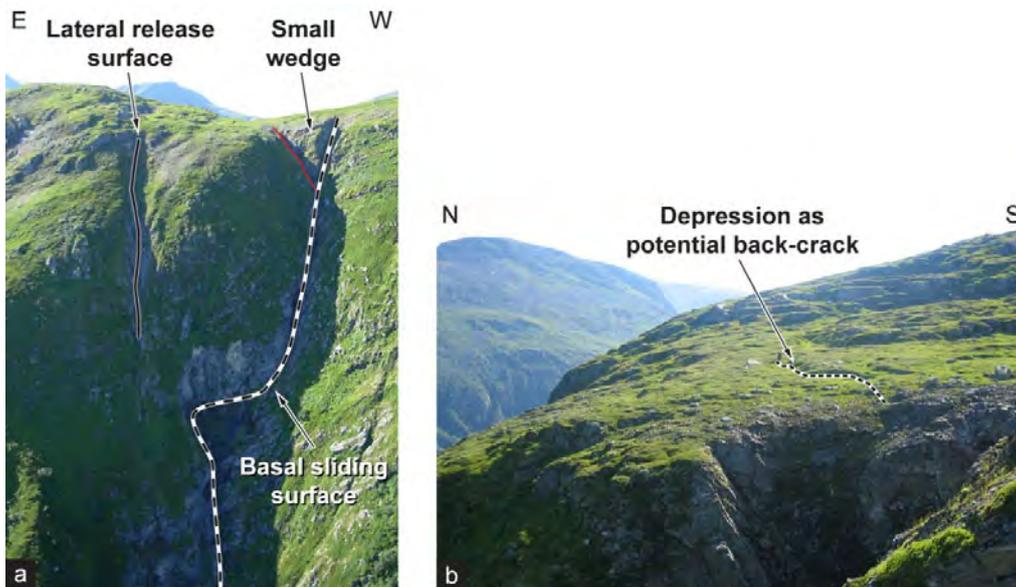
Aksla is situated on a northeast-facing slope 710 m above Sætrødal Valley and Oaldalsbygda (Figure 96). Helicopter reconnaissance in 2005 and field mapping in 2006 on top of the instability showed a linear depression that might be the morphologic expression of a back-crack (Figure 97b, Figure 98). Secondary open cracks within the instability are parallel to it. The foliation is steeply inward-dipping (Figure 97b), but a persistent moderately NW-dipping structure forms the basal sliding surface of the instability (Figure 97a). The eastern lateral release surface is not fully developed and marked by a gully due to preferential erosion of more fractured rock mass (Figure 97a). A small, highly fractured wedge is located at the western limit of the main instability and standing on the same basal surface. A massive failure or the Aksla instability would form a rock avalanche that would reach the buildings at Oaldalsbygda, but likely not form a significant displacement wave in Sunnylvsfjord.

Figure 97: Photographs of the Aksla instability: a) the basal sliding surface is formed by a moderately NW-dipping planar structure and the eastern limit is marked by a gully; b) a shallow surface depression marks the location of the potential back-crack.

Recommendation: A possible rock avalanche from the Aksla instability will have consequences, which will be assessed in the hazard and risk classification. Further follow-up activities will be decided based on this classification.

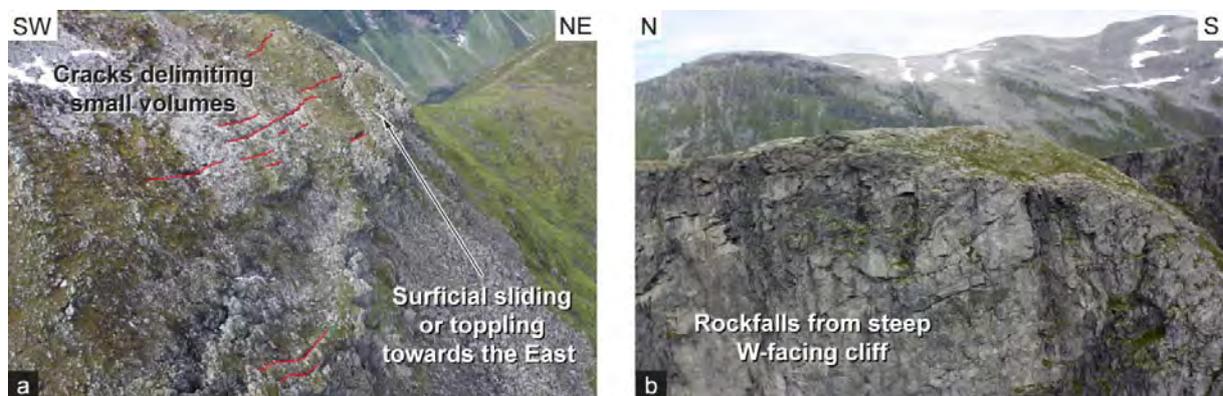
Fivelstadnibba is a mountain ridge 1209 m a.s.l. that separates the perched Sæteredalen Valley from Norangsdalen Valley (Figure 96). A helicopter reconnaissance flight was made in 2011. On the northeast-facing slope 375 m above Sæteredalen Valley several cracks enable sliding and toppling of relatively small (thousands to tens of thousands of m³) compartments (Figure 99a). Their failure would only affect the uninhabited Sæteredalen Valley and have thus no major consequences (Dahle et al. 2011a). Rockfalls may occur on the subvertical west-facing cliffs of Fivelstadnibba and fall toward Norangsdalen Valley (Figure 99b). There are no visible structures that would delimit a large unstable rock slope that could fail towards Norangsdalen Valley.

Figure 99: Photographs of the Fivelstadnibba rock slope: a) open cracks delimit slices that could slide or topple towards the East; b) rockfalls occur from the W-facing cliff above Norangsdalen Valley.

Recommendation: A possible rock avalanche from the Fivelstadnibba instability will have no consequences. No further investigations or displacement measurements are necessary. The hazard and risk classification will be made after a simple run-out assessment. Further follow-up activities will be based on this classification.

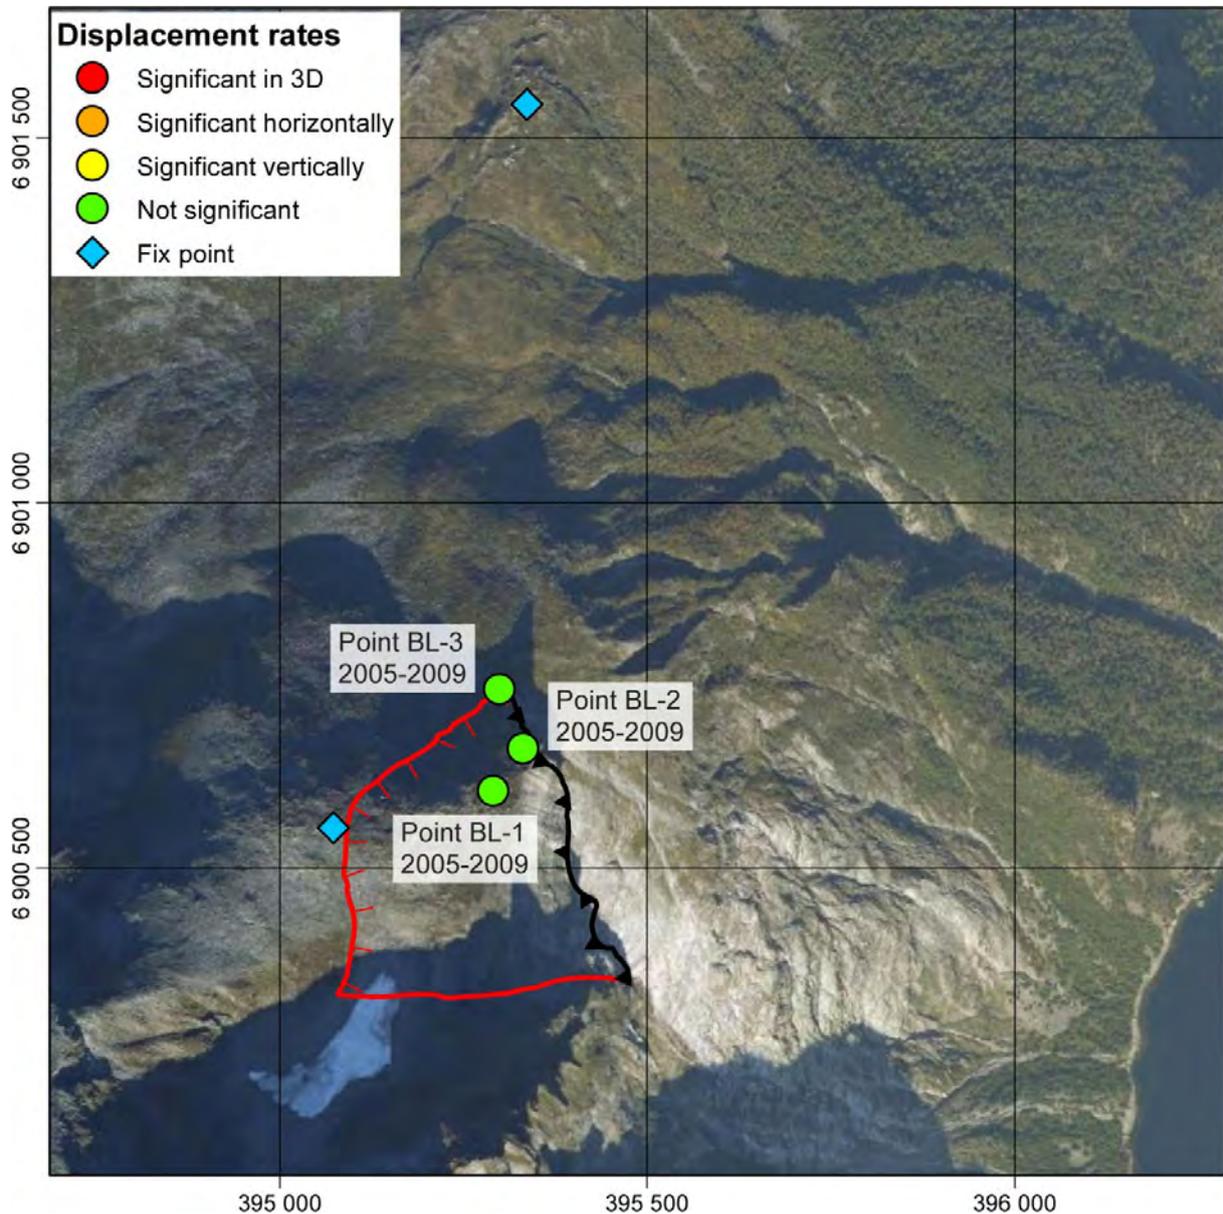
Three dGNSS measurement points were installed on Fremste Blåhornet in 2005 (Figure 100) and measured again in 2006, 2007 and 2009. No significant displacements were recorded over the 4 years measurement period.

Figure 100: Map of the potential unstable rock slope at Fremste Blåhornet with the location of dGNSS points for periodic displacement measurements. No significant displacements were detected over the 2005–2009 measurement period.

Recommendation: Fremste Blåhornet is classified as a potential unstable rock slope. At present the remaining rock slope does not show any signs of past or present displacements or deformation of a large volume. Periodic displacement measurements with

dGNSS did not reveal significant displacements. No further investigations or displacement measurements are necessary and the hazard and risk classification will not be made. However, this site may lead to rockfalls and develop over time into an unstable rock slope, due to structural and geological conditions. The site should be revisited after years to decades to detect any changes and be followed-up on InSAR data.

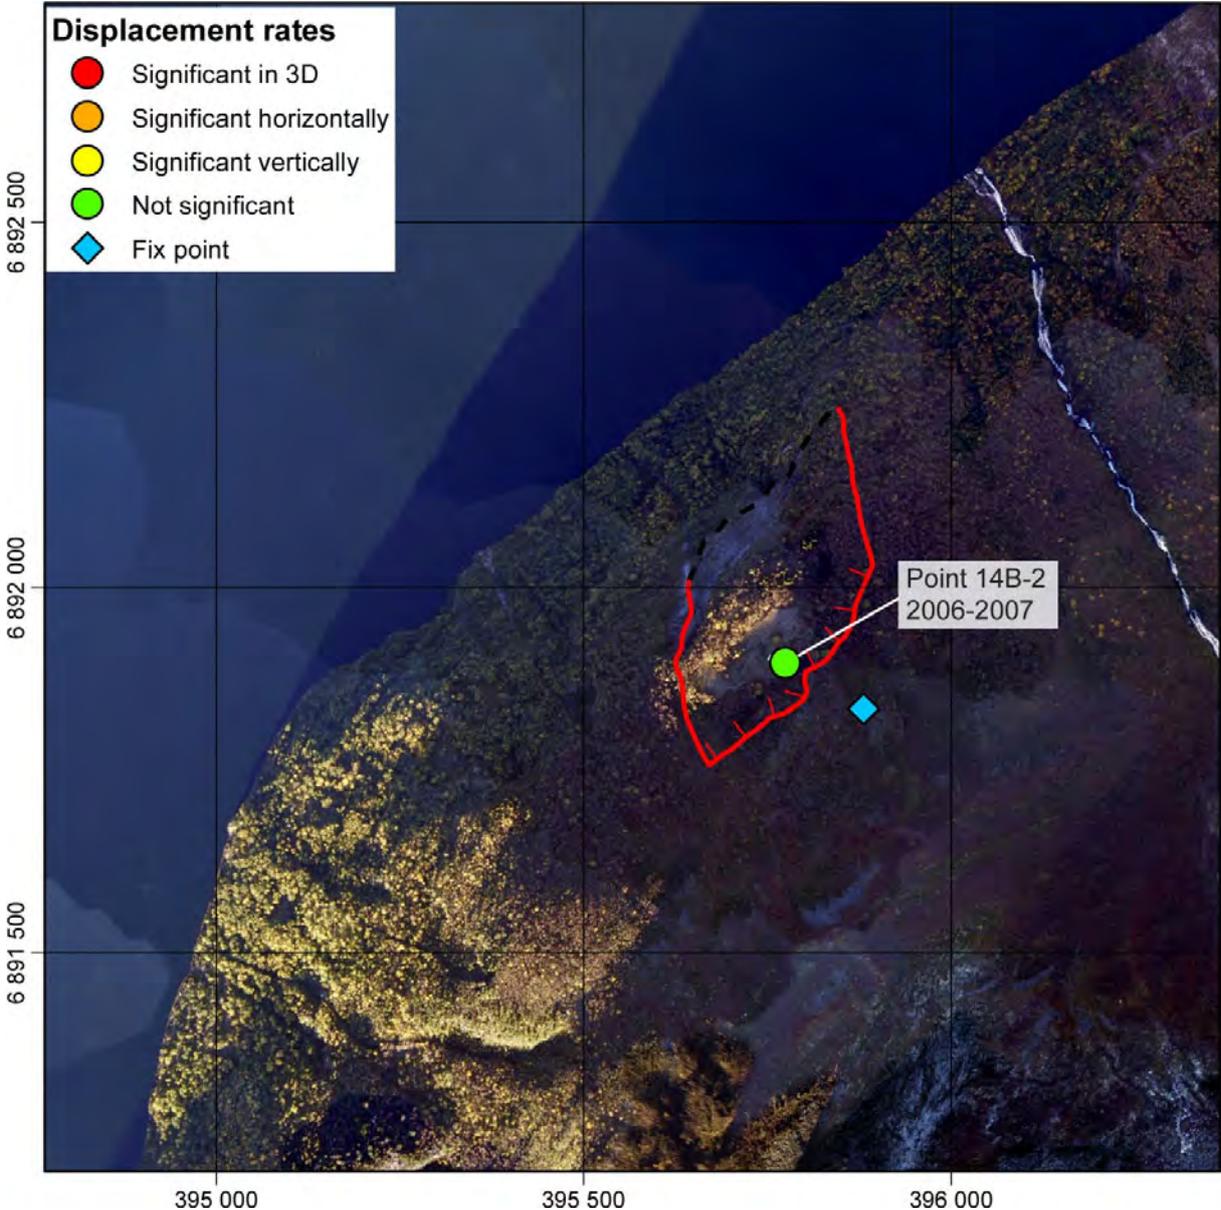
One dGNSS measurement points was installed on Furneset in 2006 (Figure 101) and measured again in 2007. No significant displacement was recorded over the 1 year measurement period.

Figure 101: Map of the potential instability at Furneset with the location of dGNSS points for periodic displacement measurements. No significant displacements were detected over the 2006–2007 measurement period.

Recommendation: Furneset is classified as a potential unstable rock slope. At present the remaining rock slope does not show any signs of past or present displacements or deformation of a large volume (except for rockfall activity). Periodic displacement measurements with dGNSS did not reveal significant displacements. No further investigations or displacement measurements are necessary and the hazard and risk classification will not be made. However, this site may lead to rockfalls and develop over time into an unstable rock slope, due to structural and geological conditions. The site should be revisited after years to decades to detect any changes and be followed-up on InSAR data.

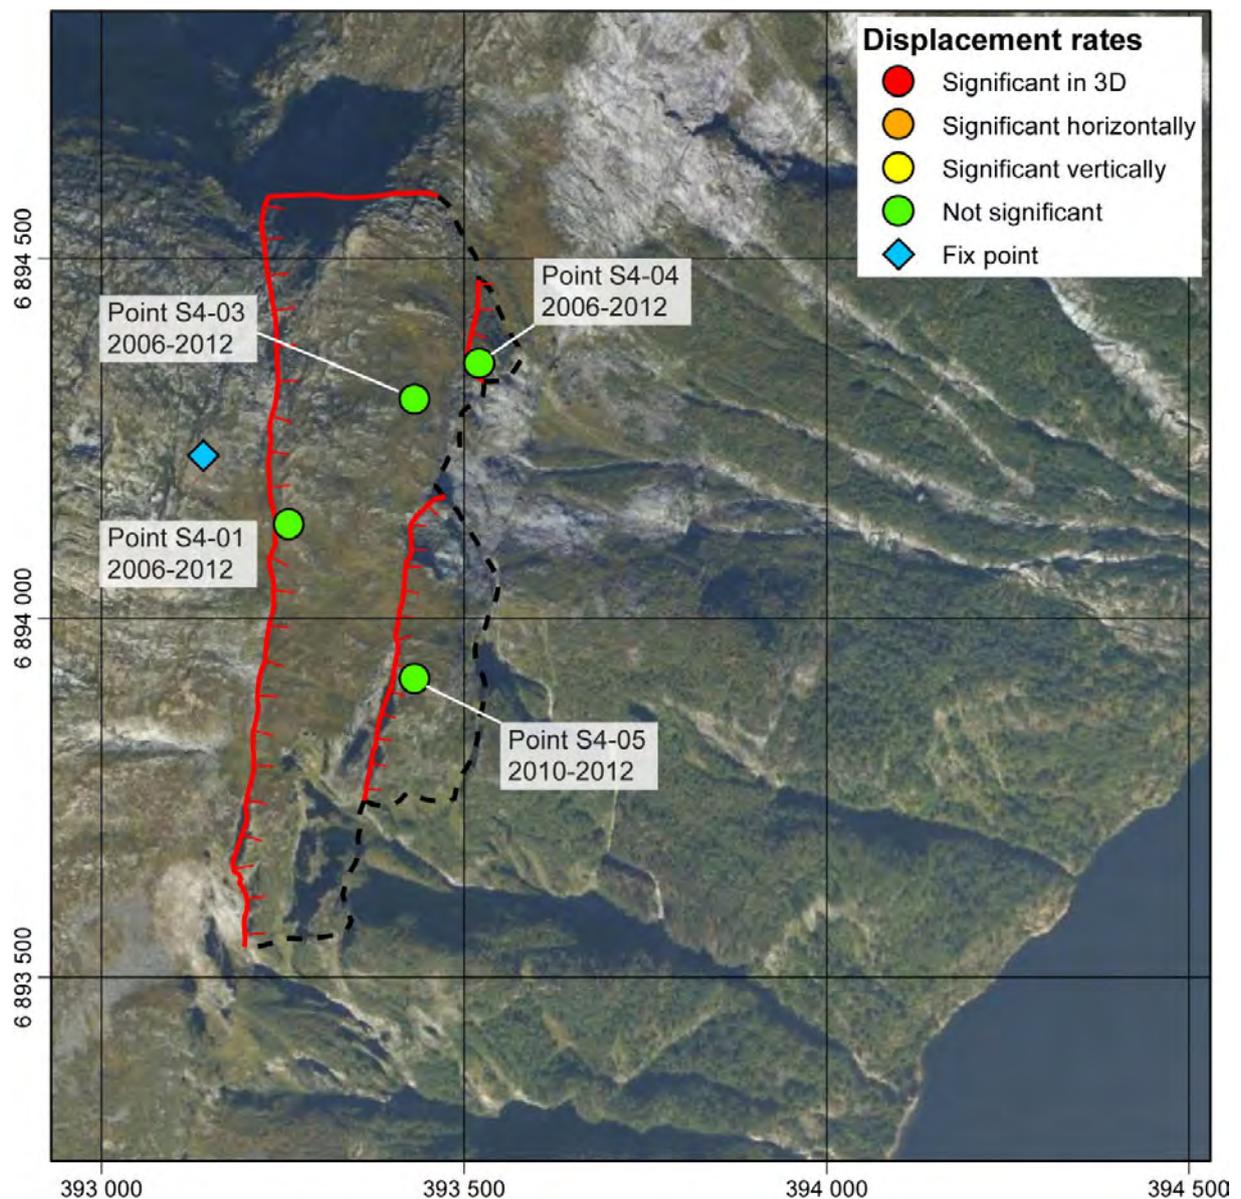
Four dGNSS measurement points were installed on Herdalsnibba (three points in 2006, one point in 2010) (Figure 102) and measured yearly until 2010 and again in 2012. No significant displacements were recorded over the 6 years measurement period.

Figure 102: Map of the potential unstable rock slope at Herdalsnibba with the location of dGNSS points for periodic displacement measurements. No significant displacements were detected over the 2006–2012 measurement period.

Recommendation: Herdalsnibba is classified as a potential unstable rock slope. At present the remaining rock slope does not show any signs of past or present displacements or deformation of a large volume. Periodic displacement measurements with dGNSS did not reveal significant displacements. No further investigations or displacement measurements are necessary and the hazard and risk classification will not be made. However, this site may lead to rockfalls and develop over time into an unstable rock slope, due to structural and geological conditions. The site should be revisited after years to decades to detect any changes and be followed-up on InSAR data.

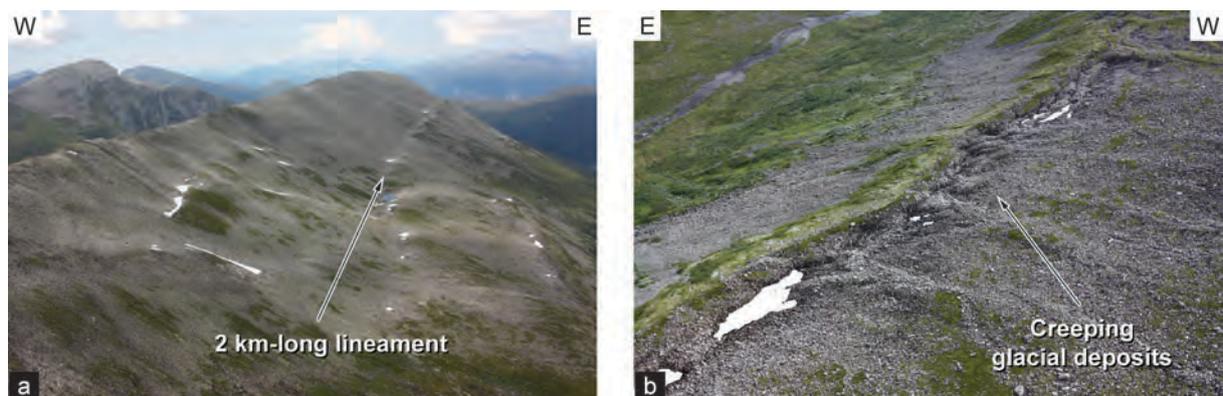
Kvitegga (Figure 96) is a long mountain ridge separating the Strandamolskreddalen and Em-dalsdalen Valleys. The locality was surveyed from helicopter in 2011 and there are no signs indicating that Kvitegga is an unstable rock slope. The 2 km long lineament on the SE flank is likely due to creep in glacial deposits (Figure 103) and not to gravitational deformation of the entire mountainside towards the WNW.

Figure 103: Photographs of the Kvitegga ridge: a) a 2 km long lineament on the SE-facing slope is likely caused by creep of loose glacial deposits; b) detail of the lineament.

Recommendation: There are no signs that the Kvitegga rock slope might fail in a massive rock slope failure. No further investigations or displacement measurements are necessary and the hazard and risk classification will not be made. However, rockfalls are possible and their run-out area is given by the rockfall susceptibility map or more detailed hazard maps, where available.
