GEOLOGI FOR SAMFUNNET

GEOLOGY FOR SOCIETY

Report no.: 2013.014		ISSN: 0800–3416	Grading: Open
Title: Investigations on unstable rock slopes in Møre og Romsdal – status and plans after field surveys in 2012			
Authors: T. Oppikofer, A. Saintot, S. Otterå, R.L. Hermanns, E. Anda, H. Dahle, T. Eiken		Client: Norwegian Water Resources and Energy Directorate (NVE)	
County: Møre og Romsdal		Commune:	
Map-sheet name (M=1:250.000) Ålesund, Kristiansund, Røros, Ulsteinvik		Map-sheet no. and -name (M=1:50.000)	
Deposit name and grid-reference:		Number of pages: 323	Price (NOK): 1285,-
Fieldwork carried out: 2006–2012		Date of report: 13.11.2013	Map enclosures: 0
Fieldwork carried out: 2006–2012		Date of report: 13.11.2013	Project no.: 309900
Fieldwork carried out: 2006–2012		Date of report: 13.11.2013	Quality control: <i>Halvor Brundhoff</i>
<p>Summary:</p> <p>This report presents investigations, analyses and displacement measurements made between 2006 and 2012 on 131 unstable or potential unstable rock slopes in Møre og Romsdal County (Western Norway). An extract of this report is available in Norwegian (NGU rapport 2013.053).</p> <p>These investigations are part of the national plan for

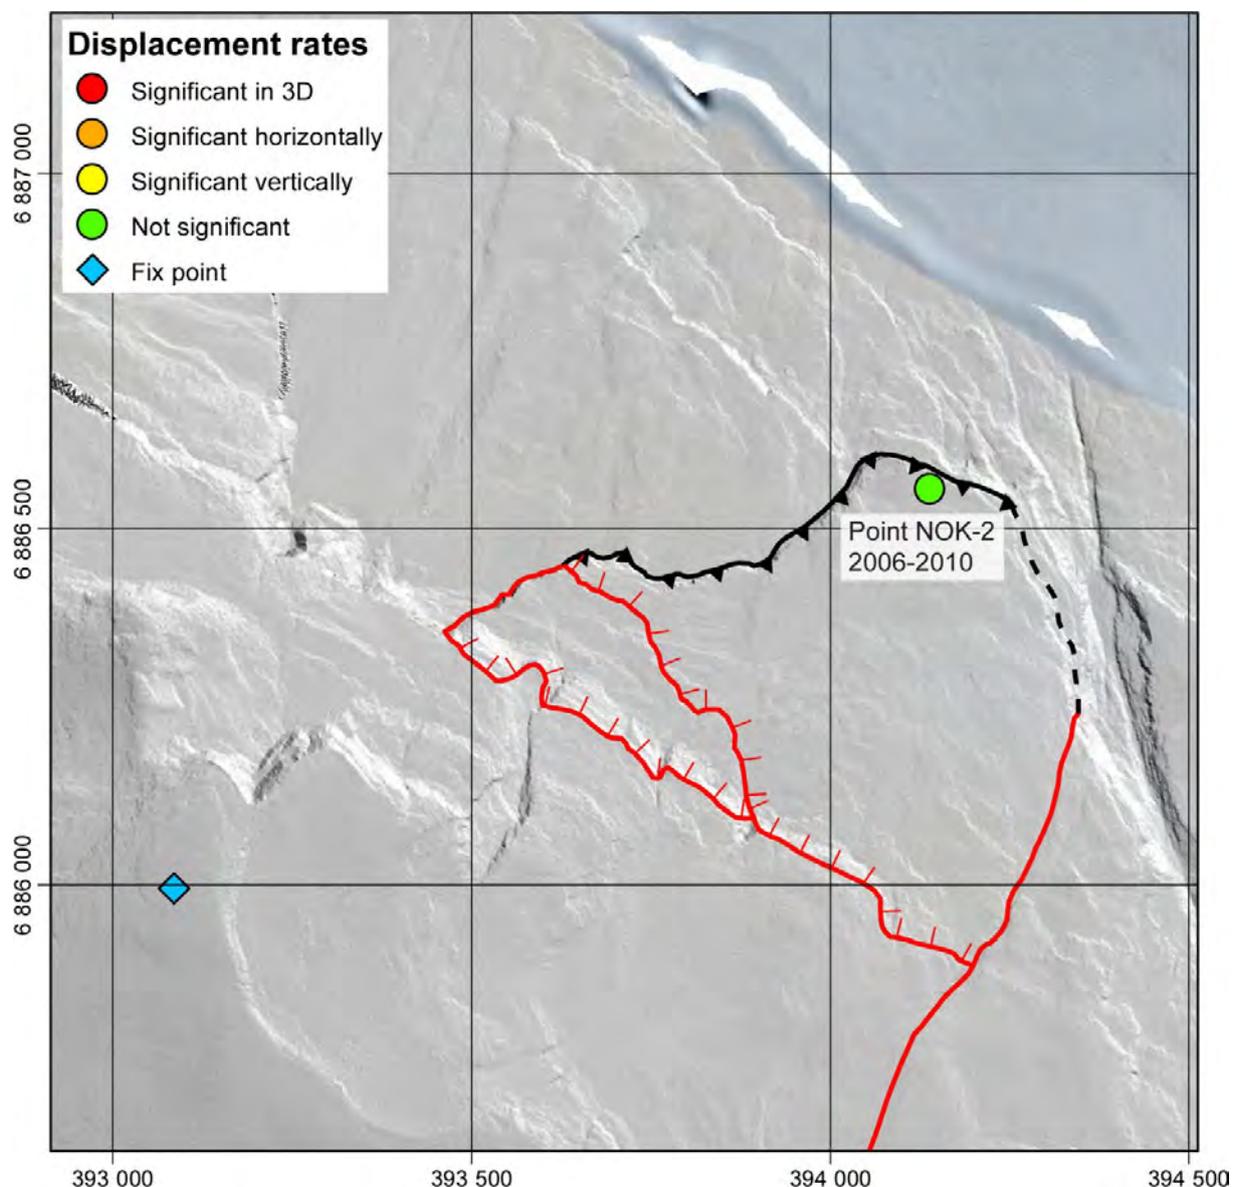
One dGNSS measurement point was installed on Nokkenibba 2 in 2006 (Figure 104) and measured again in 2007 and 2010. No significant displacements were recorded over the 4 years measurement period.

The deposits of the rock avalanche from Nokkenibba were previously dated to 8000–9000 years BP (Longva et al. 2009). Cosmogenic nuclide dating of two samples of the rock-slide scar at Nokkenibba gives an age of 7100 ± 900 years and thereby match relatively well with previous results.

Figure 104: Map of the potential unstable rock slope at Nokkenibba 2 with the location of dGNSS points for periodic displacement measurements. No significant displacements were detected over the 2006–2010 measurement period.

Recommendation: Nokkenibba 2 is classified as a potential unstable rock slope. At present the remaining rock slope does not show any signs of past or present displacements or deformation of a large volume (except for rockfall activity). Periodic displacement measurements with dGNSS did not reveal significant displacements. No further investigations or displacement measurements are necessary and the hazard and risk classification will not be made. However, this site may lead to rockfalls and develop over time into an unstable rock slope, due to structural and geological conditions. The site should be revisited after years to decades to detect any changes and be followed-up on InSAR data.

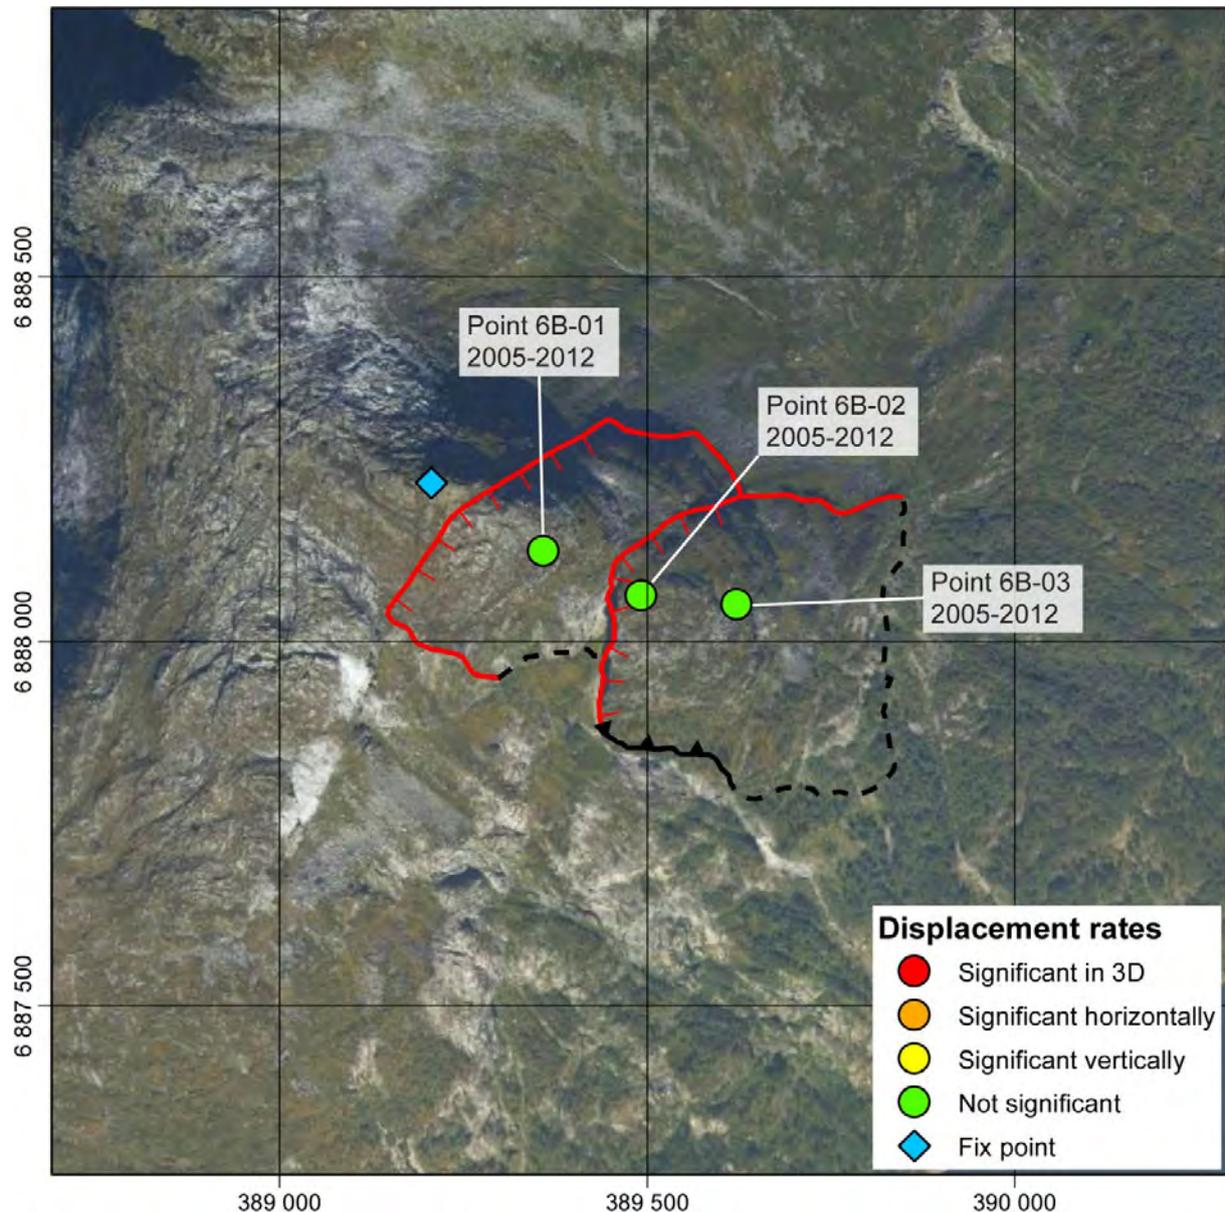
Three dGNSS measurement points were installed on the Rindalseggene instability in 2005 (Figure 105) and measured yearly until 2012, except in 2009. No significant displacements were recorded over the 7 years measurement period, even though some of the yearly measurements indicate some deformation at point 6B-03. This was however not confirmed by further measurements.

Figure 105: Map of the Rindalseggene unstable rock slope with the location of dGNSS points for periodic displacement measurements. No significant displacements were detected over the 2005–2012 measurement period.

The Rindalseggene instability was scanned by TLS in 2006 and 2011 from one viewpoint SW of the instability. The analysis of these repetitive TLS datasets does not reveal significant displacements of the instability over the 5 years measurement period.

Recommendation: No significant displacements are measured up to now at Rindalseggene. Periodic displacement measurements using dGNSS and TLS should be continued with 3–5 years interval. The hazard and risk classification needs to be made and further follow-up activities will be decided based on this classification.

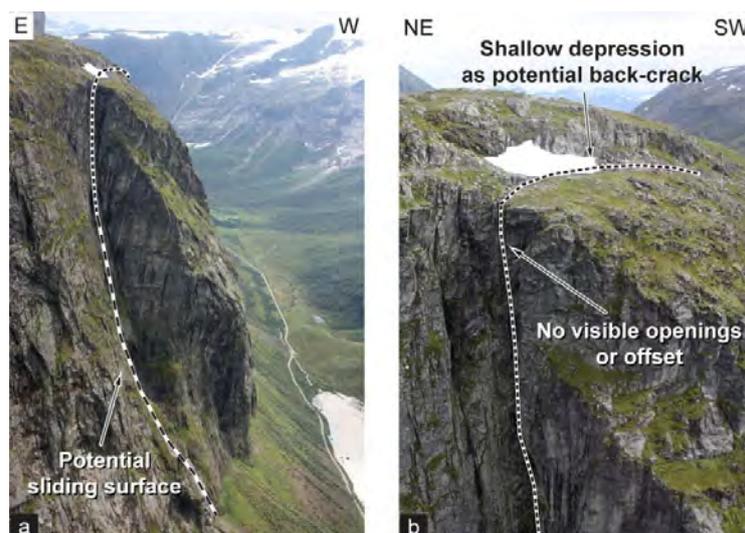
Ytstevatnet (Figure 96) is situated on a west-facing slope 780 m above Norangsdalen Valley. The site was surveyed from helicopter in 2011 and is characterized by a potential back-crack that follows subvertical valley-parallel discontinuities (Figure 106). The back-crack curves to become steeply valley-dipping at the foot of the slope and might act as a potential basal sliding surface (Figure 106a). However, there are no signs of past displacements or openings along this basal sliding surface. The foliation is gently dipping into the mountainside. The potential instability has a free lateral surface to the north, but there is no visible lateral release surface to the south (Figure 106a). There are no major signs of activity or recent displacements, but past rockslides have occurred from the surrounding rock slopes, which is underlined by several rock avalanche deposits in Norangsdalen Valley. A massive failure of the Ytstevatnet instability would likely also form a rock avalanche and cross Norangsdalen Valley, but not lead to major consequences since the valley is uninhabited.

Figure 106: Photographs of the potential unstable rock slope at Ytstevatnet: a) the back-bounding surface is slightly changing in dip angle and forms a potential sliding surface in the lower part; b) no signs of past displacements are visible along the potential back-crack.

Recommendation: Ytstevatnet is classified as a potential unstable rock slope. At present the remaining rock slope does not show any signs of past or present displacements or deformation. No further investigations or displacement measurements are necessary and the hazard and risk classification will not be made. However, this site may lead to rock-falls and develop over time into an unstable rock slope, due to structural and geological conditions. The site should be revisited after years to decades to detect any changes and be followed-up on InSAR data.

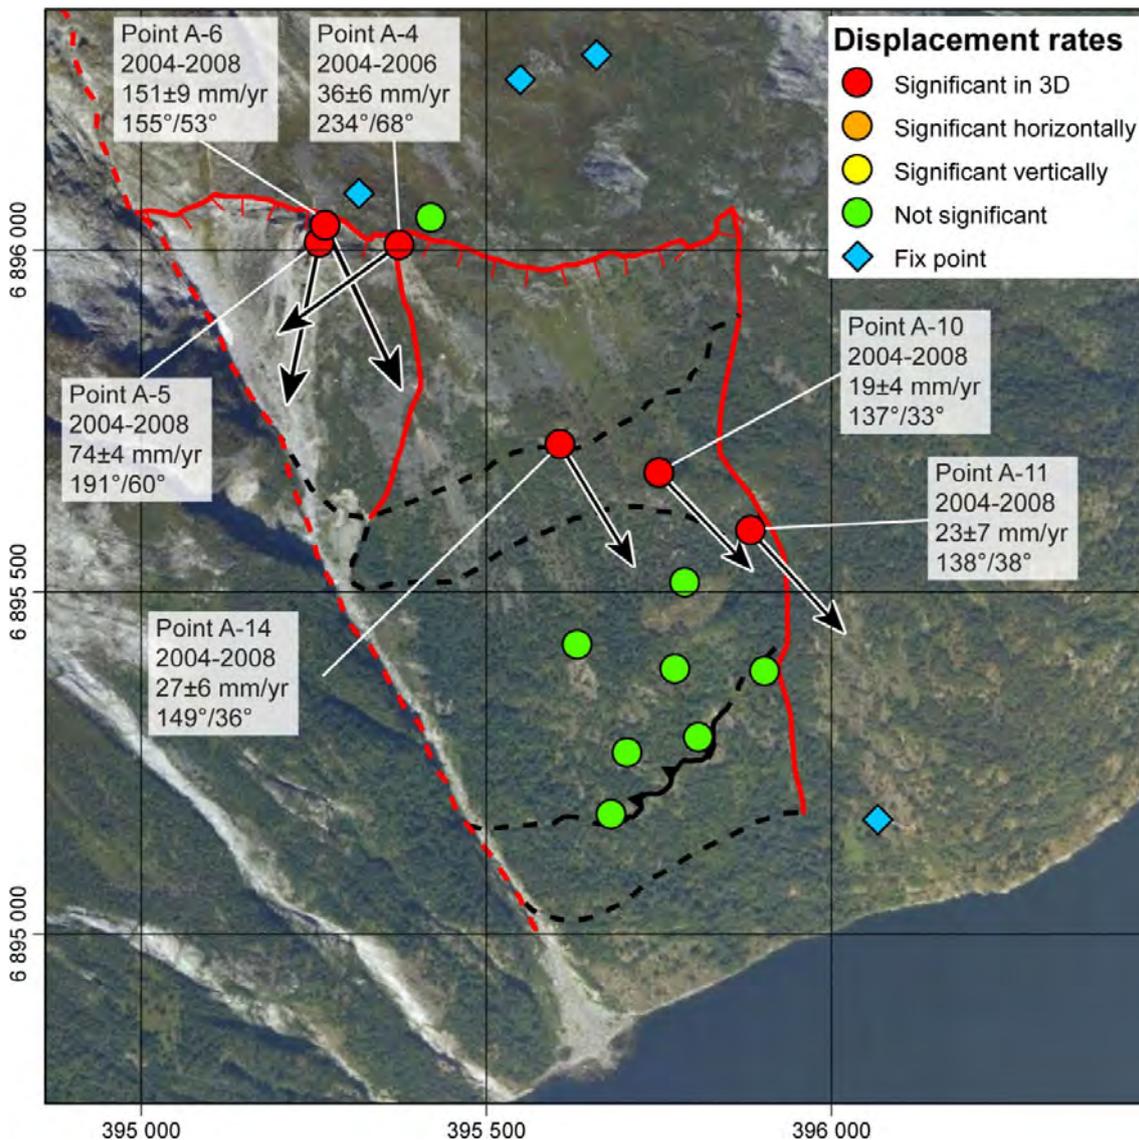
The Åknes rockslide was measured periodically using dGNSS between 2004 and 2008. Nine dGNSS points were installed in October 2004 in the upper, middle and lower part of the unstable rock slope (Figure 107). The dGNSS network was extended in August 2005 in the lower part of the slope with 5 additional measurement points. Repetitive measurements were made in June 2005 for the first series of measurement points and in October 2005, August 2006, August 2007 and August 2008 for all points.

High displacement rates are measured in the uppermost part of the rockslide with up to 151 mm/year (Figure 107). Displacement directions are roughly southward with relatively steep plunge angles, which is consistent with results from periodic TLS measurements between 2006 and 2008 (Oppikofer et al. 2009). Three measurement points in the middle part of the slope show coherent displacement rates (19 to 27 mm/year) and displacement directions towards the SE. No significant displacements are detected in the lower section of the Åknes unstable rock slope (Figure 107).

The displacement directions measured by periodic dGNSS measurements are in agreement with the conceptual model of the Åknes rockslide from Jaboyedoff et al. (2011). The model relates the diverging displacement directions to the different orientations of the basal sliding surface that should follow the conspicuous undulation of the gneiss foliation. High-resolution InSAR data from TerraSAR-X and Radarsat-2 satellites show active displacements in the upper and middle part of the slope and thus confirm the periodic dGNSS measurements (Dehls et al. 2012).

Figure 107: Map of the Åknes unstable rock slope with the location of dGNSS points for periodic displacement measurements and average displacement vectors for the 2004–2008 measurement period.

Recommendation: Åknes is under continuous monitoring and data are being sent to the Åknes/Tafjord Early-Warning Centre, which is also responsible for further follow-up activities. New scenarios should be defined for the Åknes rockslide based on the latest monitoring results and investigations.

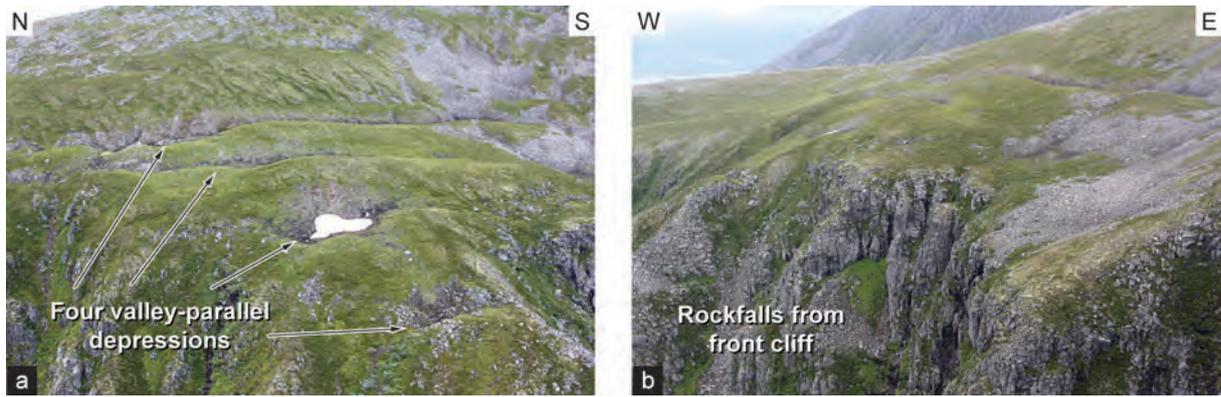
Hundatinden is located on a west-facing slope 910 m above of Hjørundfjord (Figure 93). A series of four valley-parallel depressions are visible on the plateau (Figure 108a). A helicopter reconnaissance flight in 2011 revealed that these depressions are not caused by gravitational movements, but are more likely paleodrainage systems and/or lateral moraines. There are no visible structures at Hundatinden to delimit a large unstable rock slope. Rockfalls may however originate from the highly fractured rock mass along the front cliff (Figure 108b).

Figure 108: Photographs of the Hundatindan rock slope: a) valley-parallel depressions formed by a paleodrainage system or/and lateral moraines; b) rockfalls may occur from the highly fractured rock mass along the front cliff.

Recommendation: There are no signs that the Hundatindan rock slope might fail in a massive rock slope failure. No further investigations or displacement measurements are necessary and the hazard and risk classification will not be made. However, rockfalls are possible and their run-out area is given by the rockfall susceptibility map or more detailed hazard maps, where available.

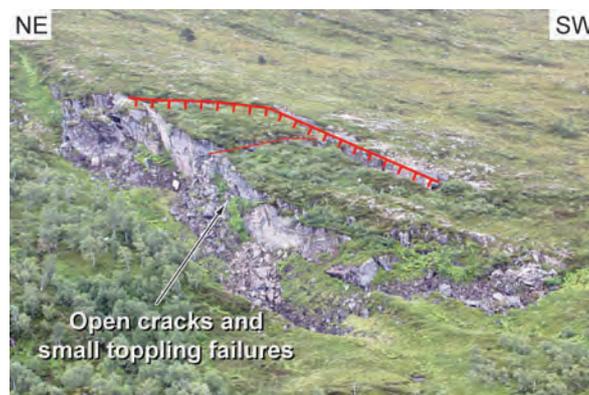
Giskemonibba (Figure 93) is situated on a northwest-facing slope 330 m above Landedalen Valley. A helicopter reconnaissance flight in 2011 showed several open cracks that delimit an unstable rock slope (Figure 109). The foliation is gently-dipping into the mountainside and subvertical discontinuities delimit several small columns that may topple towards the valley. Toppling failures have occurred in the past, but the deposits remained at the foot of the gentle slope (Figure 109). An eventual a massive failure from Giskemonibba would not reach the valley bottom and would thus have no major consequences (Dahle et al. 2011a).

Figure 109: Photograph of the Giskemonibba instability: open cracks delimit the instability and divide it into small blocks that may topple.

Recommendation: A possible rock avalanche from the Giskemonibba instability will have no consequences. No further investigations or displacement measurements are necessary. The hazard and risk classification will be made after a simple run-out assessment. Further follow-up activities will be based on this classification.

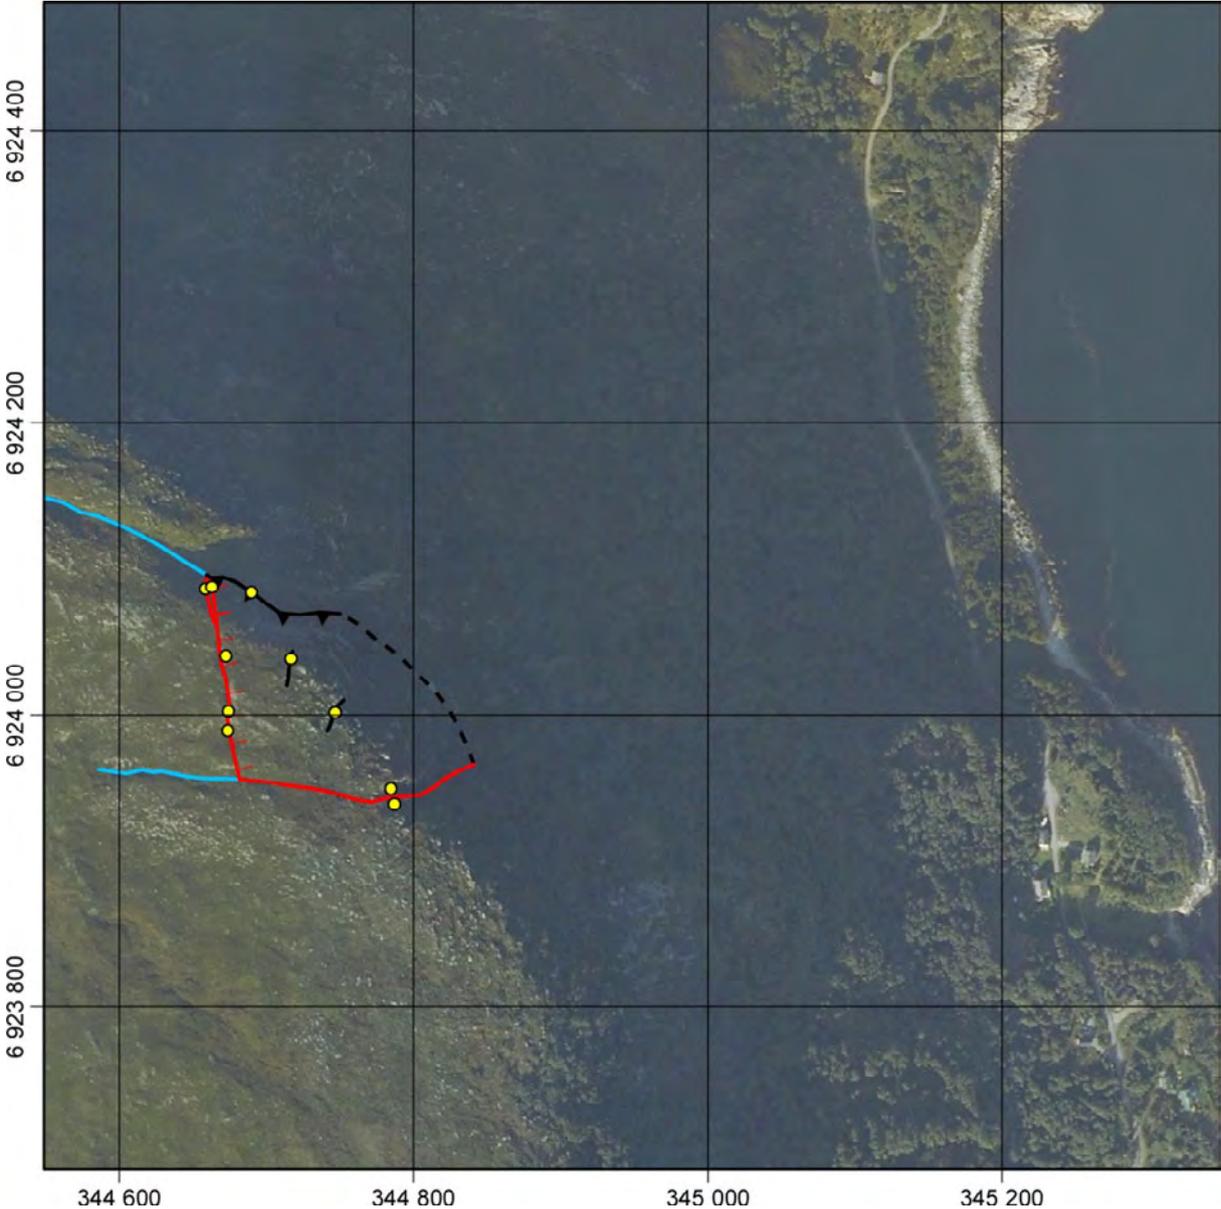
Grøthornet is located on a northeast-facing slope 420 m above Sulafjord (Figure 110). A helicopter reconnaissance flight was made in 2011 and followed by field mapping in 2012 (Figure 111). The potential unstable rock slope is delimited to the west by a more than 130-m-long, open back-crack, and to the south by a lateral release surface that is marked by a surficial linear depression (Figure 112). The gneiss foliation is folded and changes from moderately SSE-dipping in the north to shallow NNE-dipping at the lateral release surface in the south and to moderately N-dipping at the back-crack. A foliation-parallel potential basal sliding surface is observed at the base of the instability in the north (Figure 112c).

The past deformations at Grøthornet exceed several dm to m (Figure 112b). However, the measured discontinuities do not allow for a planar or wedge sliding mechanism, except at the back-crack where the foliation is favourably oriented for planar sliding. This makes possible that the gneiss foliation also is favourably oriented in the inaccessible lower part of the instability to form a basal sliding surface.

The volume of the Grøthornet instability was computed using the available digital elevation model and is approximately 0.5 million m³. The collapse of this instability could create a rock avalanche that impacts Sulafjord and creates a displacement wave (Dahle et al. 2011a).

Figure 111: Map of the Grøthornet instability showing locations of field measurements (yellow dots).

Recommendation: A possible rock avalanche from the Grøthornet instability will have consequences, which will be assessed in the hazard and risk classification. Further follow-up activities will be decided based on this classification.

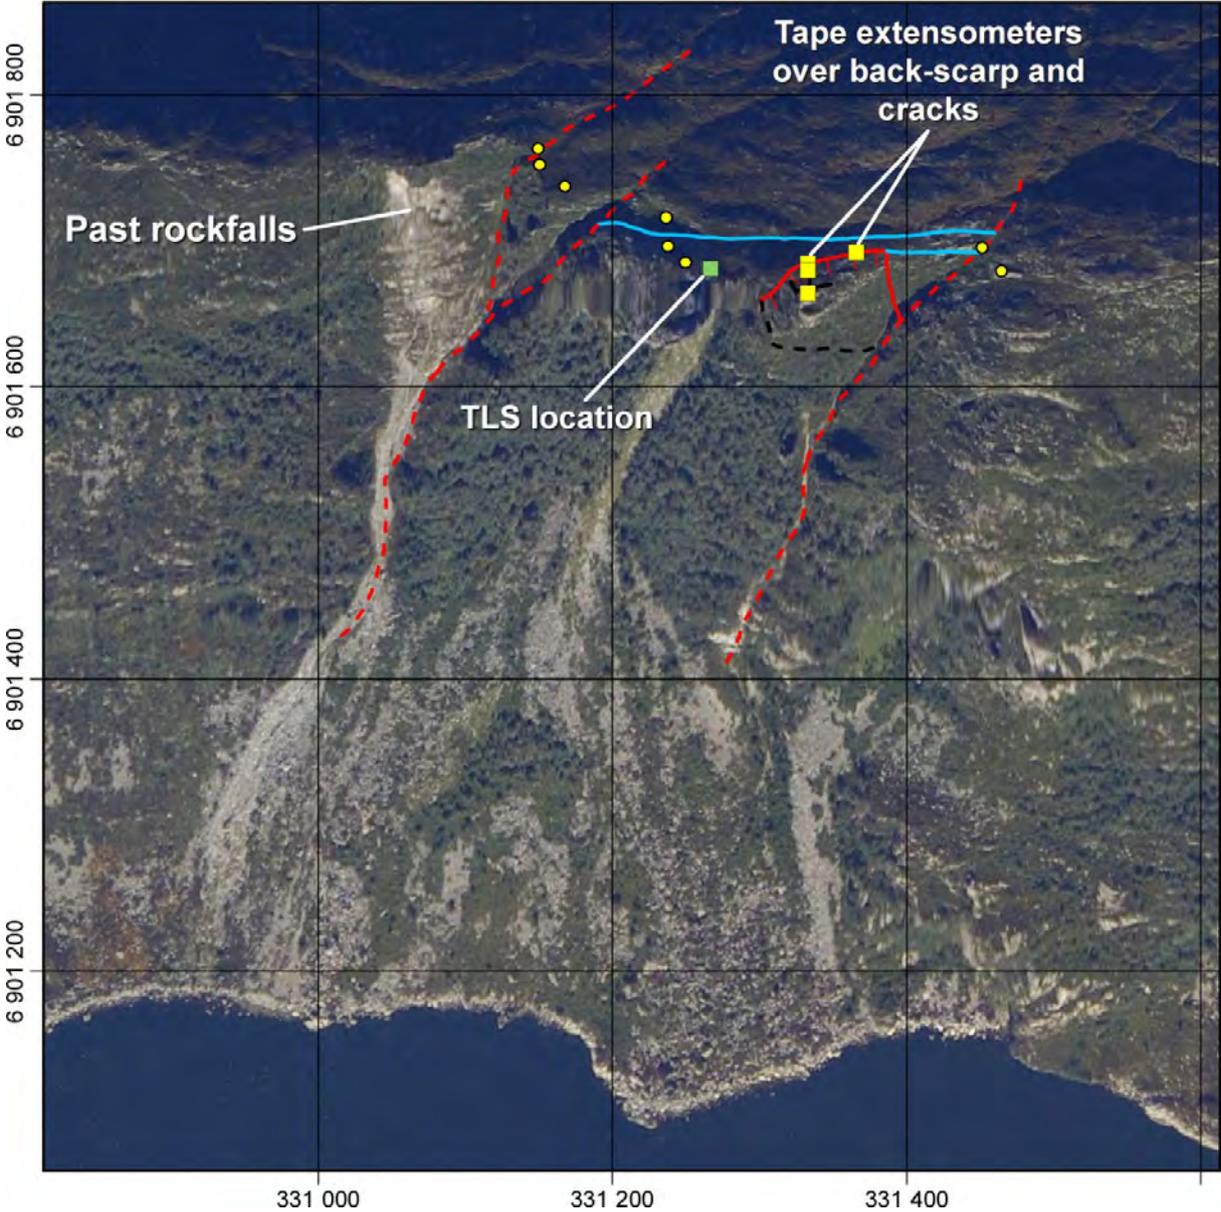
Laupsnipa is situated on a south-facing slope 540 m above Rovdefjord (Figure 110). A helicopter reconnaissance flight was made in 2011 followed by field mapping in 2012 (Figure 113). A series of steeply south-dipping faults form surface depressions and apparent counter-scarps on the inward-facing slope (Figure 114a). It could not be clarified whether these morphologic features are related to past movements of an unstable rock slope or to preferential erosion along the faults. The gneiss foliation is folded and undulating. Orientations vary from steeply N-dipping to vertical to steeply S-dipping.

An unstable column is located at the front cliff (Figure 114a, b). The measured structures allow this instability to topple along steeply N-dipping foliation surfaces. The instability is laterally delimited by NE-SW-trending vertical discontinuities and a steeply NW-dipping regional fault in the east. Gently fjord-dipping surfaces form the basal limit of the instability. The latter are similar to the stepped basal failure surface of past rockslides or rock topples in the western part of Laupsnipa.

Large rockfall scars and a large talus slope at the foot of the cliff are observed (Figure 114a, d). A past debris slide happened on the talus slope close to the shoreline (Figure 114d), indicating that the talus slope is reaching its stability limit and might be destabilized by the impact

of larger blocks falling from the Laupsnipa instability. The resulting rock and debris avalanche would create a displacement wave in Rovdefjord (Dahle et al. 2011a).

Figure 113: Map of the Laupsnipa instability showing locations of field measurements (yellow dots) and measurement instrumentation (tape extensometer & TLS).

Recommendation: Periodic displacement measurements are started at the Laupsnipa instability, but the time-series is not sufficiently long to determine displacement rates. Periodic displacement measurements using tape extensometer and TLS should be continued with 1–3 years interval. The hazard and risk classification needs to be made and further follow-up activities will be decided based on this classification.

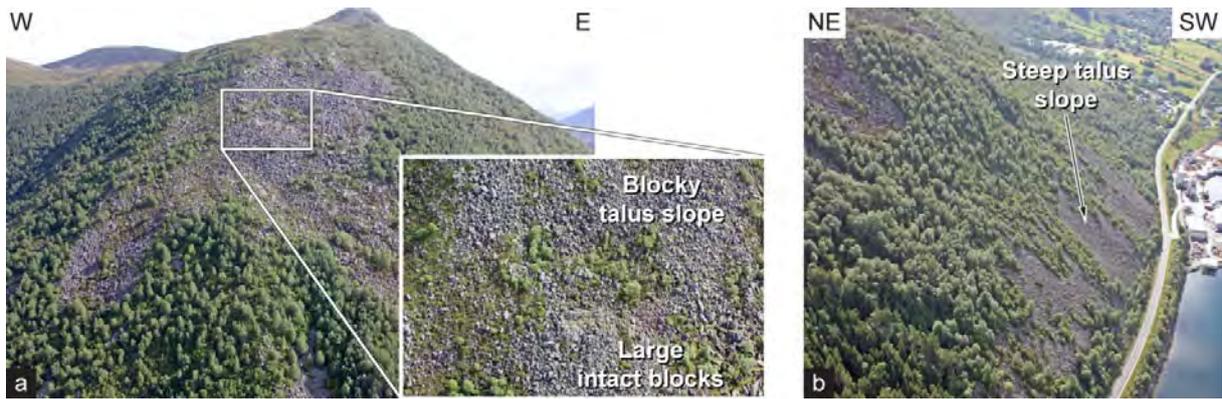
Haddalura (Figure 110) is a steep talus slope with large blocks on the west-facing slope of Ringstadhornet 370 m above Haddalsvika. The slope was investigated by Anda et al. (2000), field mapped in 2009 and visited again in 2011 by helicopter. There is no visible rockslide scar that could explain this large block field (Figure 115), but there are indications of in-situ disintegration of the large, relatively intact rock blocks (inset in Figure 115a). Furthermore, the foliation is moderately SE-dipping and thus not favourably oriented to form basal sliding surfaces along it. The extent of the block field at Haddalura appears to be lithologically controlled, since it is limited to a metagabbro outcrop (Lutro et al. 1998).

Haddalura was measured periodically with dGNSS in 2005 and 2009, but all 6 points on the slope show no significant displacements over the 4 years measurement period (Figure 116). The slope below 200 m a.s.l. is 35–40° steep (Figure 115a), which is close to the stability limit of talus slopes. Smaller debris slides from this steep talus might impact the road and Haddalsvika, but will likely have too small volume and energy to create a significant displacement wave.

Figure 115: Photographs of the Haddalura block field: a) gentle, blocky talus slope with large, relatively intact blocks and signs of in-situ disintegration; b) steep talus slope in the lower part.

Recommendation: There are no signs that the Haddalura block field might fail in a massive rock slope failure. Periodic displacement measurements with dGNSS did not reveal significant displacements. No further investigations or displacement measurements are necessary and the hazard and risk classification will not be made. However, rockfalls are possible and their run-out area is given by the rockfall susceptibility map or more detailed hazard maps, where available.

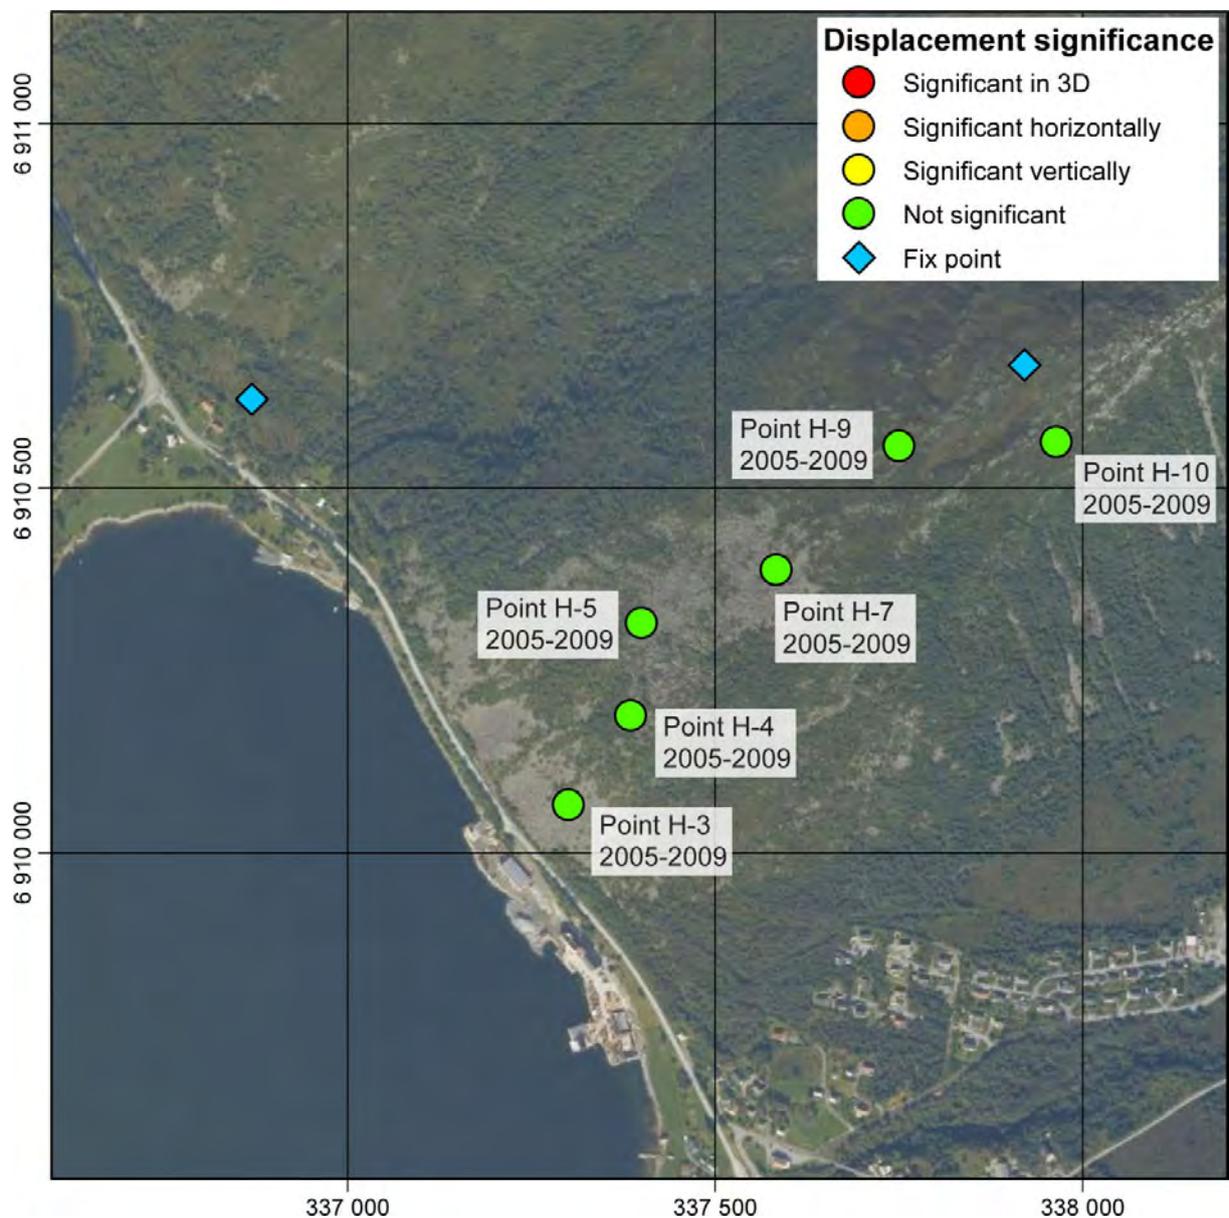
Figure 116: Map of the Haddalura block field with the location of dGNSS points for periodic displacement measurements. No significant displacements were detected over the 2005–2009 measurement period.

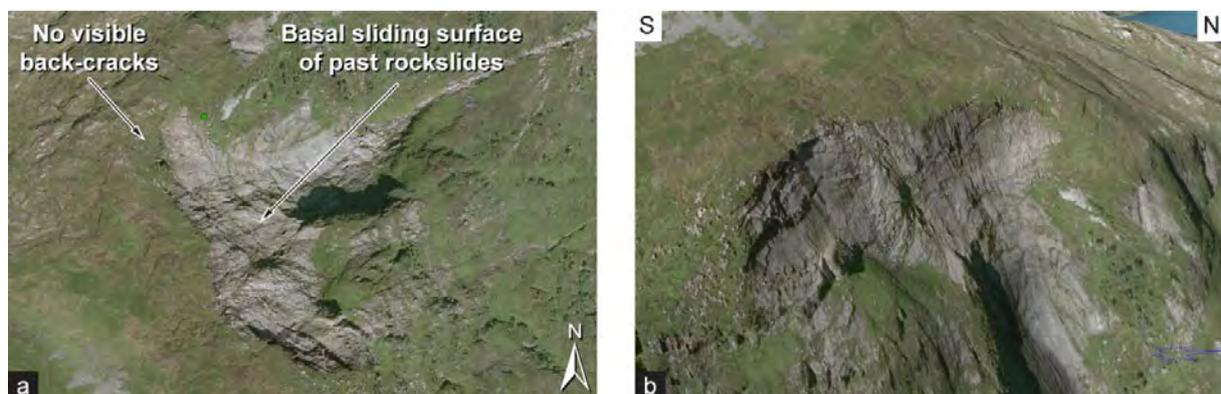
Sandfjellet (Figure 117) is a steep west-facing slope 545 m above Syvdsfjord. Road observations in 2011 identified a potential instability NNW of large scars of past rockslides and of well visible fjord-dipping basal sliding surfaces. However, aerial photographs do not reveal open cracks that may indicate present-day gravitational deformation in the area NNW of the rockslide scars (Figure 118).

Figure 118: Photographs of the Sandfjellet rockslide scars: a) orthophoto of the scars with a remaining potential instability in the NNW of the scar; b) 3D view from Norge i 3D.

Recommendation: A helicopter reconnaissance flight is planned to have a closer look at the past rockslide scars and the remaining potential instability at Sandfjellet.

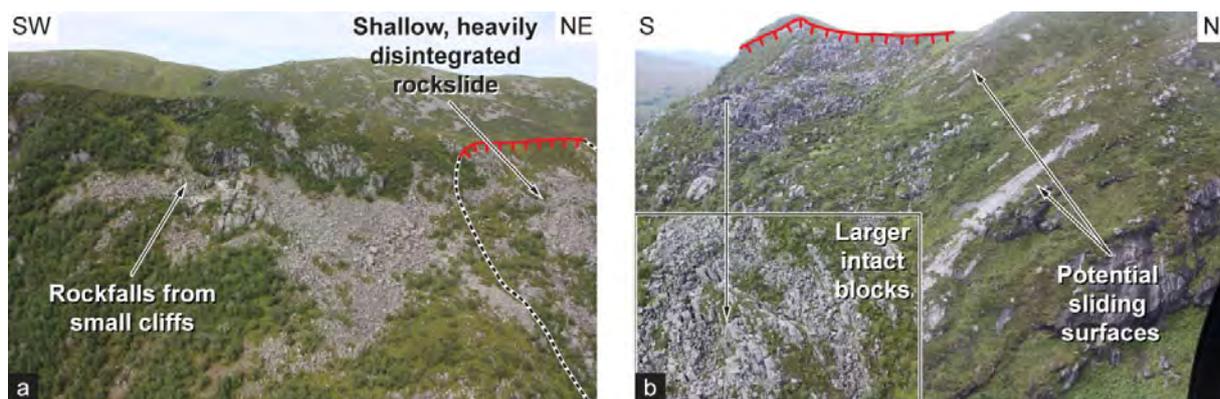
Sandnestua is a southeast-facing blocky rock slope 420 m above Sandnesdalen Valley and Sandnes (Figure 117). A helicopter reconnaissance flight was made in 2011. The unstable rock slope shows two distinct deformation styles with (1) rockfalls from small cliffs in the SW-part and (2) in the NE-part a heavily disintegrated rockslide that has moved several meters (Figure 119a). Some larger, more intact blocks are observed in both the rockfall area and the rockslide area (inset in Figure 119b). At the north-eastern limit of the rockslide area, basal sliding surfaces crop out (Figure 119b). These might be parallel to the basal sliding surface under the present rockslide area, leading to a relatively shallow rockslide, a few meters to tens of meters thick. The shallow sliding surface combined with the high disintegration of the rockslide area likely prevent from the development of large collapses.

Figure 119: Photographs of the Sandnestua unstable rock slope: a) different deformation styles with rockfalls in the SW and a shallow rockslide in the NE; b) the rockslide is heavily disintegrated with the exception of some blocks (inset). Basal sliding surfaces are exposed at the NE limit of the rockslide area.

Recommendation: A possible rock avalanche from Sandnestua will have no consequences. No further investigations or displacement measurements are necessary. The hazard and risk classification will be made after a simple run-out assessment. Further follow-up activities will be based on this classification.

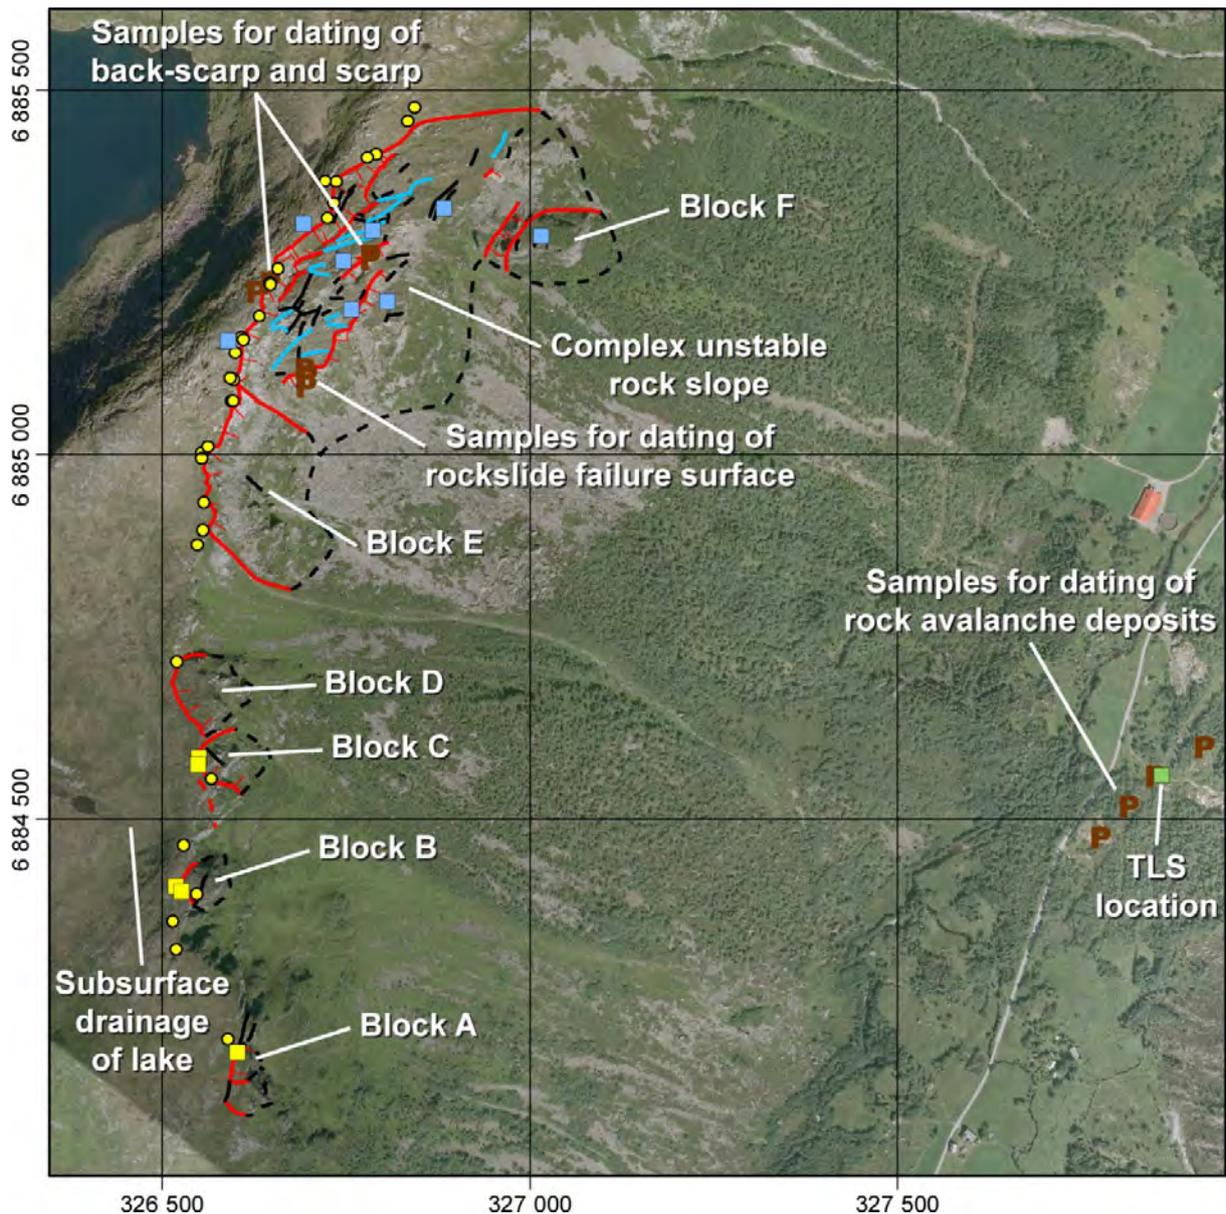
Figure 120: Map of the Storehornet unstable rock slope showing locations of field measurements (yellow dots), measurement instrumentation (blue squares: dGNSS; yellow squares: tape extensometer; green square: TLS) and sampling locations for terrestrial cosmogenic nuclide dating (letters P).

Recommendation: Periodic displacement measurements are started at the Storehornet unstable rock slope, but the time-series is not sufficiently long to determine displacement rates. Periodic displacement measurements using dGNSS, tape extensometer and TLS should be continued with 1–3 years interval. The hazard and risk classification needs to be made and further follow-up activities will be decided based on this classification.

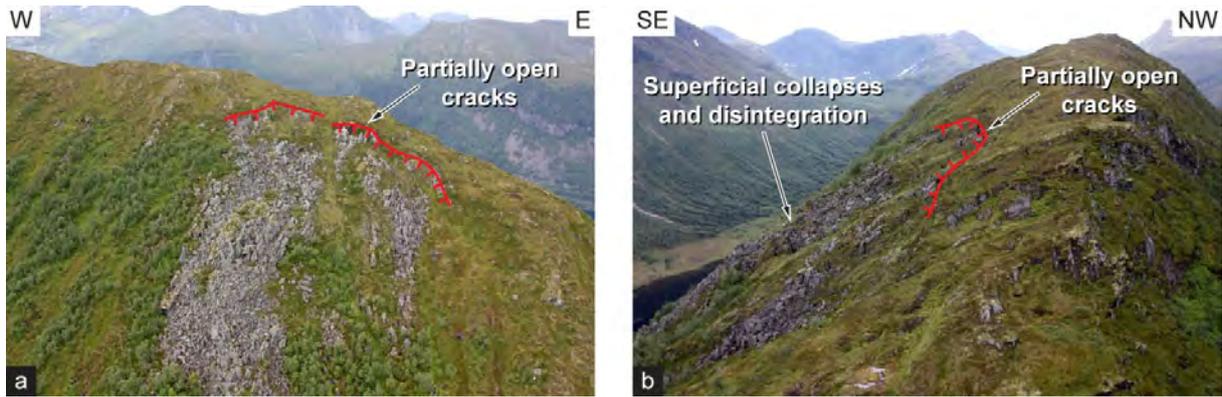
Bjørnasethornet (Figure 122) is situated on a southeast-facing slope 300 m above Stølselva Valley. During helicopter reconnaissance flight in 2011 a small unstable rock slope was observed (Figure 123). A closer inspection shows a high disintegration of the rocks into small blocks, which is likely due to the superficial collapse of relatively thin slices of rock. Only few, partially open cracks could be observed at the back. This deformation style will most likely not lead to a large rock slope failure. Furthermore, an eventual rock avalanche would affect the uninhabited Stølselva Valley and therefore have no major consequences.

Figure 123: Photographs of the Bjørnasethornet unstable rock slope: a) the block field is on a SE-facing slope above the uninhabited Stølselva valley; b) lateral view of the block field formed by superficial collapses and disintegration of rock slices.

Recommendation: A possible rock avalanche from Bjørnasethornet will have no consequences. No further investigations or displacement measurements are necessary. The hazard and risk classification will be made after a simple run-out assessment. Further follow-up activities will be based on this classification.

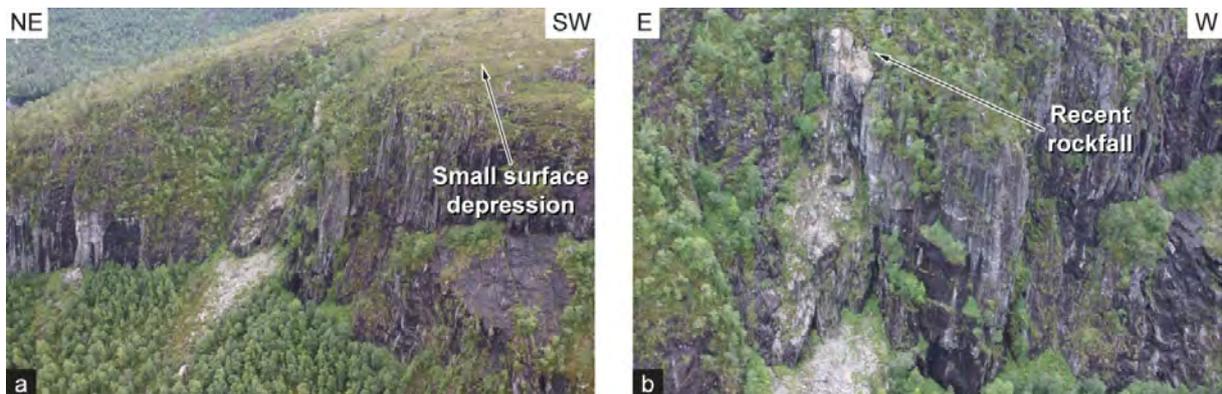
Heida (Figure 122) is located on a north-facing slope 420 m above Botnavika. The slope with a fresh rockfall scar was observed during helicopter reconnaissance in 2011 (Figure 124). The rock mass is highly fractured with a subvertical NE-dipping foliation and a perpendicular vertical discontinuity set, forming small volumes leading to rockfalls. A slightly visible surface depression is seen at the back of the rockfall scar, but there are no indications for a large unstable rock slope.

Figure 124: Photographs of the Heida rockfall area: a) the rock mass is highly fractured leading to small volumes prone to rockfall; b) detail photograph of a recent rockfall scar.

Recommendation: There are no signs that the Heida rock slope might fail in a massive rock slope failure. No further investigations or displacement measurements are necessary and the hazard and risk classification will not be made. However, rockfalls are possible and their run-out area is given by the rockfall susceptibility map or more detailed hazard maps, where available.

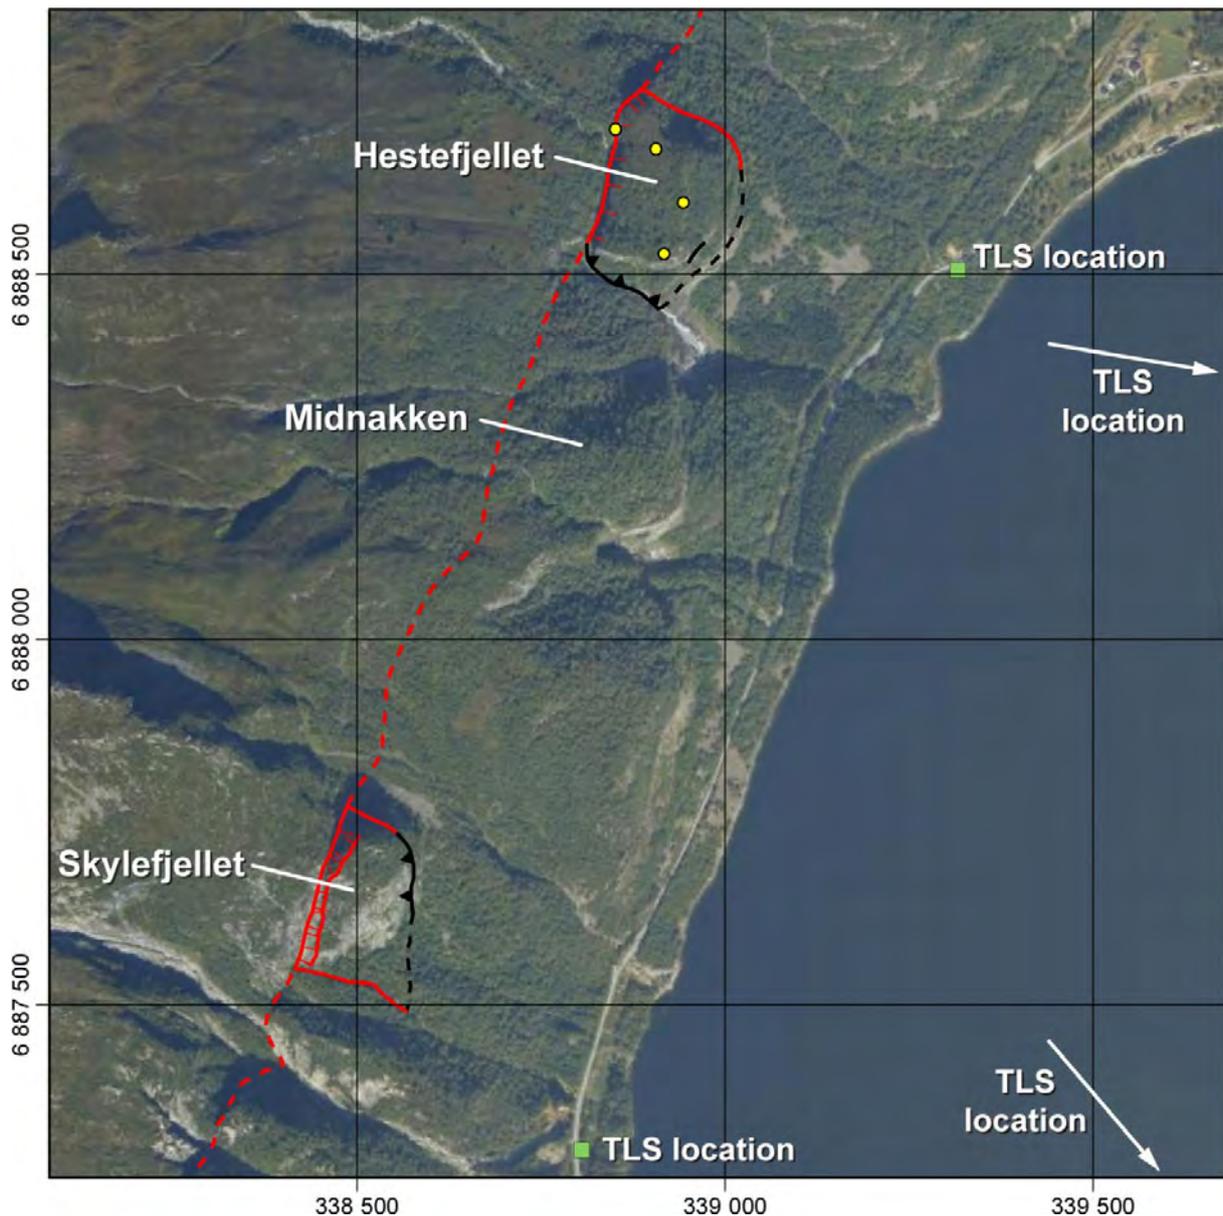
Figure 125: Location map of the Hestefjellet and Skylefjellet instabilities and the Midnakken rock slope showing locations of field measurements (yellow dots) and measurement instrumentation (TLS).

An ancient eroded fault that is followed over several km acts as the back-bounding structure for all the three sites (Figure 125, Figure 126a, b, d). At Hestefjellet the Fosselva River runs into this fault before running down on the southern side of the block (Figure 126b). There are no signs of opening along this fault at Hestefjellet. The gneiss foliation is moderately-dipping towards the fjord, but no sliding surface is visible at the base of the potential instability (Figure 126c). There are some visible rockfall scars on the frontal cliff although the scree slopes are well vegetated indicating only small rockfall activity (Figure 126b, c). The volume cannot be estimated due to the lack of basal sliding surface localization, but would certainly reach several million m³.

The Skylefjellet instability located 1 km SSW of Hestefjellet follows the same back-bounding fault (Figure 126a, d). The fault is deeply eroded and about 20 m wide. The foliation is moderately SSE-dipping and is slightly undulating (Figure 126e). A basal sliding surface parallel to the foliation is observed at the base of the Skylefjellet instability. There are no signs of recent openings along the back-crack and the rock mass at the instability is relatively intact.

Recommendation: Periodic displacement measurements are started at the Skylefjellet instability, but the time-series is not sufficiently long to determine displacement rates. Periodic displacement measurements using TLS should be continued with 1–3 years interval. The hazard and risk classification needs to be made and further follow-up activities will be decided based on this classification.

Hestefjellet is classified as a potential unstable rock slope. At present the remaining rock slope does not show any signs of past or present displacements or deformation of a large volume. No further investigations or displacement measurements are necessary and the hazard and risk classification will not be made. However, this site may lead to rockfalls and develop over time into an unstable rock slope, due to structural and geological conditions. The site should be revisited after years to decades to detect any changes and be followed-up on InSAR data.

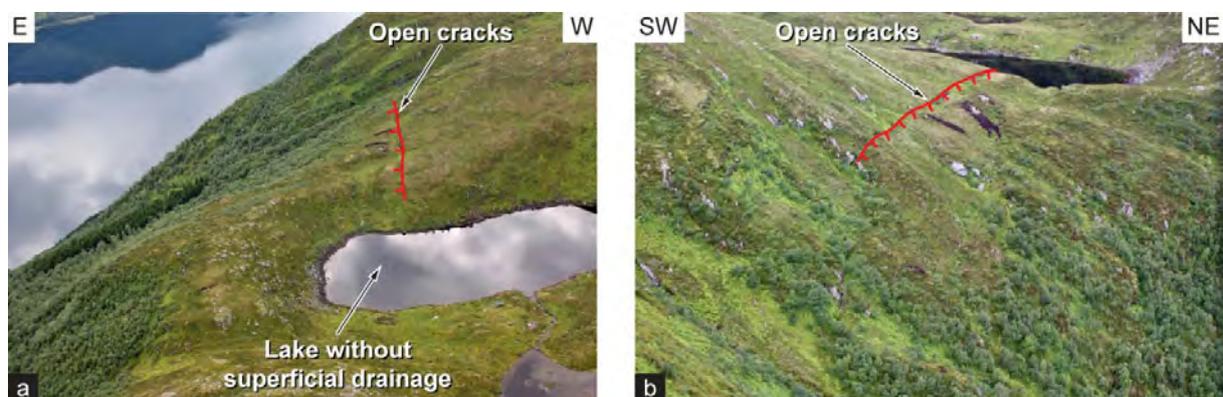
Keipedalen is located on a southeast-facing slope 580 m above Dalsfjord (Figure 122). Helicopter reconnaissance in 2011 and field mapping in 2012 showed isolated open N-S-trending cracks on the rock slope (Figure 127). The Keipedalsvatnet Lake has no superficial outflow and might drain across the rock mass through open cracks or fractures.

Figure 127: Photographs of Keipedalen: a) Keipedalsvatnet Lake has no superficial outflow and might drain across the rock mass through open fractures; b) open cracks south of Keipedalsvatnet.

Recommendation: There are no signs that the Keipedalen rock slope might fail in a massive rock slope failure. No further investigations or displacement measurements are necessary and the hazard and risk classification will not be made. However, rockfalls are possible and their run-out area is given by the rockfall susceptibility map or more detailed hazard maps, where available.
