GEOLOGI FOR SAMFUNNET

GEOLOGY FOR SOCIETY

Report no.: 2013.014		ISSN: 0800–3416	Grading: Open
Title: Investigations on unstable rock slopes in Møre og Romsdal – status and plans after field surveys in 2012			
Authors: T. Oppikofer, A. Saintot, S. Otterå, R.L. Hermanns, E. Anda, H. Dahle, T. Eiken		Client: Norwegian Water Resources and Energy Directorate (NVE)	
County: Møre og Romsdal		Commune:	
Map-sheet name (M=1:250.000) Ålesund, Kristiansund, Røros, Ulsteinvik		Map-sheet no. and -name (M=1:50.000)	
Deposit name and grid-reference:		Number of pages: 323	Price (NOK): 1285,-
Fieldwork carried out: 2006–2012		Date of report: 13.11.2013	Map enclosures: 0
Fieldwork carried out: 2006–2012		Date of report: 13.11.2013	Project no.: 309900
Fieldwork carried out: 2006–2012		Date of report: 13.11.2013	Quality control: <i>Halvor Brundhoff</i>
<p>Summary:</p> <p>This report presents investigations, analyses and displacement measurements made between 2006 and 2012 on 131 unstable or potential unstable rock slopes in Møre og Romsdal County (Western Norway). An extract of this report is available in Norwegian (NGU rapport 2013.053).</p> <p>These investigations are part of the national plan for

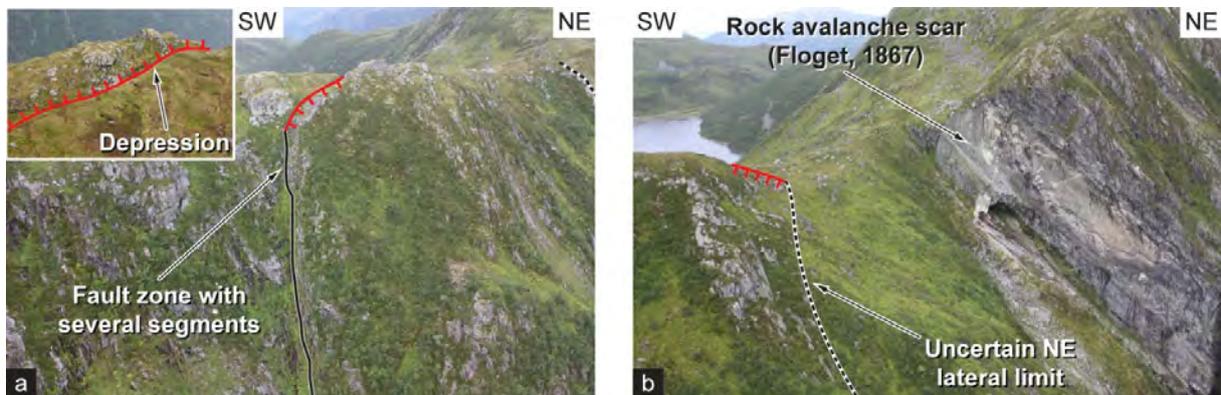
Kvanndalsskåla is located on a southeast-facing slope 740 m above Dalsfjord (Figure 122). The site was observed from helicopter in 2011 and mapped in 2012. A shallow depression on the top of the plateau developed along an ancient fault zone that currently forms the southwestern limit of the instability (Figure 128, Figure 129). The gneiss foliation is steeply-dipping towards the fjord, but does not daylight the slope. Other structures are a subvertical NW-SE-trending discontinuity set and a shallowly WSW-dipping discontinuity set. With these structures no sliding or toppling mechanism is feasible. However, a moderately valley-dipping discontinuity set was found locally on the instability and would enable a planar sliding mechanism.

The current site knowledge does not allow to ascertain whether the small depression on the top is caused by past slope deformation or preferential erosion of the fault zone. Several necessary structures to delimit an unstable rock slope are missing, such as the lateral release surface in the NE (Figure 128b) and a basal sliding surface. The toe lines shown in Figure 129 are provisional and correspond to the bottom of the steepest slope sections. There are no signs of activity on the instability itself, but the surrounding slope is affected by several landslide processes such as debris flows and rock avalanches. The latter include the 1867 event from Floget that created a displacement wave in Dalsfjord (Figure 128b), as would a rock avalanche from Kvanndalskåla likely do too.

Figure 128: Photographs of the Kvanndalsskåla instability: a) a fault zone delimits the instability laterally to the SW and to the back, where it is marked by a shallow depression (see inset); b) detail of the NE-limit and the scar of the 1867 rock avalanche from Floget.

Recommendation: A possible rock avalanche from the Kvanndalskåla instability will have consequences, which will be assessed in the hazard and risk classification. Further follow-up activities will be decided based on this classification.

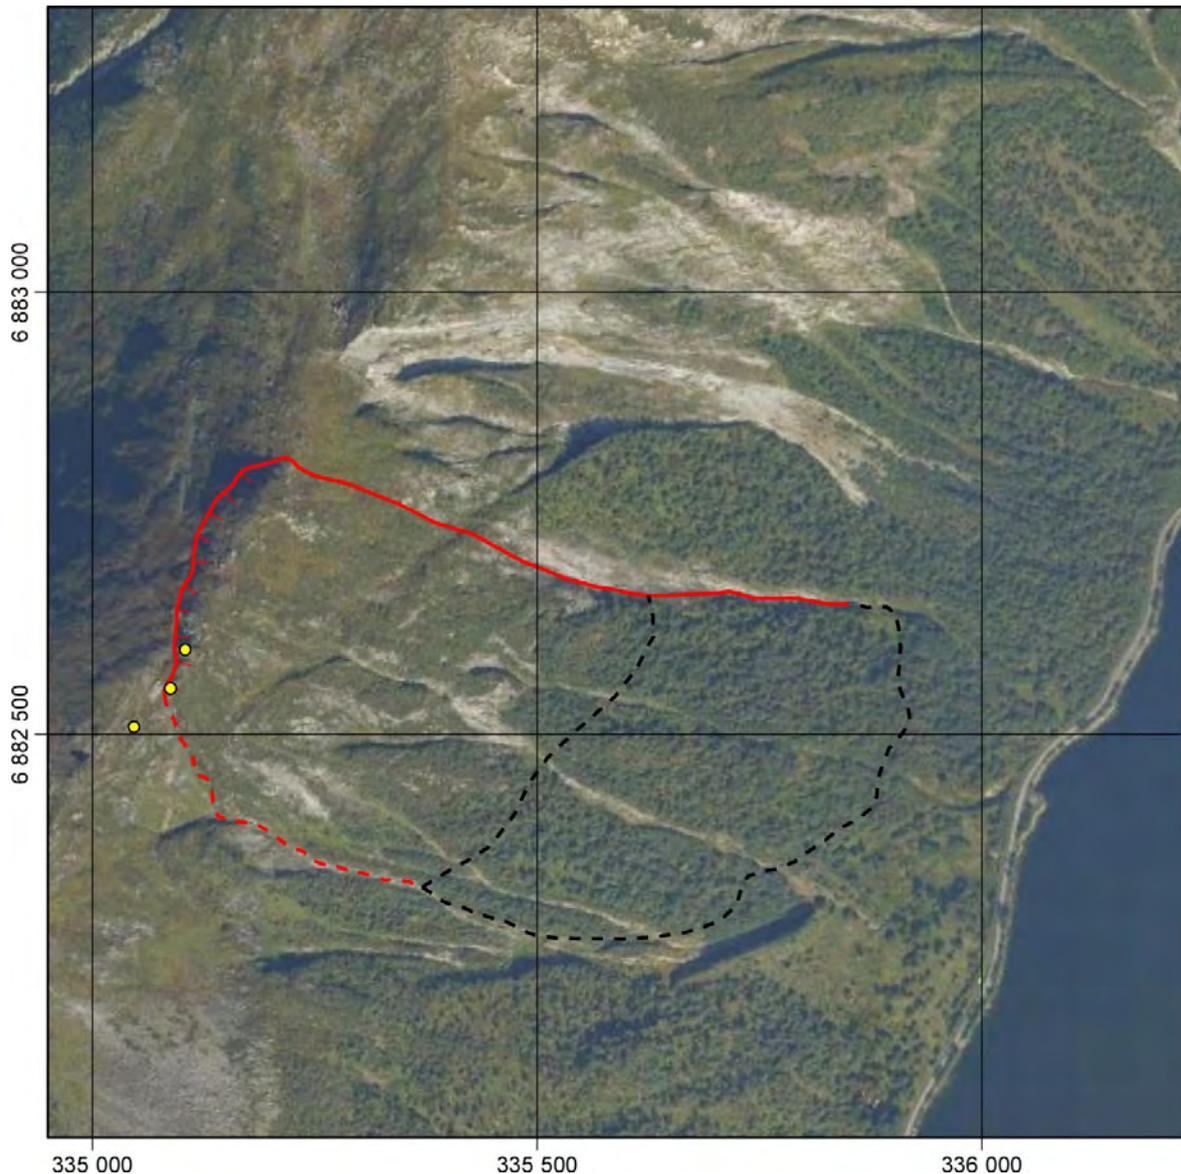
Figure 129: Map of the Kvanndalskåla instability showing locations of field measurements (yellow dots). The locations of the toe lines are provisional.

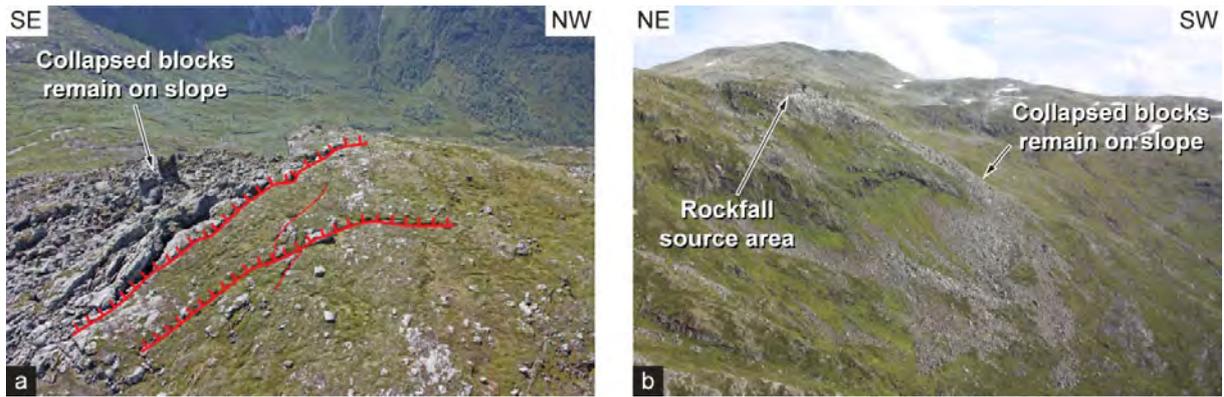
Kvivsdalshornet is located on a southwest-facing slope 680 m above Kvivsdalen Valley (Figure 122). During helicopter reconnaissance flight in 2011 a highly disintegrated rock slope was observed (Figure 130). There are several open back-cracks that – together with other subvertical cracks – delimit blocks with small volumes (tens to hundreds of m³). The foliation is parallel to the slope and might enable sliding of the small blocks. Several of them have already collapsed in the past, but did not have a long run-out distance and came to rest on the slope (Figure 130). The deformation style can be described as a superficial retrogressive sliding that leads to collapses of small blocks. In the unlikely event of a massive rock slope failure from Kvivsdalshornet only the uninhabited upper part of Kvivsdalen Valley would be reached and therefore not cause significant consequences.

Figure 130: Photographs of the Kvivsdalshornet: back-cracks and transverse cracks delimit small blocks, which generally come to rest on the slope after failure.

Recommendation: A possible rock avalanche from the Kvivsdalshornet instability will have no consequences. No further investigations or displacement measurements are necessary. The hazard and risk classification will be made after a simple run-out assessment. Further follow-up activities will be based on this classification.

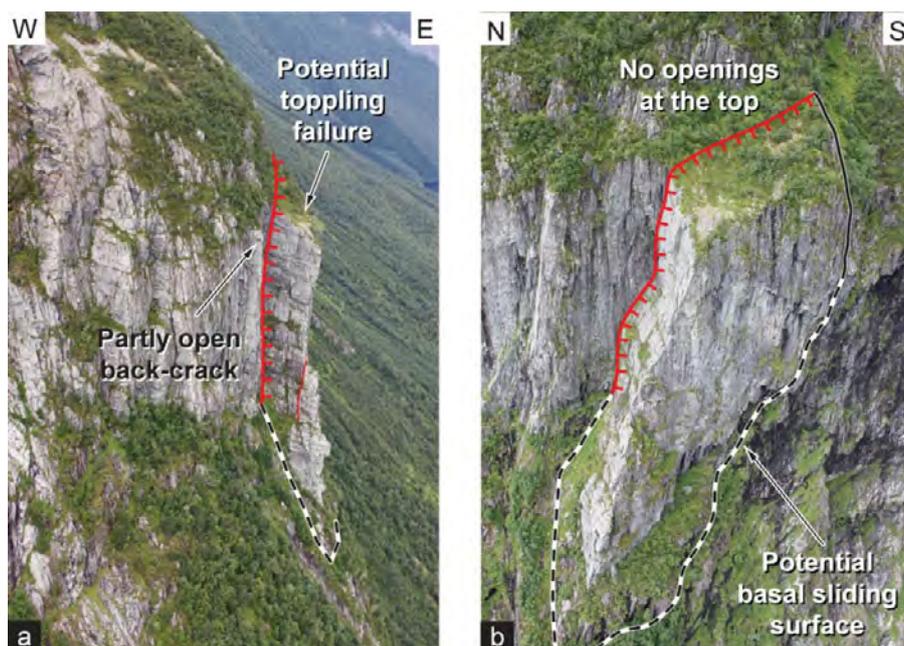
Solahylla is located on an east-facing slope 550 m above Bjørkedalsvatnet Lake (Figure 122). A helicopter reconnaissance flight was made in 2011 and showed an instability that is delimited by a vertical N-S-trending back-crack (Figure 131a). On the top of the instability no opening or escarpment is visible due to vegetation cover (Figure 131b). Yet, this indicates only small to no past displacements. The foliation is undulating and in average very steeply dipping to the south. A basal sliding surface at the foot of the instability may form on a moderately east-dipping discontinuity set (Figure 131a). The structures present at Solahylla enable sliding and toppling of the instability.

Figure 131: Photographs of the Solahylla instability: a) lateral view showing the vertical back-crack and the moderately valley-dipping basal sliding surface; b) no recent openings or escarpments are visible on the top of the instability.

Recommendation: Periodic displacement measurements are started at the Solahylla instability, but the time-series is not sufficiently long to determine displacement rates. Periodic displacement measurements using TLS should be continued with 1–3 years interval. The hazard and risk classification needs to be made and further follow-up activities will be decided based on this classification.

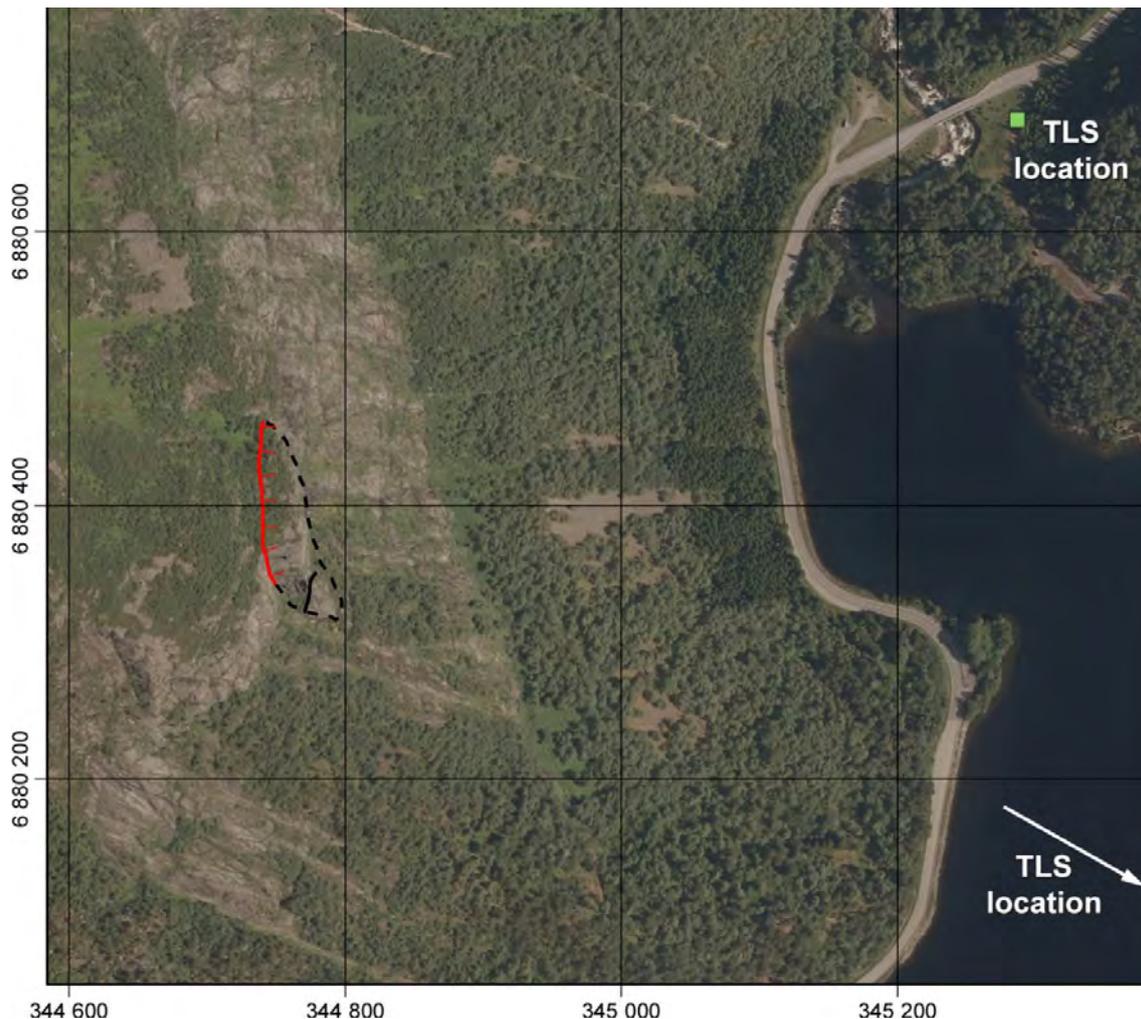
The Solahylla instability is inaccessible to field work. Therefore it was scanned by TLS from two locations in the valley providing a reference dataset for periodic displacement measurements (Figure 132). The TLS dataset and the observed structures allowed measuring a width of 90 m, a height of 130 m and a volume of 184 000 m³ for Solahylla instability. A failure from Solahylla is expected to reach Bjørkedalsvatnet Lake and will provoke a displacement wave (Dahle et al. 2011a).

Figure 132: Map of the Solahylla instability showing locations of measurement instrumentation (TLS).

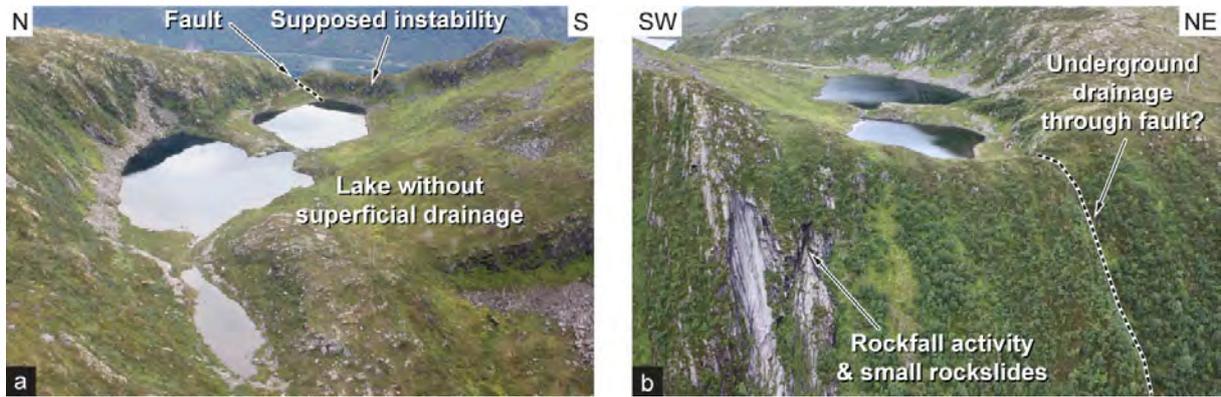
Trongedalen is located on a southeast-facing slope 660 m above Dalsfjord (Figure 122). Since the small Trangedalsvatna Lake has no superficial outflow, the hill located in front of the lake was supposed highly fractured and thus a possible unstable rock slope (Figure 133a). However, no open cracks, no structures delimiting an unstable rock slope and no other signs of activity were observed by a helicopter survey in 2011. The outflow of the lake occurs likely through a more fractured zone in the north, where an ancient fault is visible. Some rockfalls or small rockslides (with volumes of less than 10 000 m³) have however failed in the past from the observed slope (Figure 133b), but such small failures will not cause a significant displacement wave in Dalsfjord.

Figure 133: Photographs of the Trongedalen rock slope: a) the supposed instability is located in front of a lake without superficial outflow; b) rockfalls and small rockslides occurred, but no large unstable rock slope is visible.

Recommendation: There are no signs that the Trongedalen rock slope might fail in a massive rock slope failure. No further investigations or displacement measurements are necessary and the hazard and risk classification will not be made. However, rockfalls are possible and their run-out area is given by the rockfall susceptibility map or more detailed hazard maps, where available.

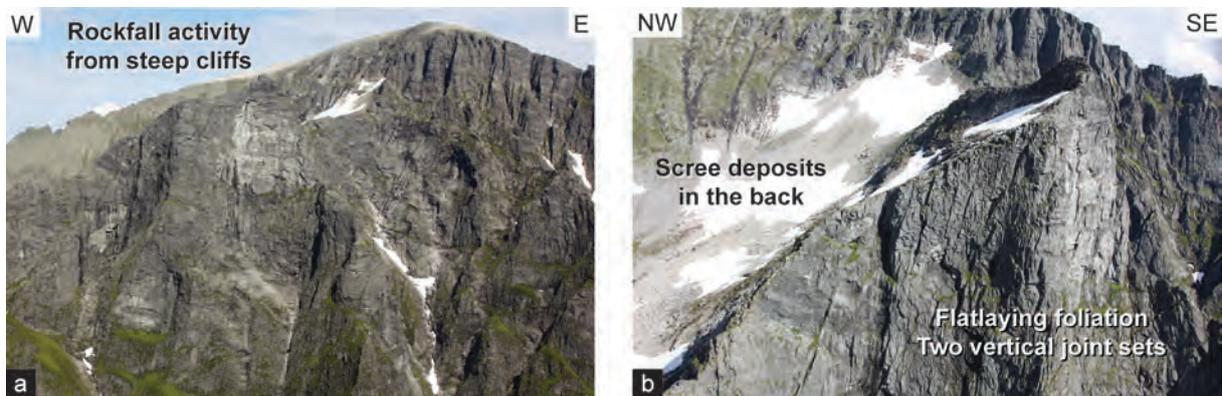
Blåhornet (Figure 134) is situated on a south-facing slope 1060 m above Viddalen Valley. A helicopter reconnaissance flight in 2011 showed evident rockfall activity from the steep cliffs at Blåhornet, but no large unstable rock slope is visible (Figure 135). This can be explained by the structural setting of the slope: the foliation is flat-laying and cross-cut by two perpendicular sets of vertical joints, which delimits relatively small rock volumes that fail as rockfalls or small toppling failures. The absence of less steeply-dipping discontinuities impedes the development of a large instability. A failure from Blåhornet will probably not reach inhabited areas of Viddalen Valley.

Figure 135: Photographs of the Blåhornet rock slope: a) rockfalls originate from the steep cliffs; b) no large unstable rock slope is visible.

Recommendation: There are no signs that the Blåhornet rock slope might fail in a massive rock slope failure. No further investigations or displacement measurements are necessary and the hazard and risk classification will not be made. However, rockfalls are possible and their run-out area is given by the rockfall susceptibility map or more detailed hazard maps, where available.

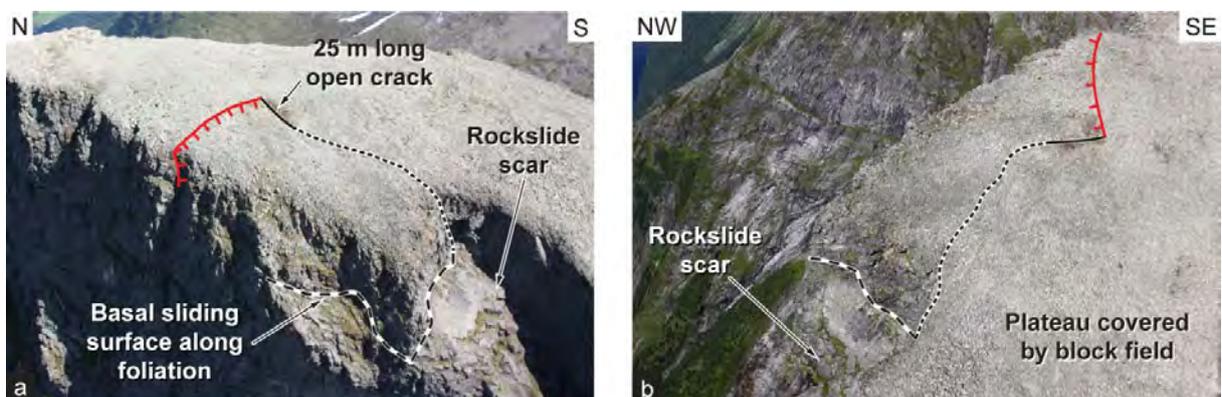
Jakta is located on a west-facing slope 1580 m above the southern end of Hjørundfjord (Figure 134). A helicopter reconnaissance flight in 2011 revealed past rock slope failures and a remaining instability (Figure 136a). The foliation is moderately SW-dipping and has served as a basal sliding surface for a past rockslide. The lateral release surface of this rockslide can be followed inwards joining an open crack observed on the mountain top (Figure 136). A massive rock slope failure would likely cause a displacement wave in Hjørundfjord.

Figure 136: Photographs of the Jakta instability: a) the foliation acts as basal sliding surface in a previous rockslide and for the remaining instability; b) the lateral release surface of the past rockslide follows inwards to join an open crack.

Recommendation: A possible rock avalanche from the Jakta instability will have consequences. Geological field mapping is necessary to evaluate the structural and geological conditions, to quantify past displacements and assess the structures involved in the previous rockslide. The hazard and risk classification will be made after this field mapping. Further follow-up activities will be decided based on this classification.

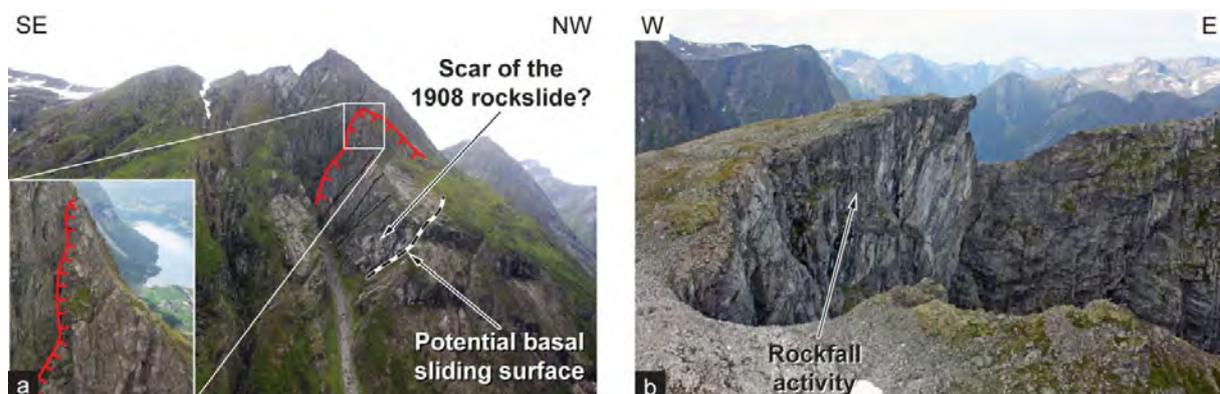
The upper, rear part is characterised by very steep cliffs and a highly fractured rock mass, which leads to rockfalls but not to a large rock slope failure (Figure 137b). Along a N-S-trending, old, brecciated fault crossing the slope, open cracks develop and can act as a back-crack (Figure 137a). Moderately SE-dipping foliation could be activated as basal sliding surface of a large potential rock slope instability with an estimated volume ranging from 0.5 to 1.8 million m³. This instability uses therefore similar structures as the 1908 rockslide, even though the exact location of this past event is not evident (Figure 137a). Anyhow, this indicates that failure is kinematically possible with the given structural setting. However, there are no signs of present active displacement at the instability.

A failure of the Keipen instability would impact the dam generated by the 1908 rock avalanche and the Lyngnstøylvatnet Lake, which might lead to a dam breach followed by downstream flooding of Norangsdalen Valley.

Figure 137: Photographs of the Keipen instability: a) an old fault guides the development of a possible back-crack for the instability (inset). The scar of the 1908 rock avalanche is likely located in front of the remaining instability, which uses the foliation as possible sliding surfaces; b) the upper part of Keipen is characterised by rockfall activity, but no large instability is currently delimited.

Recommendation: A possible rock avalanche from the Keipen instability will have consequences, which will be assessed in the hazard and risk classification. Further follow-up activities will be decided based on this classification.

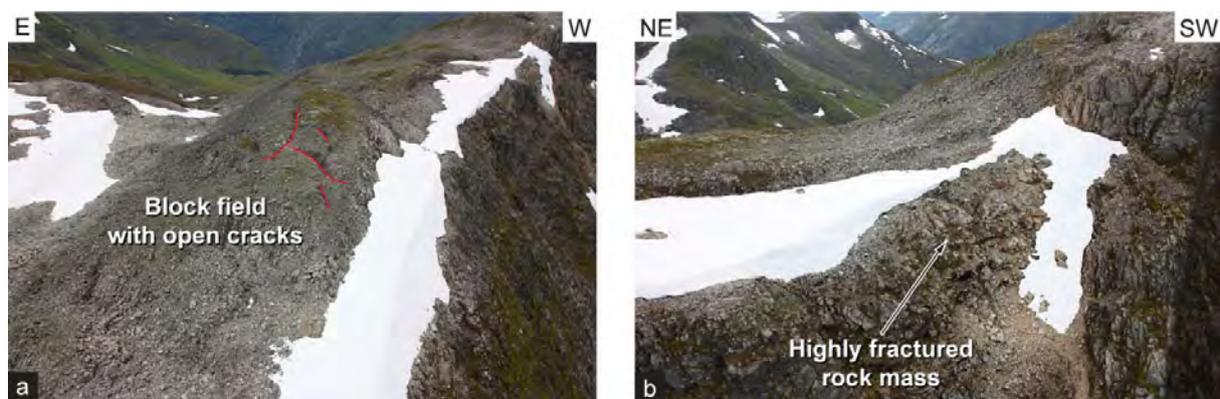
Litlehornet (Figure 134) is located on a south-facing slope 350 m above Svartedalen Valley, a small tributary valley of Norangsdalen Valley. With a helicopter reconnaissance flight in 2011 a glacially fractured rock surface forming a block field was observed (Figure 138). Open cracks are visible on the mountain crest indicating creep of the block field to the SE into the uninhabited Svartedalen Valley (Figure 138a). The rock mass is highly fractured into small blocks (Figure 138b). There are no indications for a large unstable rock slope at Litlehornet.

Figure 138: Photographs of the Litlehornet rock slope: the highly fractured rock mass forms a block field; open cracks indicate creep movements of the block field to the SE.

Recommendation: There are no signs that the Litlehornet rock slope might fail in a massive rock slope failure. No further investigations or displacement measurements are necessary and the hazard and risk classification will not be made. However, rockfalls are possible and their run-out area is given by the rockfall susceptibility map or more detailed hazard maps, where available.

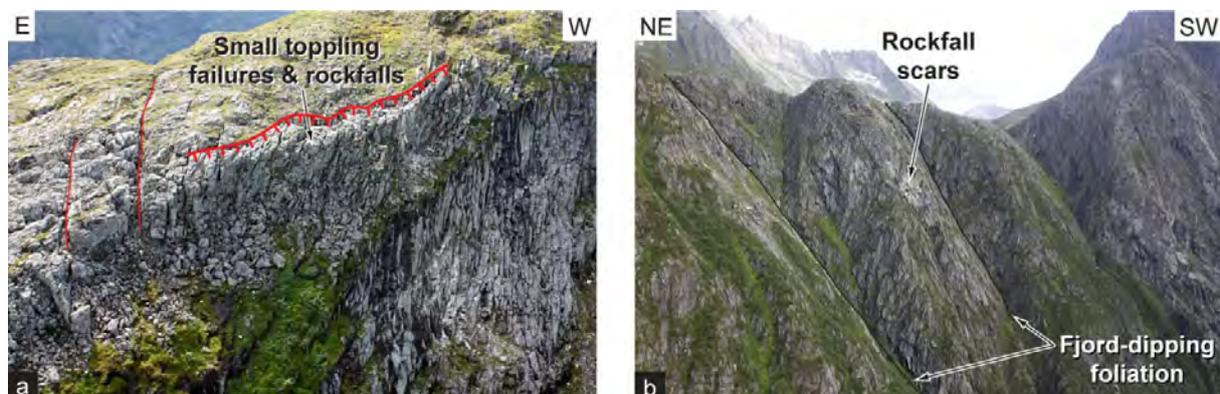
Maudekollen (Figure 134) is located at 1020 m a.s.l. above Norangsfjord. A helicopter reconnaissance flight in 2011 has allowed the identification of a highly fractured rock mass on the northern side of the crest leading to small toppling failures (Figure 139a). These tend to fall toward the uninhabited Langesæterdalen Valley. The moderately S-dipping foliation forms possible sliding surfaces on the fjord-facing slope, but there are no visible back-cracks or lateral release surfaces that would delimit a large unstable rock slope (Figure 139b).

Figure 139: Photographs of the Maudekollen: a) highly fractured rock mass leads to rockfalls and small toppling failures towards the north; b) fjord-dipping foliation surfaces might form basal sliding surfaces, but other structures to delimit a large unstable rock slope are not observed.

Recommendation: There are no signs that Maudekollen rock slope might fail in a massive rock slope failure. No further investigations or displacement measurements are necessary and the hazard and risk classification will not be made. However, rockfalls are possible and their run-out area is given by the rockfall susceptibility map or more detailed hazard maps, where available.

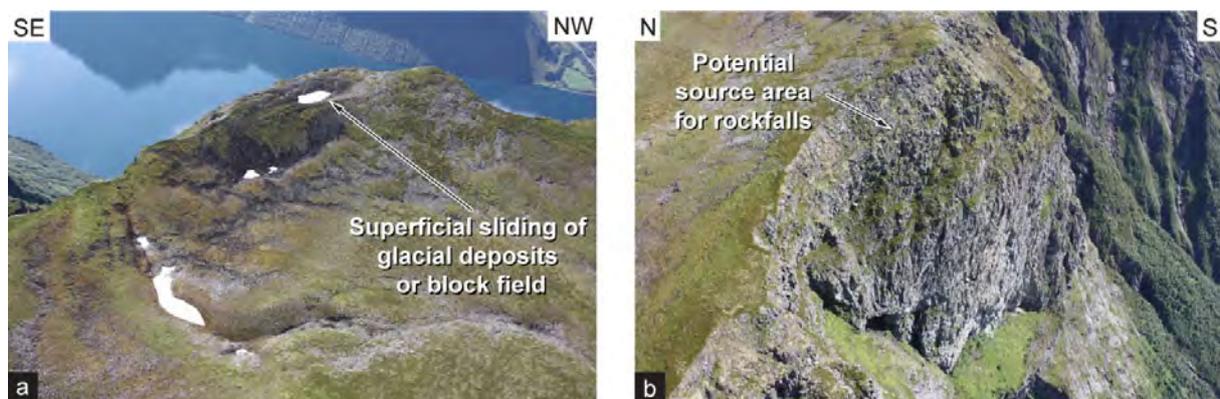
Stålberghornet is located on a south-facing slope 1060 m above the southern end of Hjørundfjord (Figure 134). A lineament observed on aerial photographs has been interpreted as a back-crack delimiting a possible instability. A helicopter reconnaissance flight showed, however, that this lineament is caused by superficial sliding of glacial deposits or a vegetated block field (Figure 141a). The highly fractured rock mass at the SW-facing slope close to the investigated lineament is a possible source area for rockfalls (Figure 141b), although only a little amount of deposits is visible down-slope. No structures delimiting a large unstable rock slope are visible.

Figure 141: Photographs of the Stålberghornet rock slope: a) superficial sliding or creep of glacial deposits forming depressions on the mountain top; b) highly fractured rock mass that is prone to rockfalls.

Recommendation: There are no signs that the Stålberghornet rock slope might fail in a massive rock slope failure. No further investigations or displacement measurements are necessary and the hazard and risk classification will not be made. However, rockfalls are possible and their run-out area is given by the rockfall susceptibility map or more detailed hazard maps, where available.

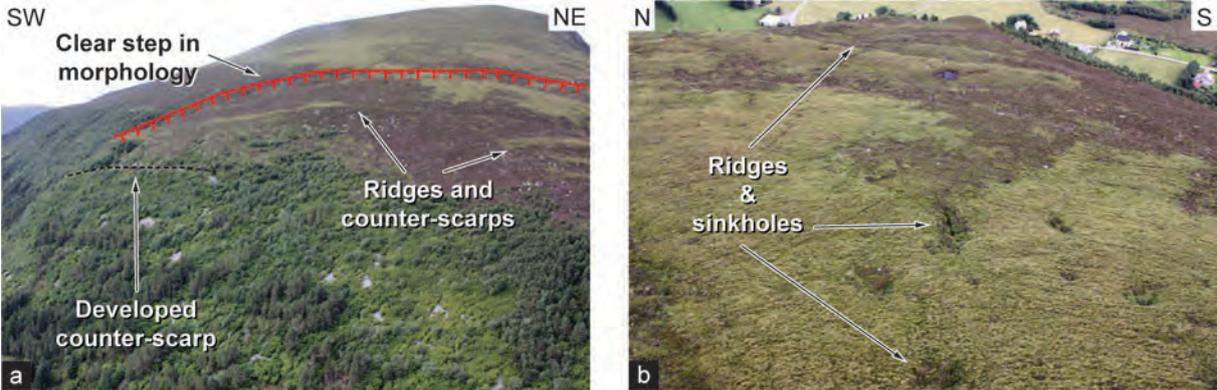
Branddalsryggen is located on a southeast-facing slope 280 m above Nymark village on Skuløya Island (Figure 142). A deep-seated gravitational slope deformation with a clear escarpment as back-scarp (Figure 143) was mapped and reported in Ganerød and Lutro (2011) and newly observed during a helicopter reconnaissance flight in 2012.

The unstable rock slope developed clearly on a band made of different rocks that also shape the slope (Ganerød and Lutro 2011). Several counter-scarps, sinkholes and ridges testify of past deformations, especially in the southwestern part and in the upper parts of the rock slope (Figure 143a). There are some scree deposits at the front of the unstable rock slope, but no clear signs of recent activity. The volume is not accurately calculated, but likely in the order of several tens of million m^3 . A massive collapse of the Branddalsryggen rock slope will affect several settlements on the southern end of Skuløya Island (Dahle et al. 2011a).

Figure 143: Photographs of the Branddalsryggen rock slope: a) morphology of the deep-seated gravitational slope deformation with an escarpment in the back and several ridges and counter-scarps on the rock slope; b) some sinkholes and open cracks are visible in the upper part of the rock slope.

Recommendation: A possible rock avalanche from the Branddalsryggen will have consequences. Geological field mapping is necessary to evaluate the structural and geological conditions, estimate the volume and quantify past displacements. The hazard and risk classification will be made after this field mapping. Further follow-up activities will be decided based on this classification.

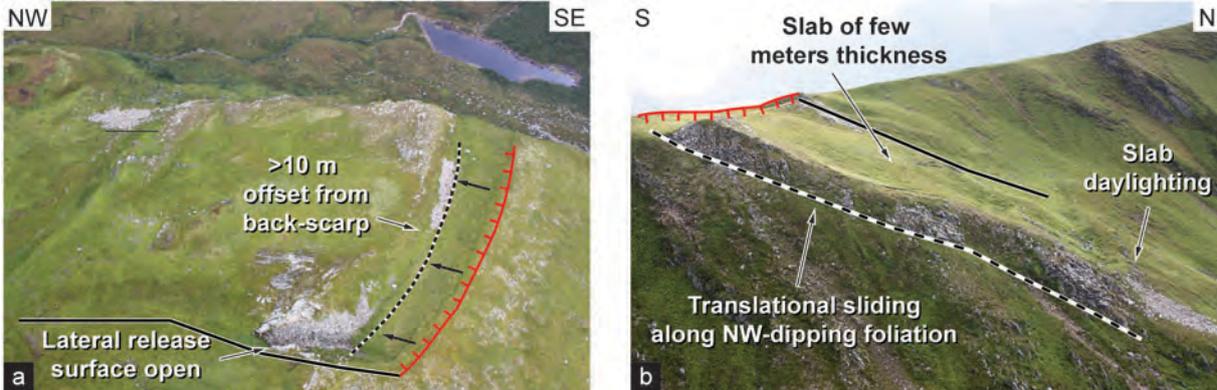
Byrkjevollhornet (Figure 142) is located on a north-facing slope 295 m above Eikedalen Valley. A helicopter reconnaissance flight in 2012 revealed a well-developed translational slide with more than 10 m apparent offset at the back-scarp (Figure 144a, b). The basal sliding surface is parallel to the moderately NW-dipping foliation and the western lateral release fracture is distinctly developed. The detached slab is only a few meters thick, 130 m wide and daylights probably 120 m further down slope, where there is a change in vegetation. The volume of this instability is between 100 000 and 200 000 m³. A massive rock slope failure from Byrkjevollhornet would therefore likely not form a rock avalanche with a run-out distance exceeding the run-out of rockfalls. The cabins on the northeastern flank of Eikedalen Valley will thus not be reached by a failure from Byrkjevollhornet.

Figure 144: Photographs of the Byrkjevollhornet rockslide: a) past displacements along the back-scarp might have exceeded 10 m; b) a several meters thick slab is sliding on the NW-dipping foliation and daylighting the slope.

Recommendation: A possible rock avalanche from the Byrkjevollhornet instability will have no consequences. No further investigations or displacement measurements are necessary. The hazard and risk classification will be made after a simple run-out assessment. Further follow-up activities will be based on this classification.

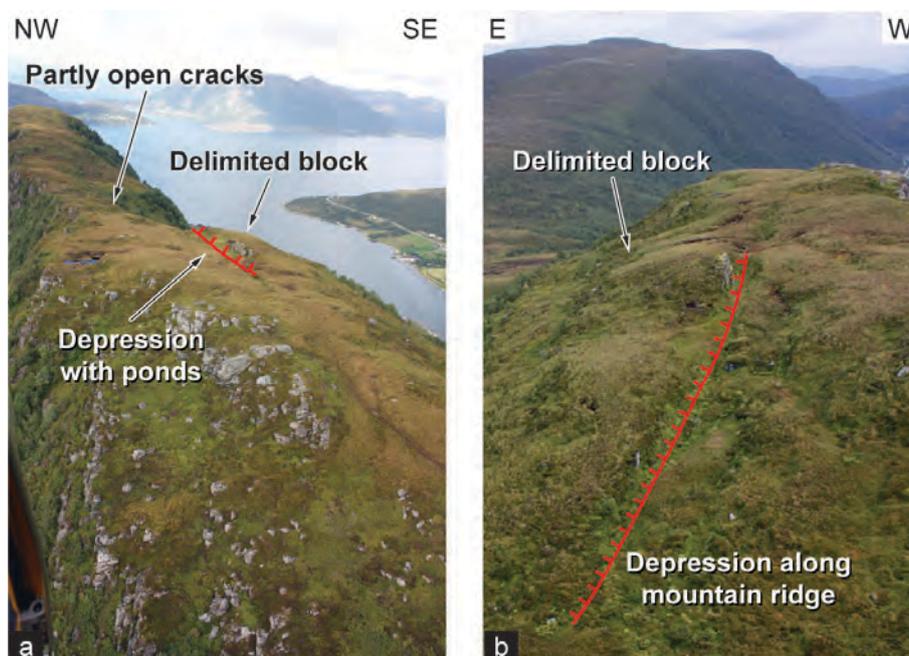
Hellenakken (Figure 142) is a N-S-trending mountain ridge 420 m a.s.l. between Vestrefjord and Vatnefjord. A helicopter reconnaissance flight was made in 2012. In the northern part of the mountain ridge a depression indicates past deformations along a back-crack (Figure 145). Small ponds of water in this depression indicate poor drainage and therefore no recent openings of this possible back-crack. Further north this depression evolves to narrow, partly open cracks. These depression and cracks possibly delimit an unstable block towards the east (Figure 145). Recent rockfall activity is noticed at the frontal cliff of this instability. However, Blikra et al. (2002b) identified an unstable rock slope that extends further north and supposed moving to the west. The gneiss foliation is subhorizontal. Together with two subvertical discontinuity sets the foliation delimits small blocks that may fail as rockfalls. In any case, the current structures are not favourably oriented for sliding, both towards the east and the west.

Figure 145: Photographs of the Hellenakken rock slope: an instability is delimited by a back-bounding depression and cracks along the mountain ridge.

Recommendation: A possible rock avalanche from the Hellenakken instability will have consequences. Geological field mapping is necessary to evaluate the structural and geological conditions, to quantify past displacements and assess the possible sliding direction. The hazard and risk classification will be made after this field mapping. Further follow-up activities will be decided based on this classification.

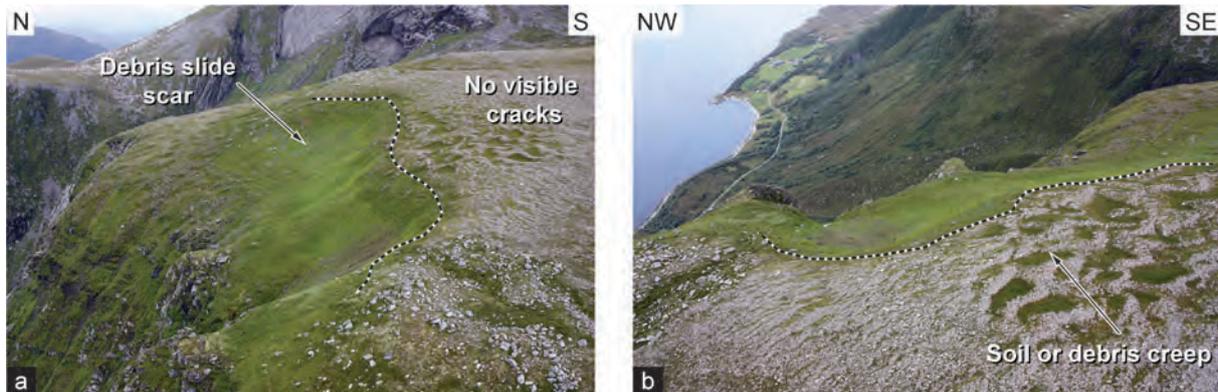
Skjerveheian (Figure 142) is located on a northeast-facing slope 650 m above Skoradalen Valley. A helicopter reconnaissance flight in 2012 revealed a circular escarpment on the flat plateau (Figure 147a). There are no visible cracks or other structures delimiting an unstable rock slope, but the terrain above the escarpment presents signs of creep movements (Figure 147b). This suggests that the circular escarpment is the scar of an old soil/debris slide that

removed the few meters thick upper layer. The loose debris moved close to the steep frontal cliff (Figure 147a). The relatively steep slope created by the slide scar favours the creep movements of the debris above. Possible rockfalls or debris falls from Skjerveheian will only affect the uninhabited Skoradalen Valley.

Figure 147: Photographs of the Skjerveheian rock slope: a) scar of a past debris slide forming an escarpment; b) creep movements of soil/debris above the debris slide scar.

Recommendation: There are no signs that the Skjerveheian rock slope might fail in a massive rock slope failure. No further investigations or displacement measurements are necessary and the hazard and risk classification will not be made. Rockfalls or debris falls are however possible and their run-out area is given by the rockfall susceptibility map or more detailed hazard maps, where available.

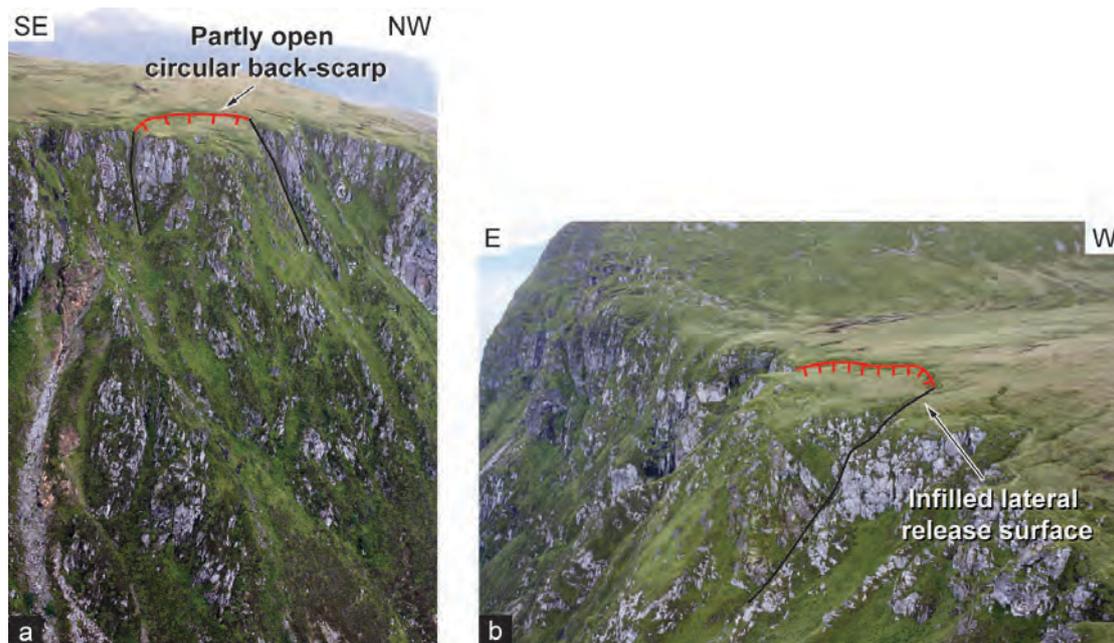
Skulen is located on a northeast-facing slope 330 m above Nogvafjord (Figure 142). A helicopter reconnaissance flight in 2012 showed a circular shaped back-scarp of an unstable rock slope (Figure 148a). The back-scarp is partly open, but extensively filled and vegetated. A depression marks the NW lateral release surface, which is totally filled (Figure 148b). There is no visible daylighting sliding surface and the instability appears unaffected by recent deformation. Two subvertical discontinuity sets are visible, and one corresponds to the foliation steeply dipping to NNW. The escarpment along the back-crack shows a few meters of past deformation and there are signs of rockfall activity along the SE lateral release surface which follows the foliation. The volume of Skulen instability is estimated to 2 million m³. A massive failure from Skulen would reach Nogvafjord and create a displacement wave (Dahle et al. 2011a).

Figure 148: Photographs of the Skulen instability: the circular back-scarp and the lateral release surfaces are partly open, but generally filled with soil and vegetation.

Recommendation: A possible rock avalanche from the Skulen instability will have consequences. Geological field mapping is necessary to evaluate the structural and geological conditions and to quantify past displacements. The hazard and risk classification will be made after this field mapping. Further follow-up activities will be decided based on this classification.

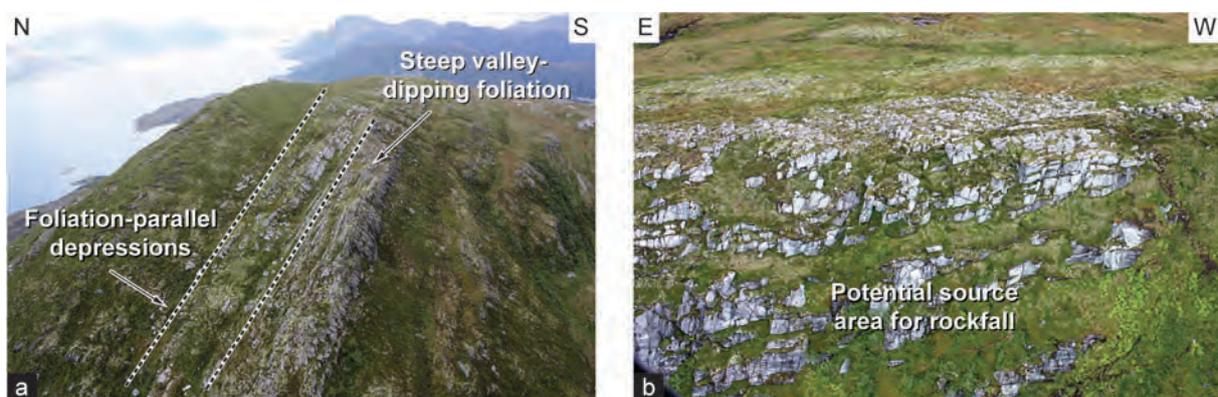
Skoraegga is located on the north-facing slope 525 m above Skor settlement and Midfjord (Figure 142). The rock slope was investigated by Blikra et al. (2002b) and during a helicopter reconnaissance flight in 2012. The gneiss foliation is steeply N-dipping and does not daylight the topography further downslope (Figure 149a). Even though there are foliation-parallel depressions on the mountain top, there are no structures delimiting a large unstable rock slope and no signs of activity. A vertical joint set perpendicular to foliation delimits small blocks that might fail as rockfalls (Figure 149b).

Figure 149: Photographs of the Skoraegga rock slope: a) depressions parallel to the steeply N-dipping foliation are visible on the mountain top; b) small blocks delimited the foliation and vertical discontinuities may fail as rockfalls.

Recommendation: There are no signs that the Skoraegga rock slope might fail in a massive rock slope failure. No further investigations or displacement measurements are necessary and the hazard and risk classification will not be made. However, rockfalls are possible and their run-out area is given by the rockfall susceptibility map or more detailed hazard maps, where available.

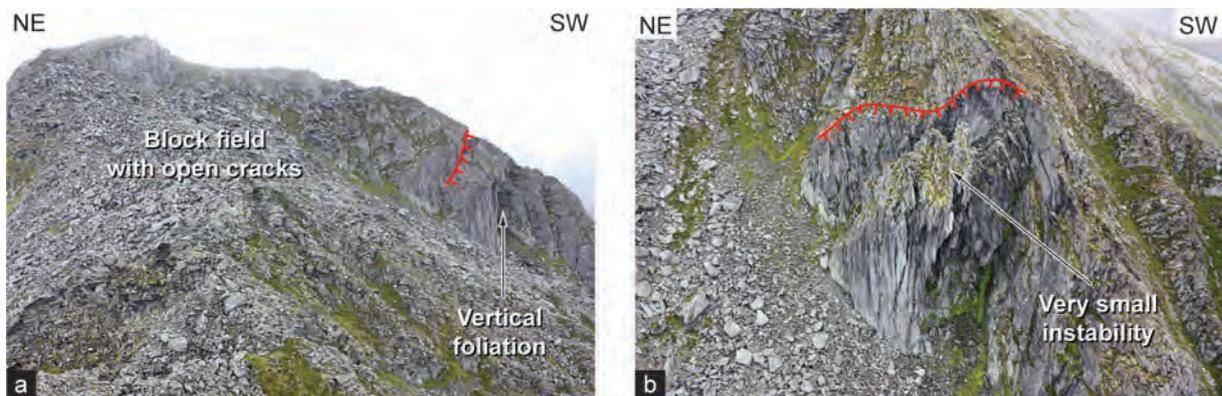
Tindfjellet (Figure 142) is located on a west-facing slope 665 m above the Vestrevatna Lake. A helicopter reconnaissance flight was made in 2012 showing a large block field formed by rockfalls from the Tindfjellet mountain top or from in-situ disintegration of highly fractured rock masses (Figure 150a). Some open cracks developed in this block field, but no large unstable rock slope is actually shaped. A small instability with a maximum volume of 50 000 m³ is located along the south-western crest of Tindfjellet and displays a fully open back-crack and a lateral release surface formed by the steeply N-dipping foliation (Figure 150b). A failure of this instability would not travel further than rockfalls (Dahle et al. 2011a).

Figure 150: Photographs of the Tindfjellet rock slope: a) a highly disintegrated block field forms the western mountain slope; b) a small instability is located on the SW-ridge of Tindfjellet.

Recommendation: There are no signs that the Tindfjellet rock slope might fail in a massive rock slope failure. No further investigations or displacement measurements are necessary and the hazard and risk classification will not be made. However, rockfalls are possible and their run-out area is given by the rockfall susceptibility map or more detailed hazard maps, where available.

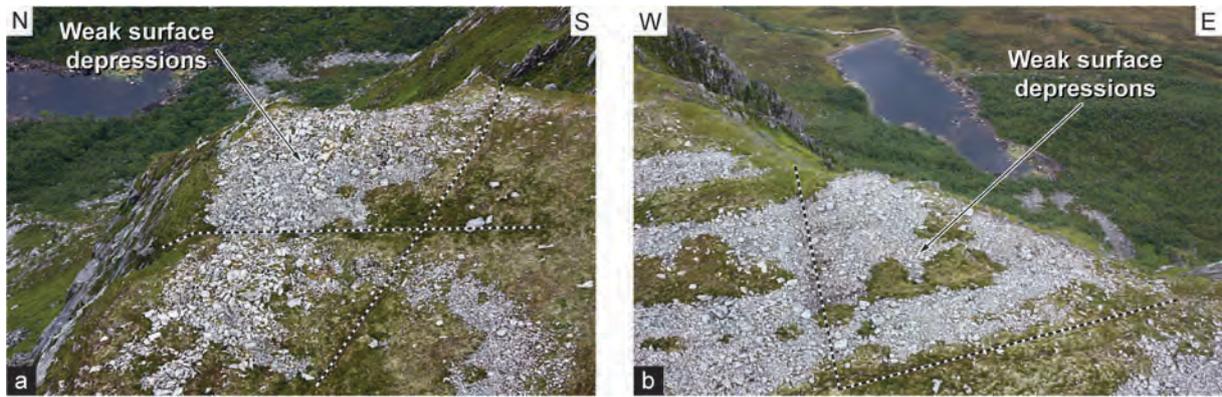
Vassbotnen 1 & 2 (Figure 142) are located on a north-facing to northeast-facing slope 270–280 m above the Eikedalen Valley, close to the Byrkjevollhornet rockslide. Shallow surface depressions were observed on aerial photographs and interpreted as possible back-cracks and lateral release surfaces (Figure 151). A helicopter reconnaissance flight made in 2012 showed that these depressions are only superficial and not related to open cracks at depth. There are no structures present at Vassbotnen 1 & 2 to delimit an unstable rock slope and no signs of past displacements. Rockfalls occur however from both sites forming a talus slope at the foot of the cliff (Dahle et al. 2011a).

Figure 151: Photographs of the Vassbotnen rock slopes: a) Vassbotnen 1; b) Vassbotnen 2. Both rock slopes display weak surface depressions that are not related to open cracks at depth.

Recommendations: There are no signs that the Vassbotnen 1 & 2 rock slopes might fail in massive rock slope failures. No further investigations or displacement measurements are necessary and the hazard and risk classification will not be made. Rockfalls or debris falls are however possible and their run-out area is given by the rockfall susceptibility map or more detailed hazard maps, where available.

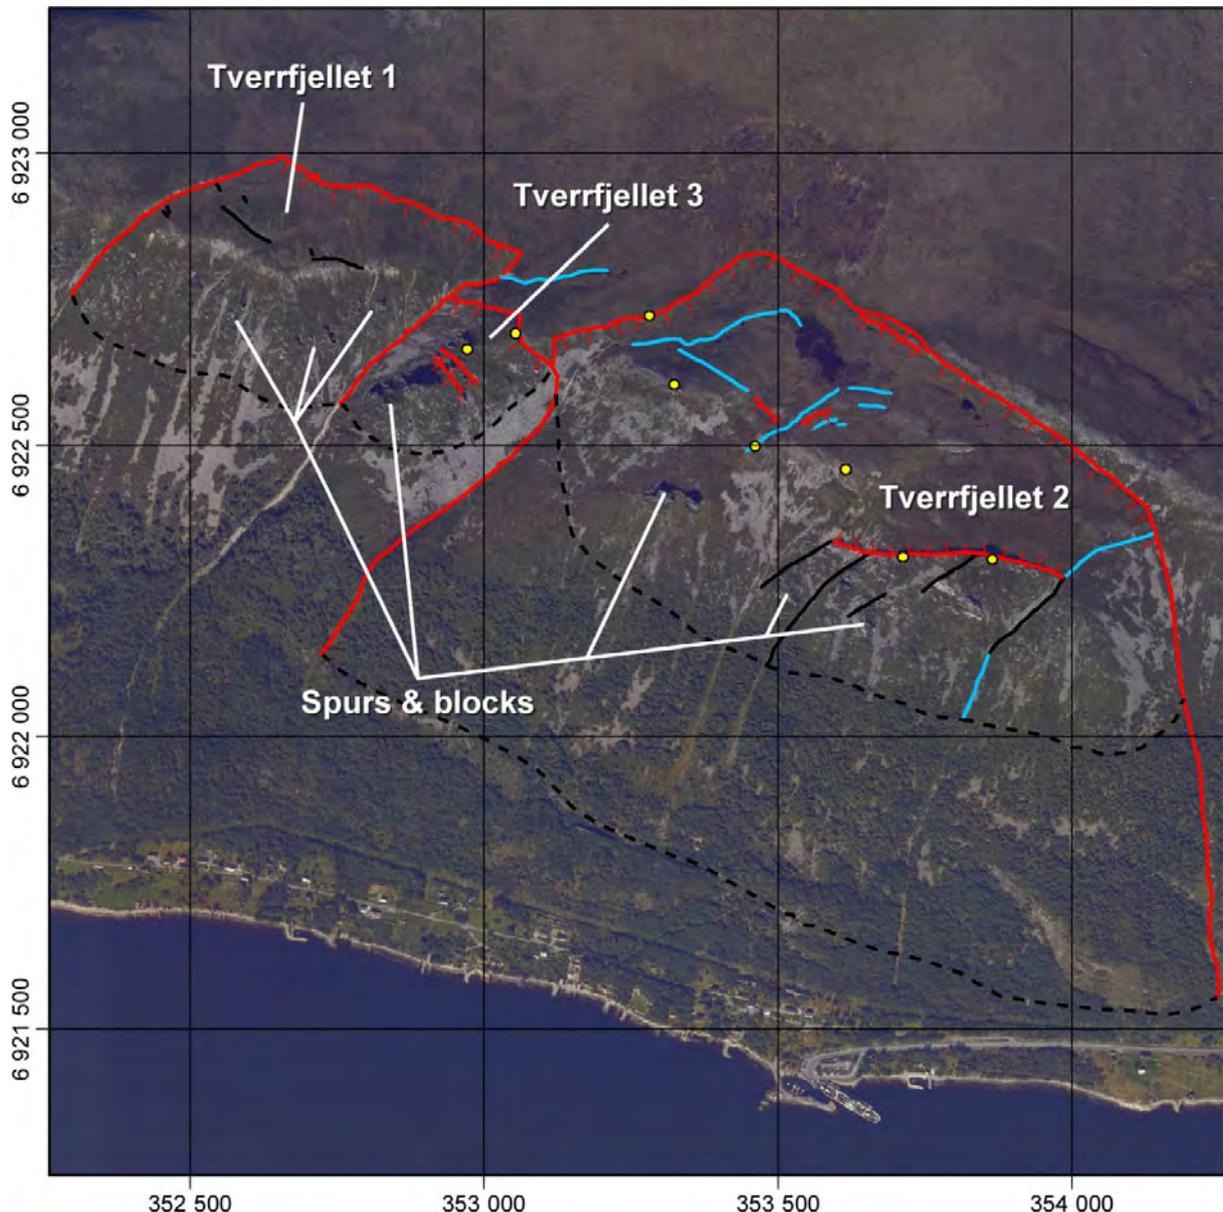
Tverrfjellet 1 is delimited to the NW by a moderately SE-dipping lateral release surface forming a 3–4 m high escarpment (Figure 153b, d). The back-scarp is formed by a complex pattern of valley-parallel cracks and transverse cracks and has a downthrow of 0.5–2.0 m. The south-eastern limit on the Tverrfjellet 1 unstable rock slope is a W-dipping lateral release surface with a throw of up to 75 cm that joins a gully (Figure 154). The basal failure surface is not visible and the toe line shown in Figure 154 is thus speculative. Past deformations are relatively small given the size of the unstable rock slope and there are only few open cracks observed within the instability (Figure 153b, d). Highly fractured spurs are located on the moderately SW-dipping slope in the front of Tverrfjellet 1 (Figure 154).

Tverrfjellet 2 is a site of complex deep-seated gravitational slope deformation with distinct lateral and rear limits and internal scarps and ridges (Figure 153a, e, f, Figure 154). The downthrow of the back-scarp increases from 1–2 m in the NW to 20–30 m in the SE, but is overgrown by vegetation and small blocks (Figure 153e). A 10–15 m high, E-W-trending ridge is located at the front of the eastern part of the unstable rock slope (Figure 153a, f, Figure 154). This ridge might be formed by differential movement between two compartments of the gravitationally deformed slope. Similarly to Tverrfjellet 1, the basal failure surface is inconspicuous so the toe line drawn in Figure 154 is uncertain and several highly fractured spurs are located on the moderately fjord-dipping slope in the front of Tverrfjellet 2 (Figure 154).

Tverrfjellet 3 is located between the Tverrfjellet 1 & 2 unstable rock slopes and is relatively small compared to both other sites (Figure 154). The instability is delimited by an open back-scarp with a downthrow of 1–2 m (Figure 153c). The lateral limits are defined by gullies on both sides of the instability. The basal failure surface is not visible and the toe line in Figure 154 is thus questionable. On Tverrfjellet 3 instability, a subblock is delimited by a 5 m wide graben (Figure 153c) without displaying traces of recent openings or signs of activity.

Figure 154: Map of the three Tverrfjellet unstable rock slopes showing locations of field measurements (yellow dots). The locations of the toe lines are uncertain.

Recommendations: Possible rock avalanches from the Tverrfjellet 1, 2 & 3 unstable rock slopes will have consequences, which will be assessed in the hazard and risk classification. Further follow-up activities will be decided based on this classification.
