GEOLOGI FOR SAMFUNNET

GEOLOGY FOR SOCIETY

Report no.: 2013.014		ISSN: 0800–3416	Grading: Open
Title: Investigations on unstable rock slopes in Møre og Romsdal – status and plans after field surveys in 2012			
Authors: T. Oppikofer, A. Saintot, S. Otterå, R.L. Hermanns, E. Anda, H. Dahle, T. Eiken		Client: Norwegian Water Resources and Energy Directorate (NVE)	
County: Møre og Romsdal		Commune:	
Map-sheet name (M=1:250.000) Ålesund, Kristiansund, Røros, Ulsteinvik		Map-sheet no. and -name (M=1:50.000)	
Deposit name and grid-reference:		Number of pages: 323	Price (NOK): 1285,-
Fieldwork carried out: 2006–2012		Date of report: 13.11.2013	Map enclosures: 0
Fieldwork carried out: 2006–2012		Date of report: 13.11.2013	Project no.: 309900
Fieldwork carried out: 2006–2012		Date of report: 13.11.2013	Quality control: <i>Halvor Brundhoff</i>
<p>Summary:</p> <p>This report presents investigations, analyses and displacement measurements made between 2006 and 2012 on 131 unstable or potential unstable rock slopes in Møre og Romsdal County (Western Norway). An extract of this report is available in Norwegian (NGU rapport 2013.053).</p> <p>These investigations are part of the national plan for

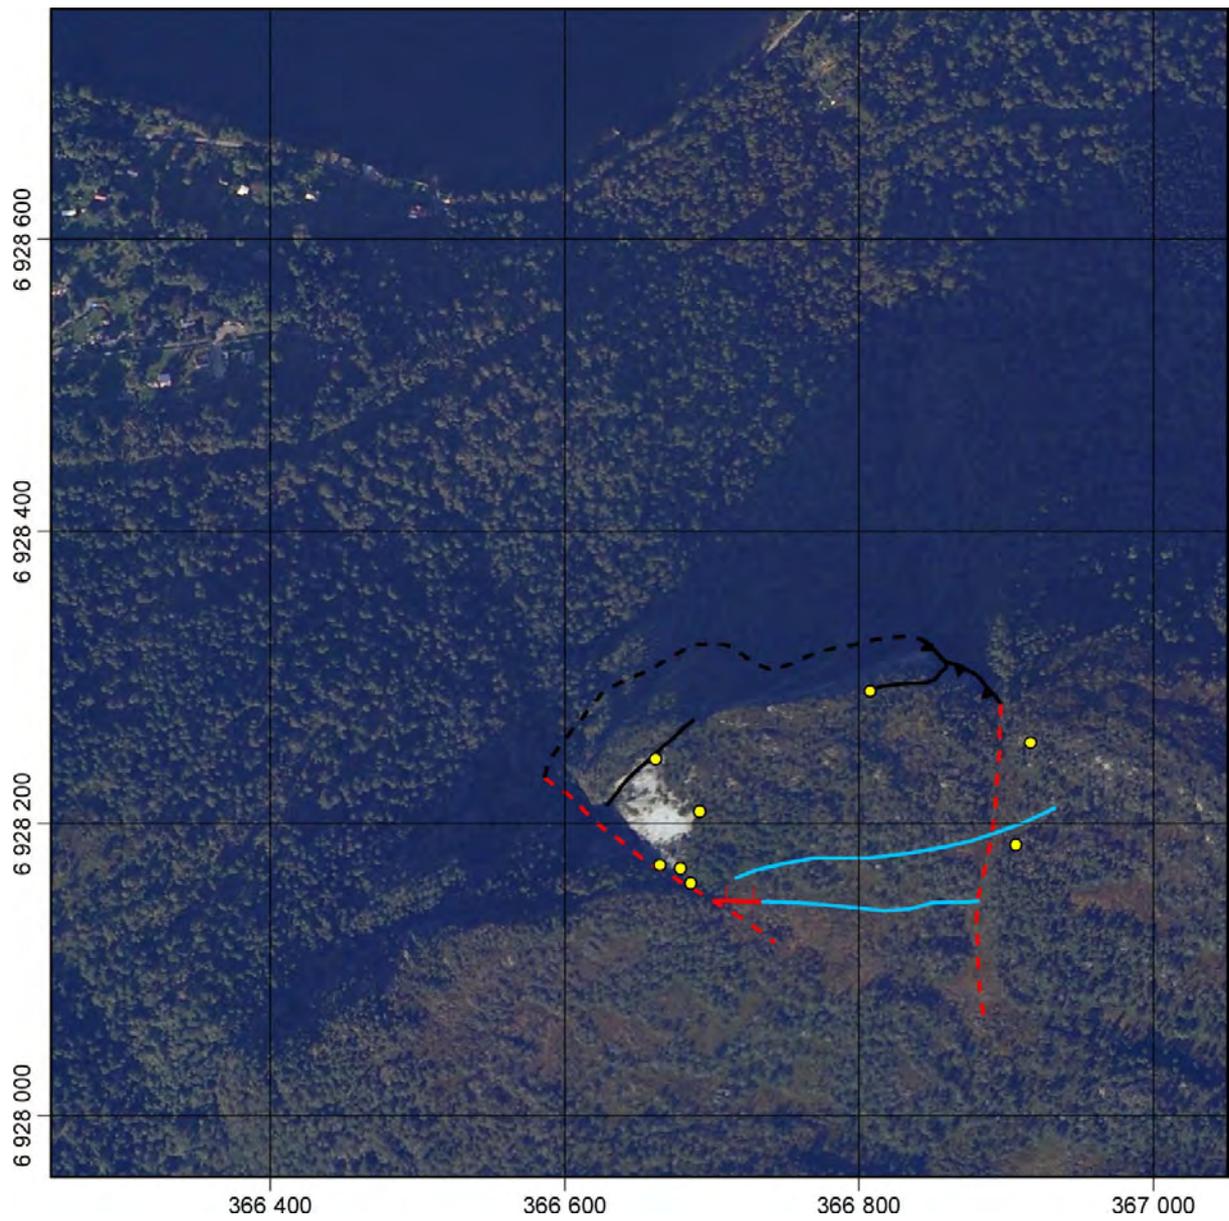
Rambjøra (Figure 152) is located on a northwest-facing slope 300 m above Litlestølen settlement and Brusdalsvatnet Lake. A helicopter reconnaissance flight in 2011 revealed an unstable rock slope that is bounded to the east and to the SW by two distinct faults (Figure 155, Figure 156). The SW-bounding fault is eroded and shows typical mineralisation with laumontite and chlorite (Figure 155c), while the eastern fault forms a marked surface depression

that can be followed inward of the plateau (Figure 156). A several meter high back-scarp is observed at the southwestern corner of the instability in direct continuation of the cliff west of Rambjøra instability. The back-scarp might thus persist into the instability and a shallow depression is indeed visible inline with the back-scarp toward the east (Figure 156). Past deformations have probably been very small, because (1) the rock mass in the instability is relatively intact and only affected by few internal cracks and (2) the back-scarp is poorly developed. At the front cliff of the instability, there is a completely detached block to the NW (Figure 155a, b) and a partly open crack delimiting a column to the east (Figure 155d).

The gneiss foliation has variable orientations and is subparallel to the faults at the SW and E limits (steeply NNE-dipping and steeply W-dipping, respectively). On the top of the instability the foliation is gently E-dipping. Four other discontinuity sets are measured and are all subvertical. Two of them form the open cracks that delimit the detached blocks and columns along the front cliff of the Rambjøra instability. These might fail by a combination of sliding and toppling, while the entire instability might fail along the intersection line formed by the faults.

A massive failure of Rambjøra instability would create a rock avalanche that would impact Litlestølen settlement and create a displacement wave in Brusdalsvatnet Lake that counts several other settlements along its shoreline (Dahle et al. 2011a).

Figure 156: Map of the Rambjøra instability showing locations of field measurements (yellow dots).

Recommendation: A possible rock avalanche from the Rambjøra and the created displacement wave instability will have consequences, which will be assessed in the hazard and risk classification. Further follow-up activities will be decided based on this classification.

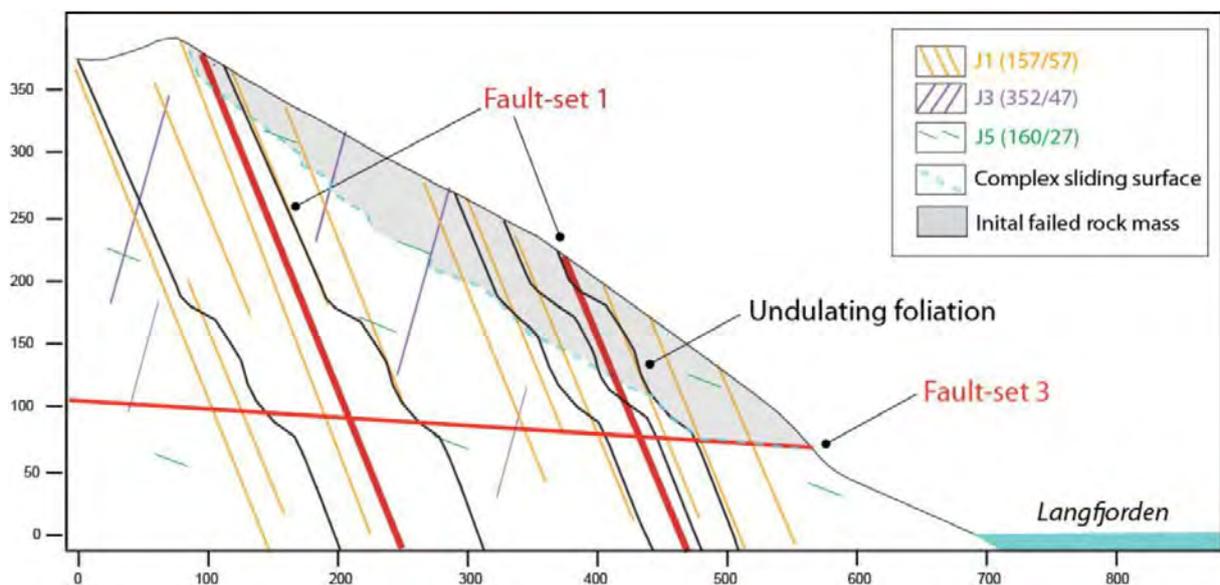
The Phase² analyses include shear strength reduction investigations and parameter sensitivity tests. It is demonstrated that the failure of the Tjellefonna slope might have required strain softening in combination with triggering factors, where high groundwater is an essential feature. Earthquake, on the other hand, is ruled out as a triggering factor. Additionally, the analyses show that a shallow-dipping structure is critical in order to induce slope instability. This could be represented either by a joint set or an observed sub-horizontal fault. Fieldwork and modelling indicates that the fault is the most important to reduce slope stability.

The sliding surface has been evaluated using the Phase² and SLBL results. It is concluded that the Tjellefonna rockslide was not lying on a uniform plane, but on a complex surface made of joints, faults, foliation and intact rock bridges (Figure 161). Moreover, it is obvious that the Tjellefonna failure was closely related to the tectonic deformation of the rocks in this area. The failure was likely also a consequence of progressive accumulation of rock weakening (strain softening), acting to degrade the equilibrium state of the slope. This could have generated a hillside creep explaining the growing tension cracks observed at the present crown prior to the rockslide.

Figure 161: Conceptual model of the Tjellefonna rockslide based on fieldwork and numerical modelling results (Sandøy 2012).

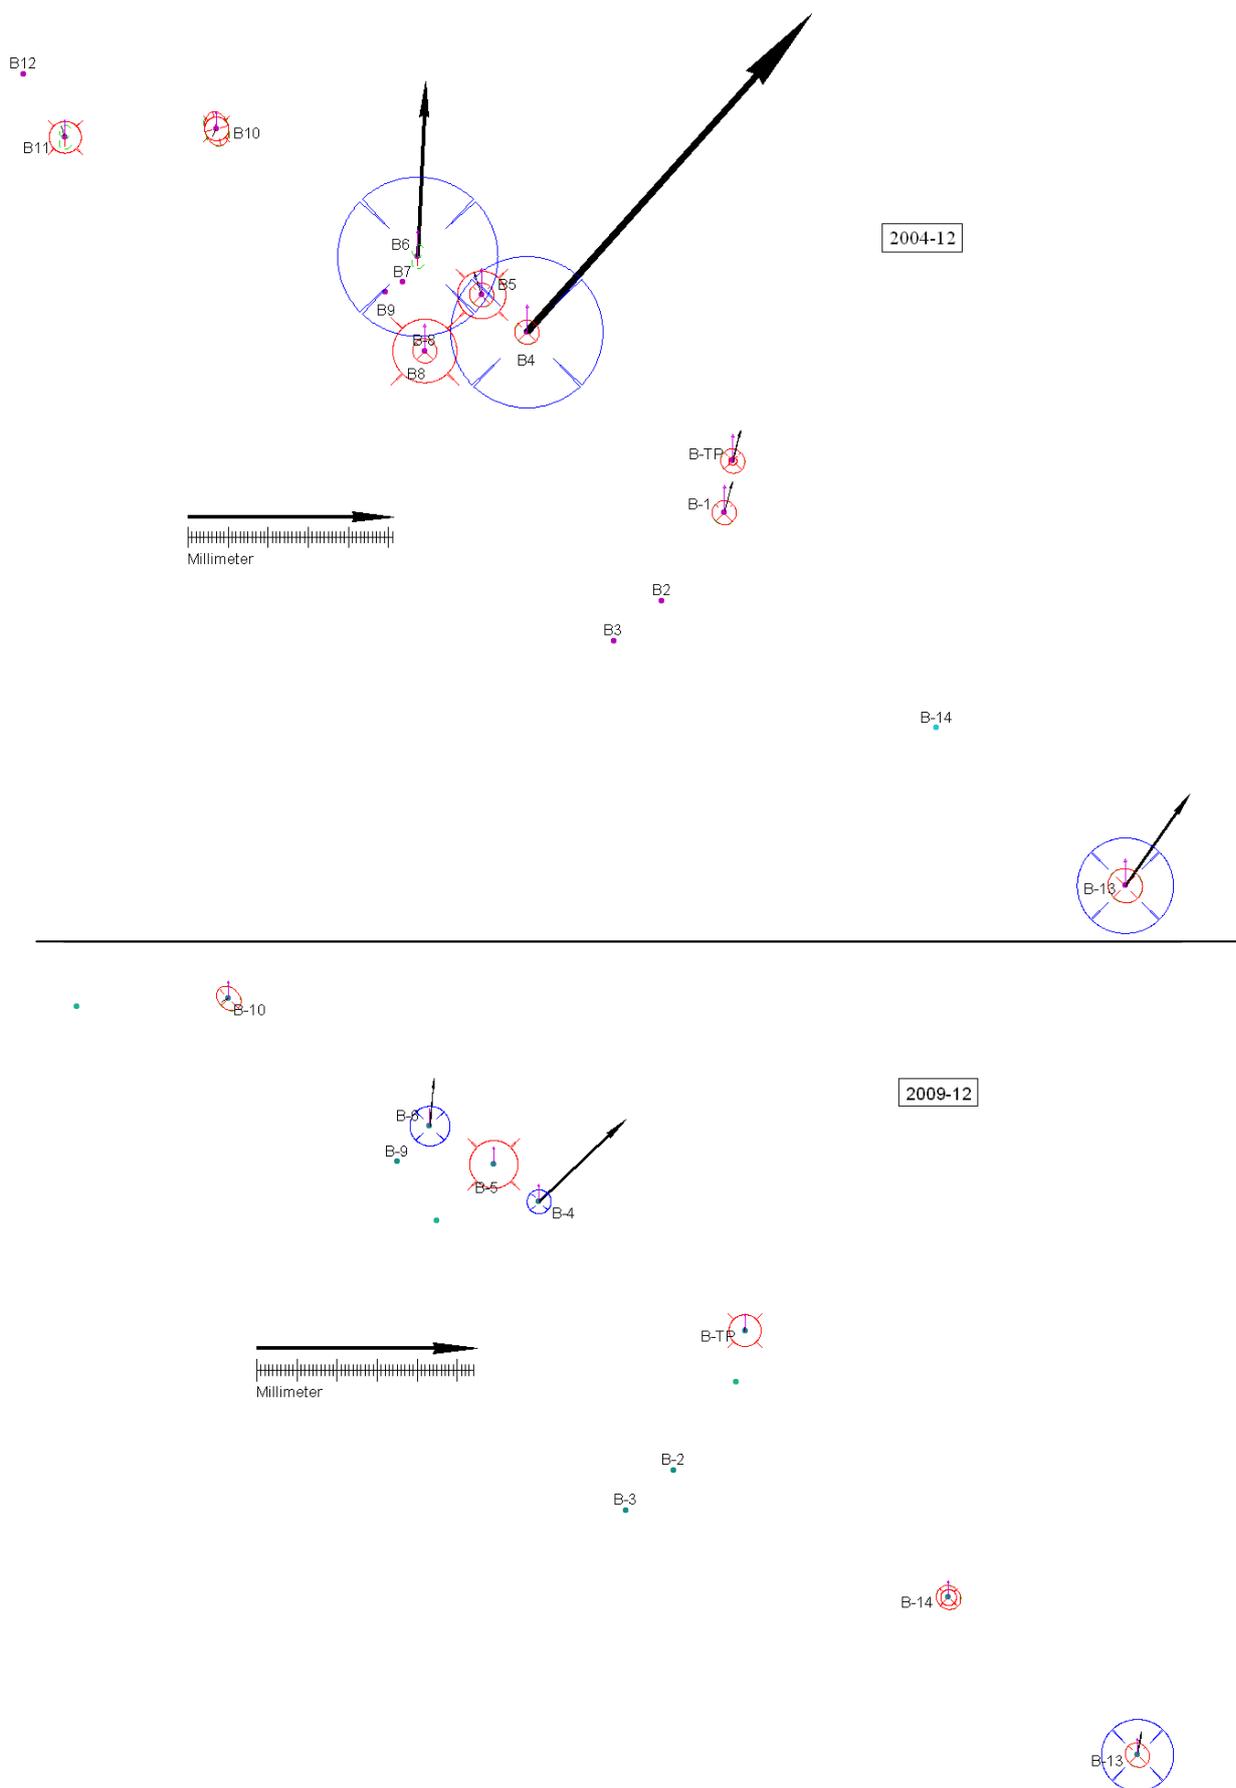
Tabell 2: Endringer mellom målinger for punkt på Børa 2003–12. Det er primært punkta B-4 og B-6 som har konsistente endringer frå år til år.

Figur 5: Grafisk endring grunnriss og høyde 2004–12 (øverst), 2009–12 (nedst), det siste inkluderer punktet B-14 etablert 2009.

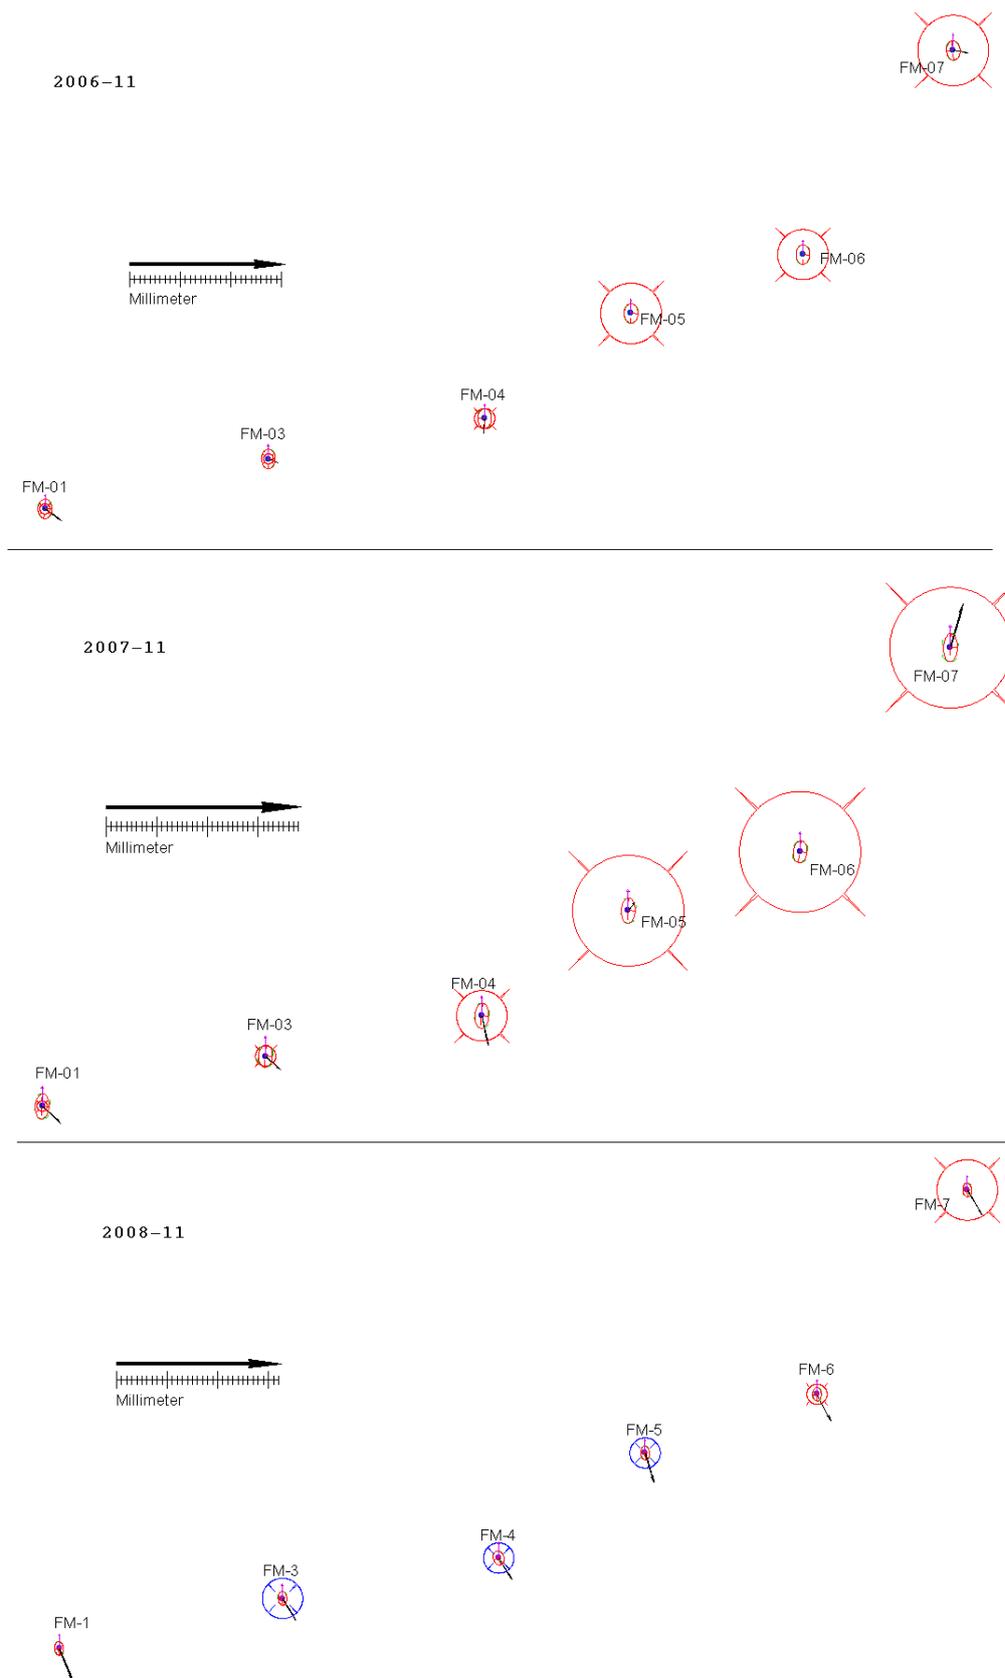
Resultata er synt i tabellar 3 og 4 og endringar grafisk i figur 7. Målingane både i alle tre åra syner god presisjon, men standardavvik for posisjon er klart underestimert som eit resultat av at sju mottakarar måler samstundes og det vert ei stor grad av korrelasjon i observasjonsmaterialet.

Figur 7: Grafisk framstilling av endring i punkta på Flatmark 2006–11 (øverst), 2007–11 (midt) og 2008–11 (nedst), med konfidensnivå for 99%. Grunnriss (pil), høgde (sirkel). Blå sirkler indikerer setning, raude heving.

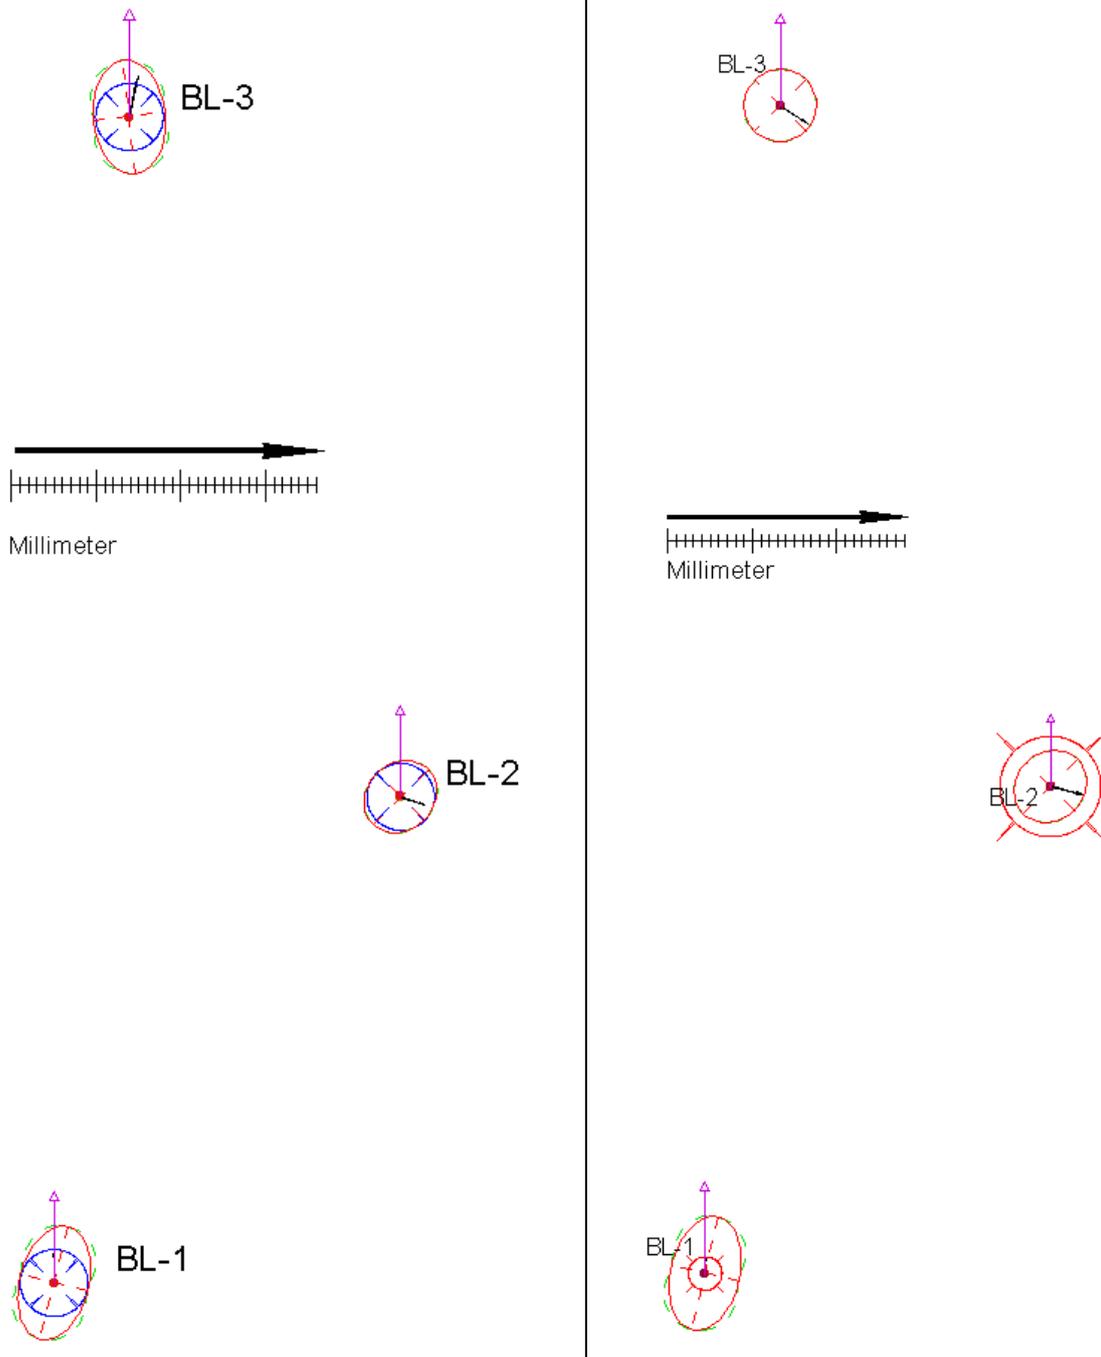
Det er ingen klare signifikante endringar, korkje i grunnriss eller høgd i noko av punkta (tabellar 5 og 6, figur 9). BL-1 har på grensa til signifikant endring i grunnriss frå 2006–07, men ikkje i høve til målingane i 2005. Punktet BL-3 syner og litt endring når 2005 resultatata vert lagt til grunn, men ein av vektorane i denne målinga var dårleg, og kan vere forklaring til dette. Mellom 2006 og 2007 syner ikkje punktet endring ut over tilfeldig målestøy.

Figur 9: Endringer i grunnriss og høyder for 2005–07 til venstre, 2005–09 til høyre, med konfidensellipser (horisontal) og stolpe (vertikal). Blå sirklar indikerer senking, raude heving.

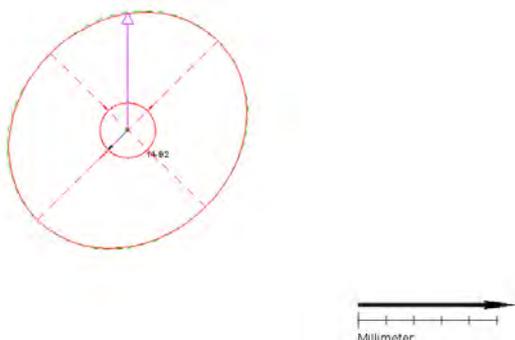
Figur 11: Endringar i punktet 14-B2, 2006–07.

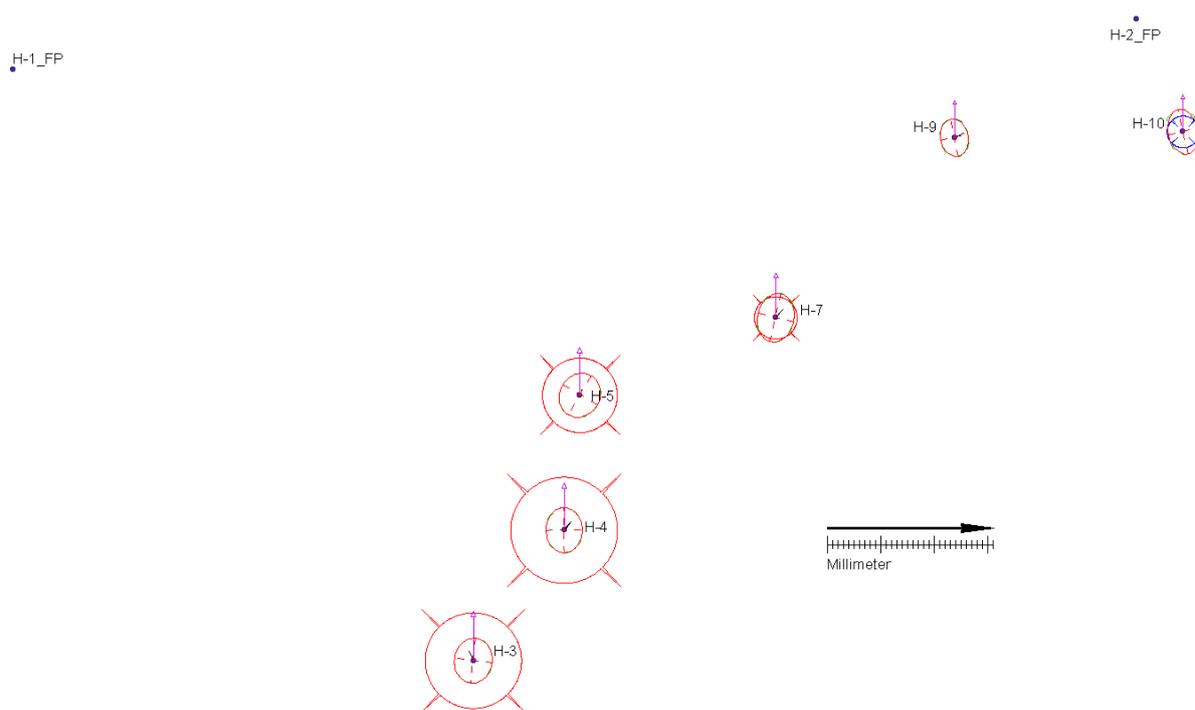
Figur 15: Grafisk framstilling av endring i punkta i Haddalura 2005–09, med konfidensnivå for 99%. Grunnriss (pil), høgde (sirkel). Raude sirkelar indikerer heving.

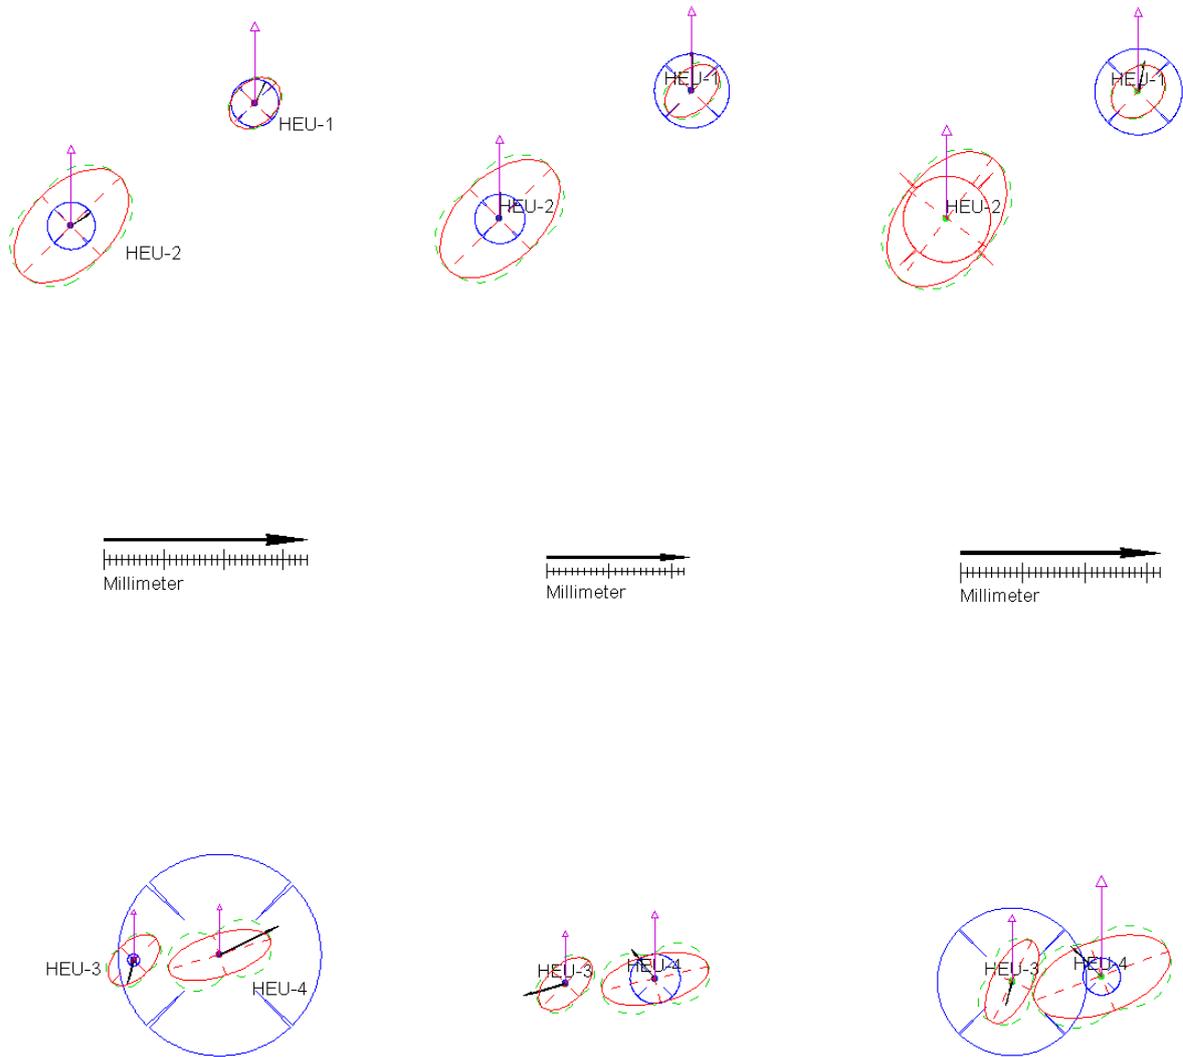
Figur 17: Endringar august 2005–august 2006 (venstre), endring august 2005–07 (midten) og endring 2005–08 (høgre).

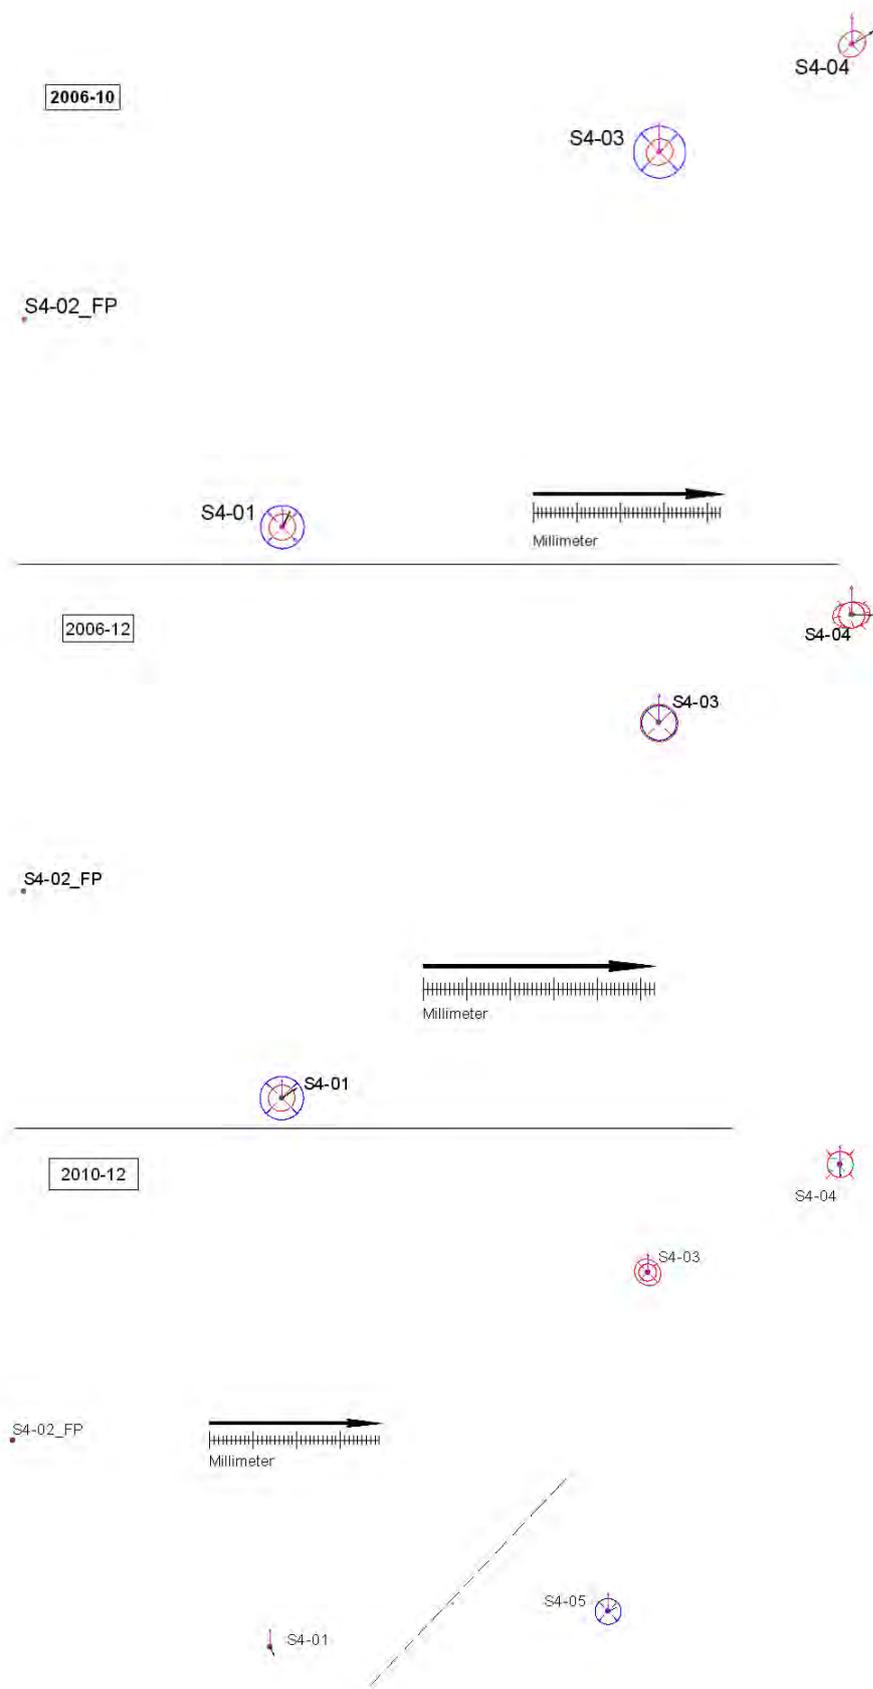
Figur 19: Endringer i grunnriss og høyder for ulike år, med konfidensellipser (horisontal) og stolpe (vertikal). Blå sirklar indikerer senking, raude heving. 2010–12 nedst inkluderer det nye punktet S4-05 lengs sør – plassering er ikkje korrekt på figuren.

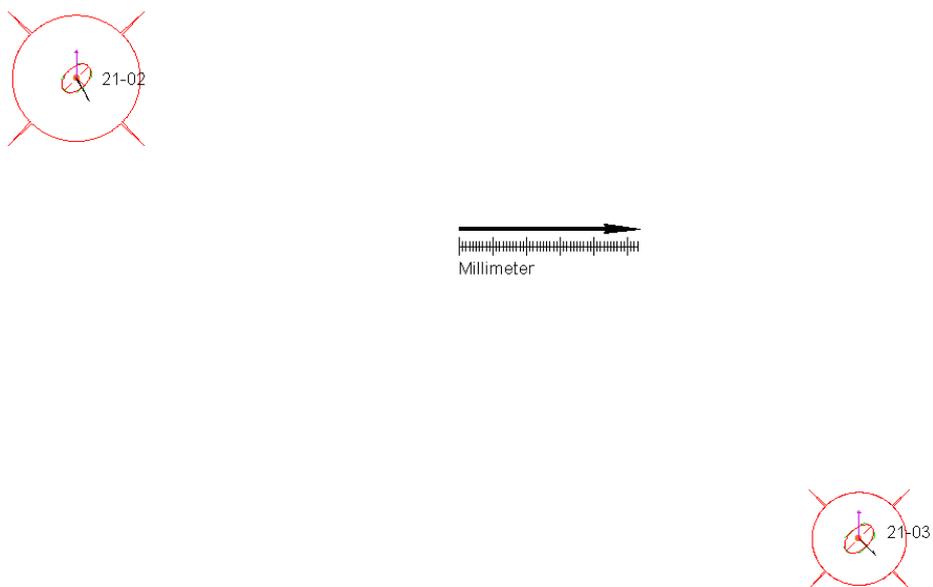
Figur 22: Endring i punkta, 2006–11 med konfidensnivå for 99%. Grunnriss (pil), høgde (sirkel). Raud sirkel indikerer heving.

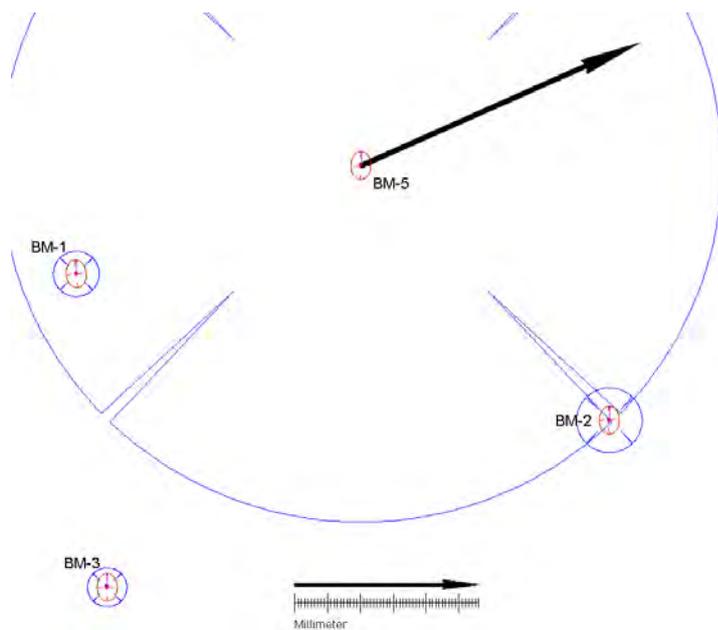
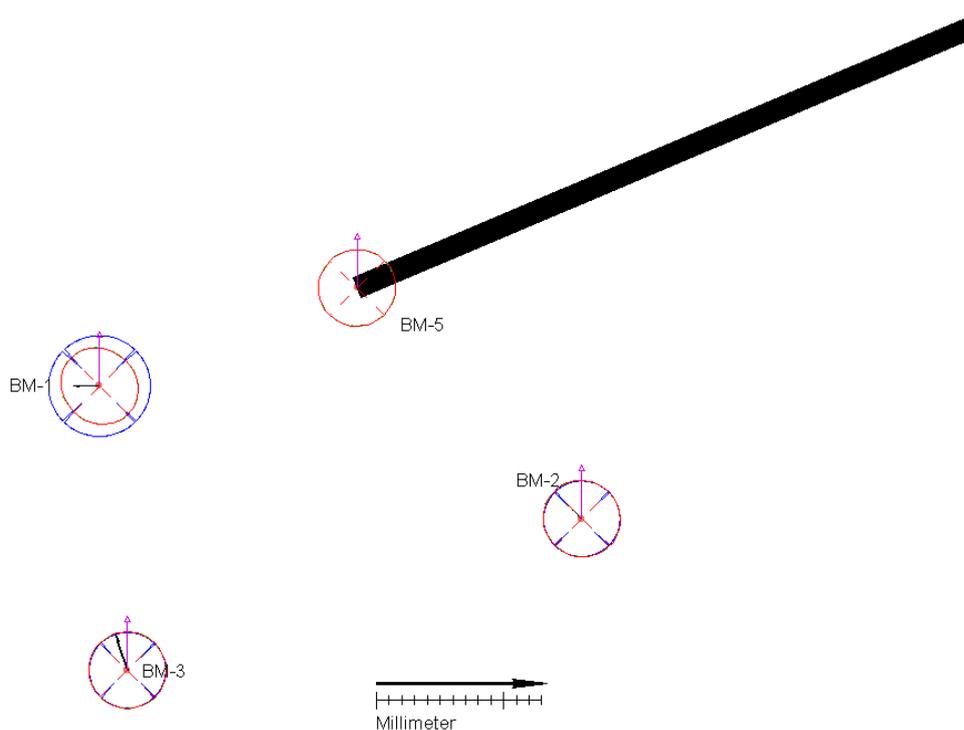
Tabell 17: Endringer mellom målinger for punkt på Mannen 2004–10. Den store variasjonen i høgd i BM-1 er ikkje reell. Det skuldast svake målinger i 2008. Det er berre punktet BM-5 som syner konsistente endringar over tid.

Figur 25: Grafisk endring grunnriss og høyde for punkta på Mannen, 2006–2009 (øverst) og 2006–2010 (nedst). Figuren for 2006–10 er i meir detaljert skala slik at horisontal og vertikal endring i punktet BM-5 går utanfor figuren. Fastpunktet på Mannen (BM-4), etablert 2006 er ikkje med på figuren.

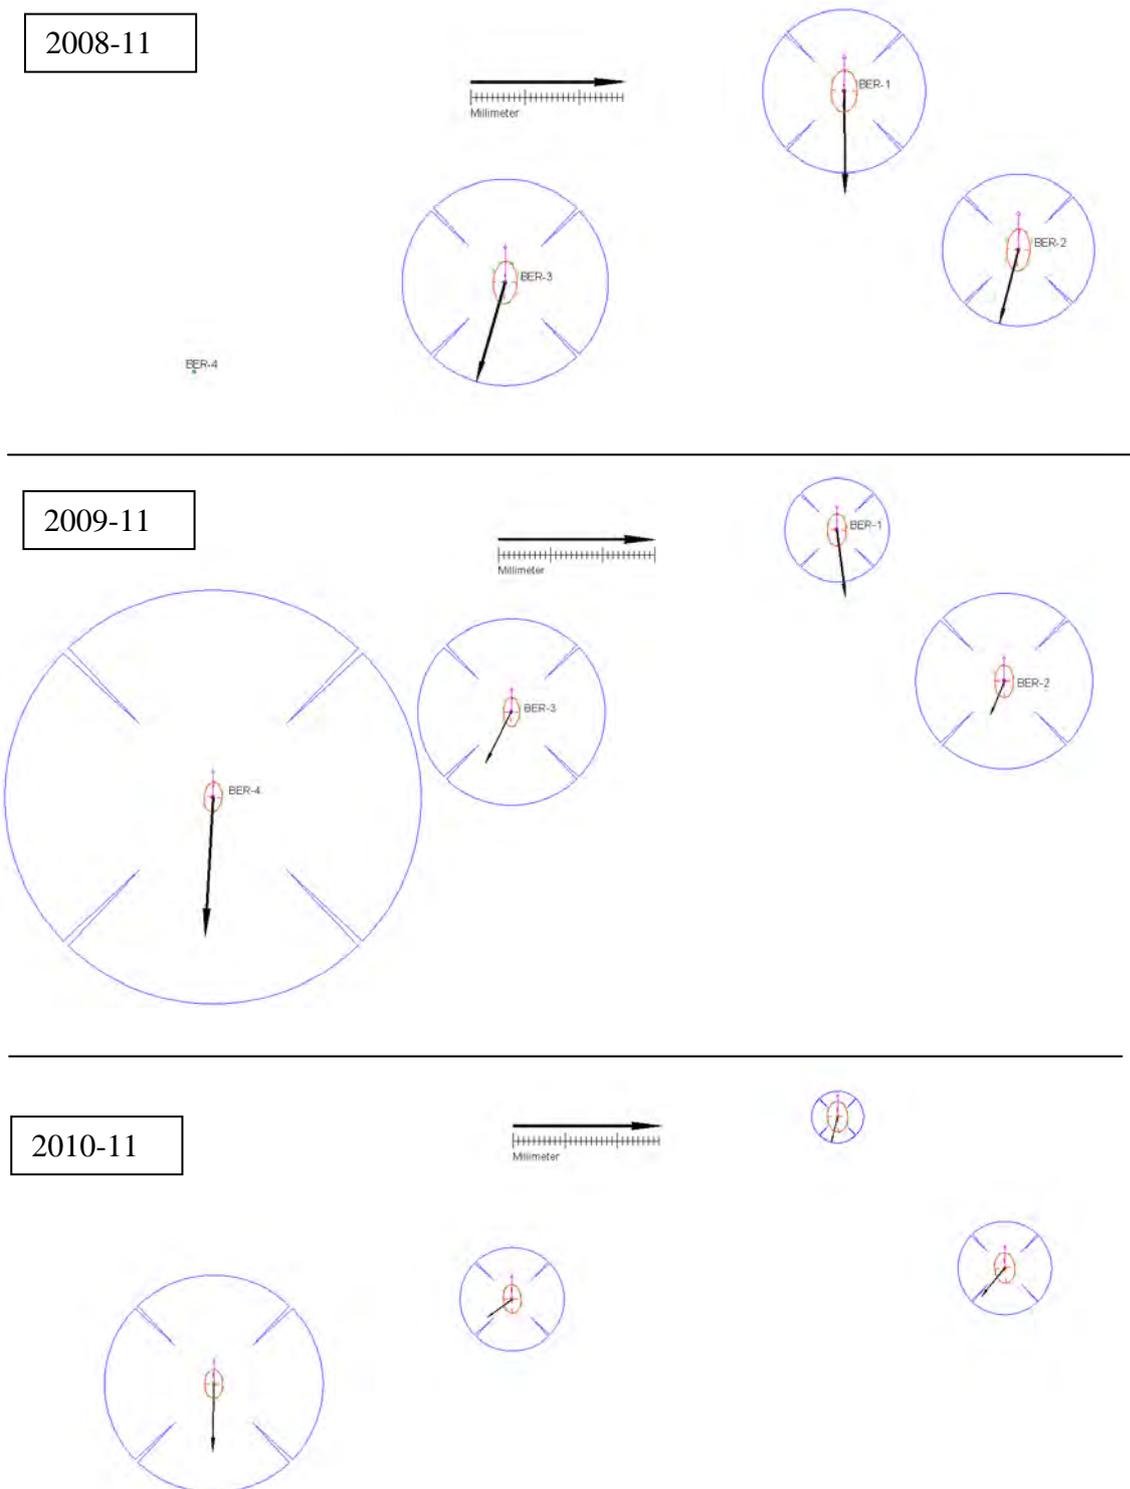
Figur 27: Grafisk framstilling av endring i punkta ved Middagstinden 2008–11 (øverst), 2009–11 (midten) og 2010–11 (nedst) med konfidensnivå for 99%. Grunnriss (pil), høyde (sirkel). Blå sirkler indikerer setning. (Punktet BER-4 vart etablert 2009).

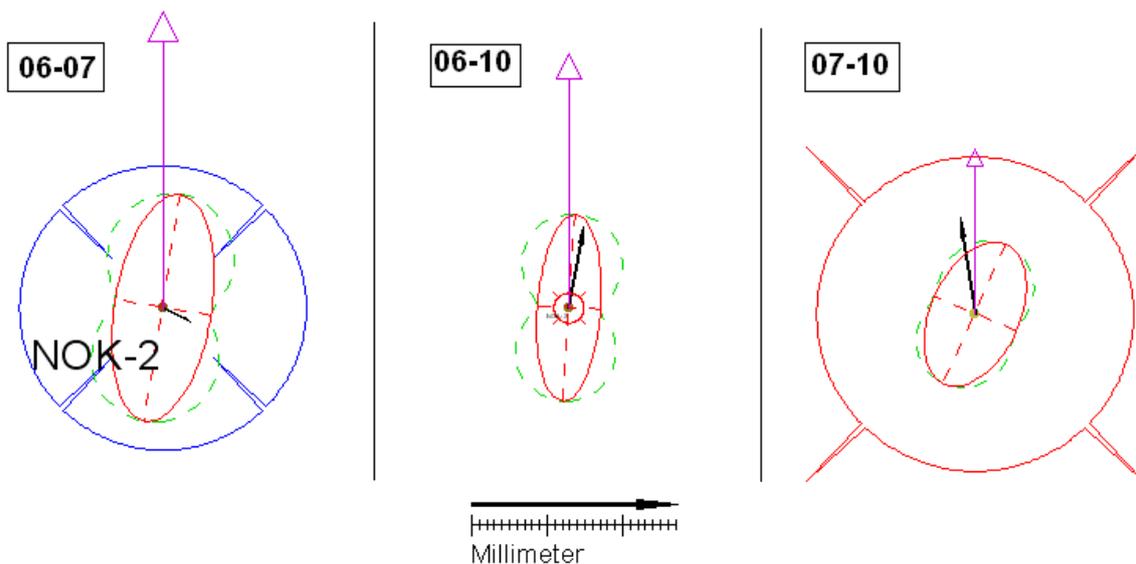
Figur 29: Horisontal- og vertikal-endringer på Nokkenibba. 2006–07 (til venstre) og 2006–10 (midten) og 2007–10 (til høyre), med 99% signifikansgrenser.

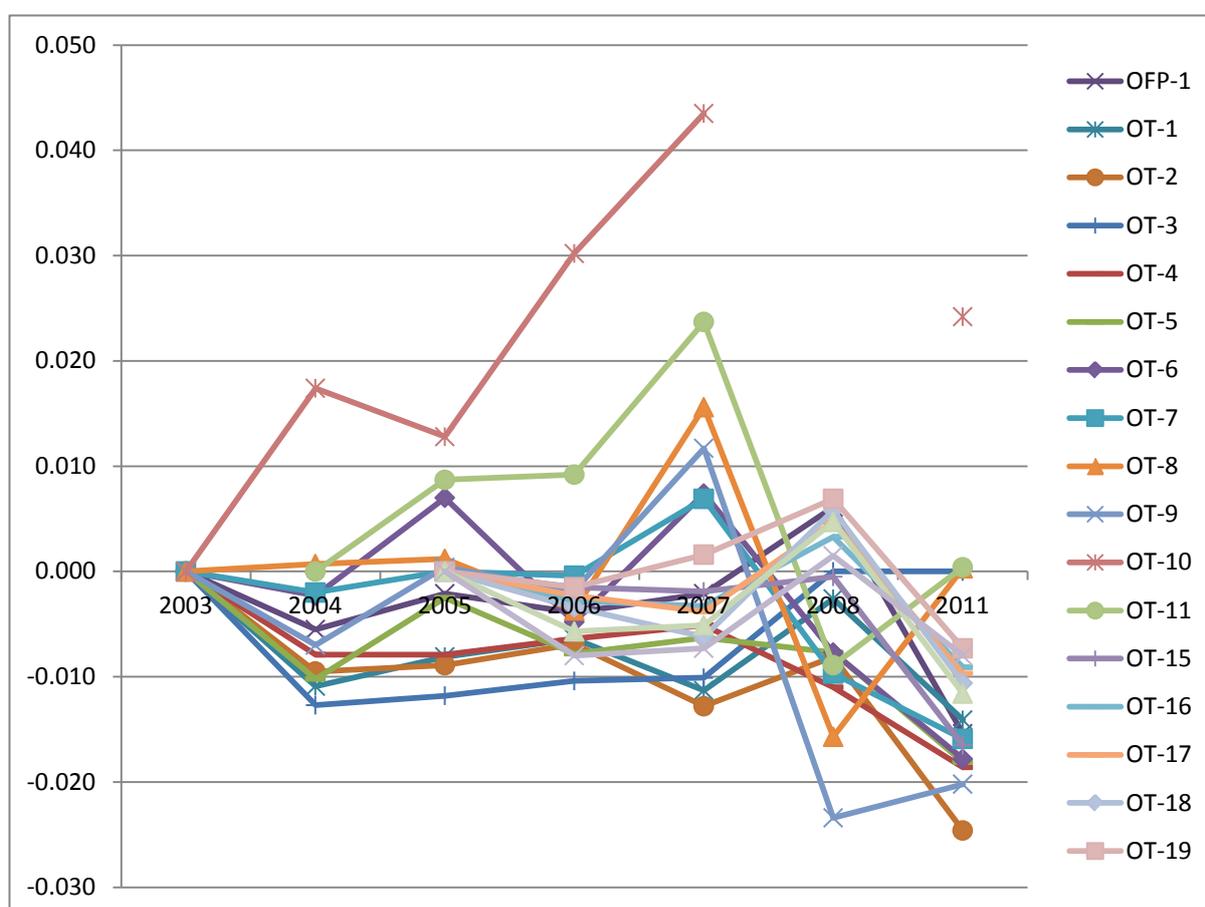
Figur 32: Relative høgdeendringer for punkta på Oppstadhornet. Punkta med store positive utslag er punkta i den nedre delen av området der variasjonar i meteorologiske tilhøve verkar sterkt inn på resultatet.

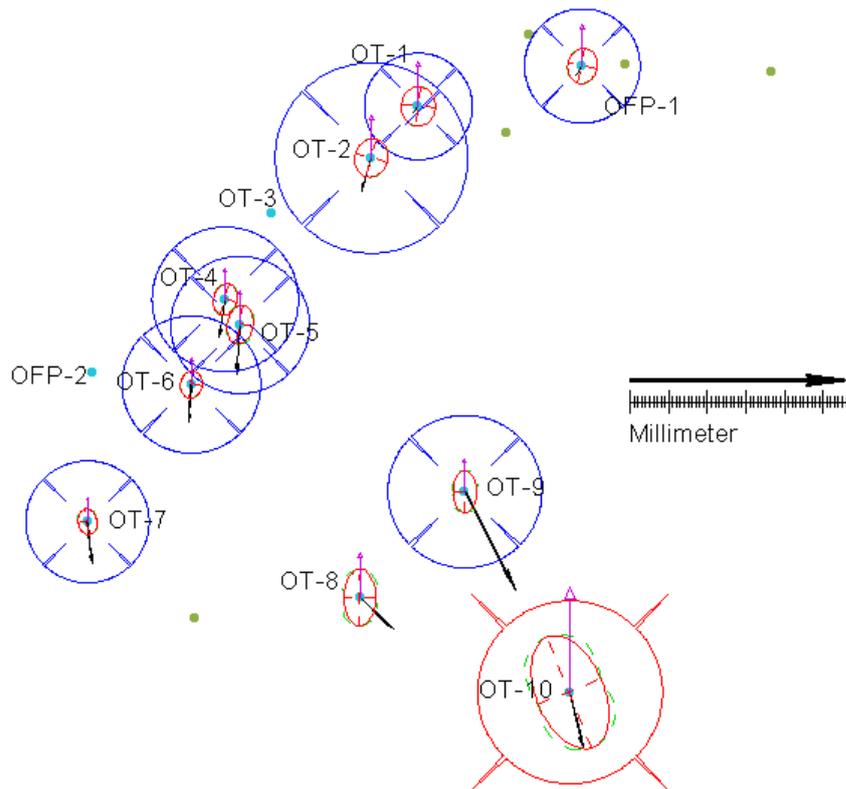
Det er påvist små men signifikante rørsler i punkta i den vestre delen. Ganske lik trend over fleire år styrkjer konklusjonen om at det er rørsle i punkta på om lag 1 mm/år.

I nokre av dei nye punkta (2005) på toppryggen er det og indikasjonar på rørsle, men dette er meir usikkert. I dei nedre punkta er endringane litt større, ca. 2 mm/år, og serleg horisontal trend er konsistent for dei ulike analysane.

Figur 33: Endringar Oppstadhornet, 2003–2011, med konfidensnivå for 99% (raud ellipse/ fiolett pil). Grunnriss (pil), høgde (sirke). Blå sirklar indikerer setning, raude sirklar heving.

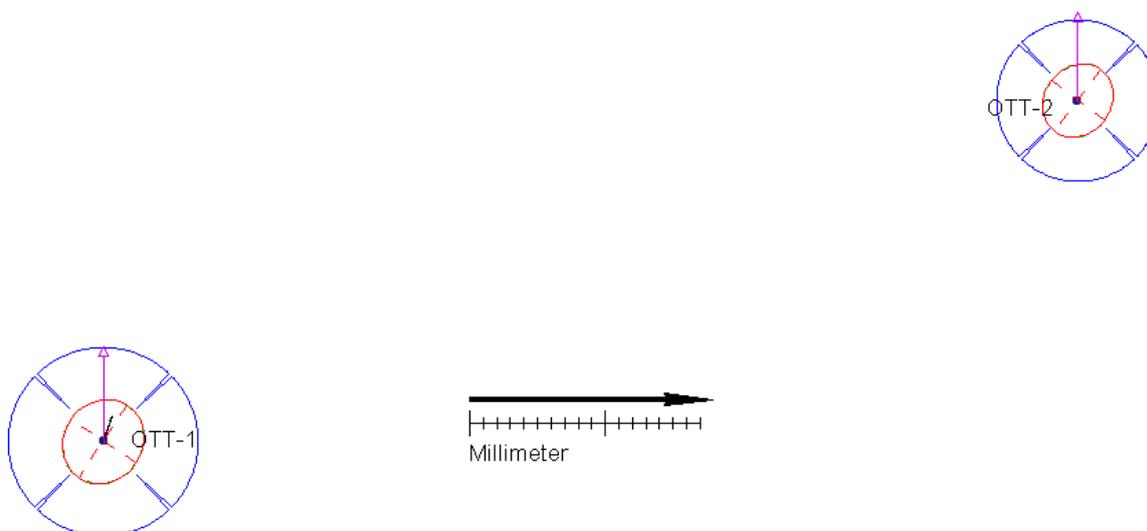
Punkta er målt om i 2009. Resultata er synt i tabell 24 og endringar grafisk i figur 37. I høgd er det på grensa til signifikant setning i punkta OTT-1 og OTT-2 på 7 og 6 mm. Sidan resultat i høgd er meir usikre, og standardavvik kan vere underestimert, er det usikkert om dette er reelle endringar.

Figur 37: Grafisk framstilling av endring i punkta på Ottem 2008–09, med konfidensnivå for 99%. Grunnriss (pil), høgde (sirkel). Blå sirklar indikerer setning.

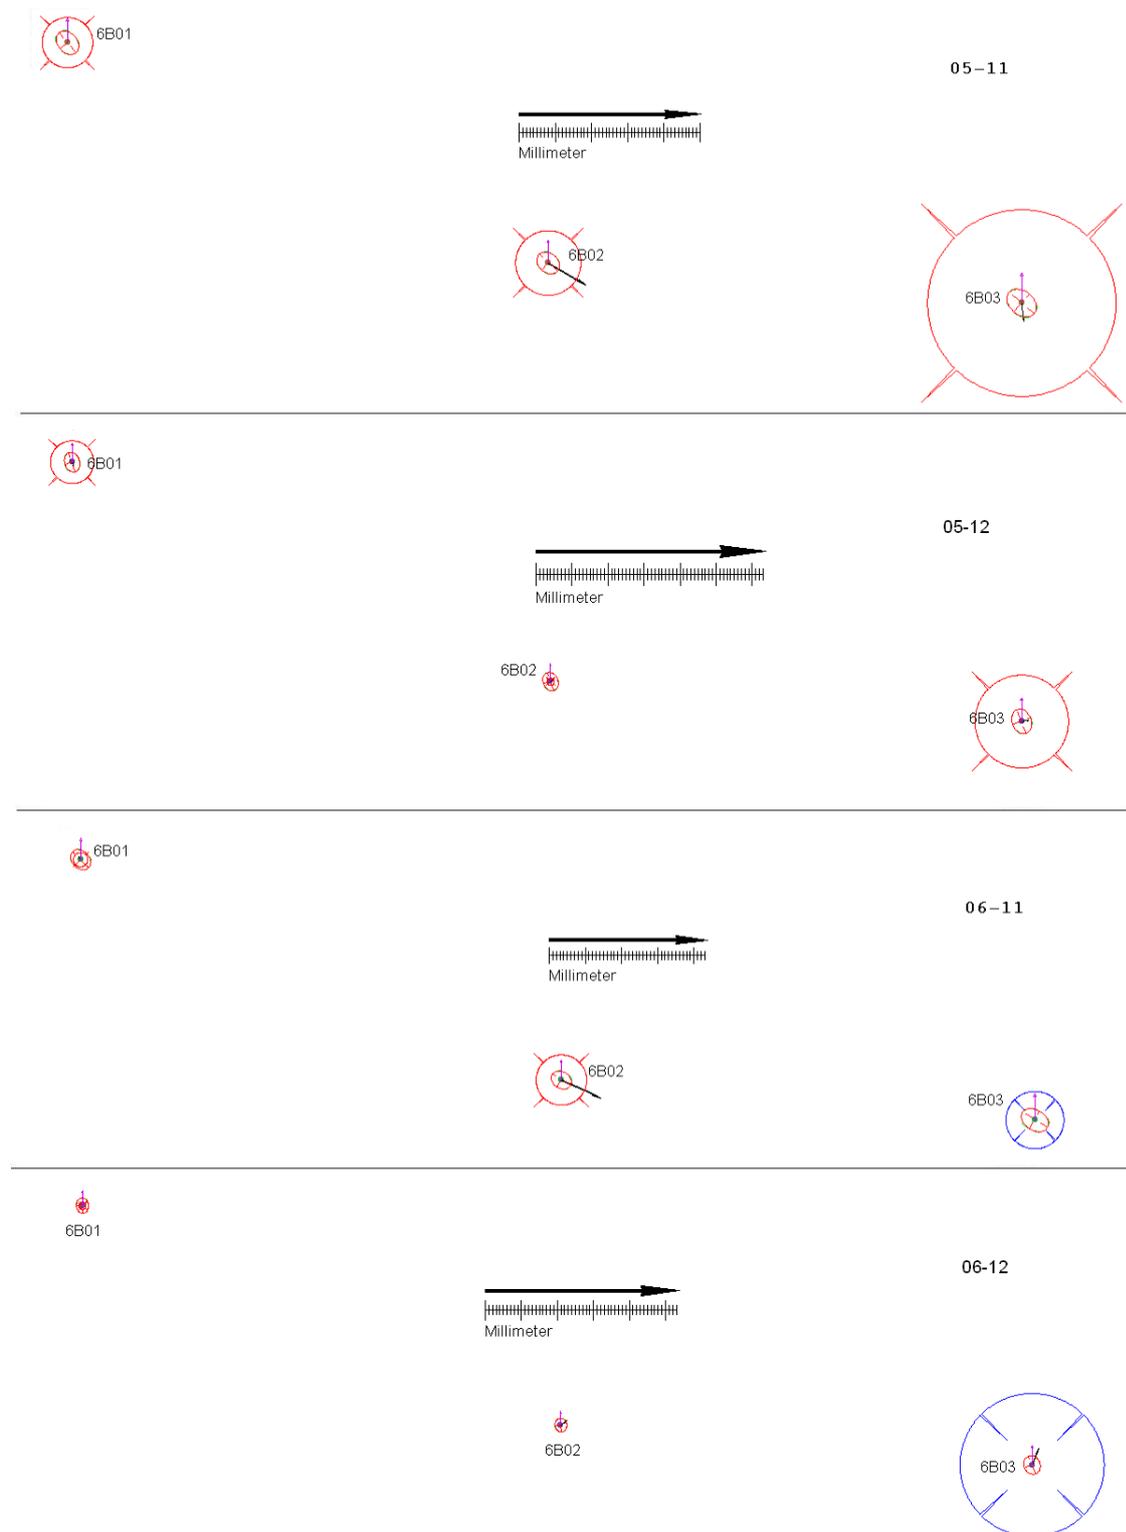
I 2011 var antenna i punktet 6B-02 ikkje i lodd, men avviket vart målt med klinometer og koordinatane er korrigerert. Det er likevel noko større uvisse i resultatet i dette punktet enn i dei andre punkta. Punktet får for 2011 signifikant horisontal endring, men tidlegare observasjonar syner ikkje slik endring og utslaget skuldast mest truleg manglande eller feilaktig korreksjon.

Figur 39: Endringar for ulike periodar 2005–12 med konfidensgrenser for 99% . Grunnriss (svarte piler) og høgd (sirklar). Raude sirklar indikerer heving, blå setning. 2005 resultatet var svært lav høgd i 6B03, medan 2006 var relativt høg og er årsak til det ulike biletet med 2005 og 2006 som utgangspunkt.

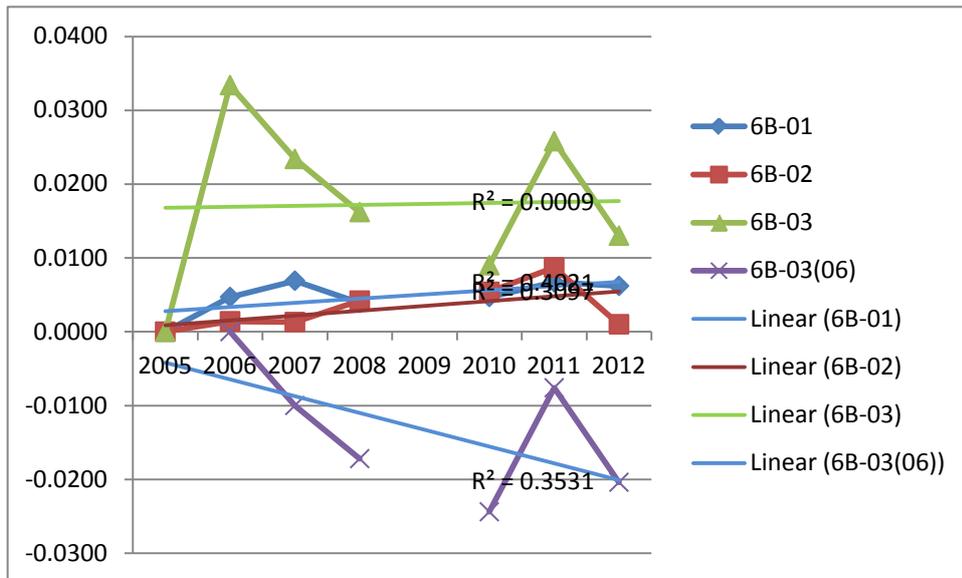
Figur 40: Endringer i høgde, med trendliner for endring.
