GEOLOGI FOR SAMFUNNET

GEOLOGY FOR SOCIETY

Report no.: 2013.014		ISSN: 0800–3416	Grading: Open
Title: Investigations on unstable rock slopes in Møre og Romsdal – status and plans after field surveys in 2012			
Authors: T. Oppikofer, A. Saintot, S. Otterå, R.L. Hermanns, E. Anda, H. Dahle, T. Eiken		Client: Norwegian Water Resources and Energy Directorate (NVE)	
County: Møre og Romsdal		Commune:	
Map-sheet name (M=1:250.000) Ålesund, Kristiansund, Røros, Ulsteinvik		Map-sheet no. and -name (M=1:50.000)	
Deposit name and grid-reference:		Number of pages: 323	Price (NOK): 1285,-
Fieldwork carried out: 2006–2012		Date of report: 13.11.2013	Map enclosures: 0
Fieldwork carried out: 2006–2012		Date of report: 13.11.2013	Project no.: 309900
Fieldwork carried out: 2006–2012		Date of report: 13.11.2013	Quality control: <i>Halvor Brundhoff</i>
<p>Summary:</p> <p>This report presents investigations, analyses and displacement measurements made between 2006 and 2012 on 131 unstable or potential unstable rock slopes in Møre og Romsdal County (Western Norway). An extract of this report is available in Norwegian (NGU rapport 2013.053).</p> <p>These investigations are part of the national plan for

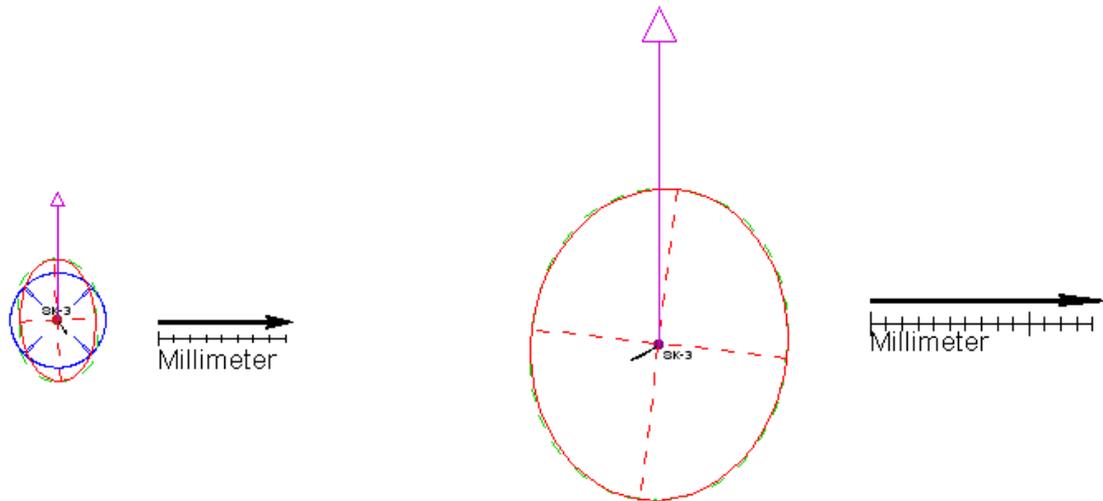
Figur 42: Grafisk illustrasjon av endringar i punkt SK-3, 2006–07 til venstre, 2006–12 til høgre – ingen signifikant endring (høge standardavvik i 2012 gir stor konfidensellipse).

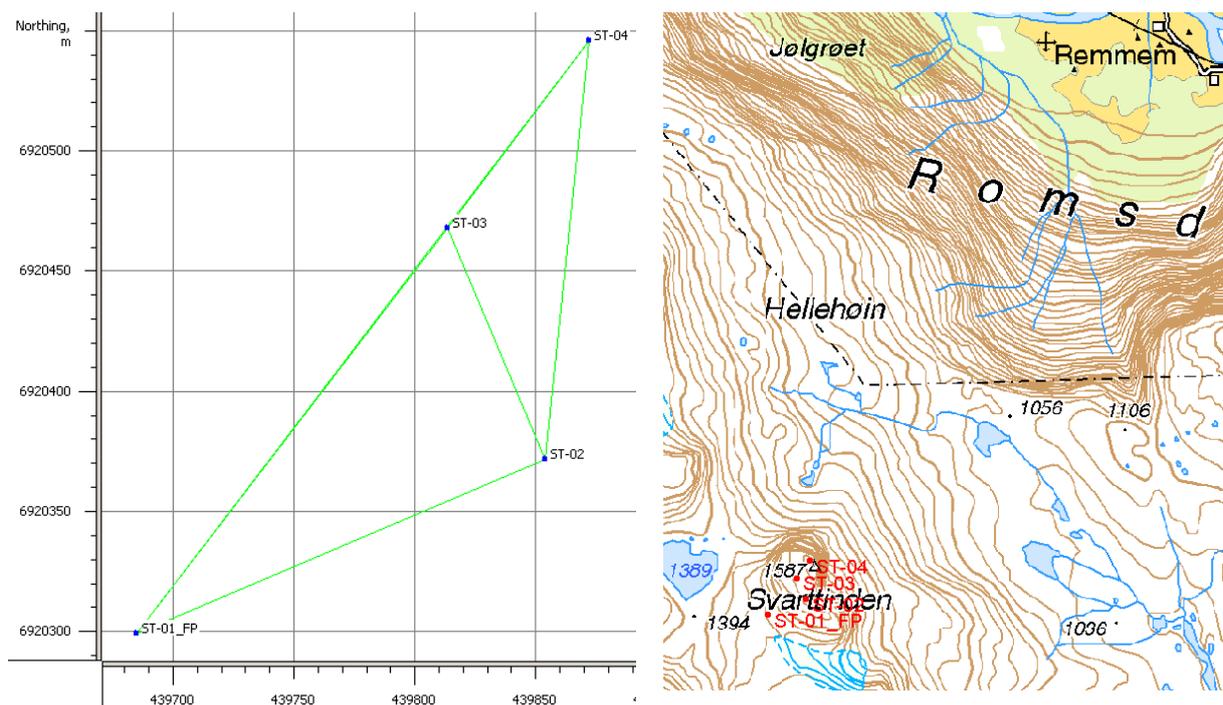
Figur 44: Riss over GPS-vektorar, ST-01_FP er fastpunkt. Kartskisse med punkt (Sk-N50).

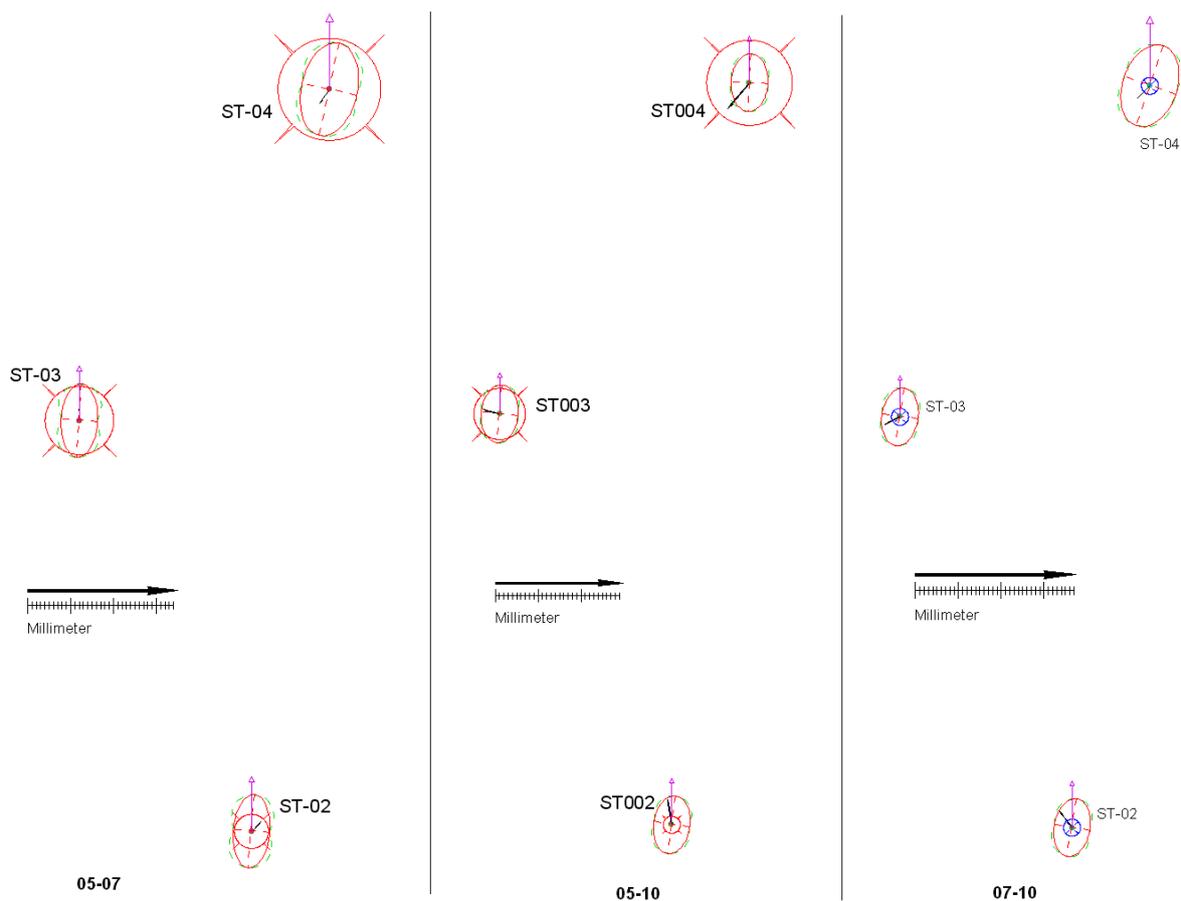
Resultata for perioden 2005–10 er gitt i tabellar 30 og 31 og figur 45, og syner ingen signifikante endringar, korkje i plan eller høgd. Det er stor høgdeskilnad frå referansepunktet til dei tre andre punkta, og det gir noko høge standardavvik for vektorane i prosjektet. Dette fører til at sjølv om det er vertikale endringar på meir enn 1 cm er dette, som det går fram av figur 45, ikkje signifikant endring. Variasjonane ein finn i koordinatane ligg elles innanfor testgrensene, og det er ikkje grunnlag for å seie at punkta er i rørsle.

Figur 45: Horisontal- og vertikal-endringar for punkt på Svarttinden for 2005–07 (til venstre), 2005–10 (midten) og 2007–10 (til høgre) med signifikansgrenser for 99%.

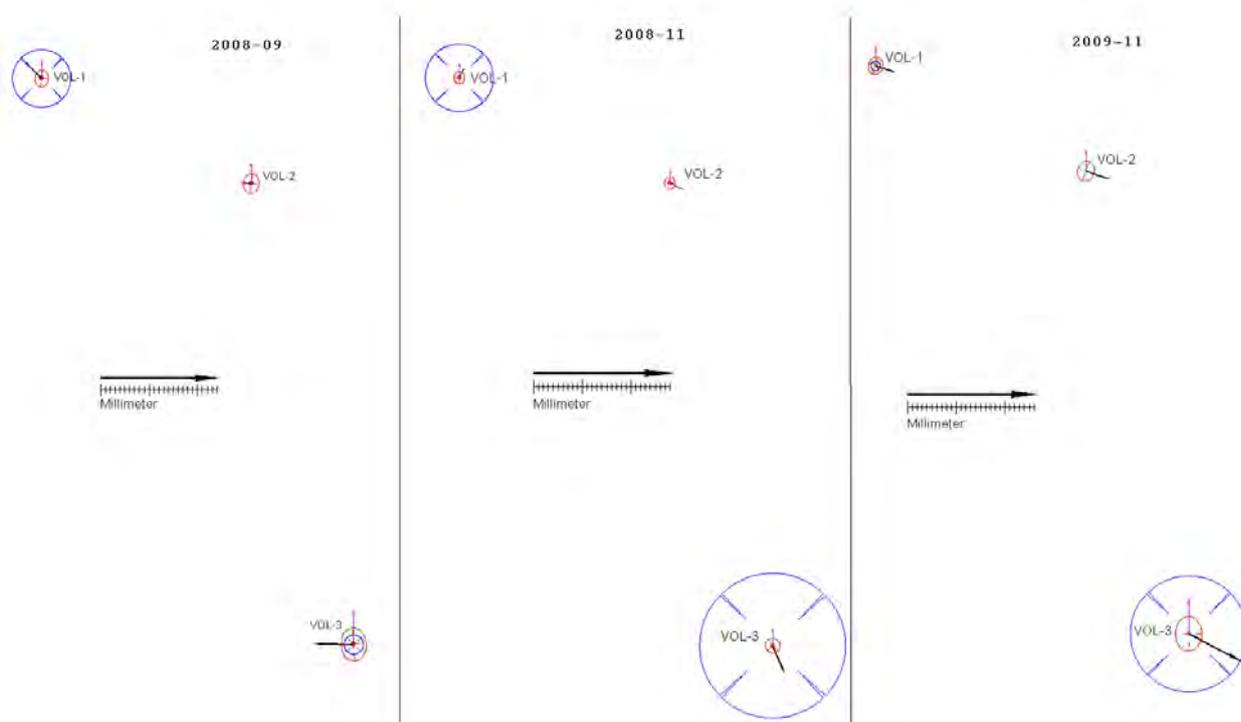
Målingane i alle åra er gode. Resultata for 2008–09 indikerte små signifikante endringar i planet i to av punkta (VOL-1 og VOL-3) med 5 og 8 mm. Resultata for 2011 peiker i planet til dels i motsett retning av 2009, og er såleis inga eintydig stadfesting av rørsle i området. Målingane på Vollan i 2011 har dei same meteorologiske ”problema” som på Gikling med ekstremt fuktig luft, og resultat prosessert med normalatmosfære gir urealistiske resultat for høgder, med heving i alle punkta. Bruk av same parameter som på Gikling – 70 % RH – gir nesten uendra høgder i dei to øvre punkta, men relativt stor setning i det nedste. Dette resultatet er difor ekstra usikkert grunna uvissa som er knytt til dei meteorologiske tilhøva.

Figur 47: Grafisk framstilling av endring i punkta ved Vollan 2008–11, med konfidensnivå for 99%. Grunnriss (pil), høgde (sirkel). Blå sirkelar indikerer setning.

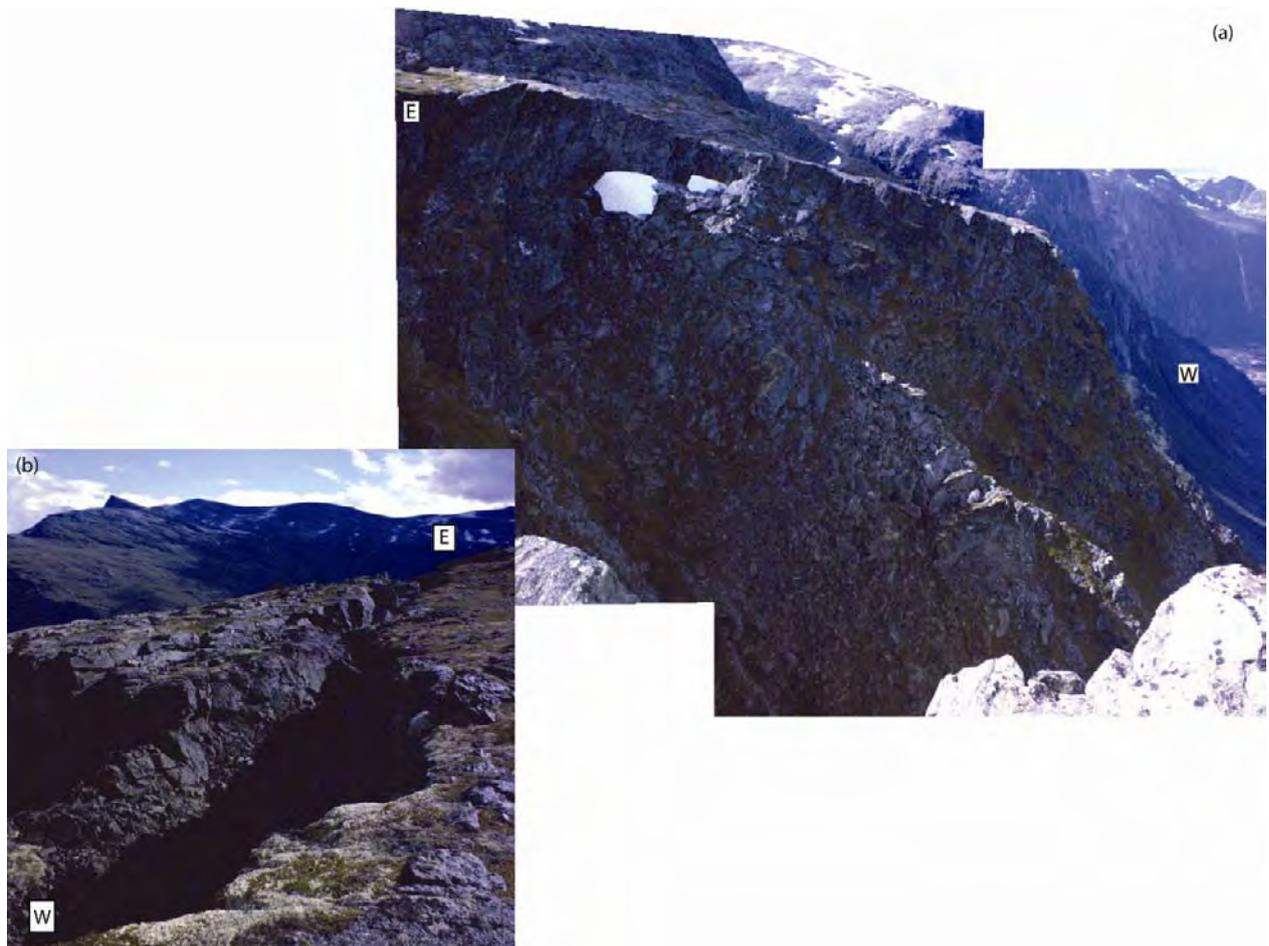
The Flatmark site is located along the valley of Romsdalen, south-east of Mannen and Børa. Its main part is a block of 15 Mm³ sliding toward the Nord (Figure 2a and Figure 3). A 700 m long and opened back scarp is visible on the plateau at the top. It has a 25-50 m opening and is oriented W-E (Figure 2b).

Figure 2: (a) Panorama view of the instability of Flatmark and (b) its back scarp

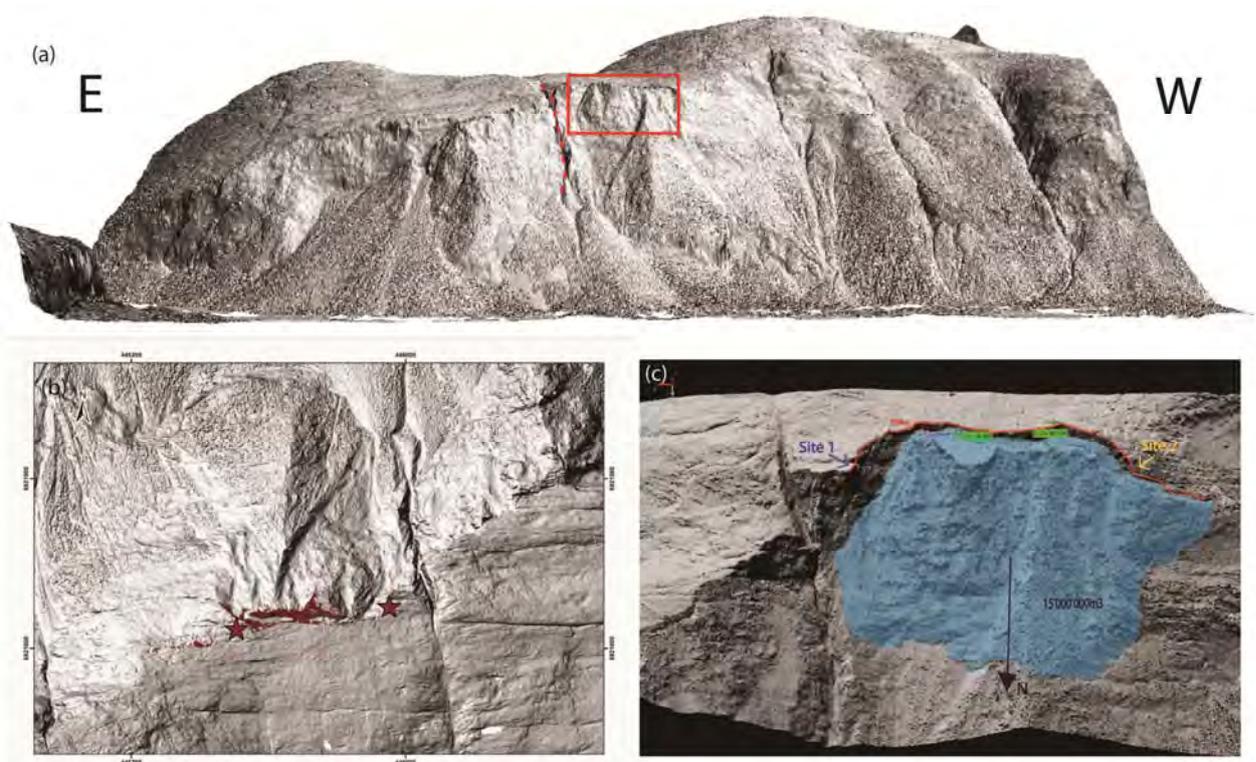
Figure 3: (a) View of the Southern side of Rosmdalen with the Flatmark site in the red box (airborne lidar data), (b) Point clouds projected on the hillshade in red and position of the Lidar during the acquisition (red stars), (c) the unstable compartment (blue), sliding down toward the North, and location of the two sites.

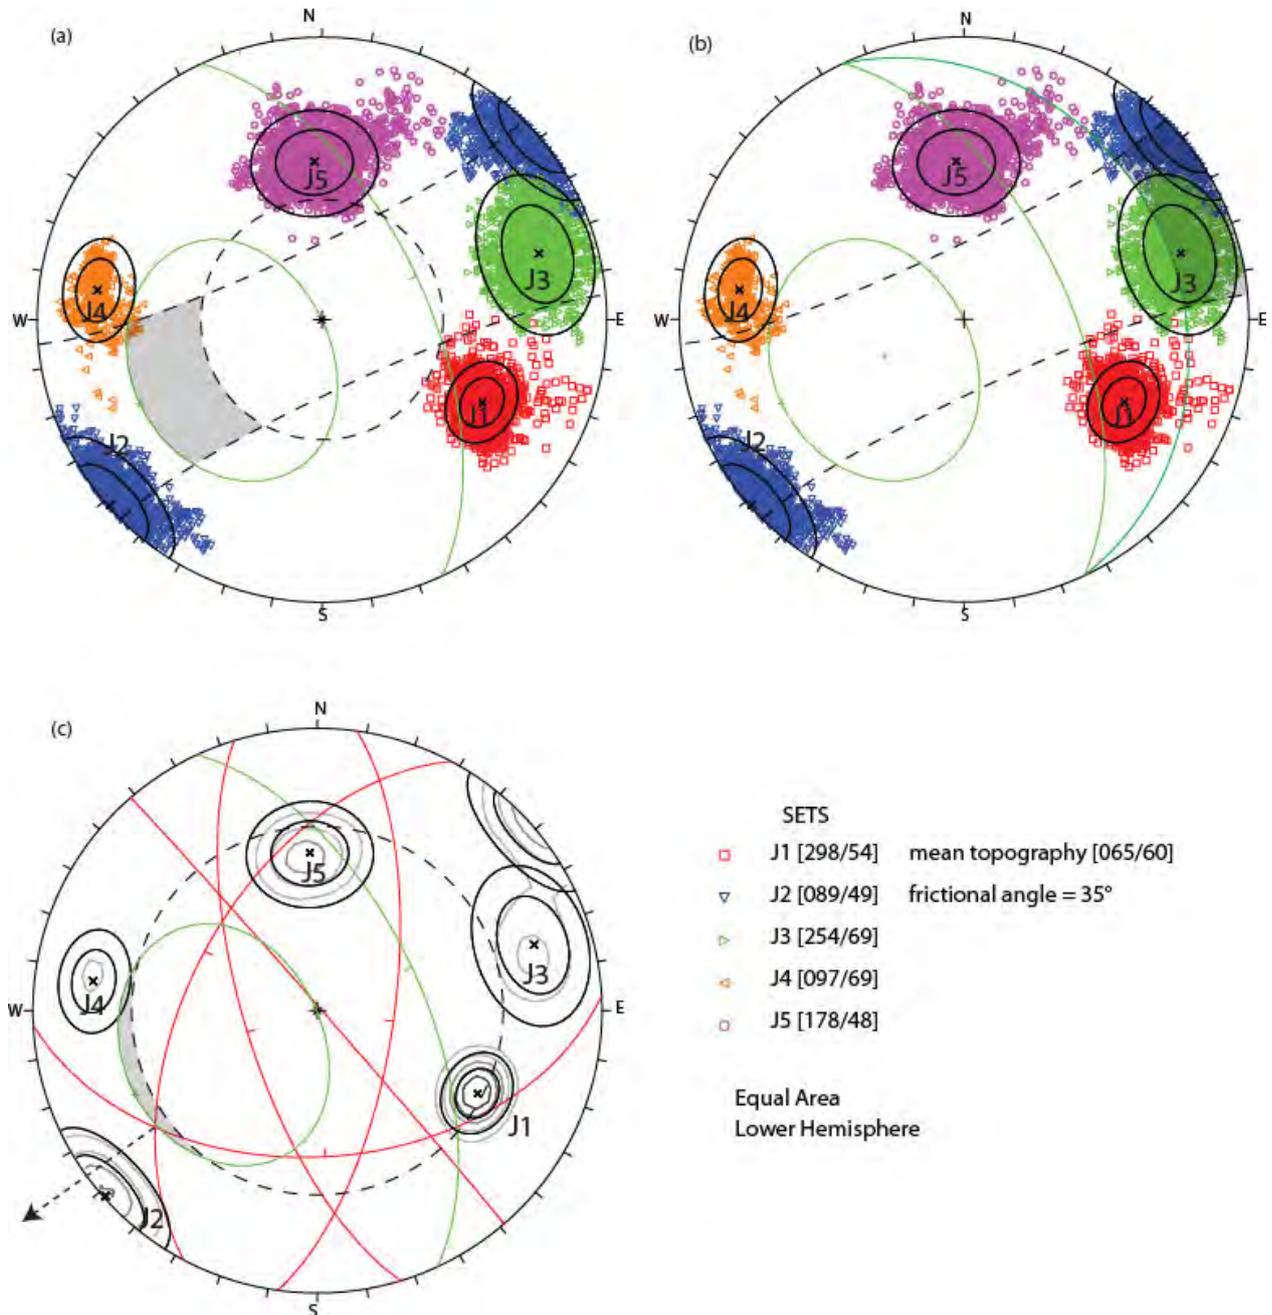
According to the kinematic tests, toppling is the most important mechanism in this zone (Figure 7b). The two discontinuity sets that could likely generate toppling are J2 and J3. Planar sliding is also possible along J4 (Figure 7a) and the discontinuity sets $J1 \wedge J5$ could generate wedge sliding.

Figure 7: Kinematic test on site 1 for planar sliding (a), toppling (b) and wedge sliding (c).

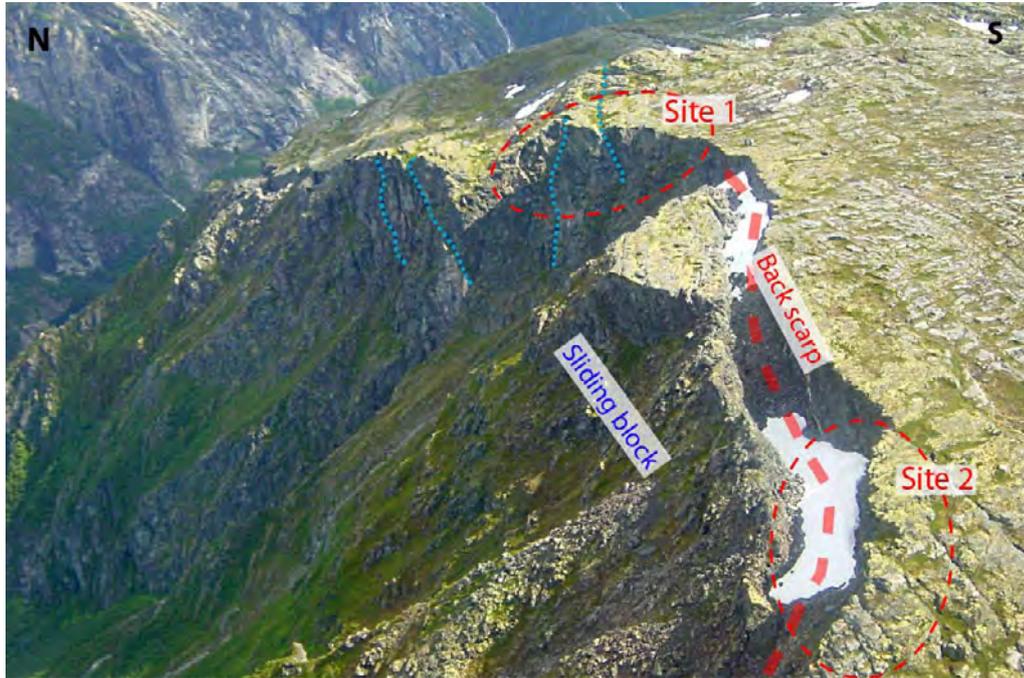
Some E-W cracks are visible on Figure 3c and Figure 8 in the sector of the site 1. The prolongation of these cracks makes steps in the topography of the plateau. They may be developed along a sub-vertical foliation (to be checked with field measurements). The dip angles of these cracks are steeper in the top part than in the lower part, indicating a potential down-bending with an important toppling component of the all eastern side. This toppling may be part of a much larger sagging affecting the whole mountain side below the site 1.

Figure 8: view of the main sliding block of Flatmark and of the two sites analyzed in details. Light blue line: steep E-W cracks.

For rockfalls, the most critical blocks should be identified and monitored (possibly with a radar system), particularly in the eastern part of Flatmark. A GPS monitoring of the central sliding block should be performed on a yearly basis. A similar monitoring would be useful on the sides of the main scarp to detect slow displacements. In general, any rockfall activities should be announced and recorded as they can represent a direct hazard but also because they can be early indicators of a much bigger slope movement.

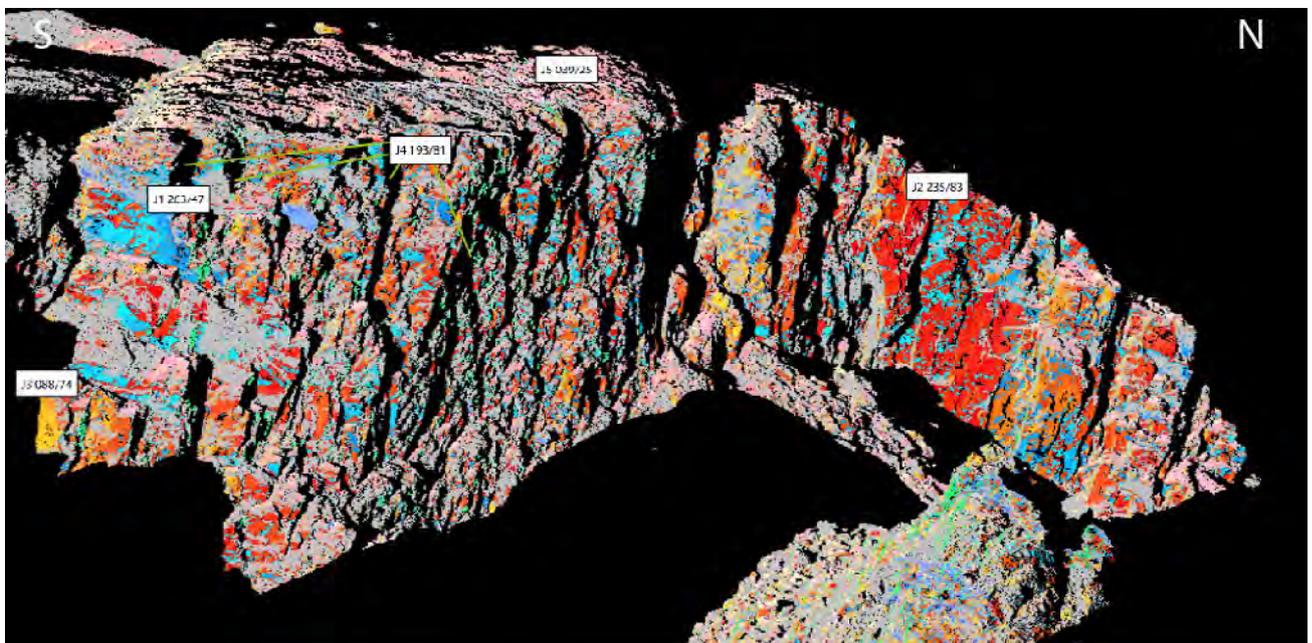
If we represent the site 2 according to these five discontinuity sets, the J2 discontinuity set makes the major part of the cliff. The combination of J2, J3 and J4 divide the rock mass in columns (Figure 12).

Figure 12: Lidar points cloud classified according to the main sets of discontinuities (blue=J1, red=J2, yellow =J3, green=J4, light pink=J5, gray=other)

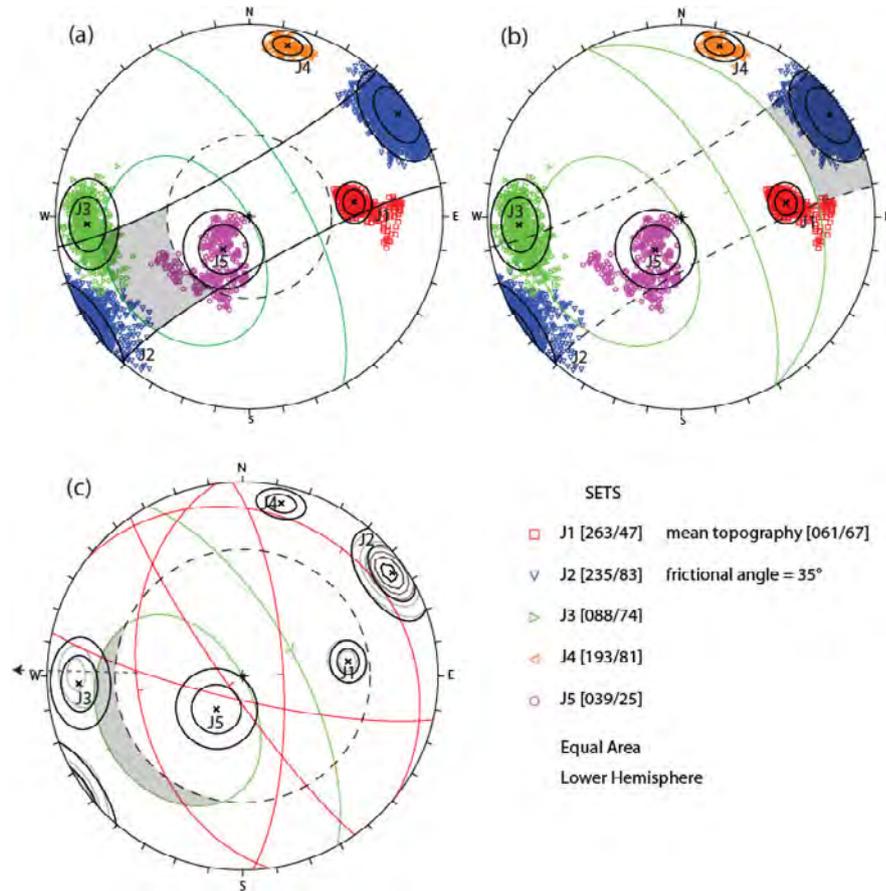
A mean topography of [061/67] was chosen based on the airborne lidar DEM. According to the kinematic tests, planar sliding is possible along J5, J3 and J2 and

toppling along J1 (Figure 13) but the most important failure mechanism affecting the area is toppling due to J2. $J1 \wedge J4$ could eventually generate a wedge.

Figure 13: Kinematic test on sector 2 for planar sliding (a), toppling (b) and wedge sliding (c).

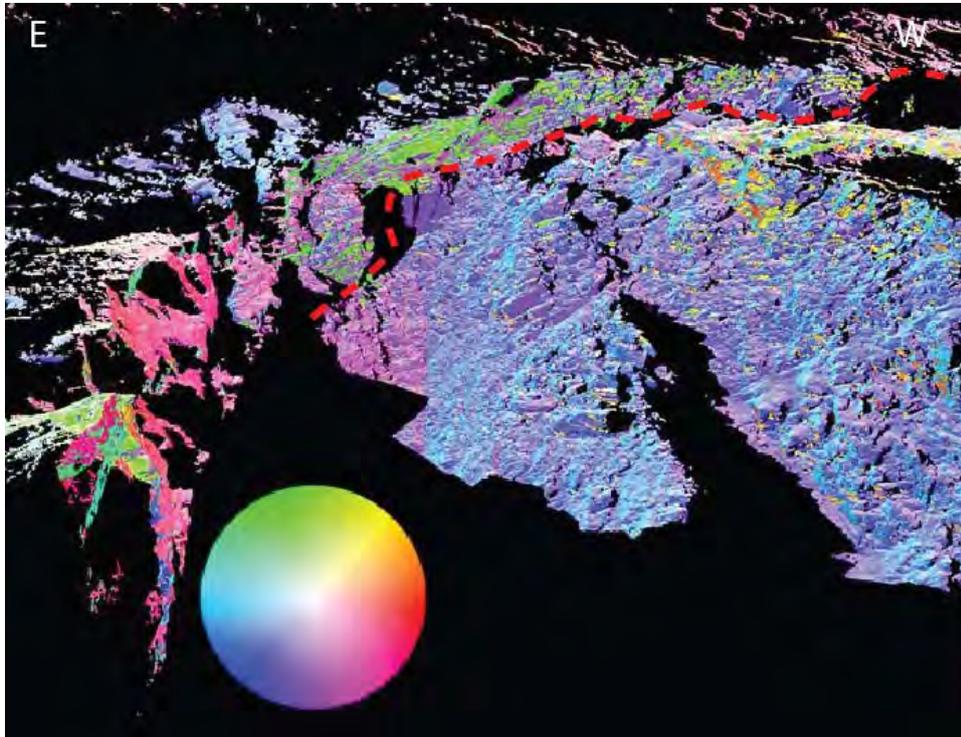
Figure 14: View of the central back scarp (red line: limit between the scarp and slid block) in Coltop 3D.

The orientation of the back scarp plane has an average orientation of [175/85], corresponding to the foliation S1 [176/78] measured in the field. Some part are south dipping (green) and some part north dipping (violet). In this area, folding influences the foliation orientation. If the lower prolongation of this sub-vertical foliation is slightly turning it can form a steep north-dipping sliding surface and it can be the cause of the displacement observed in the field. Presently we have only data for the top part of this instability.

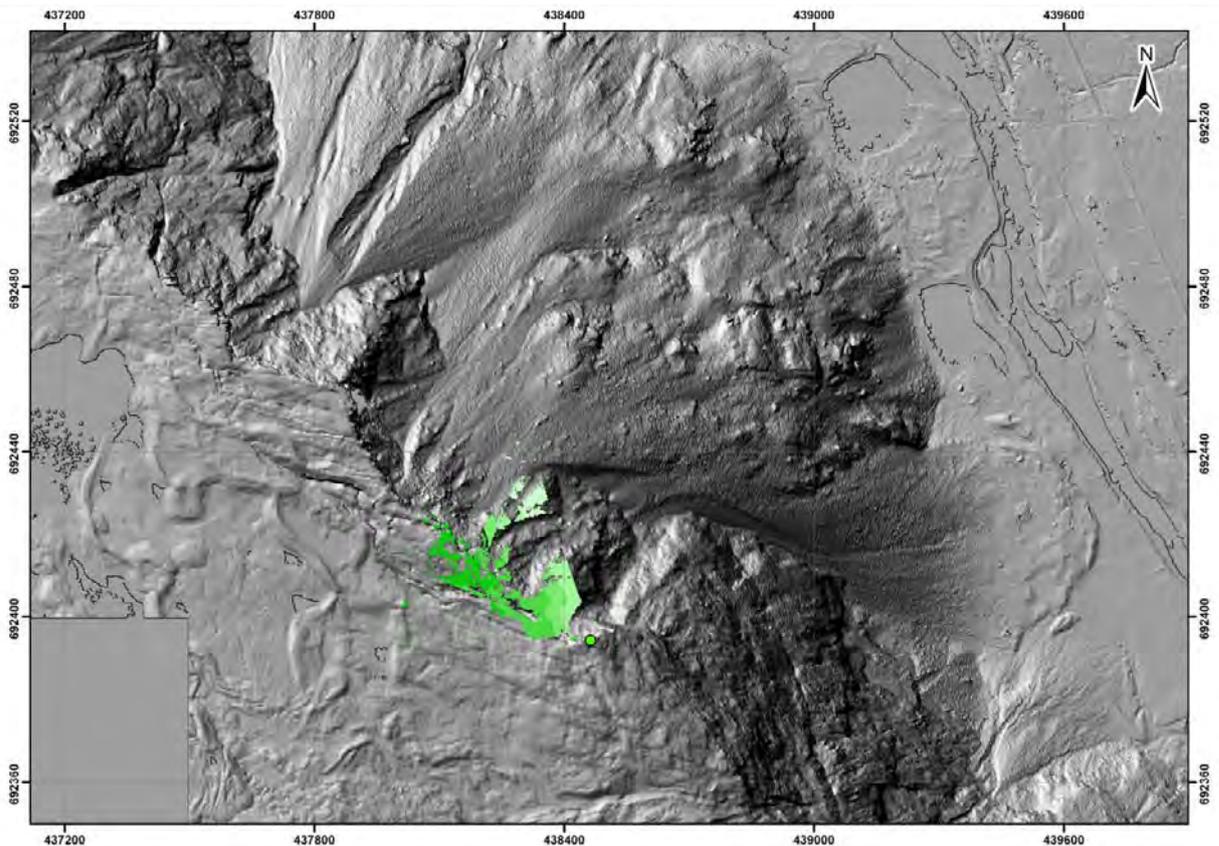
Figure 15: Upper and lower scanned sites and lidar positions (green circle) at Børa.

Monitoring of points around the graben and along the edge of the cliff is important to know if slow movements of large volumes are occurring and to delimit the different blocks. Important rockfalls already happened as it can be observed in the eastern part of Figure 15, with a run-out almost down to the Rauma river.

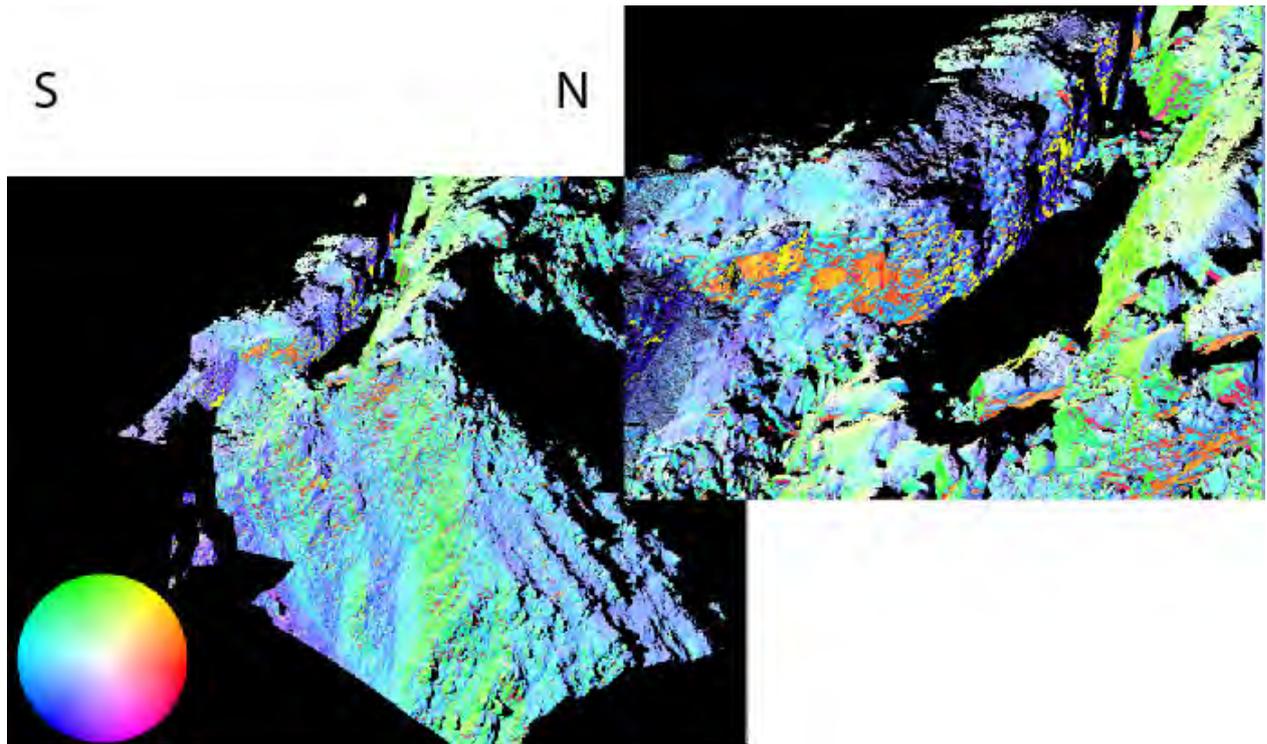
The graben site is an opening fracture oriented WNW-ESE and 600 m long. The North compartment slides toward NE, creating an opening on the plateau in the back part. The colors coding of Coltop3D (Figure 18) shows clearly the predominance of facets dipping towards NE to SE (from blue to green).

Figure 18: Coltop3D view of the cloud of points for the graben site

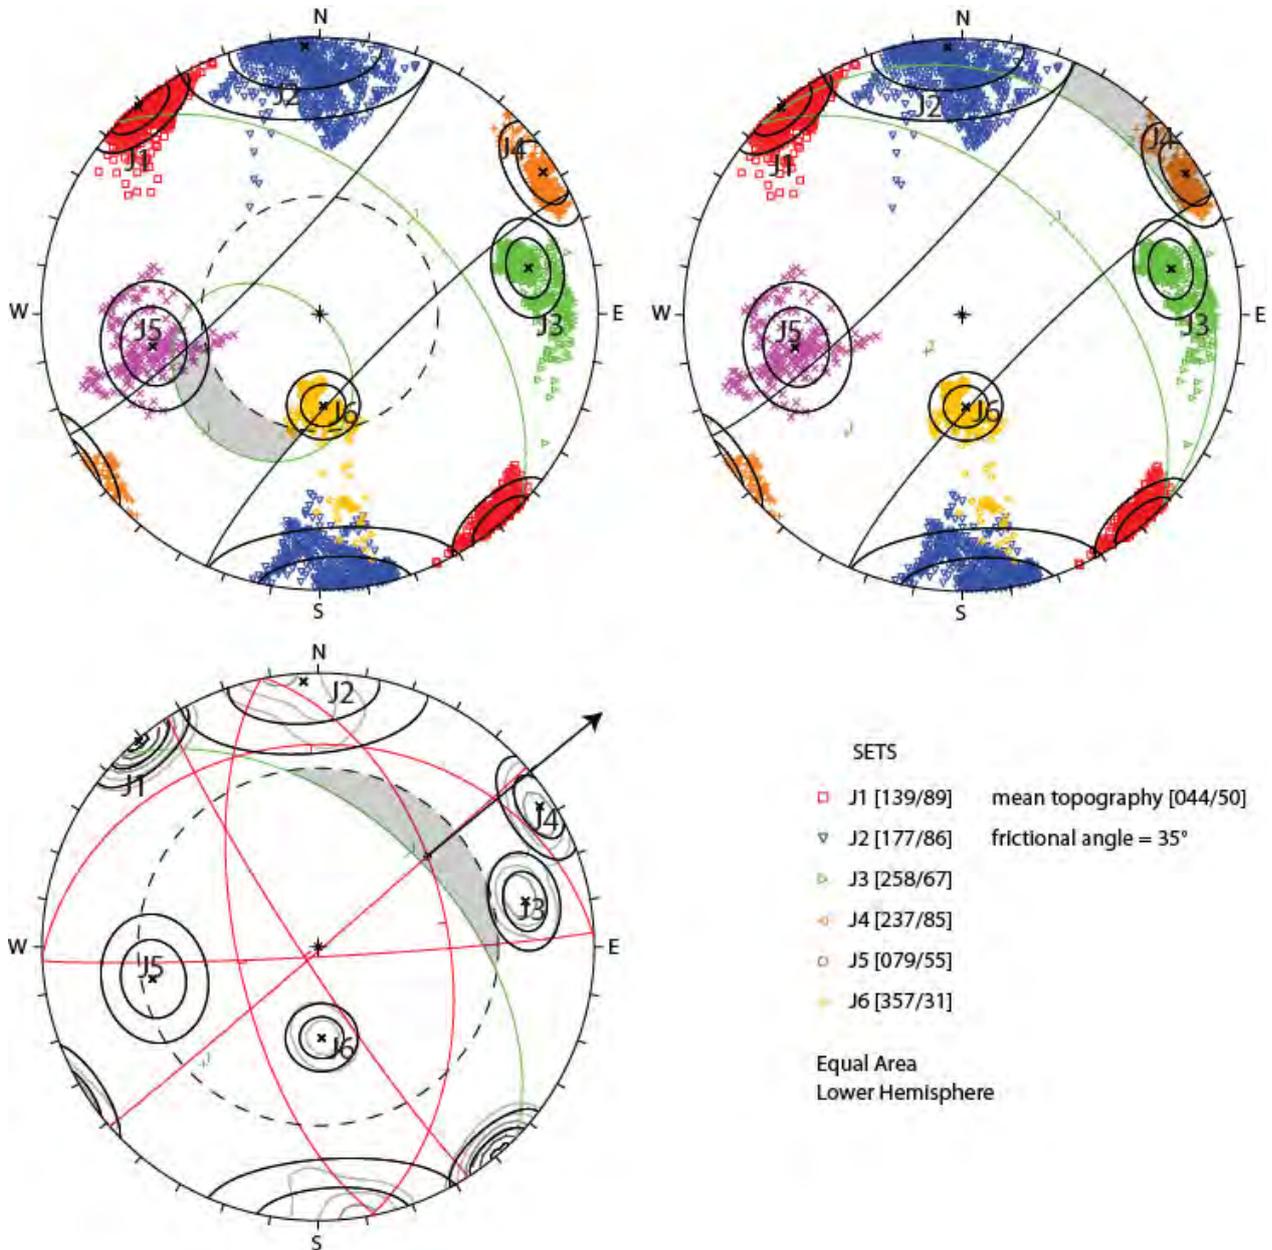
Kinematic tests (Figure 26) were done for the Upper cliff. It appears that the discontinuity J4 promotes toppling of rock columns. There is also a possibility of wedge sliding on $J1 \wedge J5$ with a sliding direction of [050/51]. Locally, planar mechanism is possible along J5 and J6.

Figure 26: kinematic tests (planar sliding, toppling and wedge sliding) for the studied area.

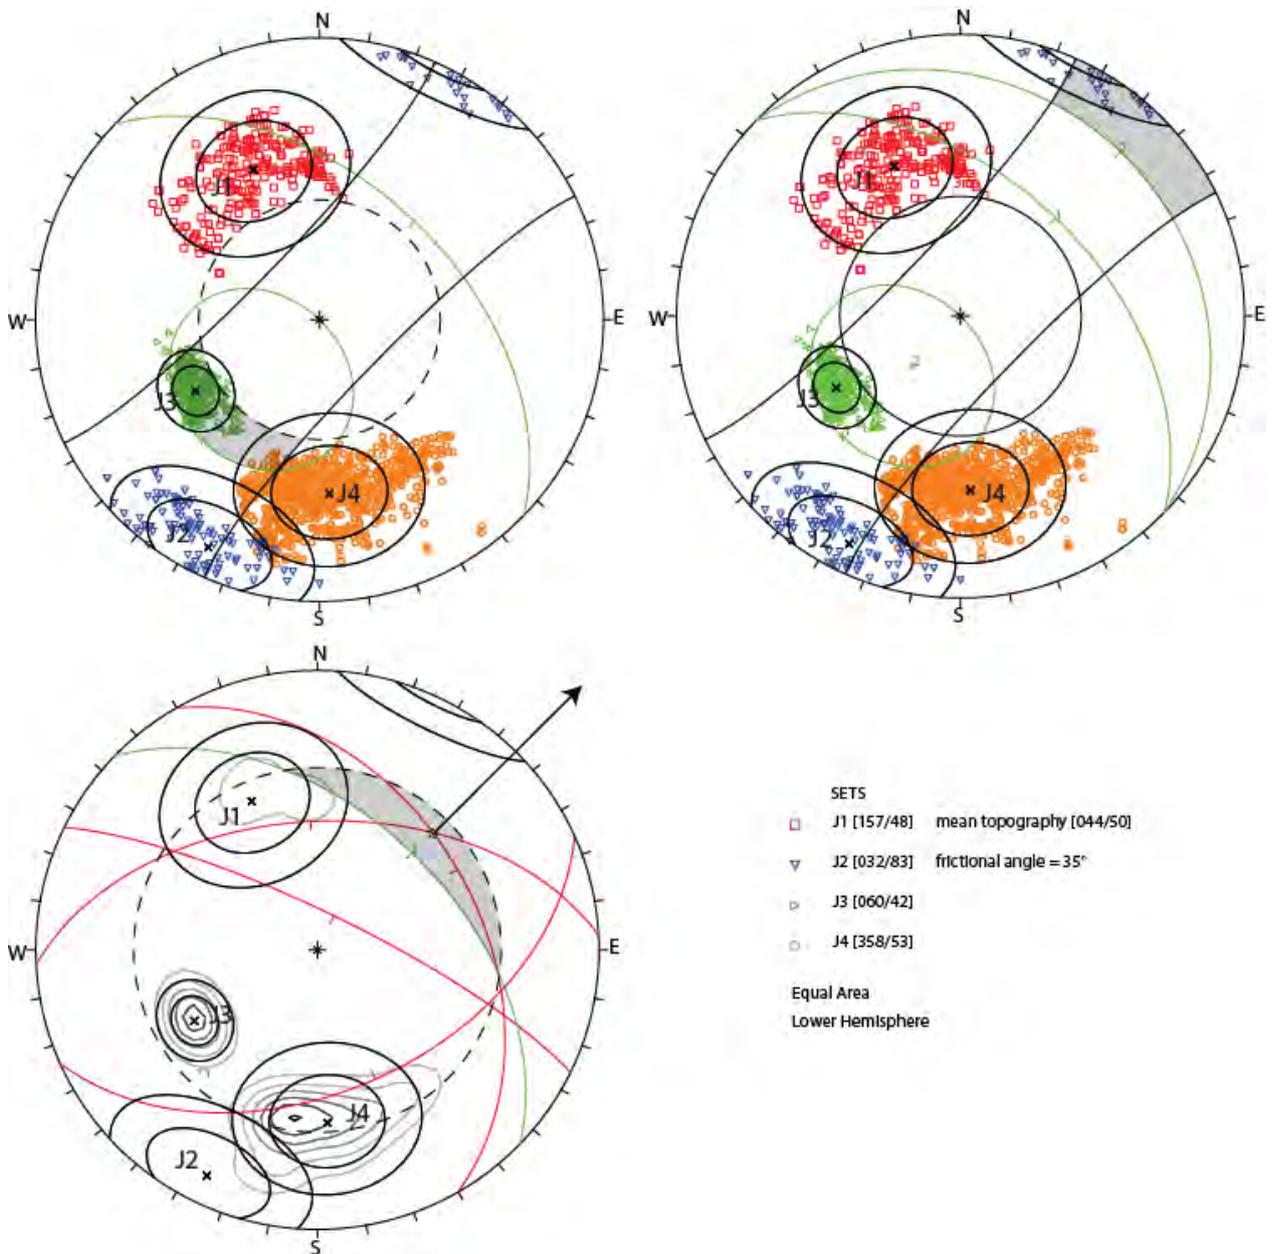
The kinematic tests done with the airborne data (Figure 28) show that, for a regional topography orientation [044/50], a sliding movement along J3 and J4 is possible. This discontinuity orientation is present on the whole site (= J3 "graben site", = J5 "upper cliff") and may be related to movement of large slabs of the mountain side (and formation of the graben ?). For smaller volumes toppling due to J2 or wedge sliding $J4 \wedge J3$ with a sliding direction of [047/41] are possible too.

Figure 28: Kinematic tests on the MNT (planar sliding, toppling, wedge sliding).

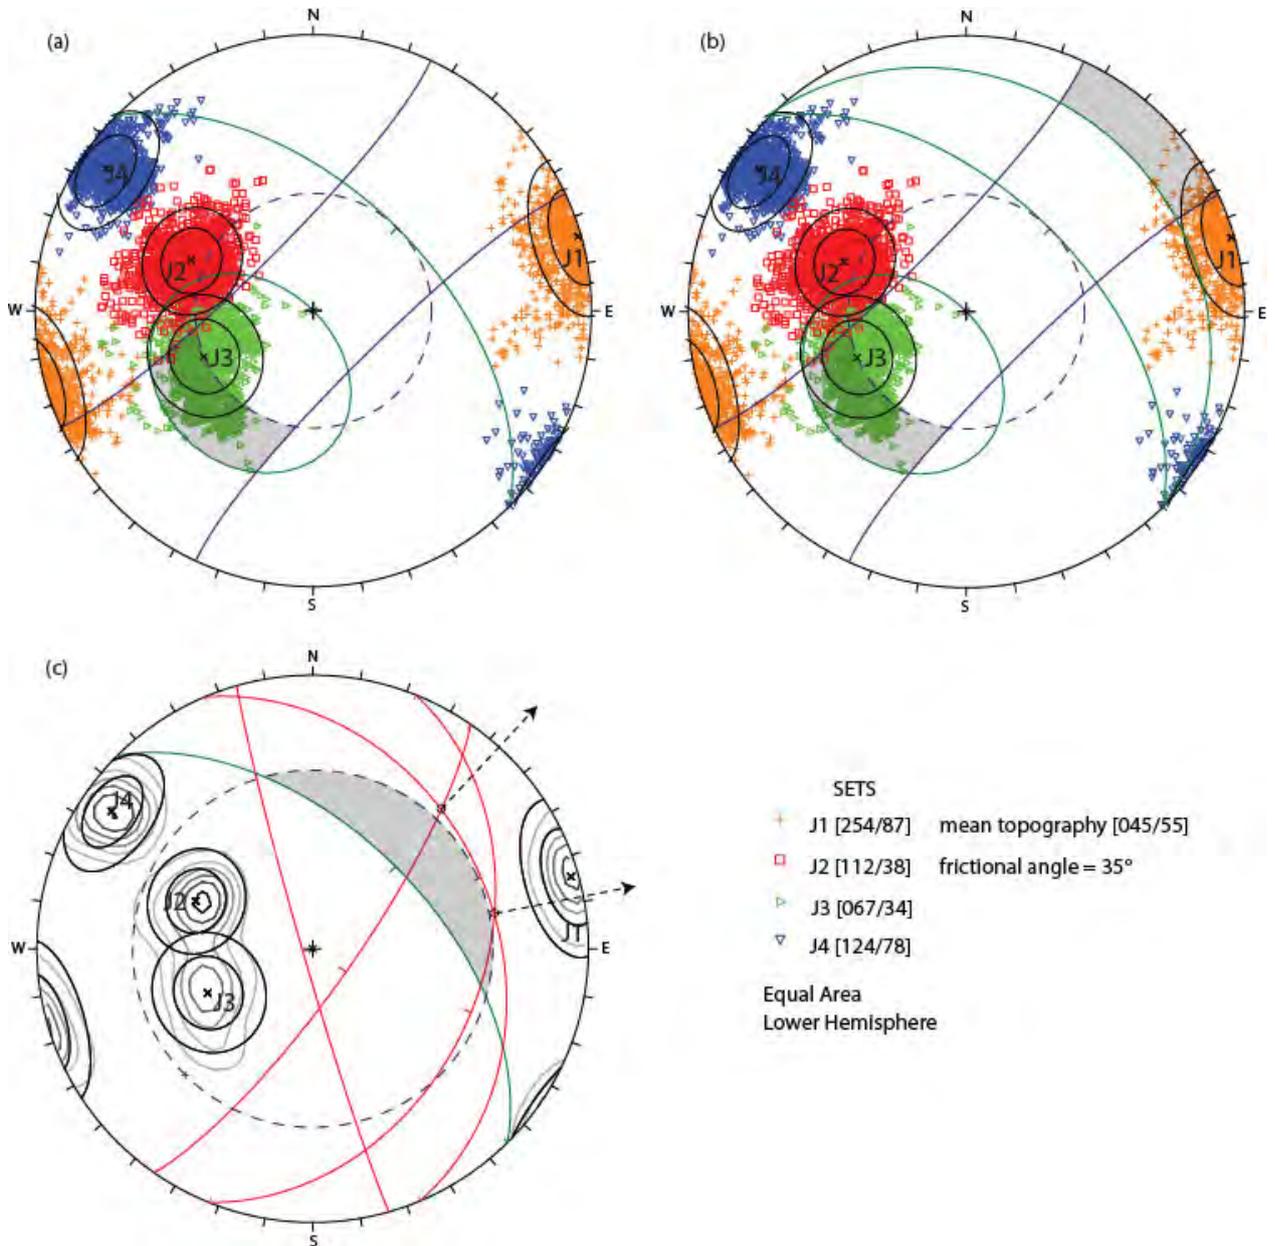
Kinematic tests were carried out with a mean topography of [045/55]. It appears that the discontinuity sets J3 and possibly J2 enables planar sliding (darker area in Figure 33a). Based on the point cloud analysis (Figure 34) the blocks seem to be laterally delimited by J4 and at the back by J1. The discontinuity J1 could involve toppling. In Figure 33c, we observe two possibilities of wedge sliding: $J3 \wedge J2$ with a plunging direction of [079/33] and $J3 \wedge J4$ with a plunging direction of [041/31].

Figure 33: kinematic tests for (a) planar failure (b),toppling and (c) wedge failure (equal area, lower hemisphere stereoplot).

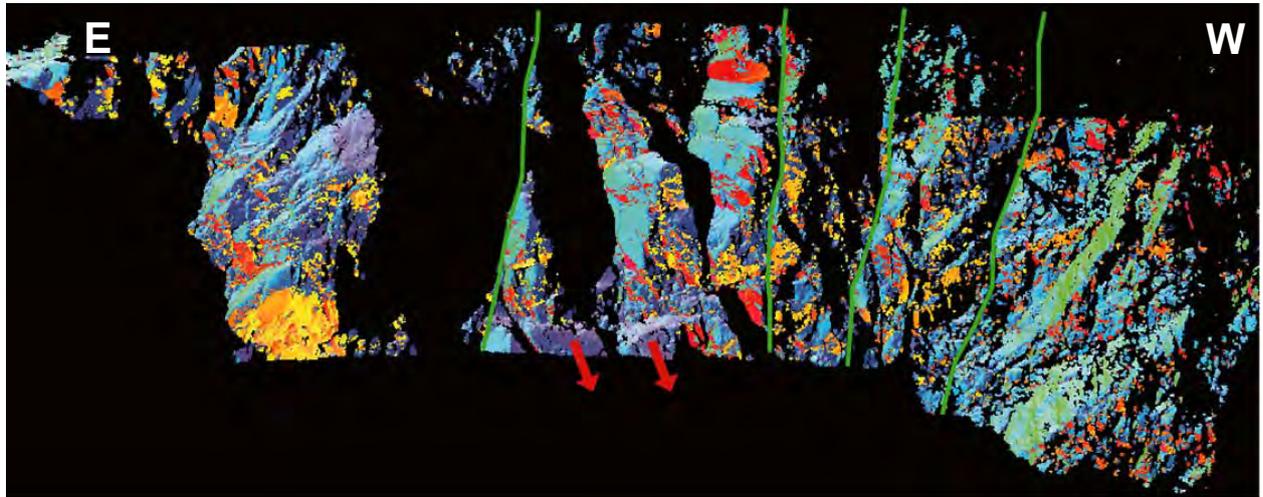
Figure 34: detail of the upper part: the blocs a laterally delimited by J4 (green lines) and at the back by J1 (dark blue – yellow in this Coltop 3D representation) and slide along J3 (red arrows).

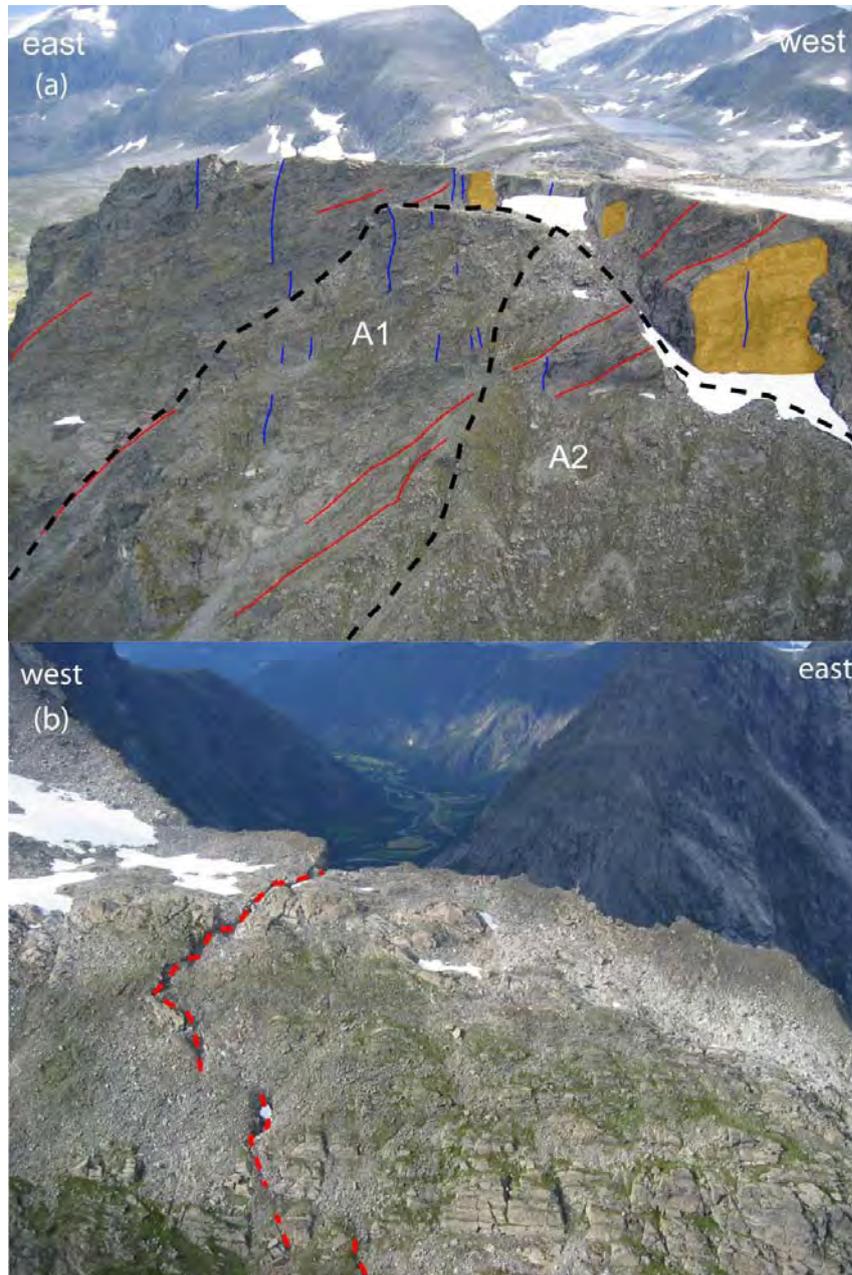
A preliminary study was carried out by L H Blikra to estimate the volumes and the possible run-out for the unstable area of Mannen. The cliff has been divided into two possible scenarios (Figure 35a). The volume A1 has been estimated to 2-3 million m³ and a more extreme scenario corresponding to the volume A2 around 15-25 million m³. In the Figure 35a, at the exception of J3 that is not visible in the picture, the main discontinuity sets are highlighted (J4 = blue, J2 = red, J1 = orange). The Figure 35b is a view of the open back crack.

Figure 35: (a) general view of the instability with the two scenarios for the unstable volumes (A1 and A2) and (b) view of the back scarp (red dashed line) Pictures from Blikra (A/T -IKS)

Several points have to be noticed: (1) the moving mass is strongly dislocated, with numerous vertical open cracks along J4 (in blue in Figure 35a), (2) the valley side under Mannen is steeper than in the neighboring Børa, (3) the Figure 29b shows that Mannen forms a large convex volume hanging above the valley.
