GEOLOGI FOR SAMFUNNET

GEOLOGY FOR SOCIETY

Report no.: 2013.014		ISSN: 0800–3416	Grading: Open
Title: Investigations on unstable rock slopes in Møre og Romsdal – status and plans after field surveys in 2012			
Authors: T. Oppikofer, A. Saintot, S. Otterå, R.L. Hermanns, E. Anda, H. Dahle, T. Eiken		Client: Norwegian Water Resources and Energy Directorate (NVE)	
County: Møre og Romsdal		Commune:	
Map-sheet name (M=1:250.000) Ålesund, Kristiansund, Røros, Ulsteinvik		Map-sheet no. and -name (M=1:50.000)	
Deposit name and grid-reference:		Number of pages: 323	Price (NOK): 1285,-
Fieldwork carried out: 2006–2012		Date of report: 13.11.2013	Map enclosures: 0
Fieldwork carried out: 2006–2012		Date of report: 13.11.2013	Project no.: 309900
Fieldwork carried out: 2006–2012		Date of report: 13.11.2013	Quality control: <i>Halvor Brundhoff</i>
<p>Summary:</p> <p>This report presents investigations, analyses and displacement measurements made between 2006 and 2012 on 131 unstable or potential unstable rock slopes in Møre og Romsdal County (Western Norway). An extract of this report is available in Norwegian (NGU rapport 2013.053).</p> <p>These investigations are part of the national plan for

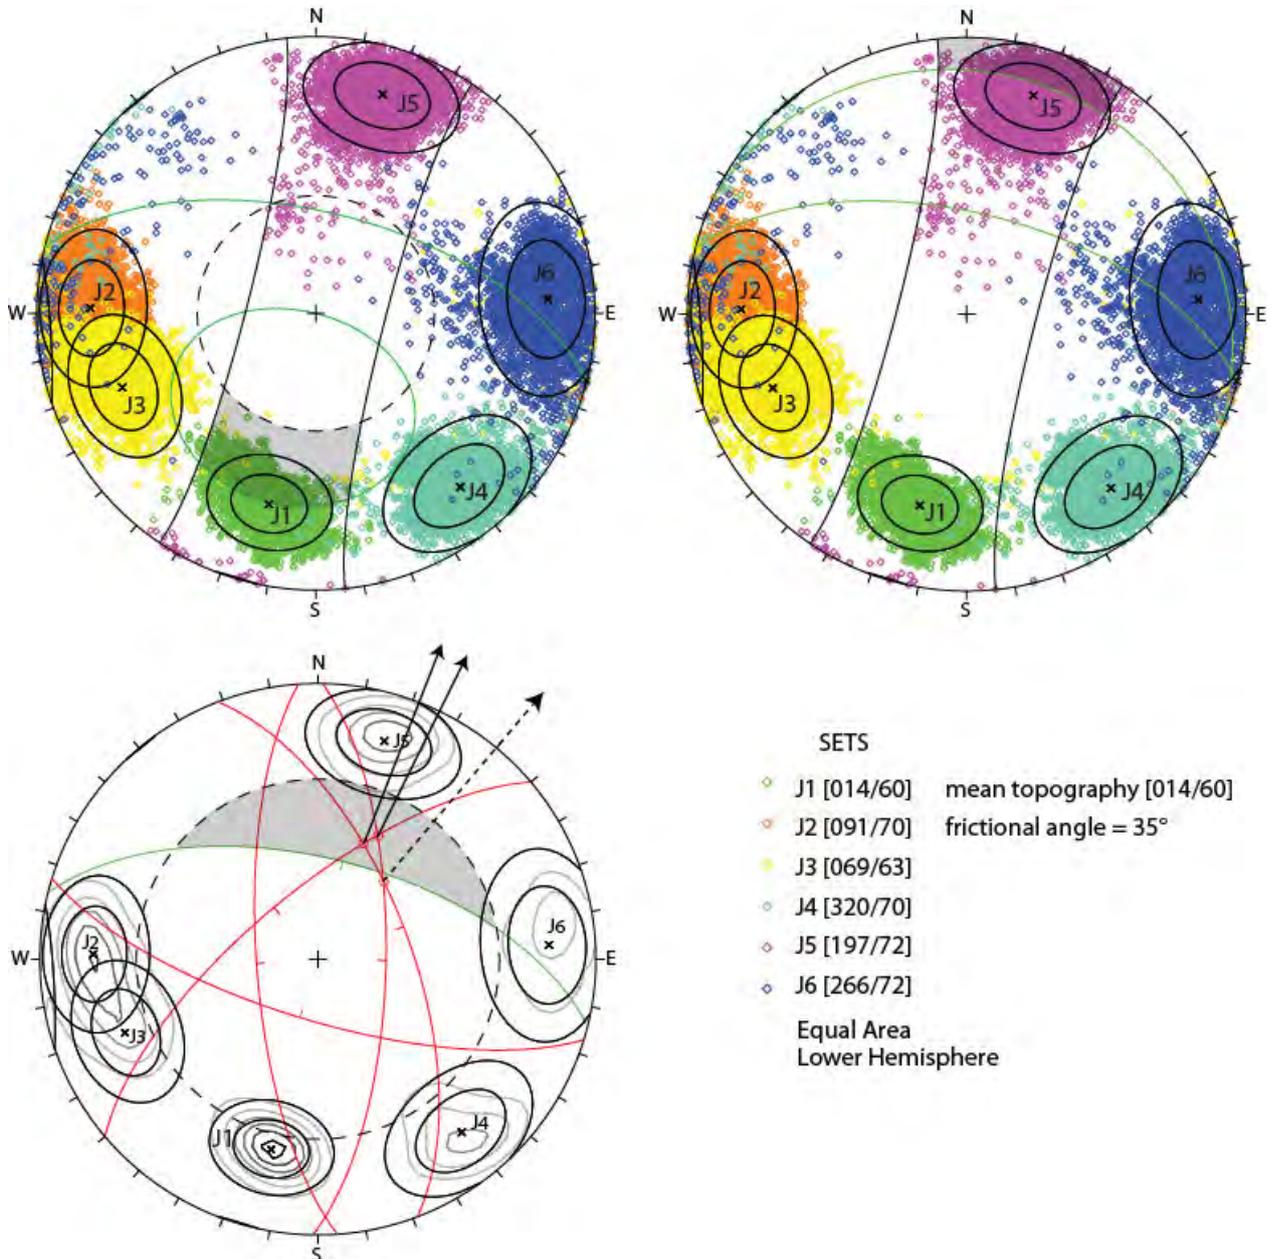
Kinematic tests were carried out in the studied area in order to see the different failure mechanisms potentially affecting the cliff. The [014/60] topography of the North face and a frictional angle of 35° are used (Figure 39). Figure 39a shows that planar sliding on J1, J3 and J4 is possible. The kinematic tests show that the discontinuity J5 enables the toppling and that there are three possibilities for wedge sliding ($J4 \wedge J2$, $J4 \wedge J3$ and $J2 \wedge J3$).

Figure 39: Kinematic tests of Svarttinden. Top left: planar sliding, top right: toppling, bottom: wedge sliding).

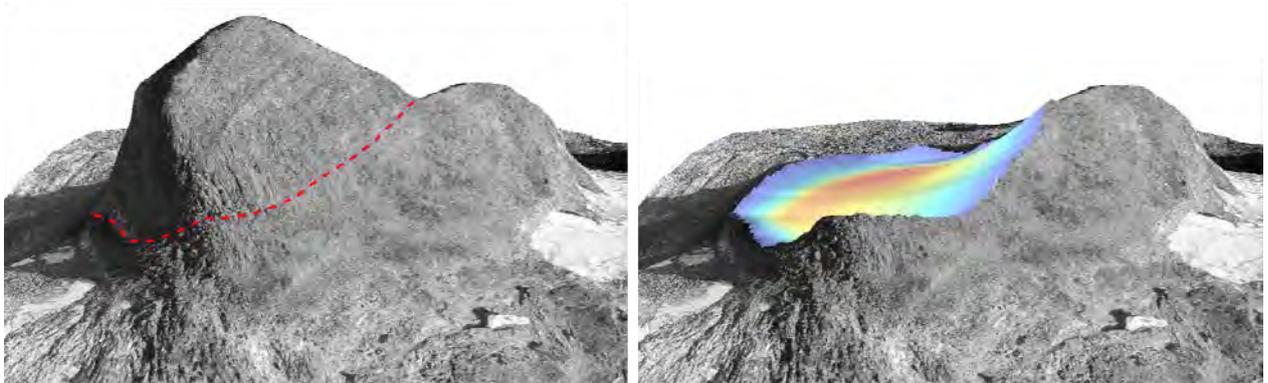
Based on field and pictures observations, the most probable failure mechanism for the bigger volume is planar sliding on the continuation of the sliding surface outcropping in the eastern part. This surface cut the base of the pyramid but it is not a plane as its orientation changes slightly from one side to the other: in the eastern part of the pyramid the sliding surface has a J1 orientation (Figure 42a) but on the western side the surface is less steep than J1 (Figure 42c). We can then suspect it is curved as suggested in early works (Figure 40)

Figure 40: Left: view from SE of Svarttinden (red line: apparent trace of the sliding surface). Right: example of possible sliding surface interpolated using the SLBL method

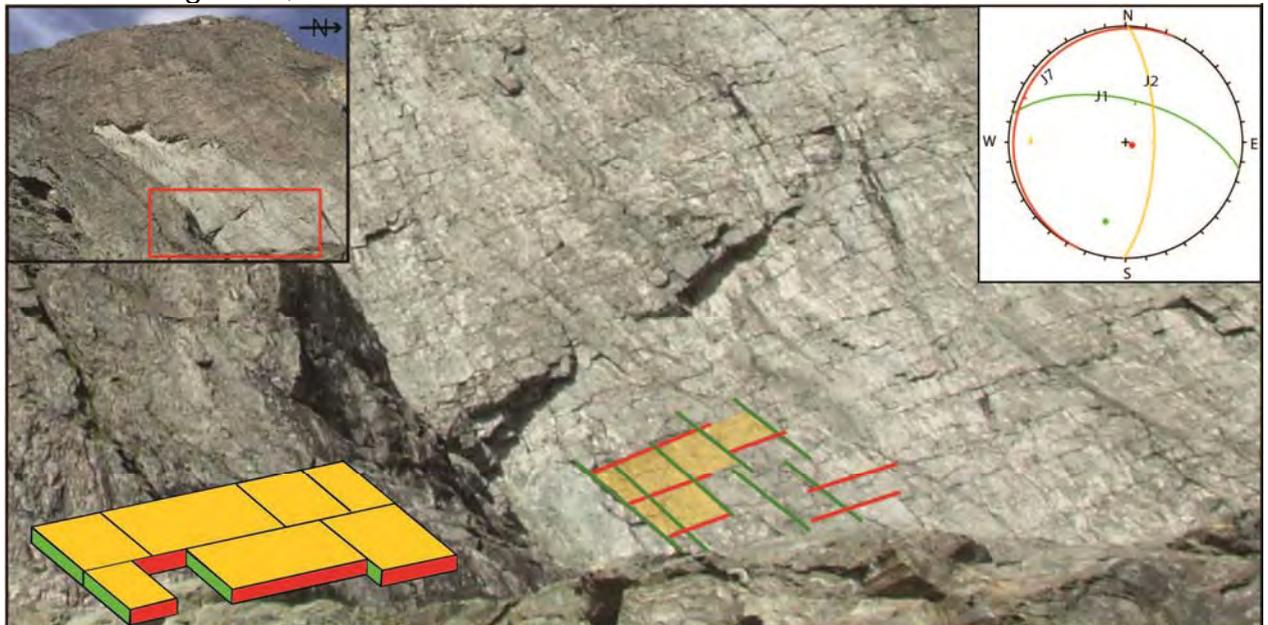
Another important feature at Svarttinden is the dense fragmentation in prisms of the rock body. As we can see in the Figure 41, the decimeter to meter prisms are cut according to J1, J7 and J2.

Figure 41: Cutting of the blocks in the East wall of the block.

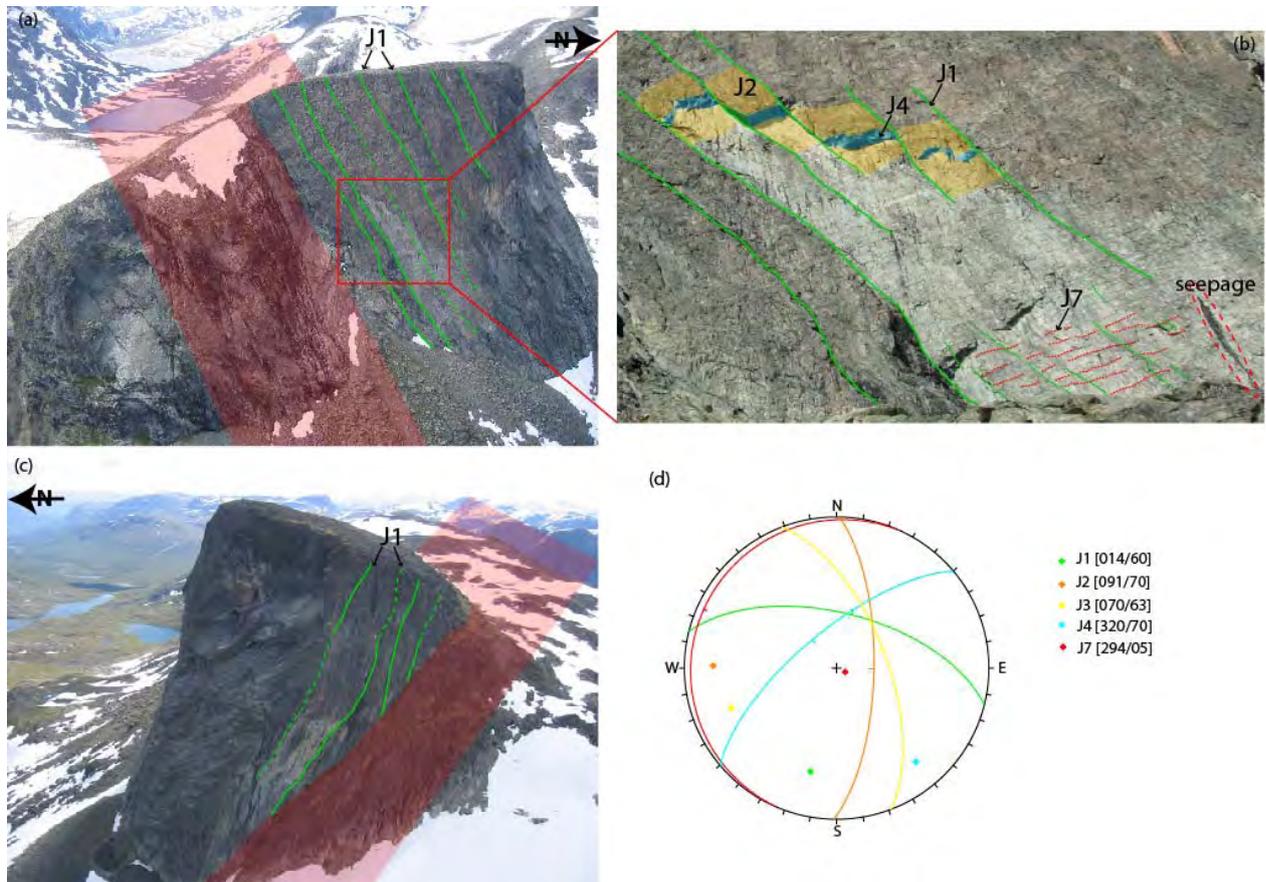
The same mechanism affects bigger blocks (Figure 42b). In this case, the sides of the blocks are delimited by J4 and J1 instead of J7 and J1.

As discussed previously, the old sliding plane seems to extend through the present potentially unstable block. The East wall is cut by an important fracture that has the same orientation than the sliding plane [014/60] (Figure 42a) and it can be followed in the West wall but with a slightly different orientation [070/63] (Figure 42c). The volume of the block (pyramid) is estimated up to 5 Mm³.

The presence of seepage in different places of the cliff suggests that the entire block is completely fractured and that the water can infiltrate the massif (Figure 42).

Figure 42: detailed view of the instable block of svarttinden, (a) east wall, (b) zoom of the east wall, (c) western wall, (d) stereonet of the sets highlighted in (a), (b) and (c).

The major hazard at Svarttinden is a large planar sliding that may turn into a rock avalanche that would reach the Romsdalen valley. Other smaller volumes may fall, but considering the location of this mountain they represent only minor risks (geologists at the foot of the faces for instance). A regular GPS monitoring of the top of the pyramid seems a good start to detect if there is any movement. That can be completed by some measurements along cracks. Occasionally it would be interesting to compare scans of the faces of the pyramids to estimate the rockfall activity.

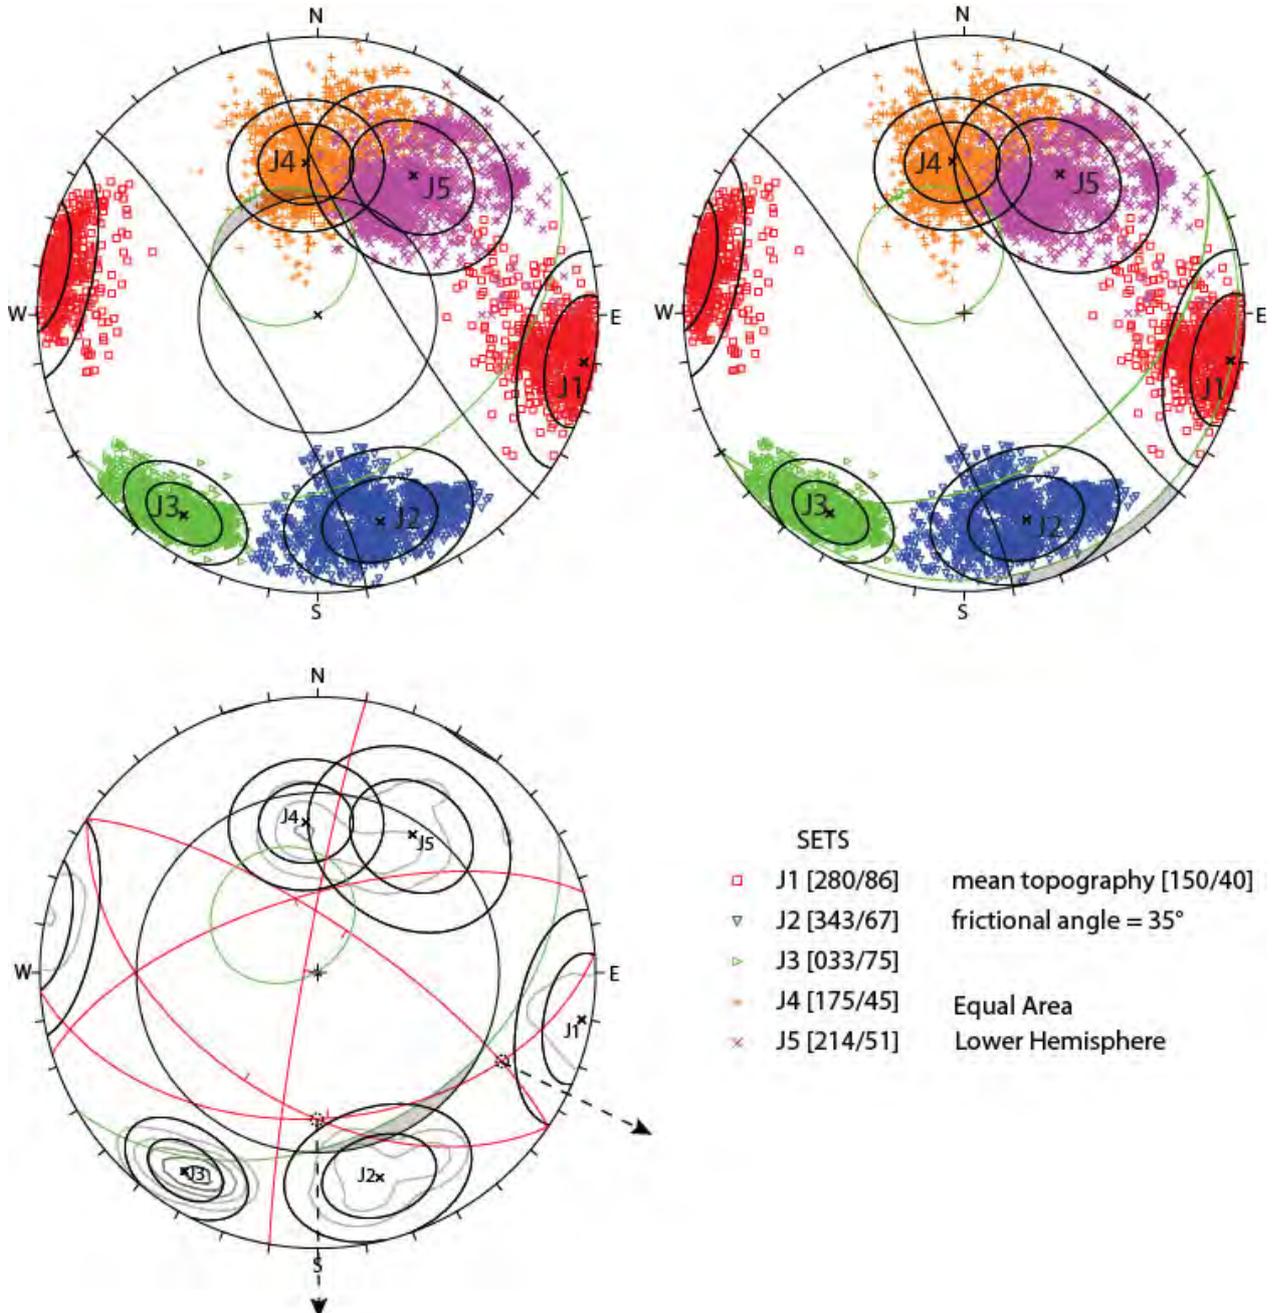
Figure 46: kinematic tests (planar sliding, toppling and wedge sliding) for the studied area.

Based on the kinematic tests (Figure 29), it appears that planar along J4 is the most probable mechanism. Based on field observations, J2 can generate toppling but it is more probable that it affects only small volumes/blocks. The tests suggest also that $J4 \wedge J3$ and $J4 \wedge J5$ could generate wedge sliding but, again, it seems to affect lesser volumes.

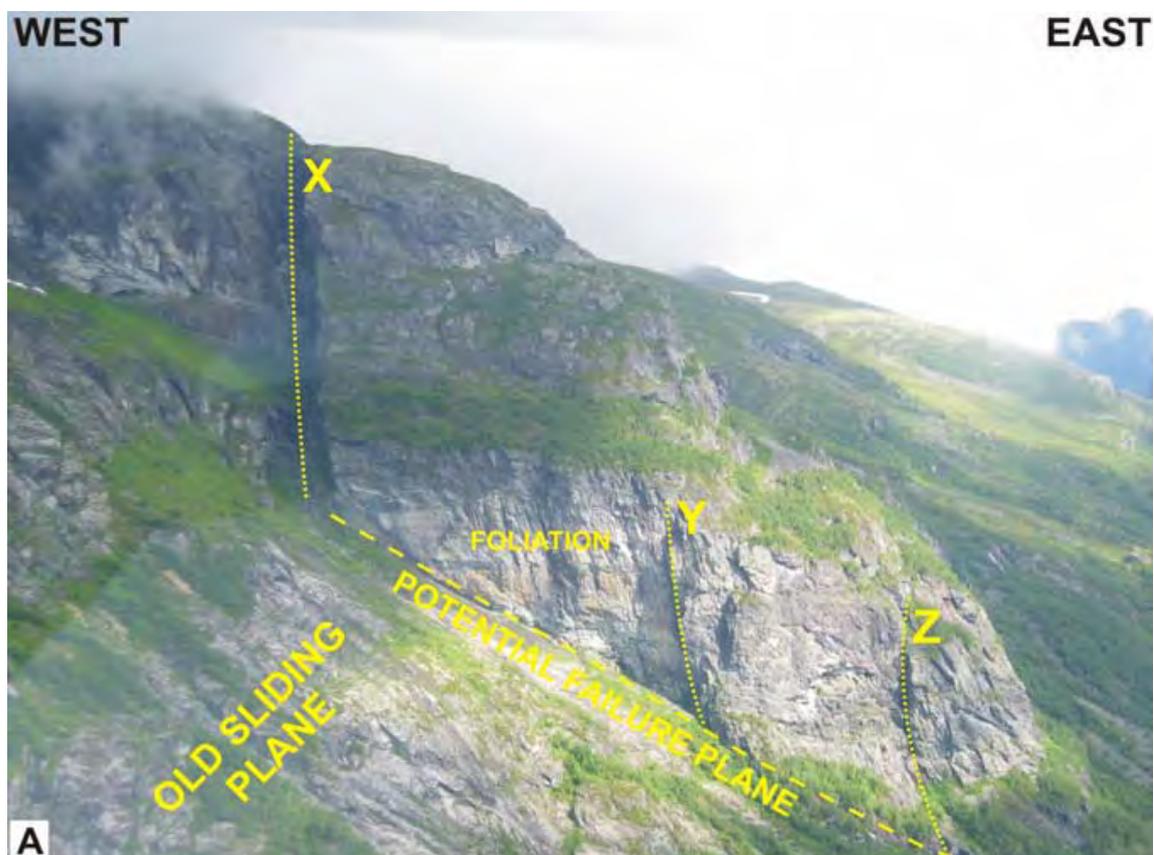
As suggested previously, planar sliding is the most probable failure mechanism affecting an important volume of the Hellesylt area. In fact, on the field, there is evidence of an old sliding plane (Figure 47). An important volume delimited backward by a large open fracture (X on the picture) could potentially fall down along a failure plane of orientation J4. Other vertical fractures may delimit small volume in the front of the large block.

Figure 47: Photo of the structures of the Hellesylt_6b site. X is a large opened extensional fracture, suggesting several meters cumulative displacement. Y and Z are extensional fractures, trending NE-SW. The sliding plane is well defined on the picture (after the NGU-report of Henderson et al, 2006).

For the Hellesylt-6b site only collapses of large volumes are of interest because of the tsunami risk in the fjord. The block is well delimited with a widely open crack at the back and well identified sliding plane. The next step is to know if there is presently any movement of the block. This is currently done by yearly GPS monitoring. If a movement is detected, that could be interesting to return scanning in some years to check if any dislocation is taking place in the rock mass. But the site is difficult to access and a regular monitoring by terrestrial lidar does not seem a priority.

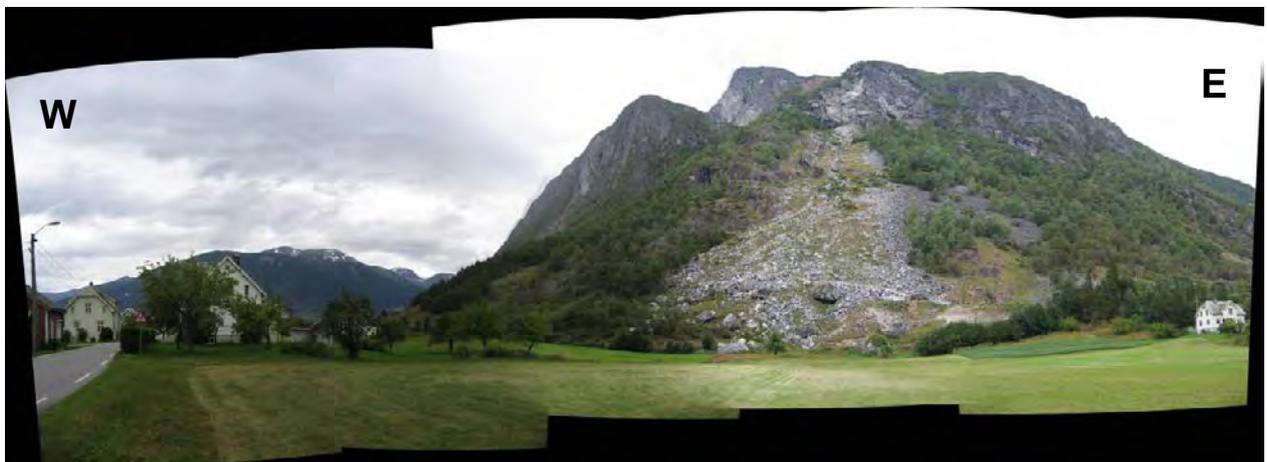
The site of Nordal_21 is located above the village of Nordal (Nordal Kommune) . The unstable part of this site is an upper steep cliff with a large rockfall deposit fans at the foot (Figure 48). According to local people, rockfalls occurred with a run-out down to the road during the XX century, but the blocks were removed from the fields.

Figure 48: panoramic view of the instability of Nordal_21

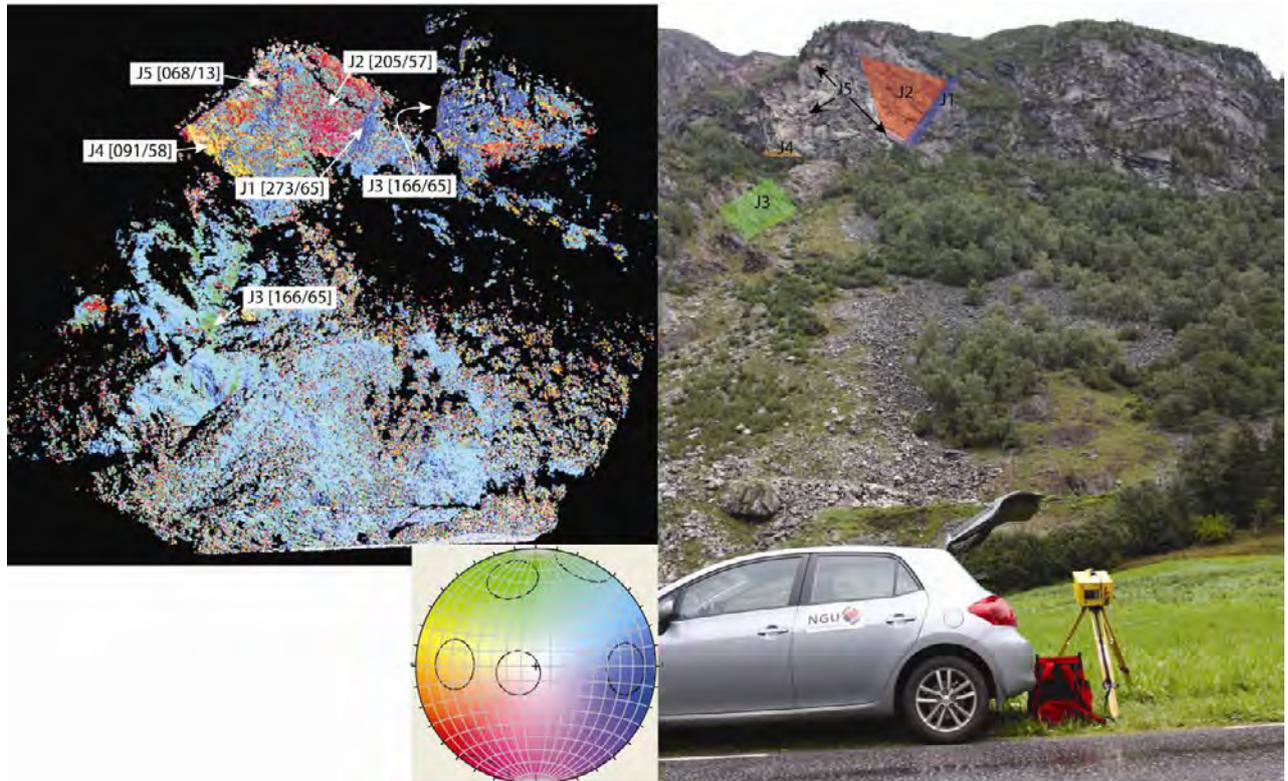
The mean topography orientation of [220/70] was estimated on the DEM. The structural analysis was carried out with COLTOP-3D and five discontinuity sets were highlighted (Figure 49).

Figure 49: coltop view of the cliff (left) and a general view with the main sets (right).

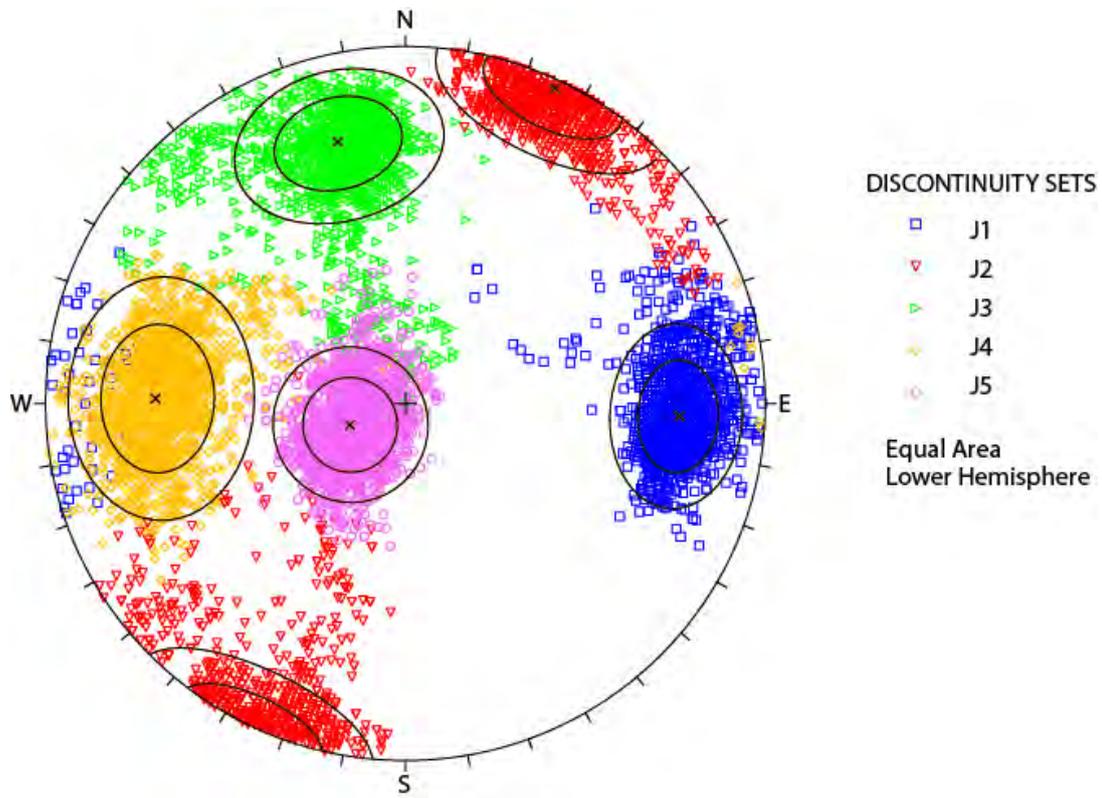
These five main sets were imported in Dips (Figure 50) in order to estimate their orientation and standard deviation. The results are summarized in the Table 9.

Figure 50: Stereoplot of the main surfaces of discontinuity for the site of Nordal_21. The circles represent the ± 1 -sigma and 2-sigma dispersion.

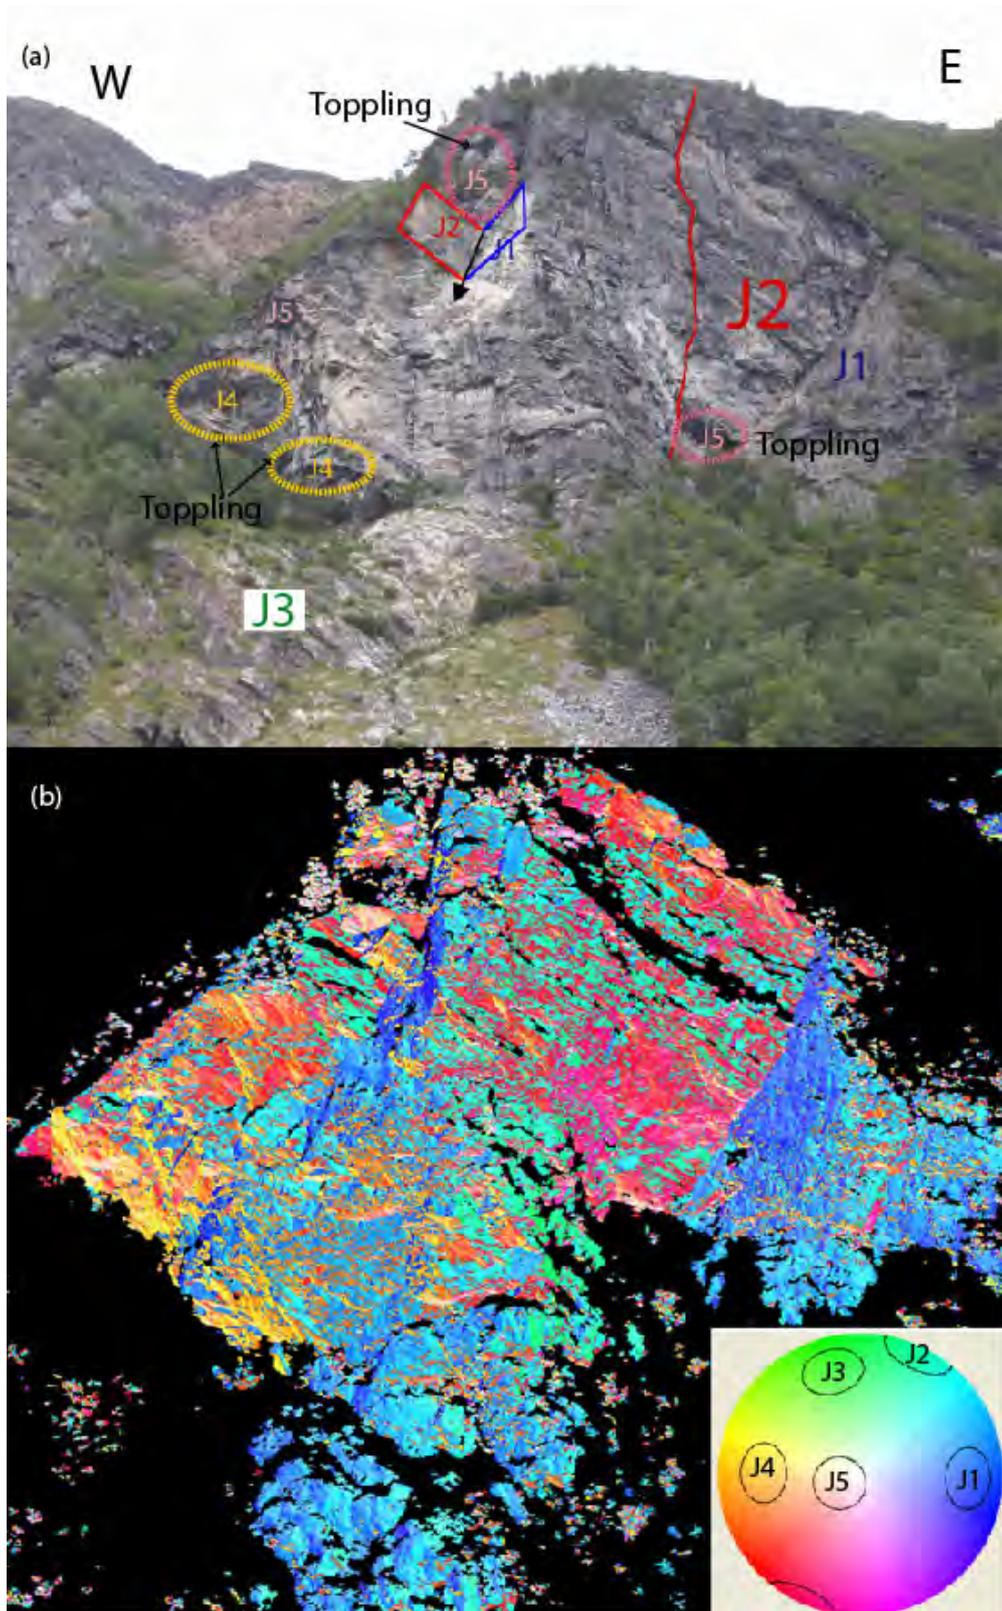
A detailed analysis of the pictures allowed the identification of vertical and parallel fractures that did not appeared on the lidar data (Figure 51b). In particular, one of these fractures crosses the totality of the cliff (in red in Figure 51a) and should be a concern of future investigation.

Figure 51: (a) detailed view of the potentially unstable block with the discontinuity sets and the vertical fracture F1 crossing the cliff (red line), (b) a detailed view of the cliff with COLTOP-3D.

Based on observations on photos, there is another possibility for wedge sliding in the rockface (with a different orientation of the topography). In fact, a fallen wedge involving J1 ^ J2 with a plunging direction of [289/64] is present in Figure 51a. But

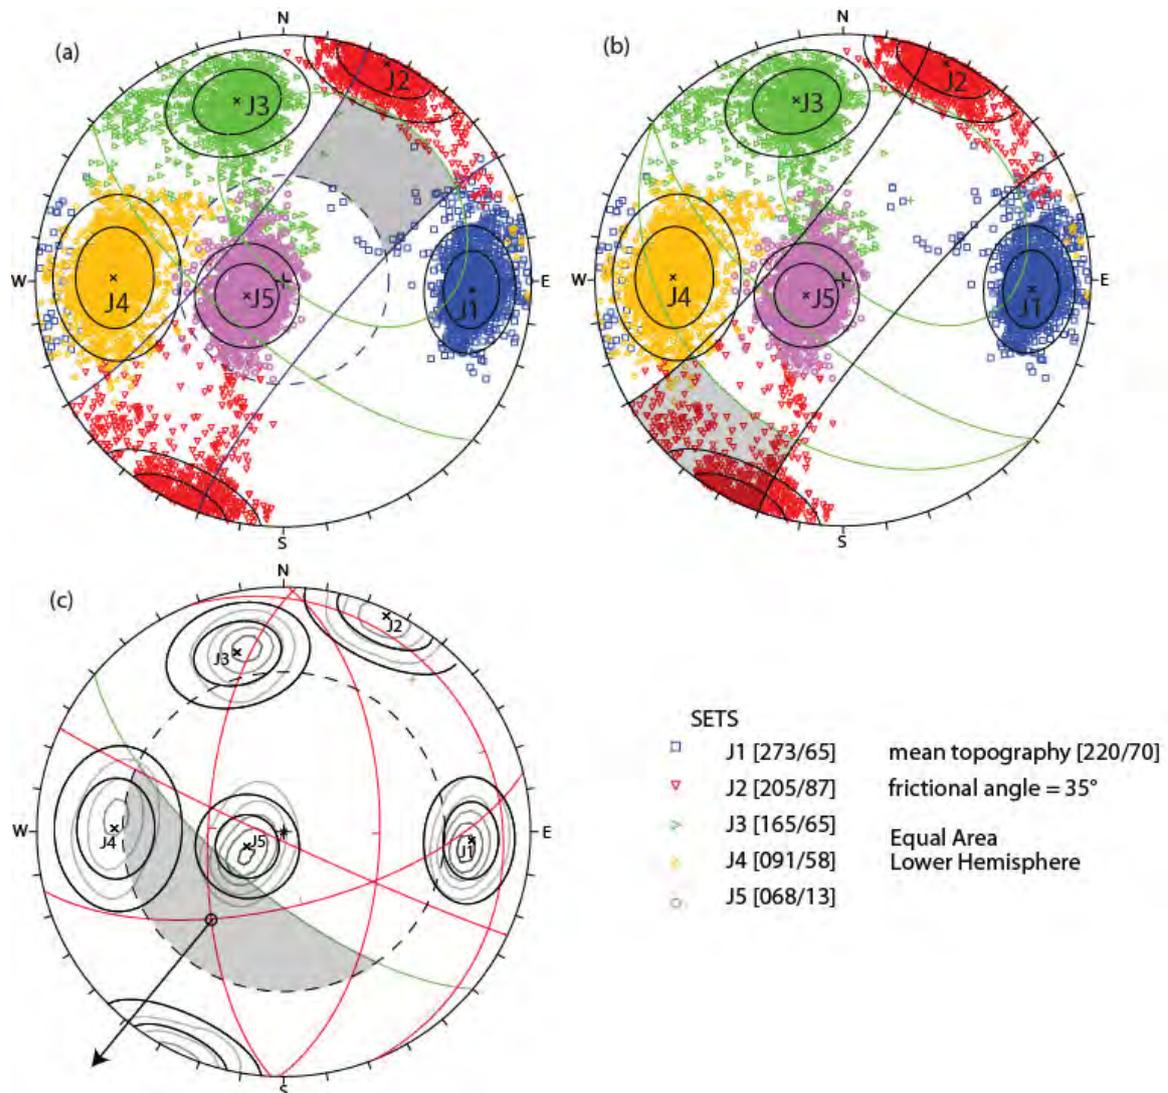
Kinematic tests were carried out in the studied area in order to see the different failure mechanisms that may affect the cliff. The [220/70] topography and a frictional angle of 35° were used. J1 and J2 could involve planar sliding (Figure 52a). It appears that the discontinuity set J2 enables toppling (Figure 52b) as well as J5 and J4, based on the Figure 51a. In Figure 52c, we observe a possibility of wedge failure on J1 ^ J3 with a plunging direction of [219/52].

Figure 52: kinematic tests (a) planar sliding, (b) toppling and (c) wedge sliding.

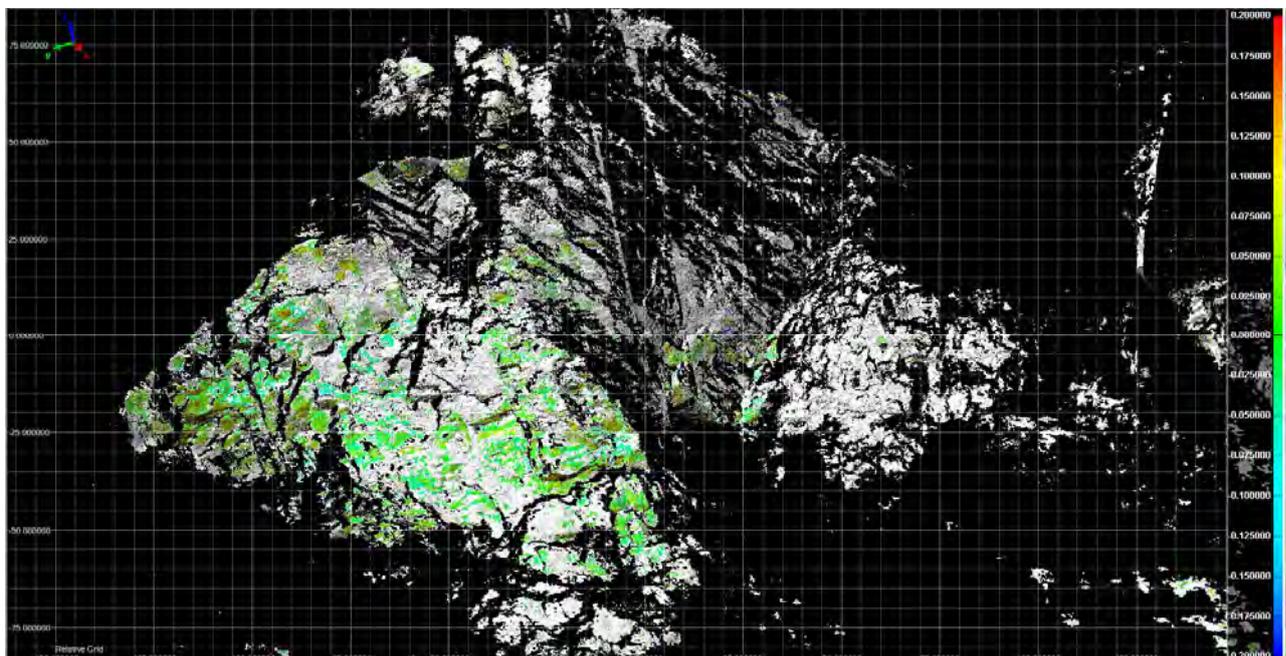
A movement analysis was done by comparing the 2006 scans and with the 2009, but no evidence of movements of the overall cliff was detected. This is partly due to the low quality of the 2009 scan at long range (it was raining during the acquisition). Then this movement detection should be checked again with a new acquisition.

Figure 53: Scan comparison 2006-2009 (maximum distance = 0.2m). Due to difficult atmospheric conditions (rain) the quality of the 2009 scan is poor and the top of the cliff is not covered.
