# **Applied Structural Geology – Case Studies of Underground Constructions and Rockslides**

Guri Venvik Ganerød

Dissertation for the degree philosophiae doctor (Ph.D.)

The Faculty of Mathematics and Natural Sciences  
Department of Earth Science  
University of Bergen

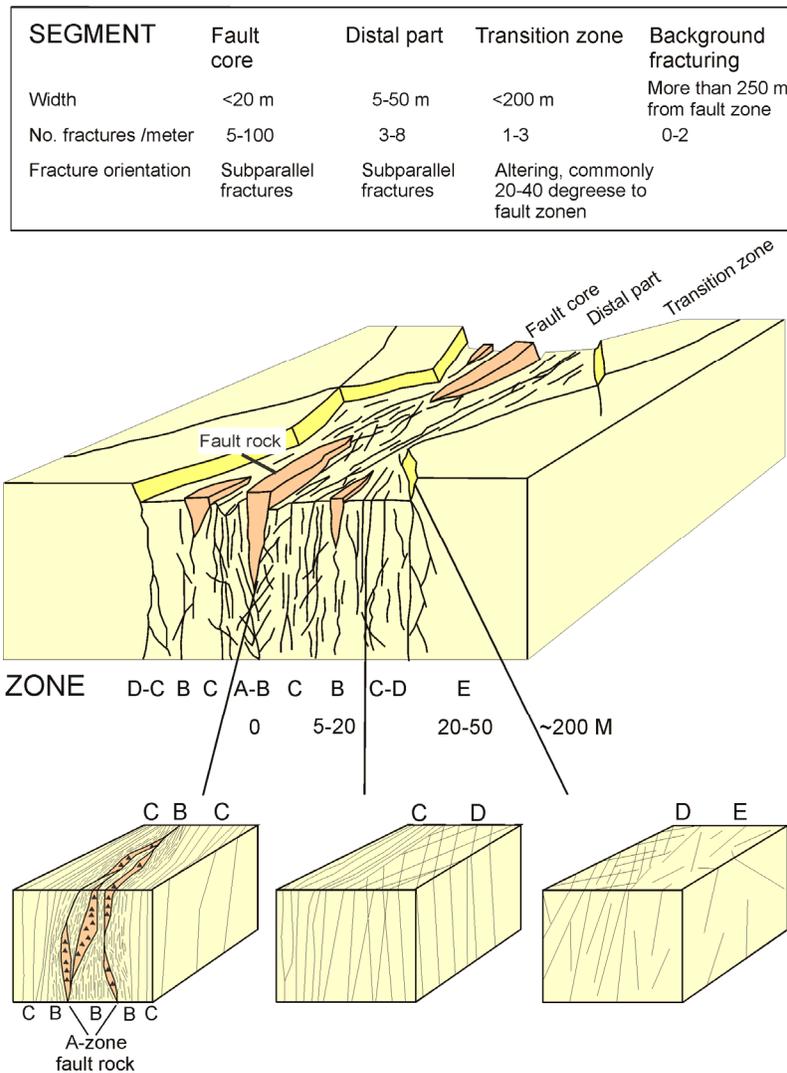
**Figure 1. Fault zone model modified after Braathen & Gabrielsen (2000). In this model the fault zone is divided into five different sections with different characteristics, based on fracture frequency and orientation, fracture connectivity and fault rock permeability. See the text for further description.**

connectivity. Zone E is a transition zone towards background fracturing in the host rock. During the project period, drilling of 5 inclined wells through faults and a well-field, yielded results that was supportive of the flow model, however, which were not conclusive. This thesis pursues this line of studies aiming on new knowledge in our understanding of faults. Natural laboratories have been tunnel sites and rock slope failures.

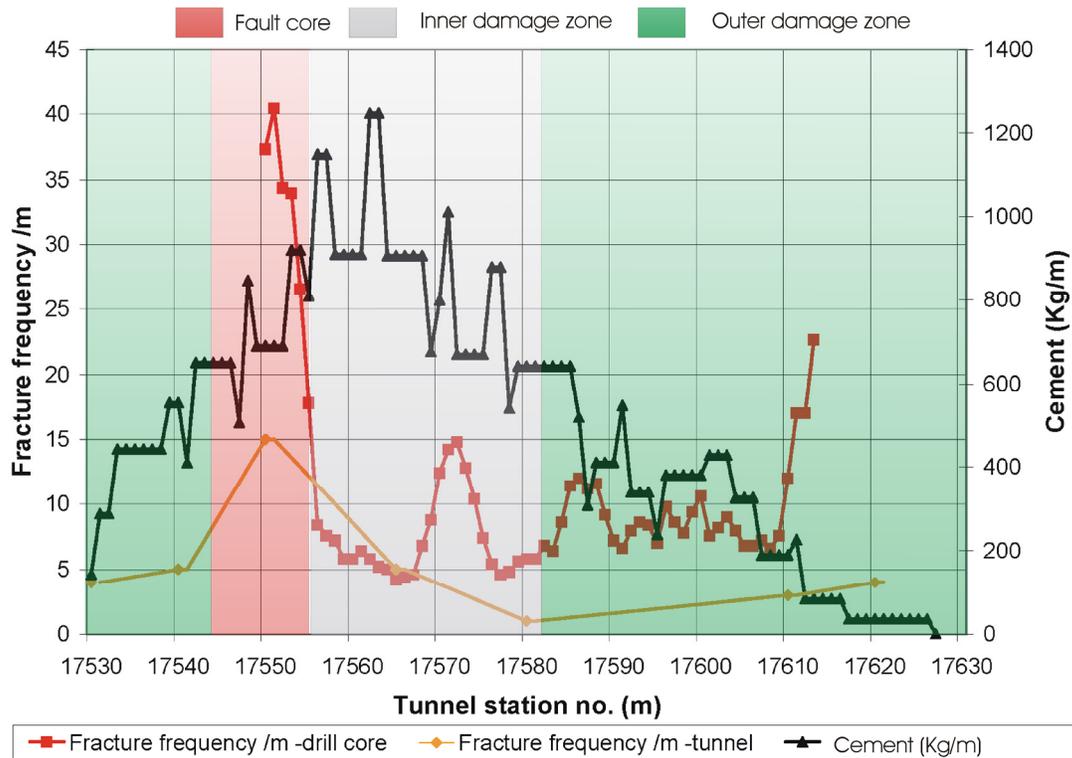
**Figure 2. Correlation between fracture frequency and cement injected in the sub-sea Oslofjord tunnel, southern Norway. The tunnel goes from Storsand in the west to Drøbak in the east, south in the Oslofjord. In the graph the black line show the amount of cement injected in a part of the tunnel while the red and yellow line show the fracture frequency in the same tunnel distance, recorded from drill cores and tunnel wall. As predicted the peak of cement lies in the inner damage zone, proximal to the fault core, while decreasing in the fault core and outer damage zone.**

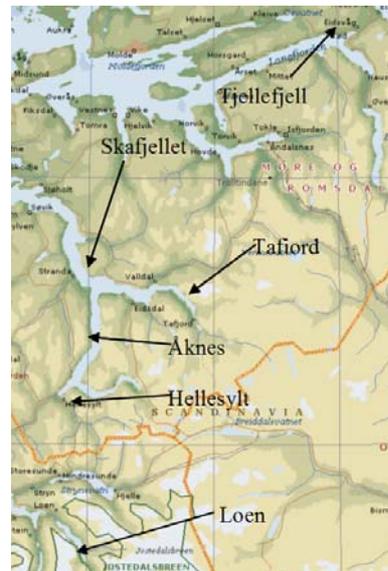
Figure 2. Locations of historical rock slides in the county of Møre og Romsdal. Skafjellet (year 1731), Tjellefjell (1756), Loen (1905 and 1936) and Tafjord (1934) generated destructive tsunamis killing 224 people. At Åknes, a tsunami generating slide is feared.

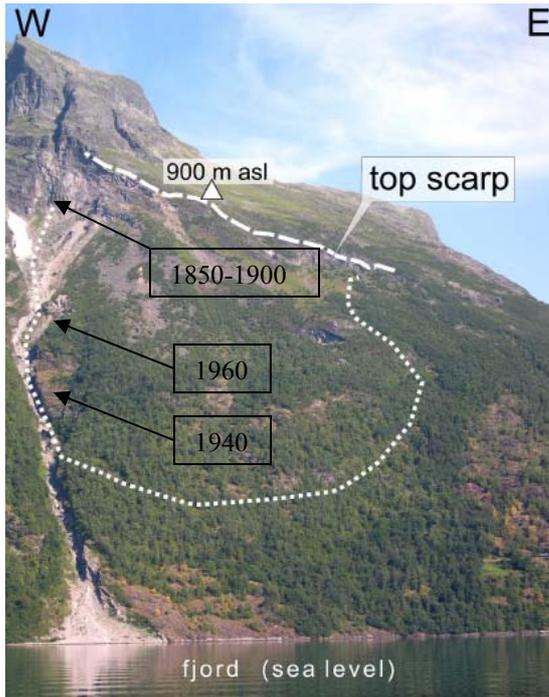
Figure 3. Overview of the Åknes rock slope. The white dotted line indicates the contour of the landslide (slightly modified after Derron, M.-H., et.al. 2005). The length of the “top scarp”/upper crack is about 700m measured from west to east. Numbers show approximate dates of known rock slides.

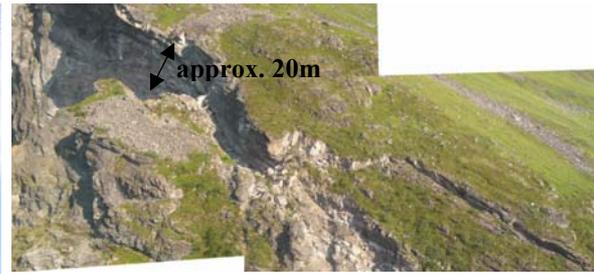
Figure 4. Details of the upper crack. The minimum horizontal crack width at the right hand side of the photo and further towards east (to the right) is typically around 1m

Figure 4 shows details of the western part of the upper crack. The upper western flank is separated from the back wall by about 20 – 30m. To the east of the upper western flank the minimum horizontal crack width of the upper crack is typically around 1m.

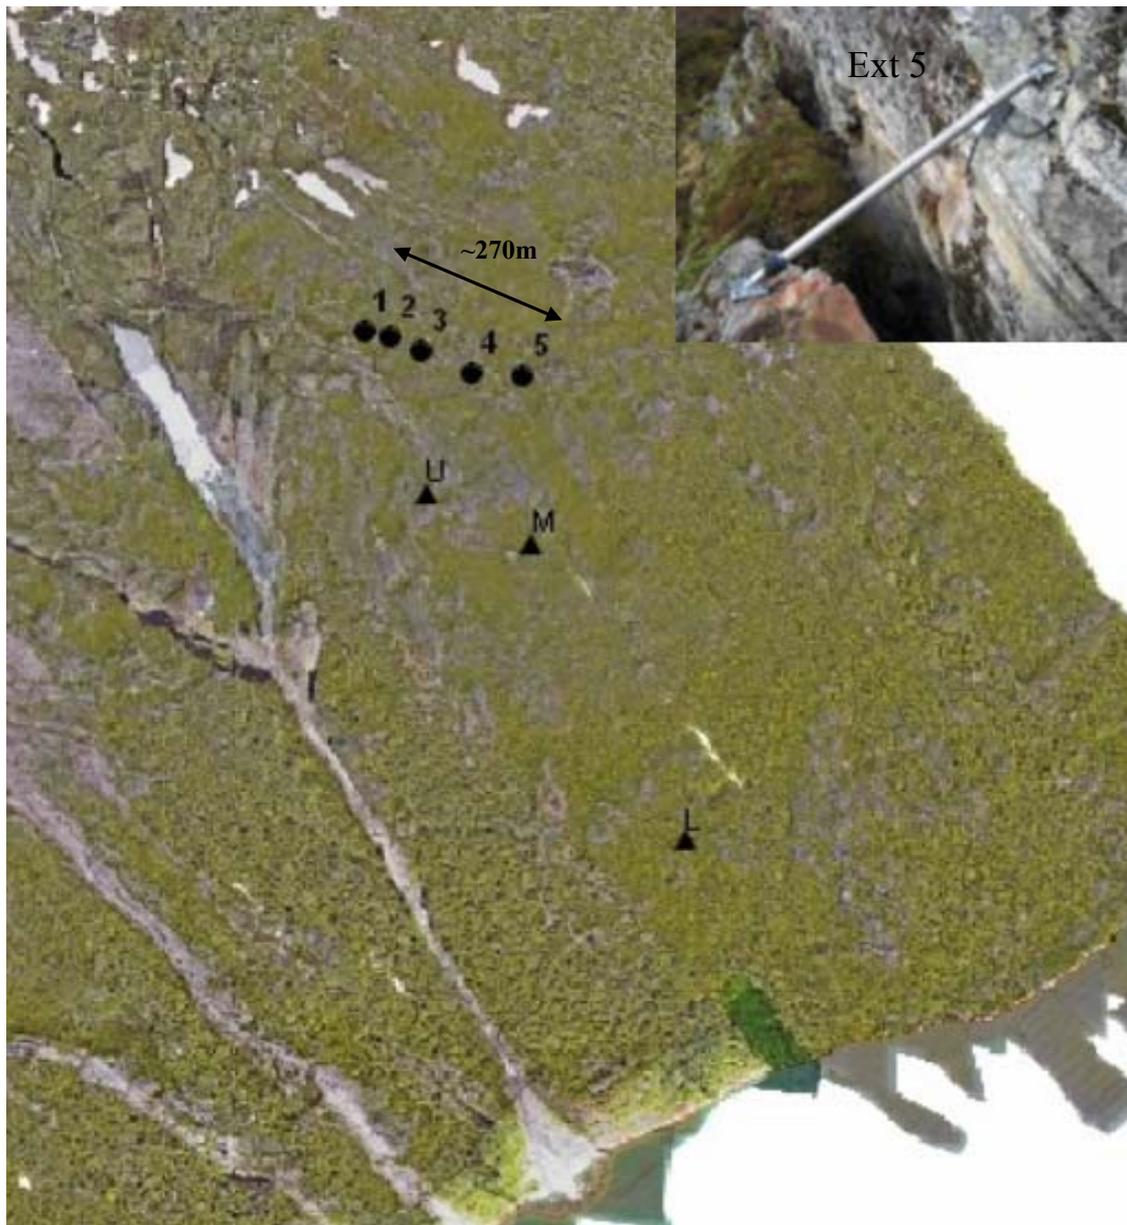
Figure 5. Ortophoto of the Åknes Landslide area. The extensometers along the upper crack are marked with circles and numbers (Nos.1 – 5). A detail of Ext 5 is shown. Locations of core borings are marked with triangles. (U = upper, one boring, M = middle, two borings and L = lower, one boring).

With reference to Figure 5 Mp 1 is placed 10m east of Ext 1, Mp 3 is placed a few metres east of Ext 1, and Mp 2, Mp 4a and Mp 4b are placed a few metres west of Ext 4.

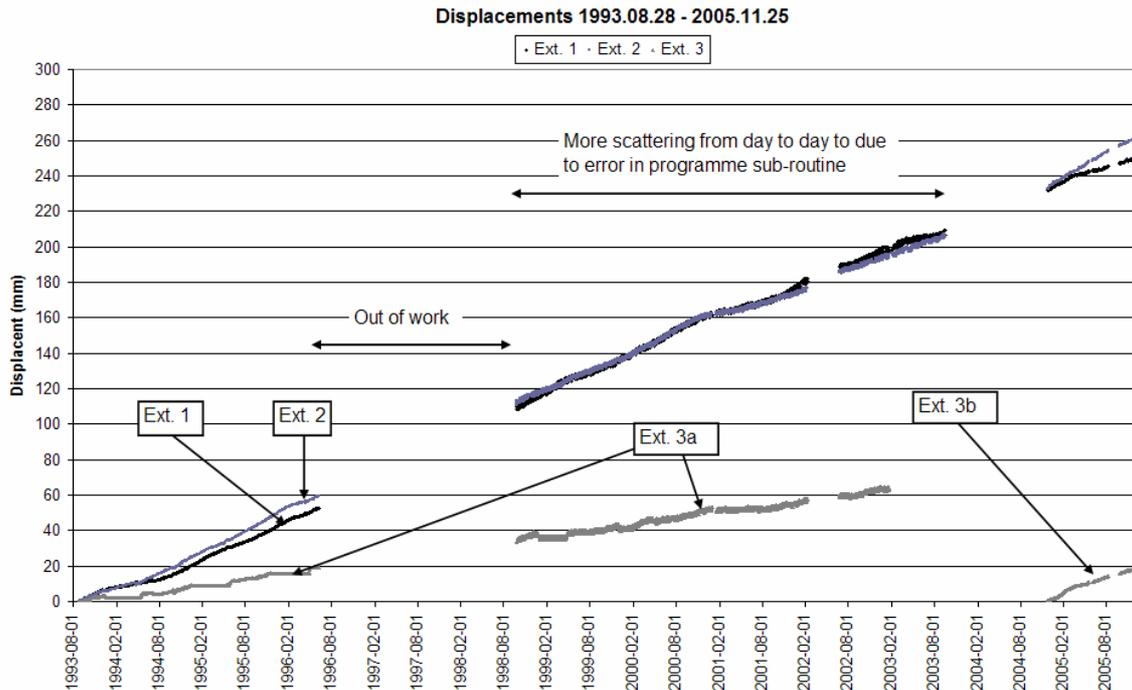
Figure 6. Displacements at the upper crack. Extensometer readings from 1993-08-28 to 2005-11-25. Ext 3b is a replacement of Ext 3a which was destroyed. Ext 3b is aligned more parallel to the slope movement than Ext 3a, which means that Ext 3b picks up a larger portion of the movement.

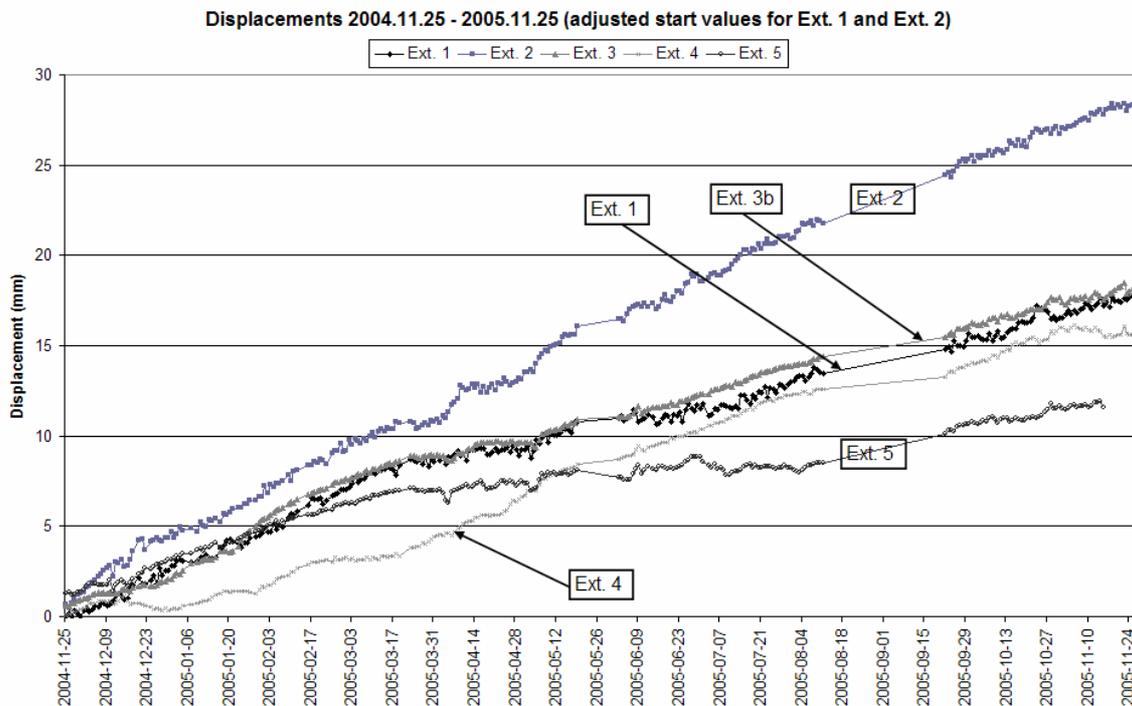
Figure 7. Displacements at the upper crack. Extensometer readings from 2004-11-25 to 2005-11-25.

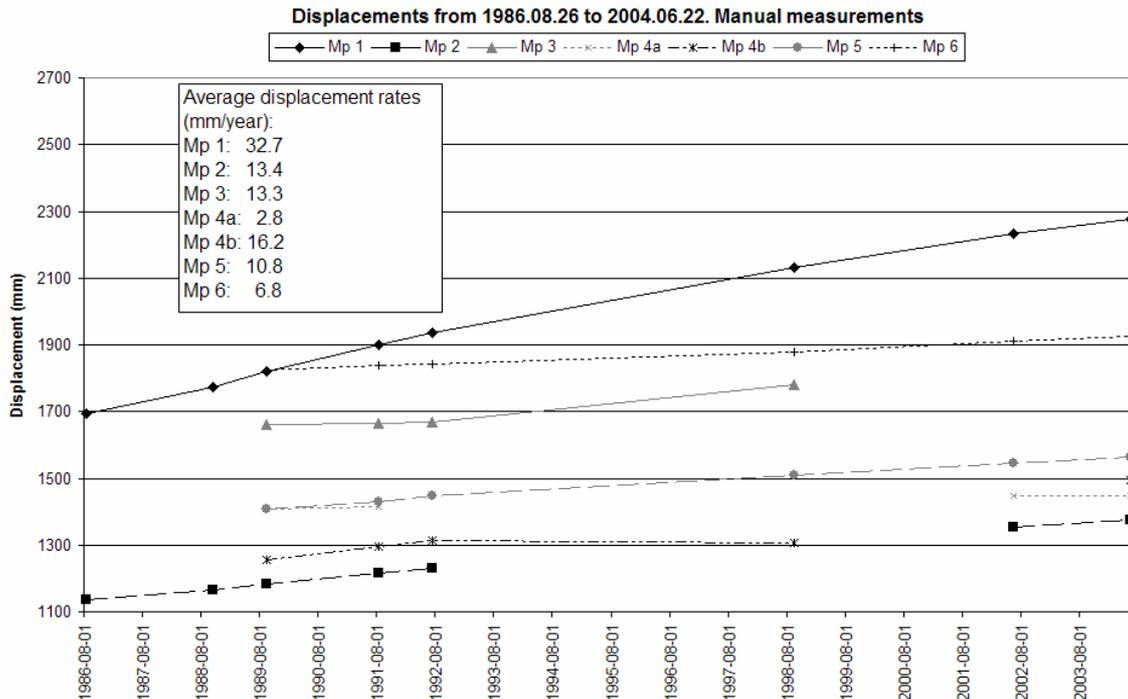
Figure 8. Displacements at the upper crack. Manual measurements from 1986-08-26 to 2004-06-22.

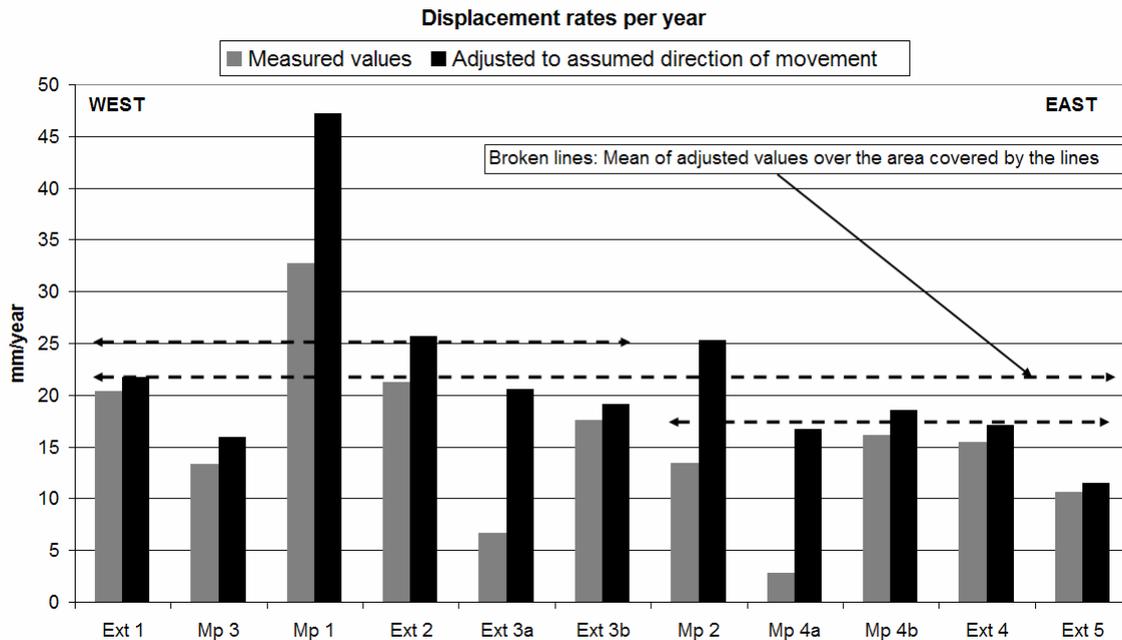
Figure 9. Displacements at the upper crack in terms of mean values per year. The assumed direction of movement is N157°/35° (dip direction/dip angle), which is sub-parallel to the slope itself. Ext 3a was in operation up to 2003-01-22. Ext 3b was put into operation 2004-11-25 at almost the same location as 3a, but aligned more parallel to the assumed direction of movement.

Figure 9 sums up the displacement in terms of mean displacement per year for all the measuring locations at the upper crack. The recorded values have been adjusted to an assumed direction of slope movement. This adjustment should not be regarded as a “correct” adjustment, but is believed to give a better comparison of the results than the measured values since some of the measuring directions are quite oblique to the assumed direction of movement, meaning that they only pick up a fragment of the real displacement. The mean values of the adjusted values for all measuring locations are 21.7mm/year, in the westernmost part 25mm/year and in the eastern part 17.8mm/year. Ext 5 in particular draws down the mean value of the eastern area. Ext 5 is located about 30m west of the point where upper crack dies out as a clearly visible open crack. From Figures 6 – 8 it is clear that the displacements at the upper crack go on with an overall steady pace. Some periods with faster movements and some periods with slower movements can be identified, but there is no general tendency of acceleration or deceleration. It may be noted that some places, near the upper crack, narrow cracks sub-parallel to the upper crack, exist. Up to now, these cracks have not been monitored, but their existence shows that the total displacement in the upper part of the slide area is somewhat larger than shown in Figures 6 – 9.

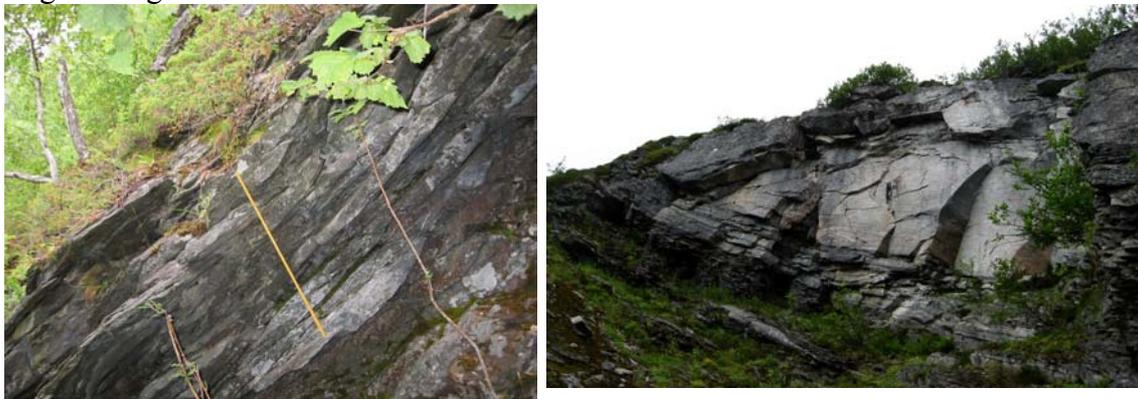
Figure 10. Rock outcrops. Left: dense jointing along the foliation. Right: dense jointing along the foliation with more massive rock above.

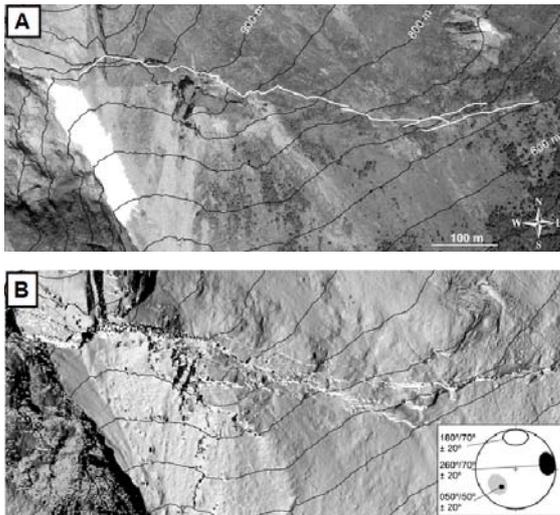
Figure 11. A) Orthophoto of the upper part of the Åknes landslide. The white line is the open upper crack. B) Detection of the cells of the DEM which have orientations that correspond to the joint sets J1 (foliation joints, white), J2 (black) and J3 (grey) respectively. From Derron, M.-H., et.al. (2005).

Derron, M.-H., et.al. (2005) identified three joint sets in the upper part of the landslide area by structural analysis of the DEM (Figure 11). The mean orientations of the joint sets are: J1-N180/45 (foliation parallel joints), J2-260/70 and J3-050/50. Derron, M.-H., et. al. (2005) compared this to field mapping of joints along and near the upper crack and found a fairly good agreement (Figure 12).

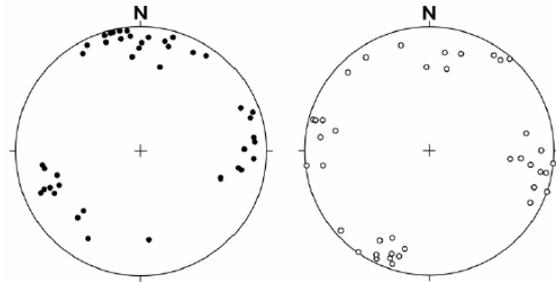
Figure 12. Measurements of the joint orientations of the upper part of the Åknes landslide. Left: DEM analysis. Right: Field measurements (courtesy of Braathen, A.). Lower hemisphere stereographic projections. From Derron, M.-H., et.al. (2005).

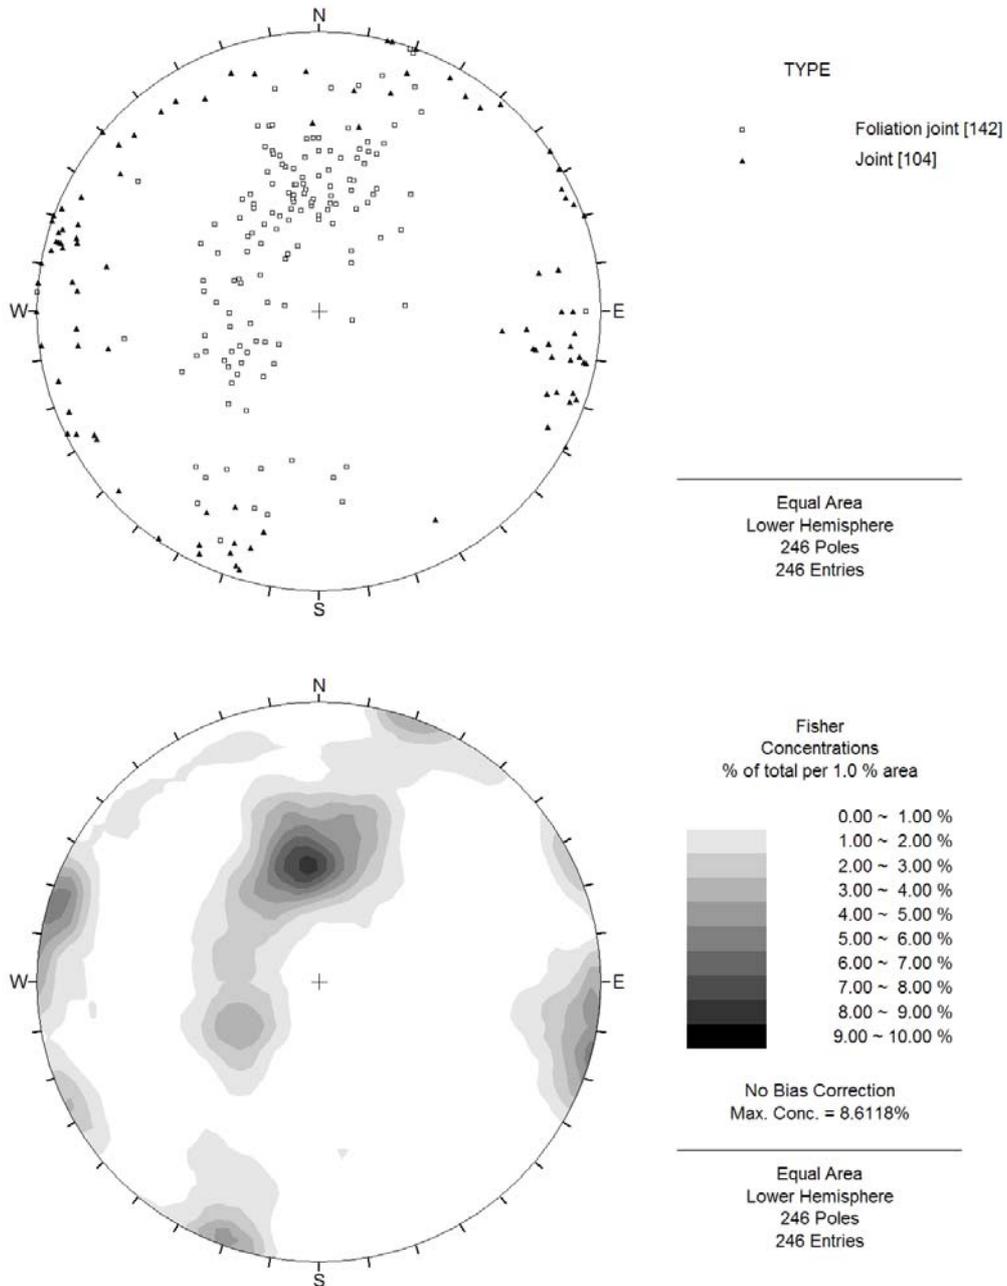
Figure 13. Structural measurements in the landslide area. Top: Pole plot of all the joints. Bottom: Contour plot.

246 orientations have been measured by field mapping in the whole landslide area, distributed as 142 foliation parallel joints and 104 joints that are not parallel to the foliation (Figure 13). Figure 13 compared with Figure 12 shows that the joint orientations are much more scattered when measurements from the whole landslide area are included. Figure 13 shows also that the joints that are not parallel with the foliation are generally sub-vertical.

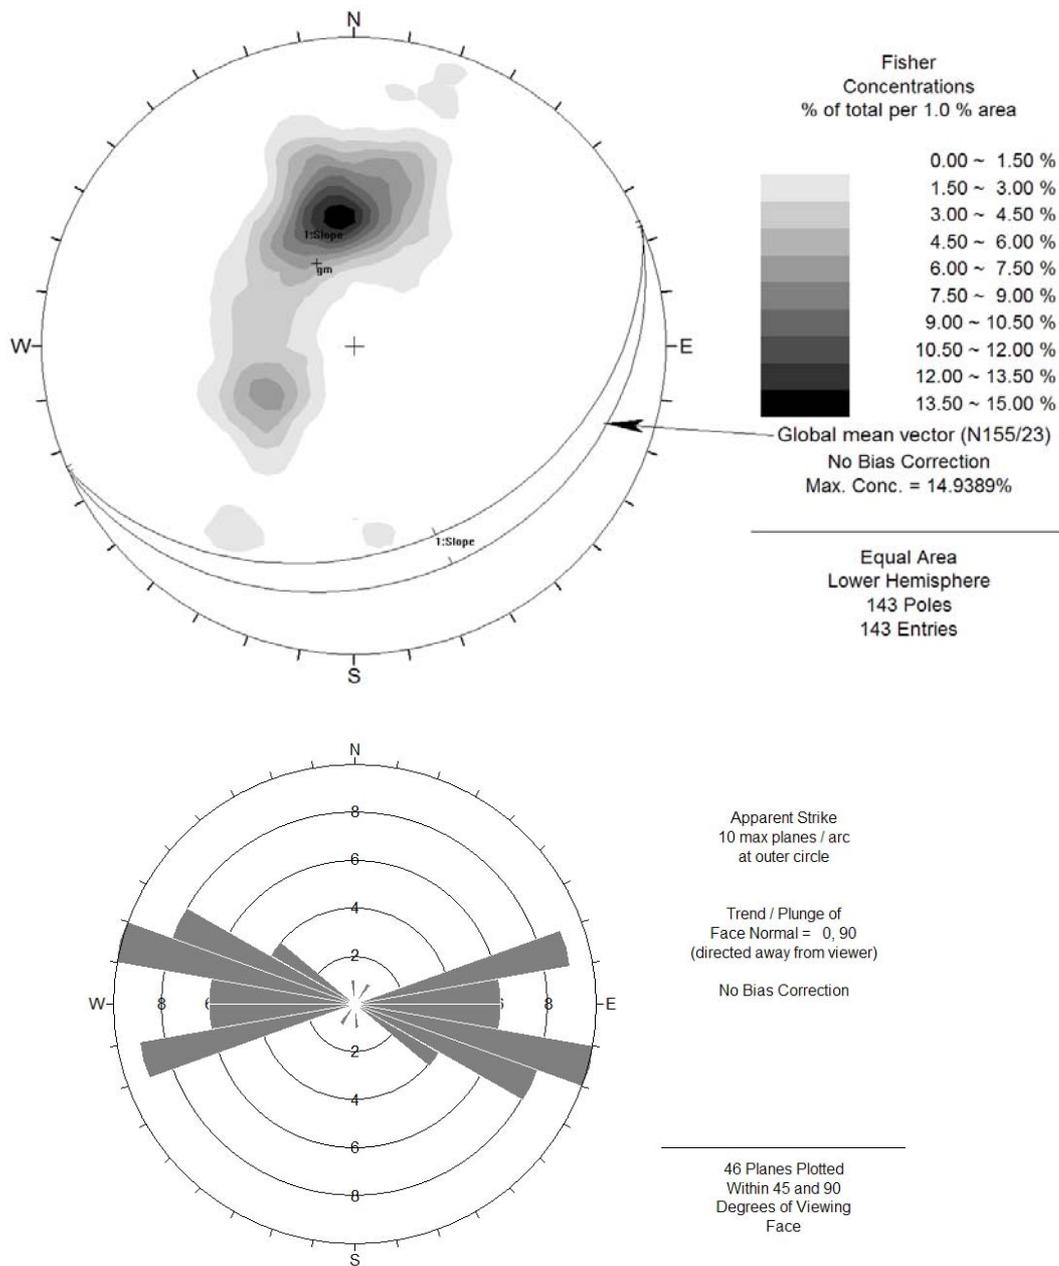
Figure 14. Foliation joints. Top: Contour plot with the global mean vector and the slope orientation. Bottom: Rosette plot.

Only foliation parallel joints have been plotted in Figure 14. It is clear from the plot that the global mean vector of the foliation joints (N155°/23°) is nearly parallel with the slope orientation (N157°/34°).

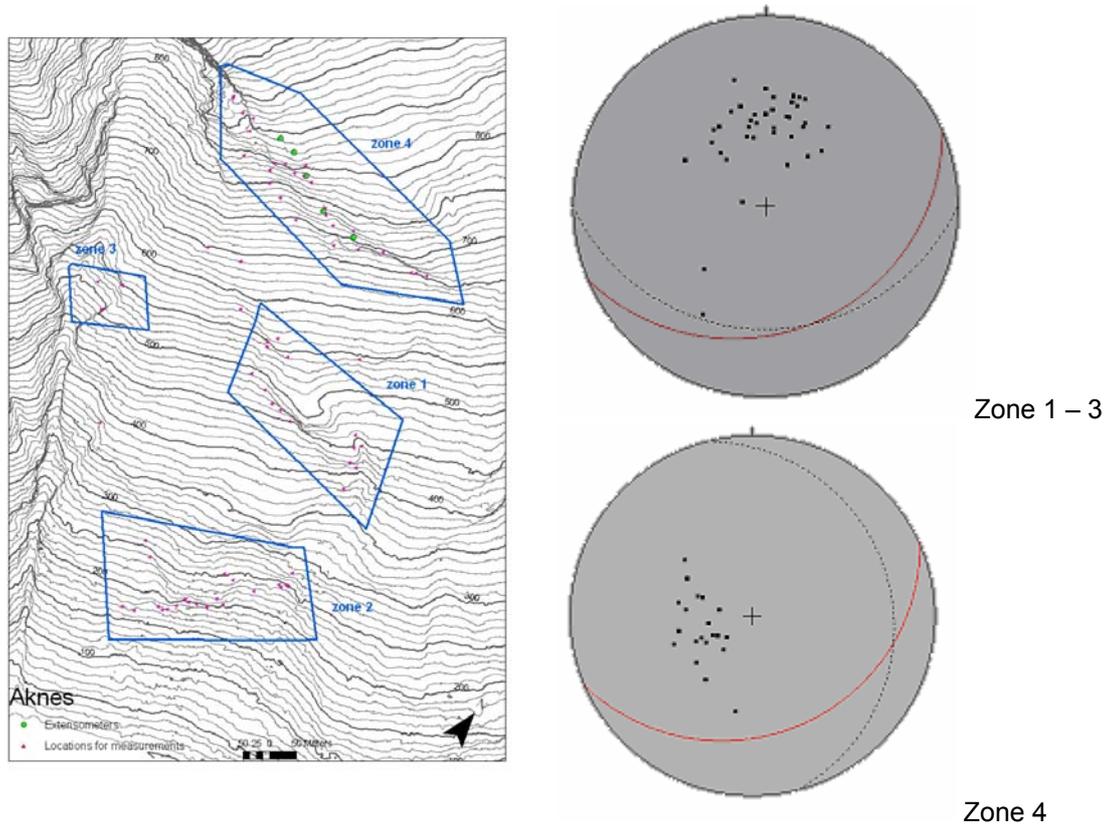
Figure 15. Pole plots showing foliation joints in different areas of the slope. The mean great circle calculated from the pole plot is shown as the dotted line. The slope is shown as the solid line.

Foliation joints from different areas are shown in Figure 15. The figure shows that the foliation generally dips quite parallel to the slope in Zones 1 – 3 whereas the foliation dips more easterly and non-parallel to the slope in the upper part along the upper crack (Zone 4).

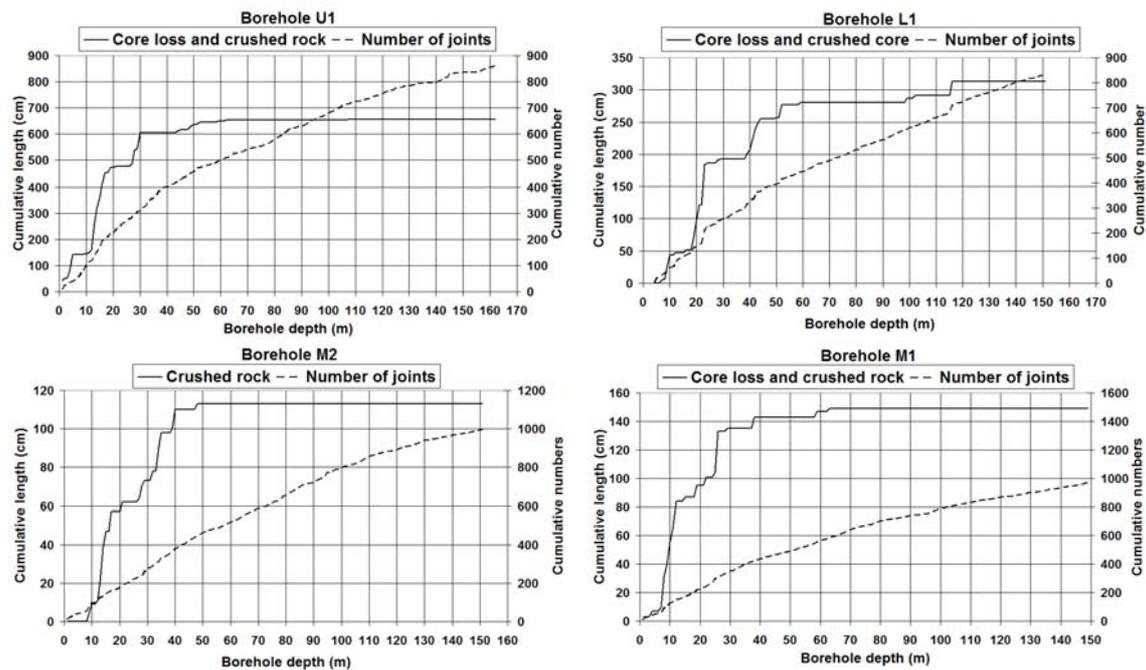
Figure 16. Cumulative number of joints and cumulative length of core loss / crushed core for Boreholes U1 (vertical), L1 (vertical), M2 (vertical) and M1 (60°).

The jointing and core loss / crushed core in the boreholes are summarized in Figure 16.

Figure 16 shows that the major part of the core loss / crushed core has occurred from 0m to 50 – 60m depth, and that the joint frequency decreases at about 50m in all four boreholes. It is reasonable to assume that some, perhaps the major part, of the poor rock mass quality leading to core loss / core crushing during drilling is associated with ongoing movements in the slope. It follows from this assumption, that ongoing movements in the slope may be restricted to depths of about 60m.

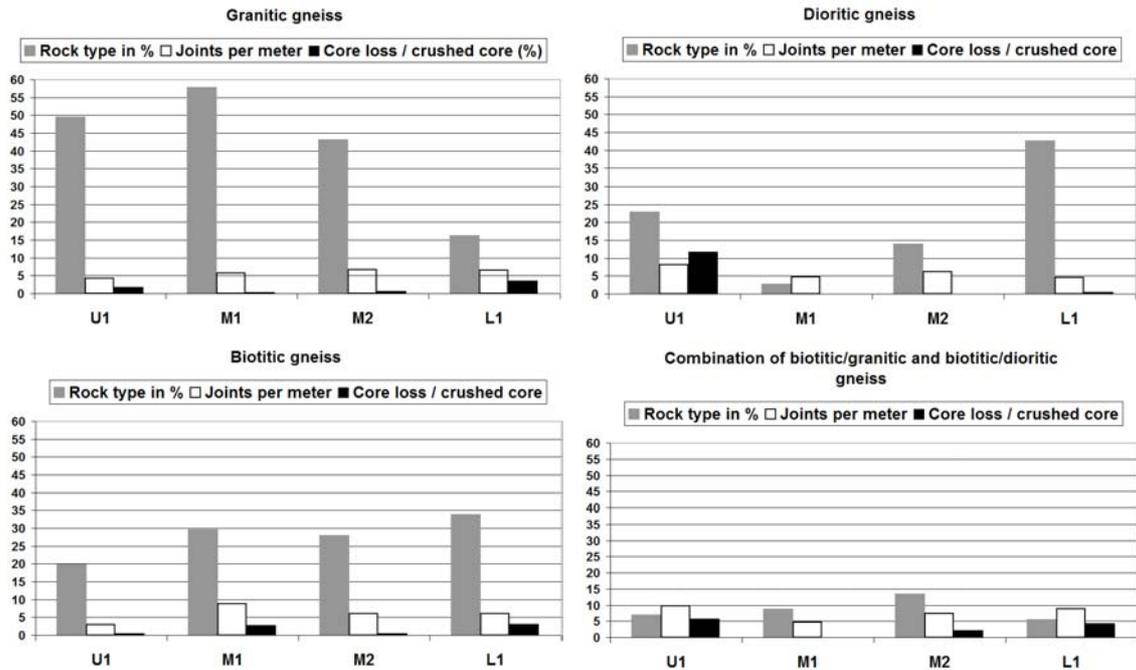
Figure 17. Rock type distribution, joint frequency and core loss / crushed core for the full lengths of Boreholes U1, M1, M2 and L1. Core loss / crushed core is given as percentage of the total length of the rock type in the borehole.

Figure 17 shows the rock type distribution, joint frequency and core loss / crushed core for the full lengths of the four boreholes. Figure 18 shows the same information, but restricted to the upper 60m of all four boreholes. Figure 17 does not reveal any specific trends with respect to core loss / crushed core and joint frequency versus rock type. Figure 18, however, shows that the biotitic gneiss and biotitic gneiss in combination with granitic or dioritic gneiss has more core loss / crushed core than the other rock types, and also; it is more jointed. Figure 19 shows that the dioritic gneiss has most core loss / crushed core when one looks at the total without considering the distribution in the various boreholes. However, this is caused only by the large portion of core loss / crushed core of dioritic gneiss in Borehole U1.

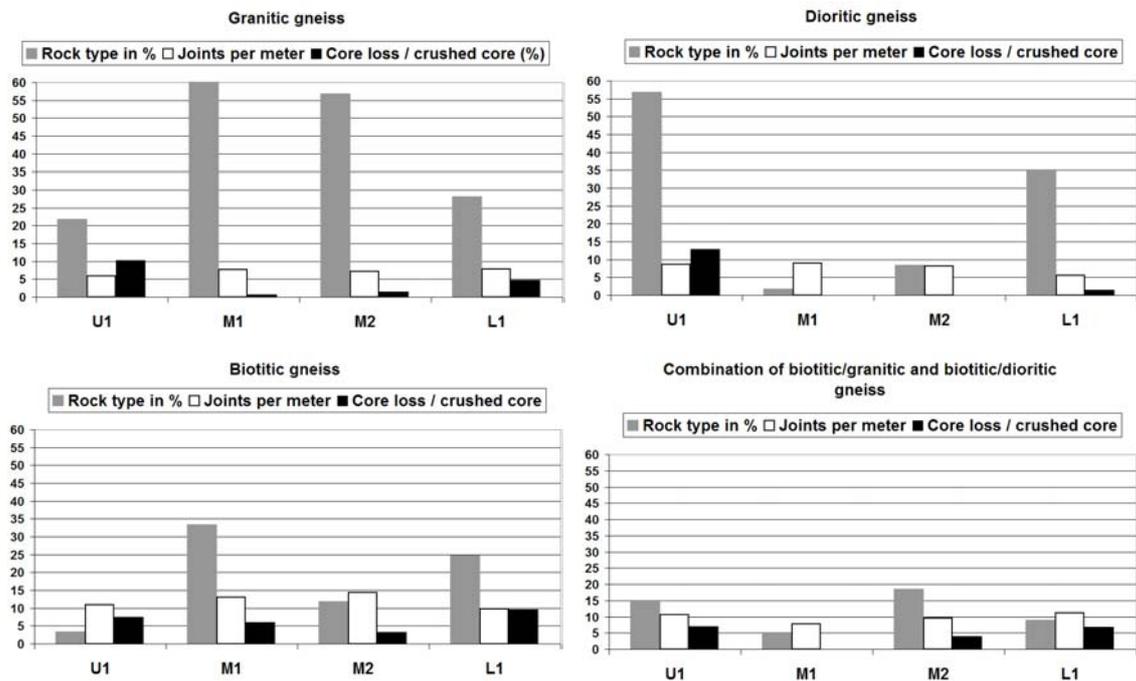
Figure 18. Rock type distribution, joint frequency and core loss / crushed core for the upper 60m of Boreholes U1, M1, M2 and L1. Core loss / crushed core is given as percentage of the total length of the rock type in the upper 60m of the borehole.

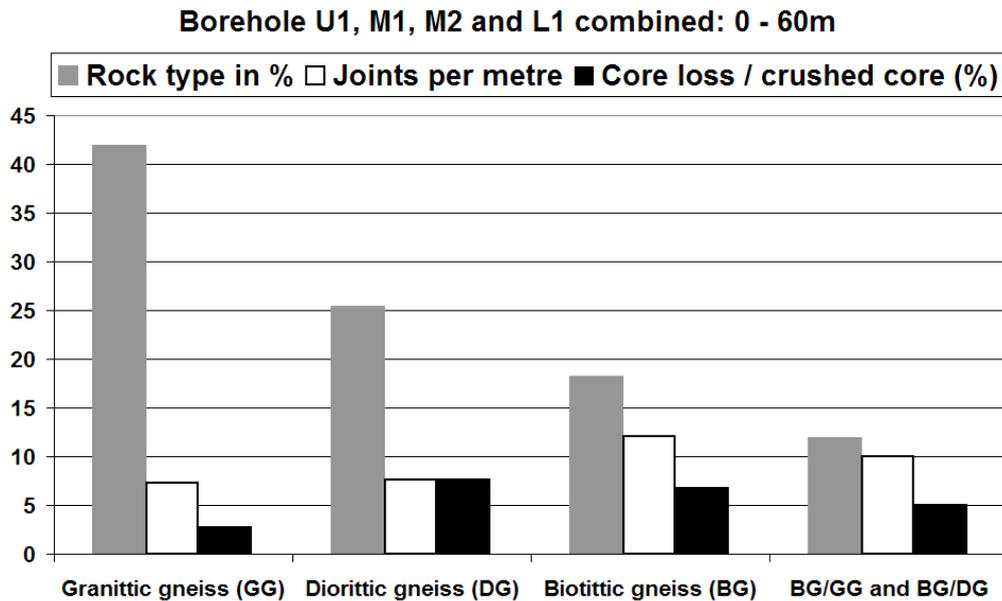
Figure 19. Rock type distribution, joint frequency and core loss / crushed core for the upper 60m of Boreholes U1, M1, M2 and L1 combined.

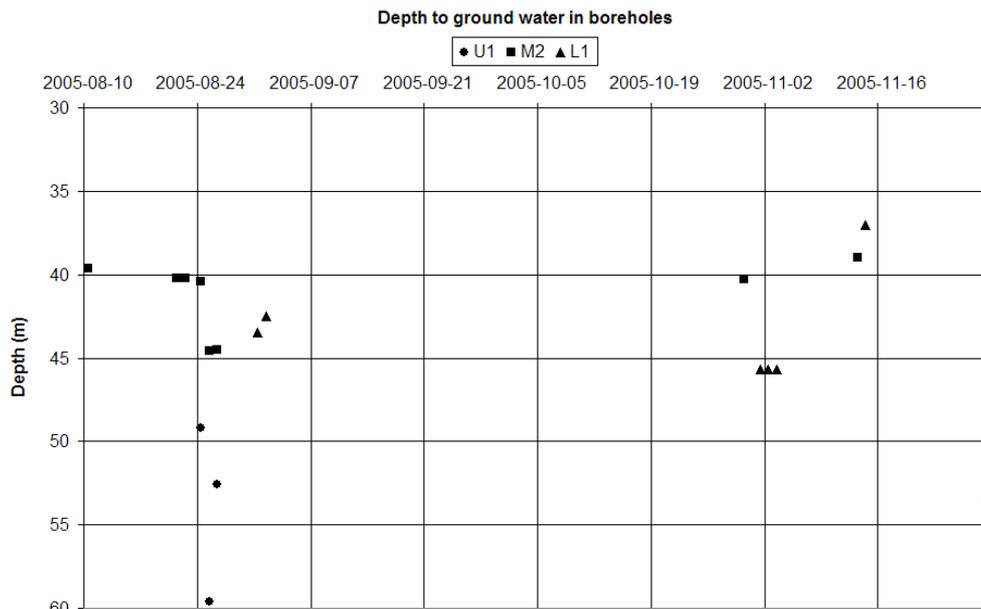
Figure 20. Depth to ground water in the vertical boreholes U1, M2 and L1.

The depth to the ground water in the four boreholes has been measured a few times during the autumn 2005 (Figure 20). In this period the depth is around 50 – 60m in Borehole U1, and around 40 – 45m in Boreholes M2 and L1. Continuous monitoring of the ground water level in Borehole M2 started in December 2005, and in the period December 2005 – February 2006 the depth to the ground water has fluctuated between 38m and 40m. The period of measurement is too short to draw firm conclusions about the ground water, but pretty large depths to the ground water in the slope are certainly indicated.

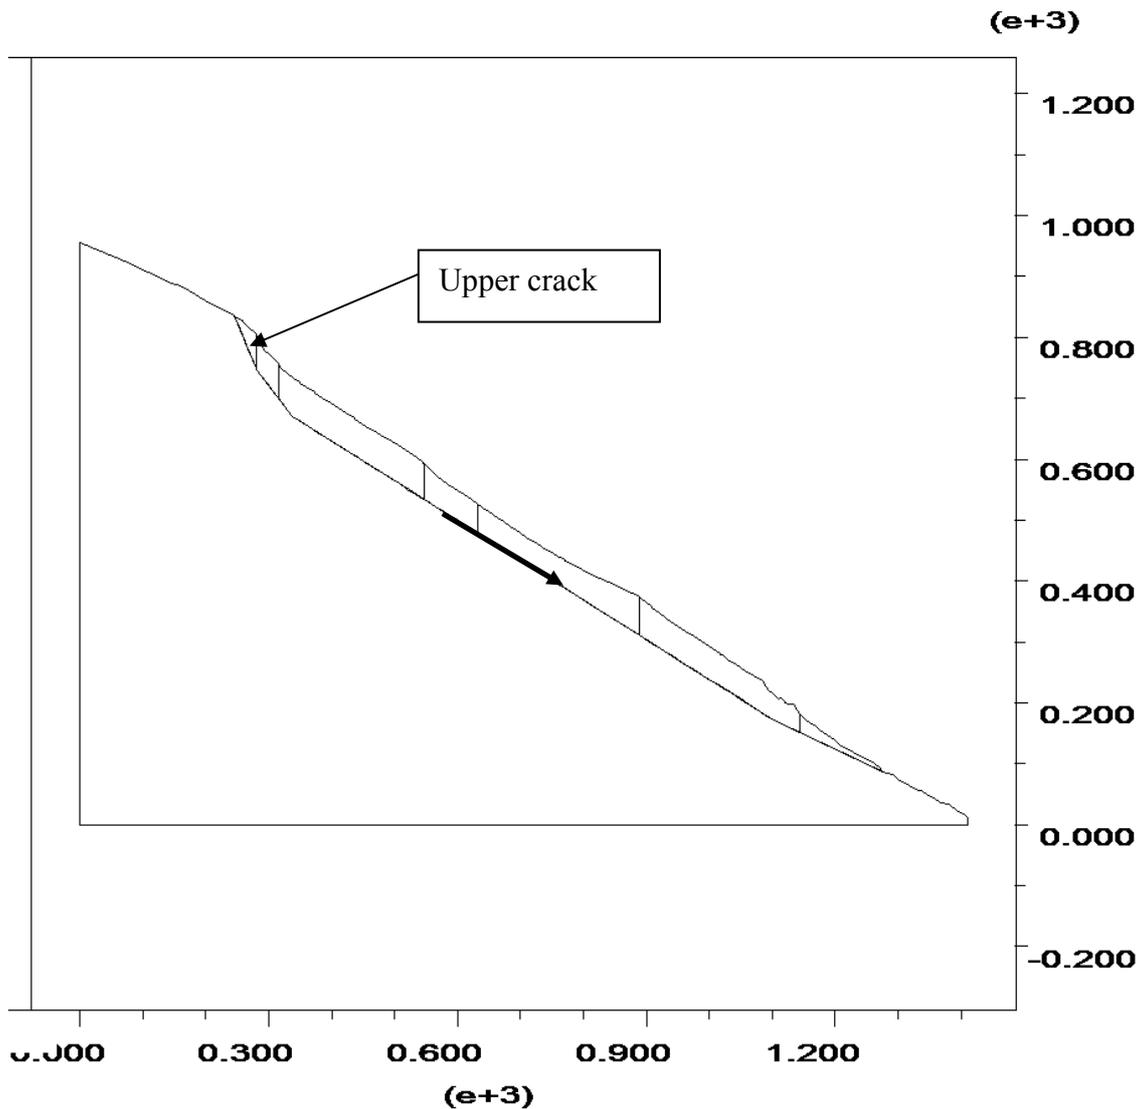
Figure 21. Profile through the central part of the landslide area. Possible lowest level of shear movements are indicated (modified after geophysical survey conducted by the Geological Survey of Norway).

The instability of the Åknes rock slope appears to be caused mainly by unfavourable orientation of the foliation in relation to the orientation of the slope. The presence of gneiss rich in biotite may play an important role due the relative weakness of this rock type. The instability may be restricted to depths of about 60m below the ground. It is suggested that shear movements along the foliation take place at several levels in the rock mass from depths of about 60m and upwards. The possible maximum depth of about 60m may be governed both by the presence of ground water at these depths as well as the slope inclination of 35 – 40°. A possible lower failure plane is indicated in Figure 21.
